Aberdaunant, Llanerfyl Bat Report

Prepared for Chrysalis Architectural Design

Project Number TT3219

Document Number R01-Bat Roost Assessment-Rev01

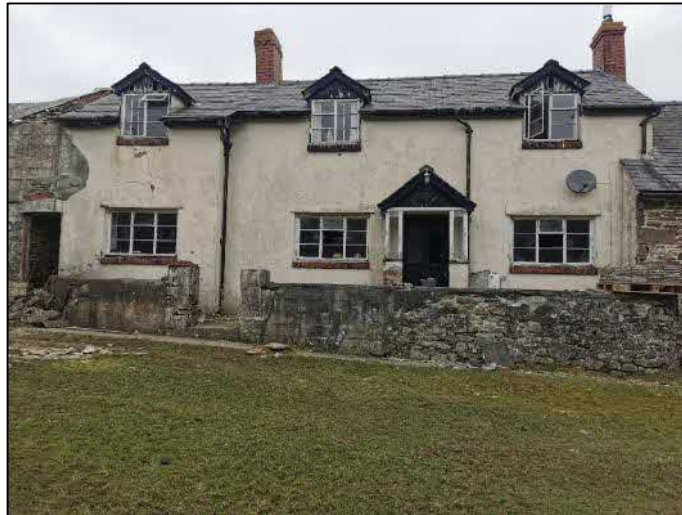
Plate 1. South-eastern elevation of the farmhouse

The farmhouse at Aberdaunant is a two-storey white-rendered property with pitched, slate tiled roof and three brick chimneys. A porch, dormer windows and metal-framed windows, some of which contain broken panes of glass, are present on the southern aspect (*Plate 1*). The northern aspect has a sloping roof down to the ground floor level with a combination of timber, uPVC and metal framed windows and doors (*Plates 2 and 3*). Timber soffit boxes are located along the north-western and south-eastern elevations and timber barge boards are located on the north-eastern and south-western gable ends (*Plates 2 and 4*).

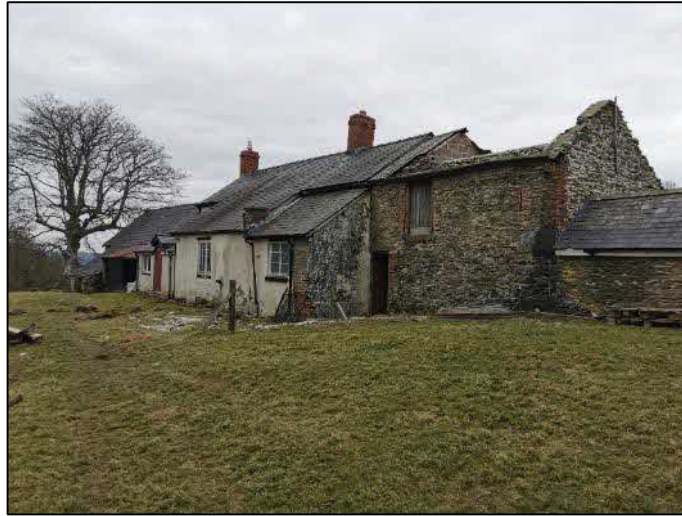
Plate 2. North-western elevation of farmhouse, attached stone extension and Pigsty

A two-storey stone and concrete block extension is present on the western aspect of the farmhouse, this is in poor condition with the majority of the corrugated metal roof missing and the windows in a poor state of disrepair (*Plates 2 & 3*). A single storey pigsty adjoins the western end of the extension. The pigsty has stone walls and a pitched, slate tiled roof with timber roof frame and a timber barge board on the western gable end. Two open doorways are present along the southern elevation of the pigsty and a low level retaining stone wall is located to the south (*Plates 2 and 5*).

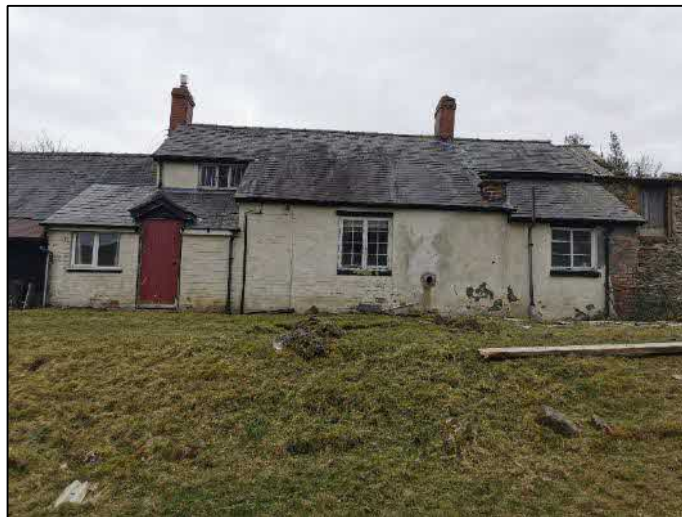
Plate 3. North-western elevation of farmhouse

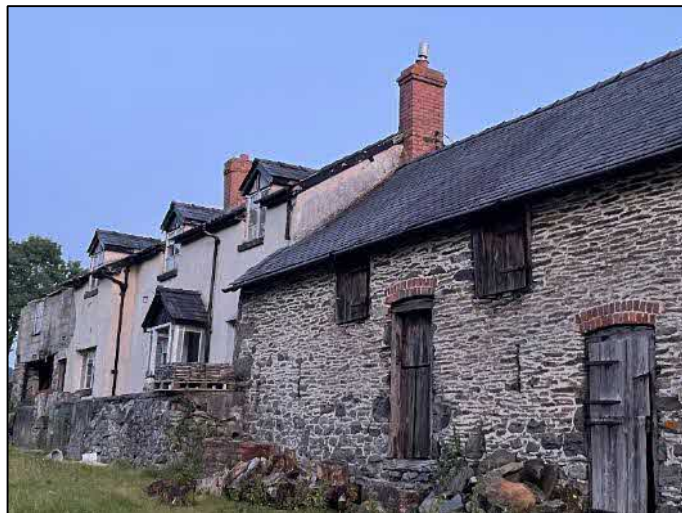
Plate 4. North-eastern gable end of farmhouse adjoining barn

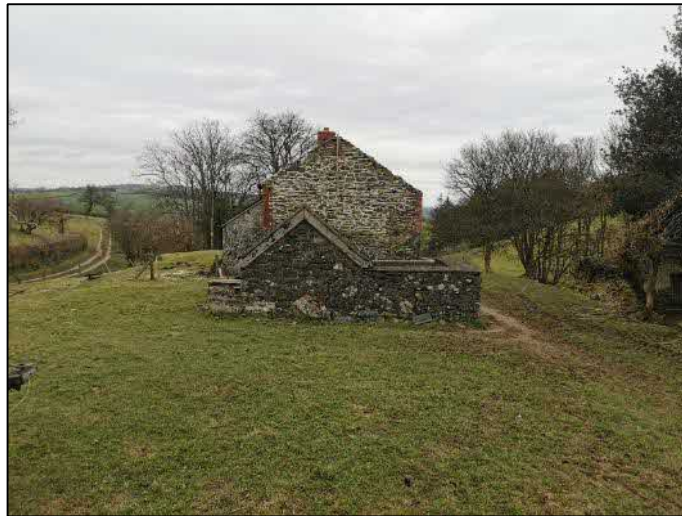
Plate 5. South-western end wall of the stone extension and single-storey pigsty

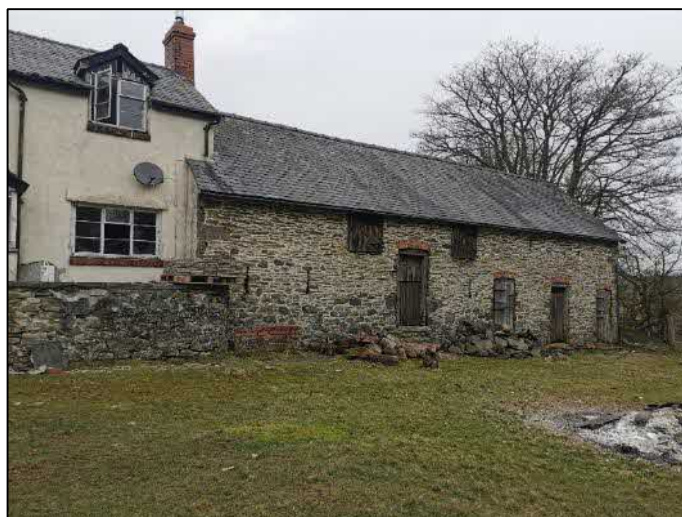
Plate 6. South-eastern elevation of agricultural barn

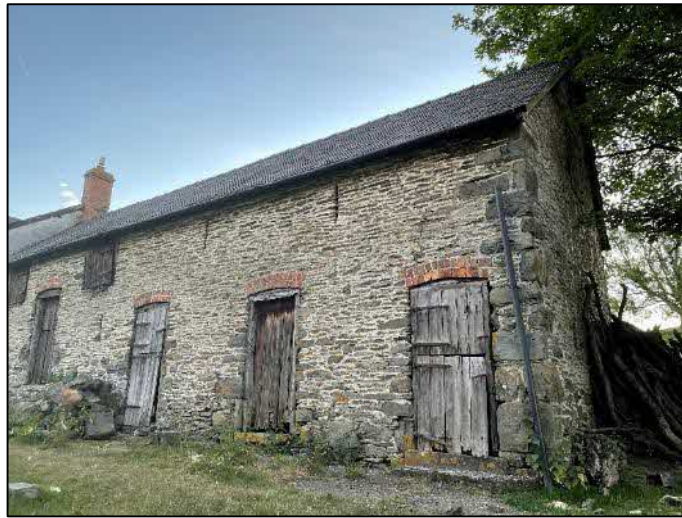
Plate 7. North-eastern gable end and south-eastern elevation of barn

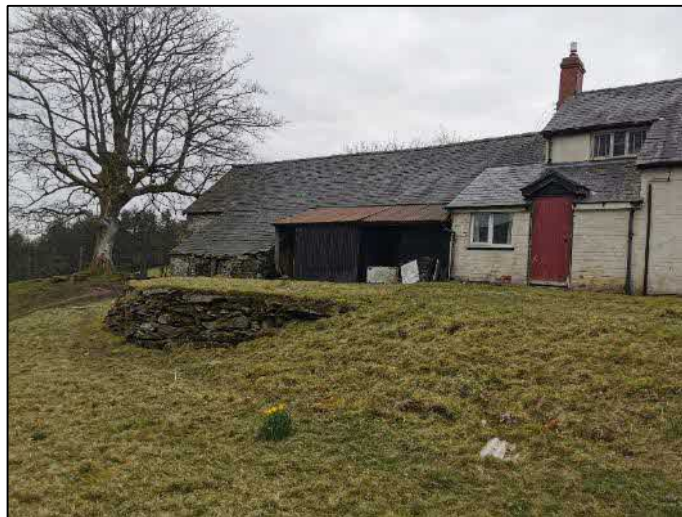
Plate 8. Northern aspect of agricultural barn and lean-to extensions

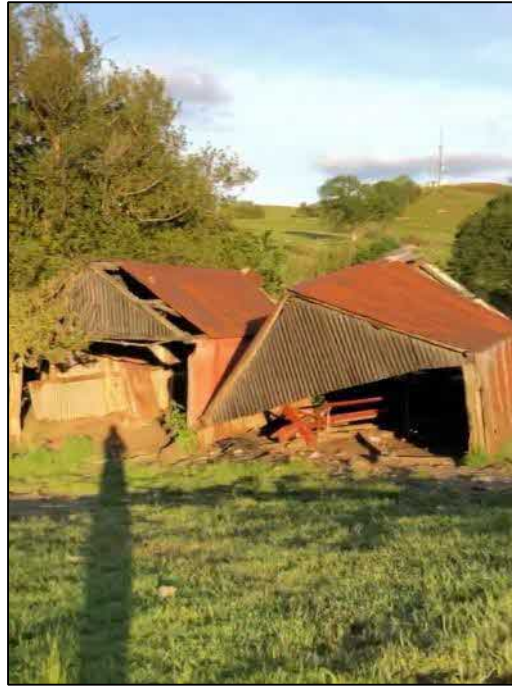
The outbuildings to the south-west of the farmhouse comprises two open-fronted, simple timber framed buildings with corrugated metal roofs and walls (*Plate 9*). The roofs of the outbuilding have missing tin sheets and the outbuilding to the south-west has partially collapsed. Both structures are disused and in very poor condition.

Plate 9. Outbuildings

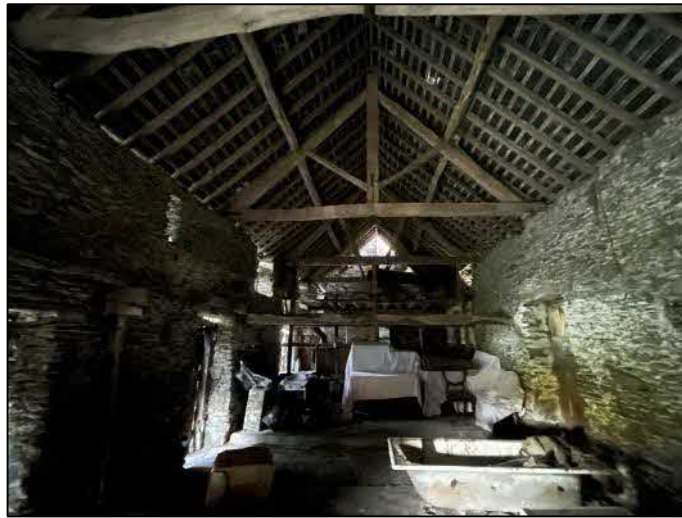
Internally the agricultural barn has exposed stone walls and a King post timber roof frame (*Plate 10*). Due to the shuttered windows and solid timber doors, the interior of the barn is dark with the exception of the southern gable end where there is a hole in the roof abutting the farmhouse. There is no enclosed loft space within the attached agricultural barn, the barn is open to the roof.

Plate 10. Interior of agricultural barn

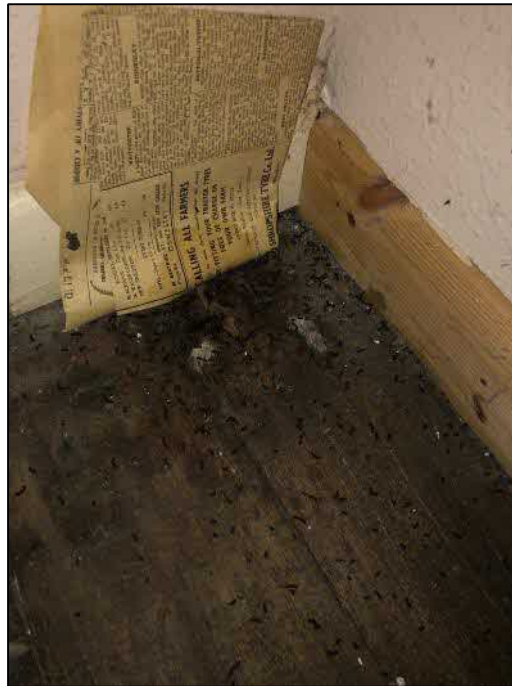
During the Preliminary Roost Assessment small numbers of scattered bat droppings characteristic of a Pipistrelle species were recorded within the ground floor of the farmhouse. An accumulation of bat droppings (<20) characteristic of Brown Long-eared Bat and a small number of moth wings were recorded in a doorway on the first floor landing. During the August activity surveys accumulations of fresh bat droppings characteristic of Lesser Horseshoe (*Rhinolophus hipposideros*) were noted in two locations on the landing of the first floor (*Plate 11*) and within the side loft on the first floor. An individual Common Pipistrelle was also observed roosting on the wall of the ground floor sitting room (*Plate 12*).

Plate 11. Accumulation of Lesser Horseshoe droppings on landing within farmhouse

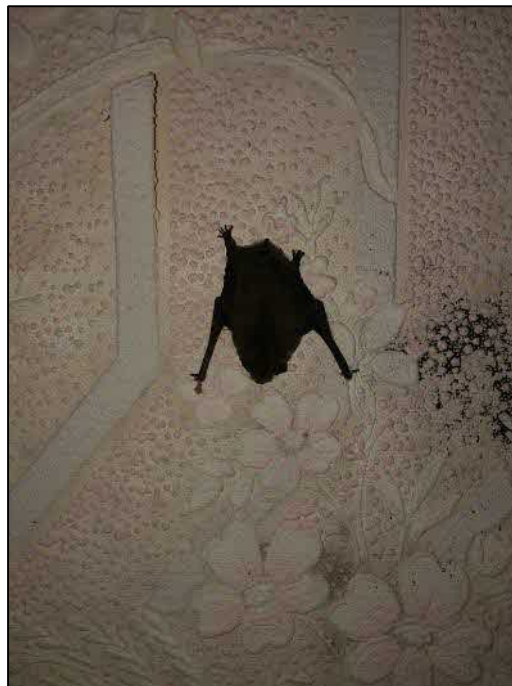
Plate 12. Common Pipistrelle within sitting room in farmhouse

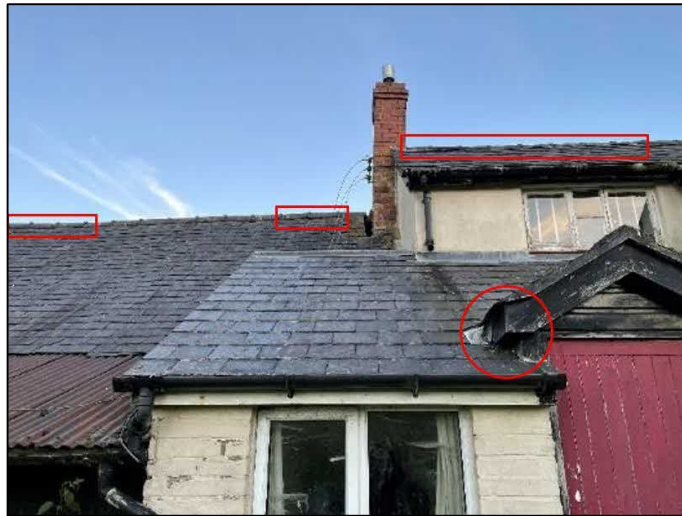
Numerous features suitable for roosting bats were recorded in and around the farmhouse and associated extension and pigsty. These included gaps along the ridge line, lifted and broken roof tiles, gaps around the chimneys (*Plate 13*), gaps around the dormer windows, gaps under the barge boards (*Plate 14*), holes into timber soffit boxes (*Plate 15*), holes into walls and wall tops (*Plate 16*) and gaps under lifted lead flashing. There is open flight access into the farmhouse via an open window on the first floor and broken panes of glass on the ground floor along the south-eastern elevation (*Plate 17*).

Plate 13. Gaps in flashing and under lifted ridge tiles

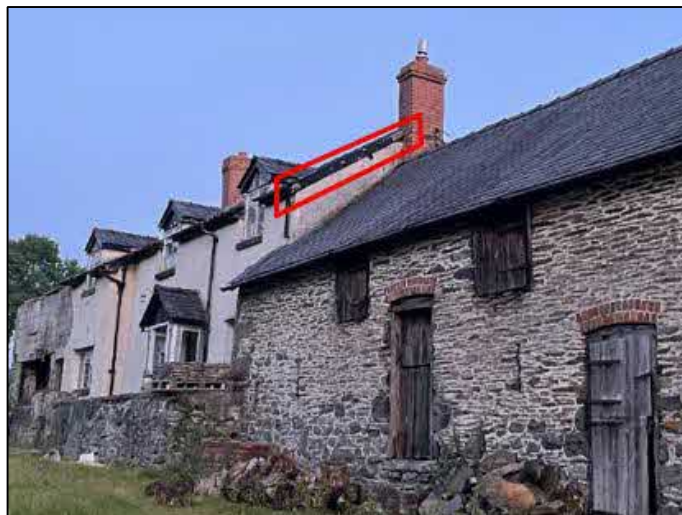
Plate 14. Gaps behind barge board and around chimney on north-eastern elevation of farmhouse

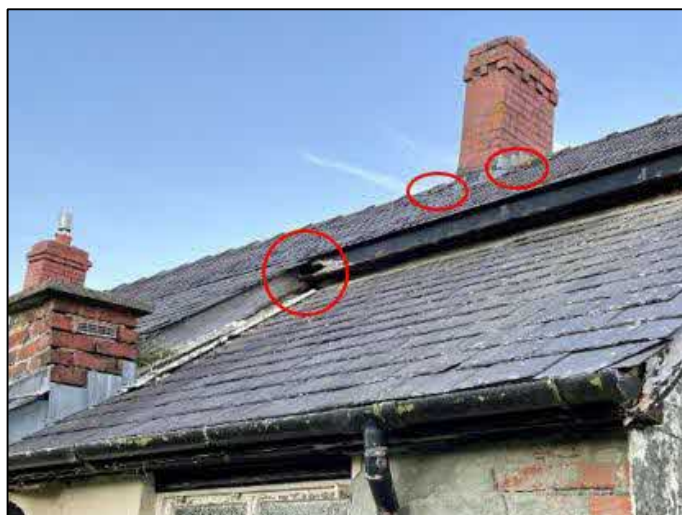
Plate 15. Hole in soffit and under lifted roof tiles

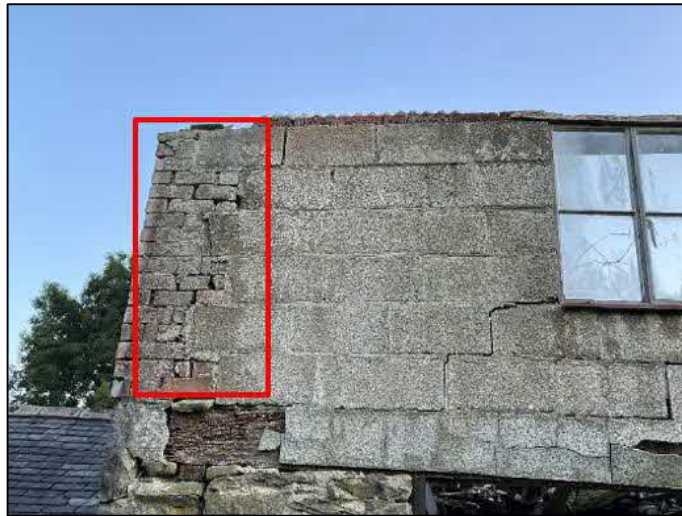
Plate 16. Holes into walls of extension

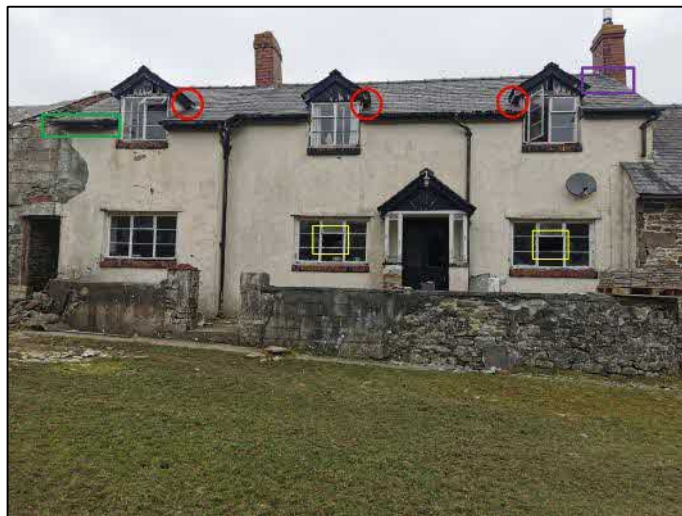
Plate 17. Gaps by dormer windows (red circles), broken windows on ground floor (yellow rectangles), open windows on first floor, gaps at wall top (green rectangle) and lifted tiles around chimney (purple rectangle)

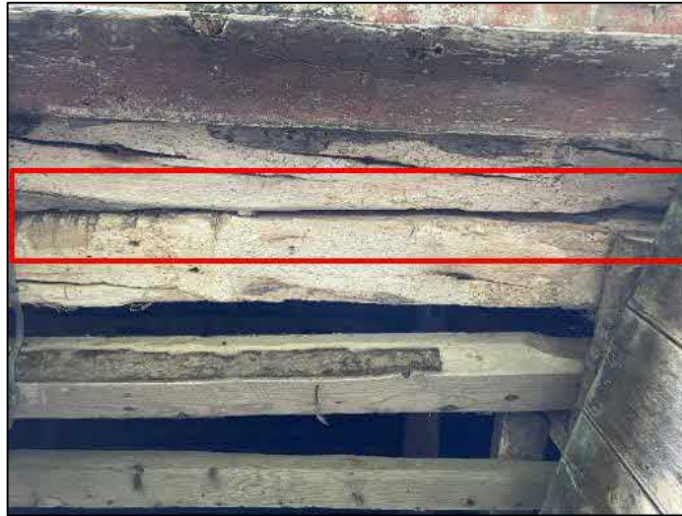
Scattered bat droppings characteristic of Brown Long-eared Bat and a Pipistrelle species were recorded within the barn and an accumulation of fresh droppings (<20) characteristic of Brown Long-eared Bat were noted below a hole into a door lintel with small numbers of droppings (<10) observed within the hole (*Plates 18 and 19*).

Plate 18. Hole in door lintel in barn where droppings characteristic of Brown Long-eared Bat were recorded within and below

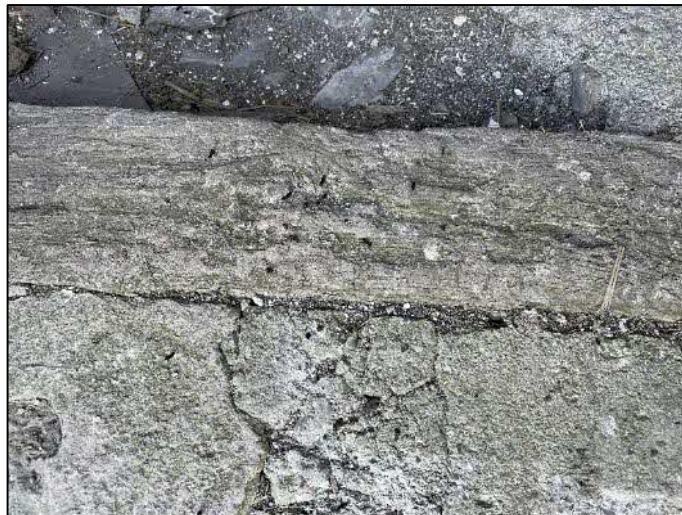
Plate 19. Droppings characteristic of Brown Long-eared Bat below door lintel in barn

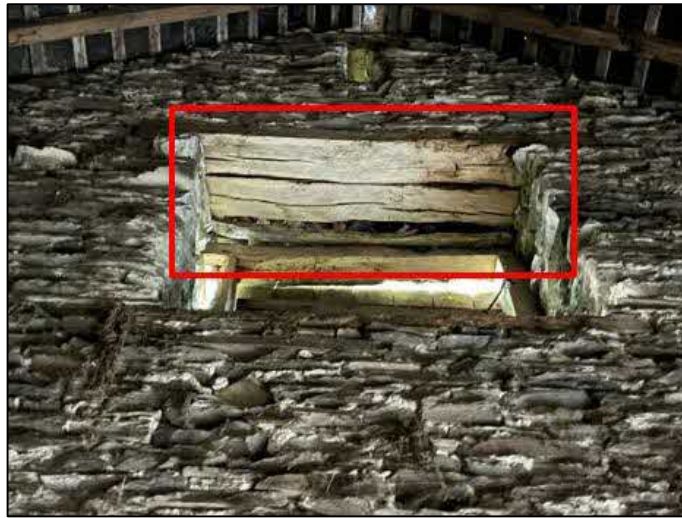
Numerous suitable features were noted around the barn which included gaps in the stonework, gaps around window and door frames and lintels (*Plate 20*), gaps at wall tops and gaps under lifted roof and ridge tiles (*Plates 13, 18 and 19*). There is open flight access for bats into the barn via the hole at the south-western end of the barn roof (*Plate 21*).

Plate 20. Holes in window lintel on north-eastern gable end of barn

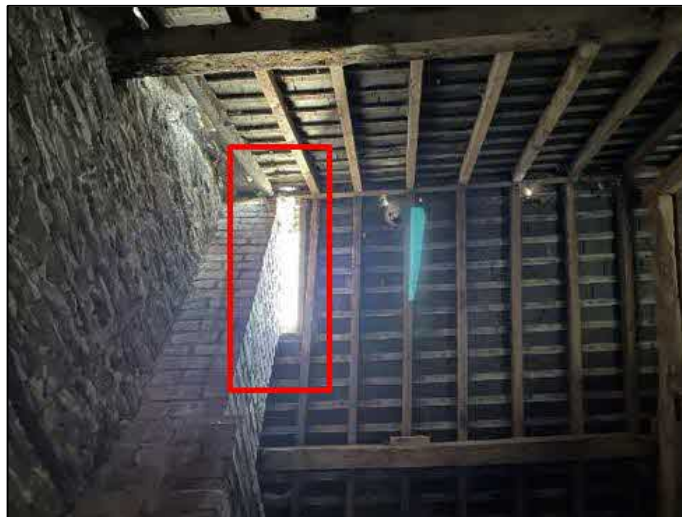
Plate 21. Hole in south-western end of barn roof

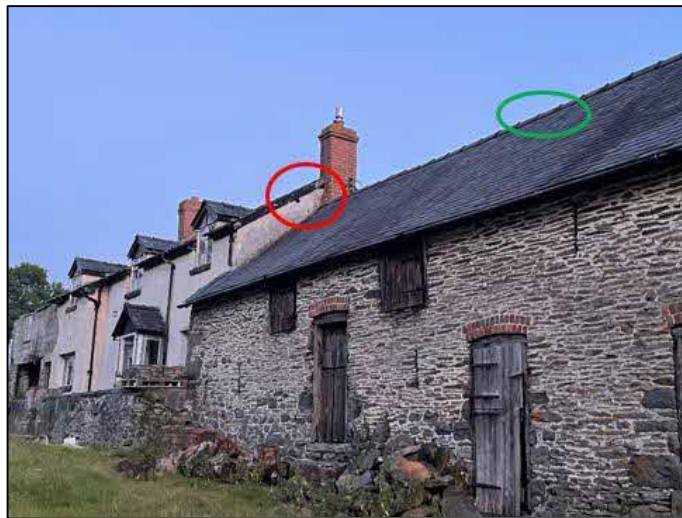
Plate 22. Emergence/re-entry location of Soprano Pipistrelles from north-eastern gable end (red circle), individual Common Pipistrelle and individual Whiskered/Brandt's Bat (green circle)

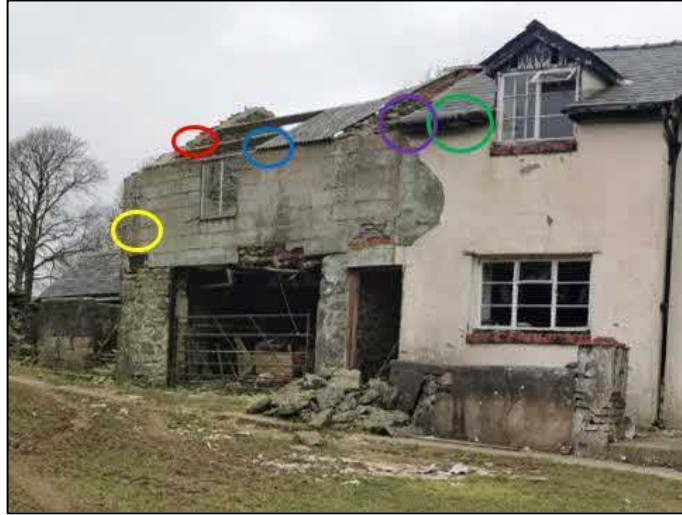
*Plate 23. Re-entry location of *Myotis* spp. (red circle), re-entry locations of two Soprano Pipistrelles (yellow circle), re-entry location of 3 Soprano Pipistrelles (blue circle), emergence location of individual Brown Long-eared Bat (green circle) and emergence location of an individual Soprano Pipistrelle (purple circle)*

Individual *Myotis* spp. re-entered a feature at the top of the south-west gable end wall (where there is no roof) at 04:10 (*Plate 23*)

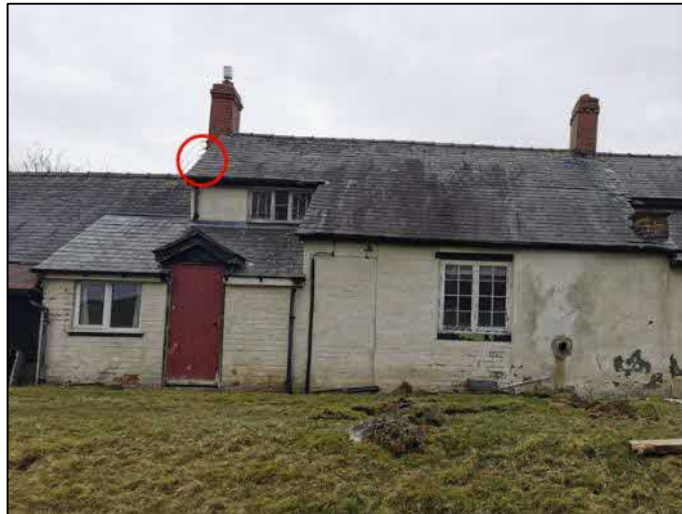
Plate 24. Emergence and re-entry location of individual Soprano Pipistrelle

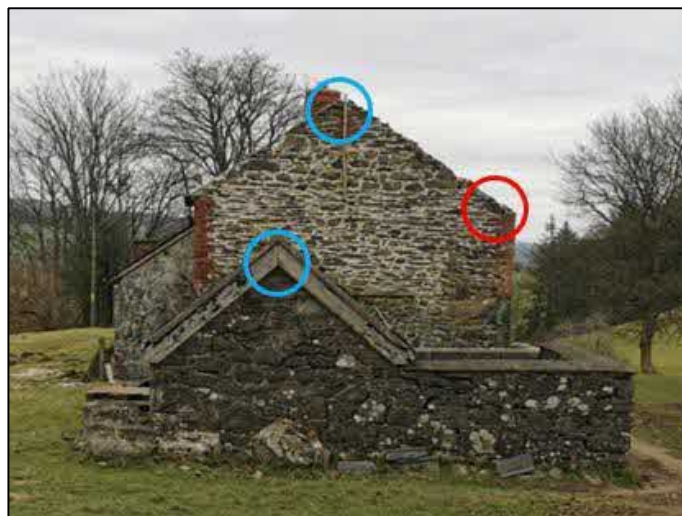
Plate 25. Emergence location of probable Pipistrelle species and individual Soprano Pipistrelle (red circle) and individual Soprano Pipistrelles (blue circle)

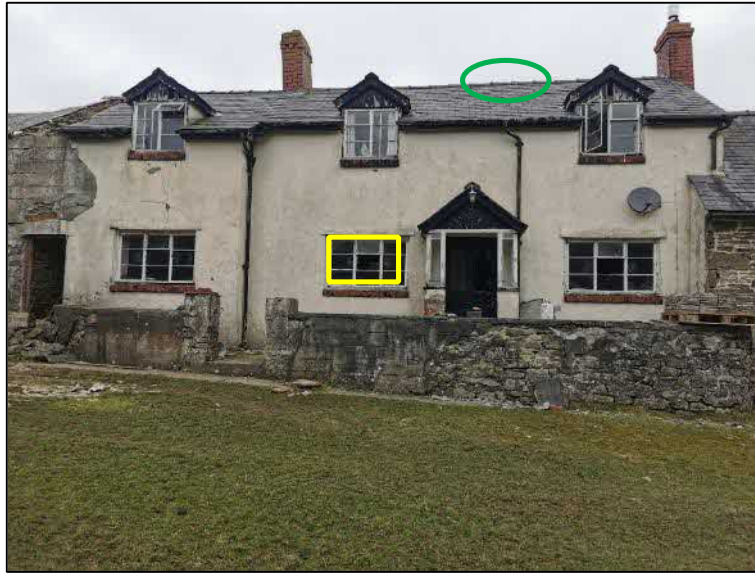
6 Soprano Pipistrelles emerged out of farmhouse via broken window on ground floor from **20:08 to 20:25** (*Plate 26*)

Plate 26. Location of emerging Soprano Pipistrelles via broken window (yellow rectangle) and location of emerging Common Pipistrelle from lifted ridge tile (green circle)

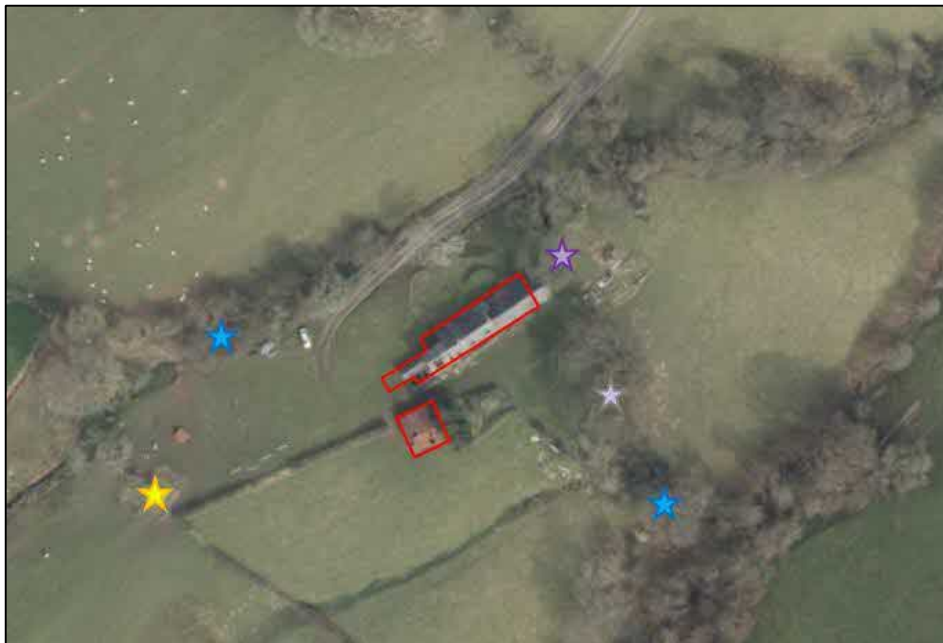
Figure 11. Proposed bat and bird box locations (yellow star = Schwegler 1FF, or equivalent and hole fronted nest box; blue star =Schwegler 2F, or equivalent, and open-fronted nest box, purple star=Causa maternity box or equivalent)

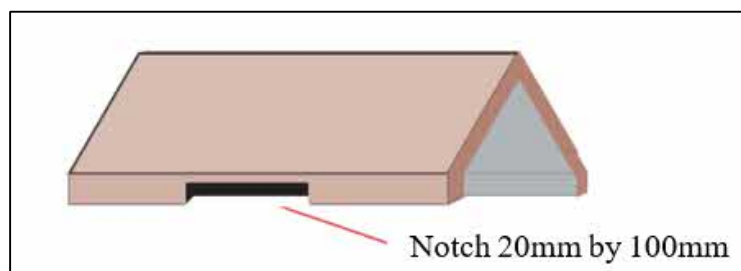
Figure 15. Creation of access and roosting opportunities under lifted ridge tiles in roof of new dwelling

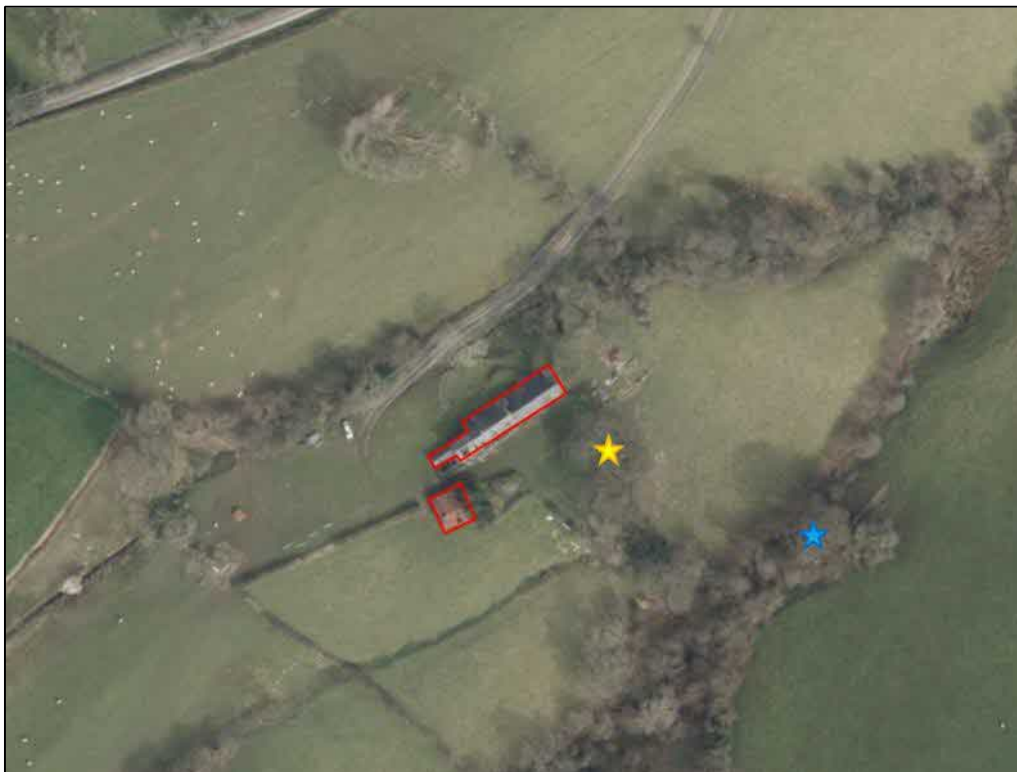
Figure 22. Location of hole fronted nest box (green star), large open-fronted nest box (yellow star), and Barn Owl box (blue star) on boundary trees

Replacement nesting features should be created as part of the proposals, and this will include one integrated open-fronted nest box and two integrated hole-fronted nesting boxes or bricks on southerly facing walls of the new residential dwelling (*Figures 11 and 12*). One large, open-fronted nest box suitable for Jackdaw will be erected on the trees to the south-east of the site, within the ownership boundary (*Figure 22*).

There are features that are suitable for nesting Barn Owl although no evidence of Barn Owl was recorded during the surveys. Barn Owls are known to occur in the area and it is recommended a Barn Owl box is erected on a suitable mature tree within the same land ownership as the development site (*Figure 22*).
