## THE THATCHED COTTAGE, HOLEMOOR, DEVON

### *Ecological Impact Assessment*

APRIL 2021

**PES reference:** PES/1239

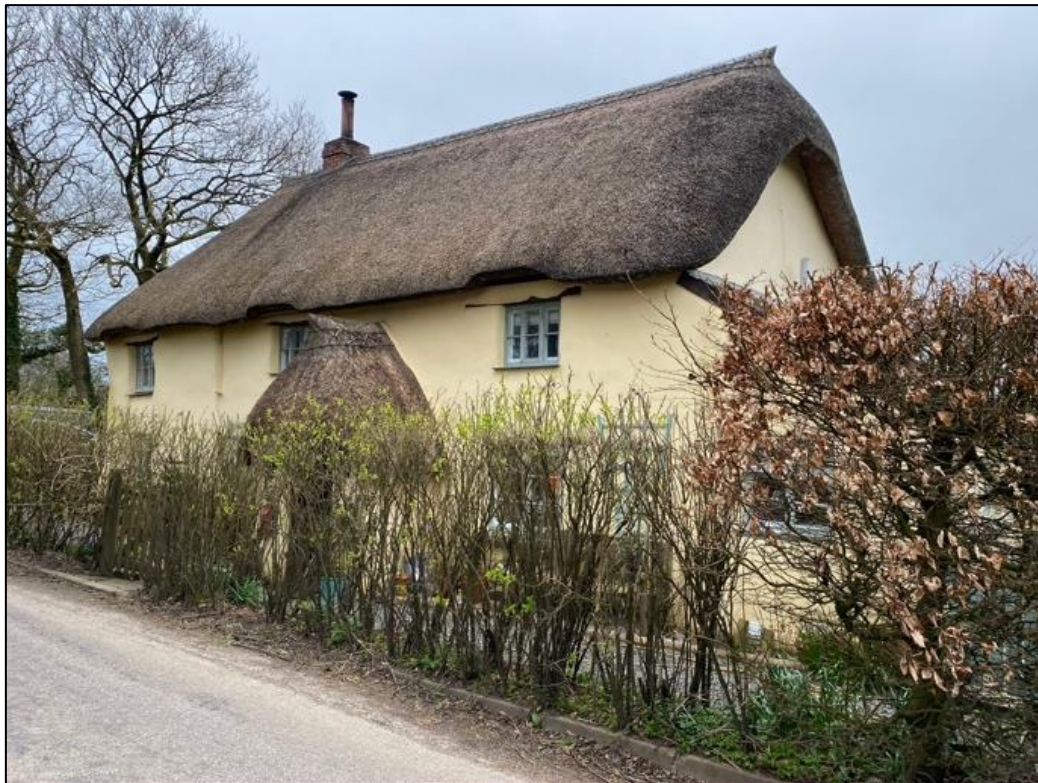
The surveyed areas include Thatched Cottage, the northerly lean-to, and a 5m section of roadside hedge (Fig 3).

**Fig 3 – The Thatched Cottage, lean-to and hedge.**

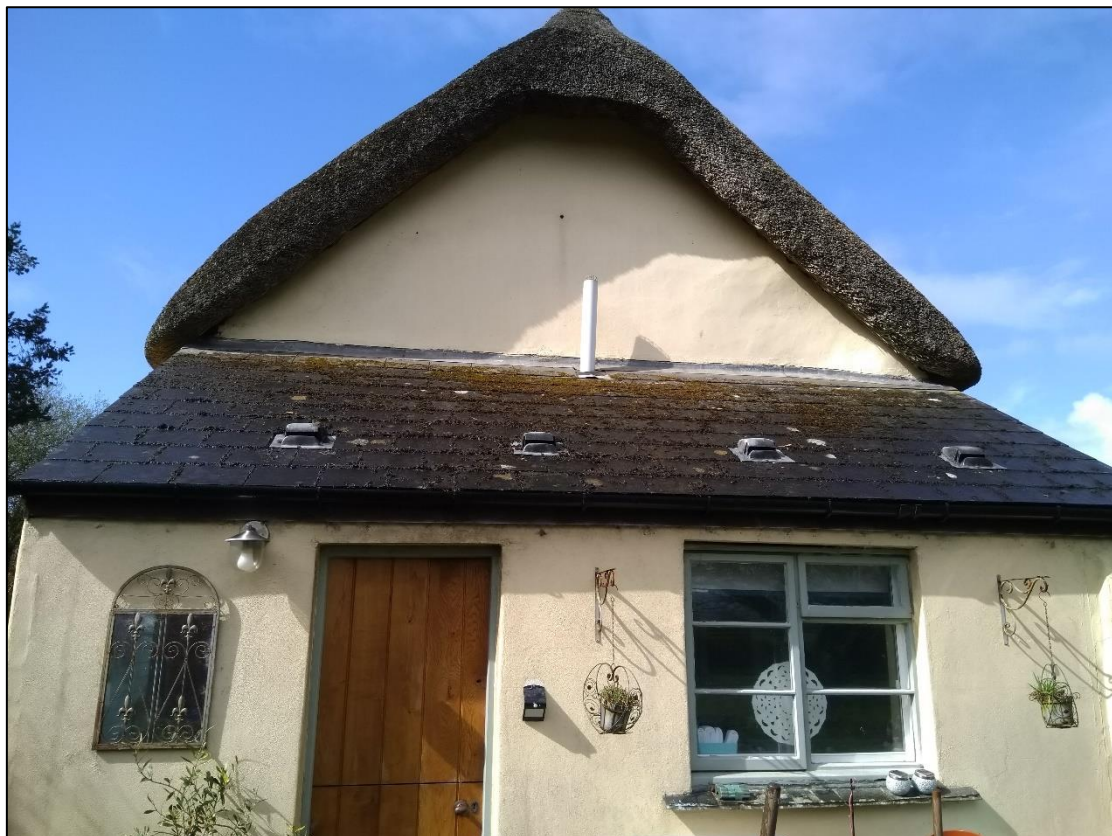
The Thatched Cottage is a detached house arranged over two storeys. There is a single-storey lean-to extension to the northerly gable end (Fig 4). The Thatched Cottage is of rendered stone construction with a thatched roof. The lean-to has a man-made tiled roof, with timber fascias. There are no exterior gaps that might provide access for nesting birds or roosting bats.

***Fig 4 – Existing lean-to extension to northerly gable end.***

Access to the lean-to loft is made via a hatch over. The loft has a simple timber frame and is lined with bitumastic underfelting. The loft area is less than 1m in height, and is

full of stored items leaving very little potential flight space. No evidence of bats was identified.

- *The existing lean-to extension shall be dismantled by hand. Should bats be identified at any time, works shall cease immediately, and the advice of Natural England or a licensed bat ecologist shall be sought.*
- *If works are to be undertaken during the bird nesting season, the roadside hedge shall be checked by a suitably qualified ecologist for nesting birds immediately prior to removal. Should an active nest be identified works shall be delayed until young have fledged.*

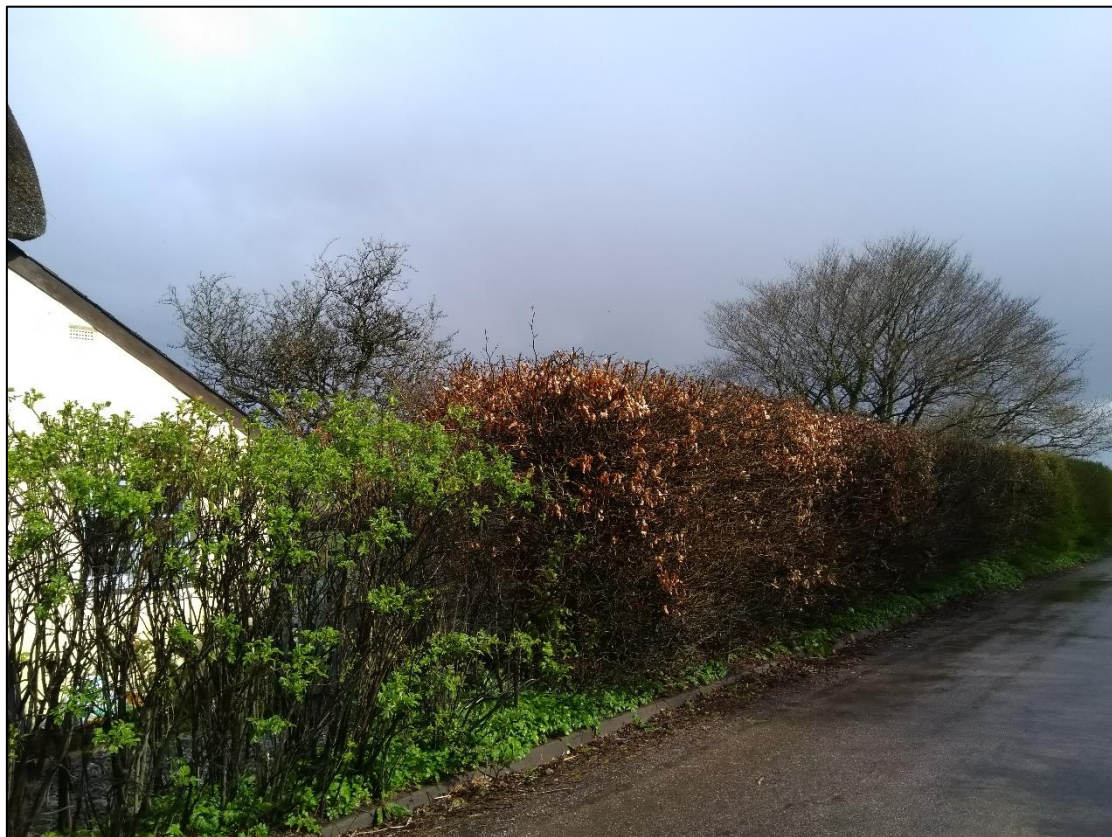
The surveyed section of roadside hedge was inspected for signs of Dormouse presence of for suitable habitat to support Dormouse. The hedge includes non-native rose and beech (Fig 5), with no bank. The hedge is thin and 'leggy' due to unsympathetic management. It is considered unlikely Dormouse is present due to:

- Lack of woodland (Dormouse primary habitat)
- Lack of woodland edges and thick hedgerows (secondary habitat)
- Lack of strong connectivity with woodland
- Lack of Hazel, Honeysuckle and other fruiting species (Dormouse primary food and nest-making resources)
- Human disturbance (presence, traffic, domestic pets).

***Fig 5 – Roadside hedge is thin and 'leggy', includes non-native species and lacks floral diversity.***

The beech section of hedge may provide limited bird nesting habitat.
