Cottage Farm

HERITAGE ASSET ASSESSMENT

Cottage Farm Buxhall : principal south elevation

Jane Blanchflower

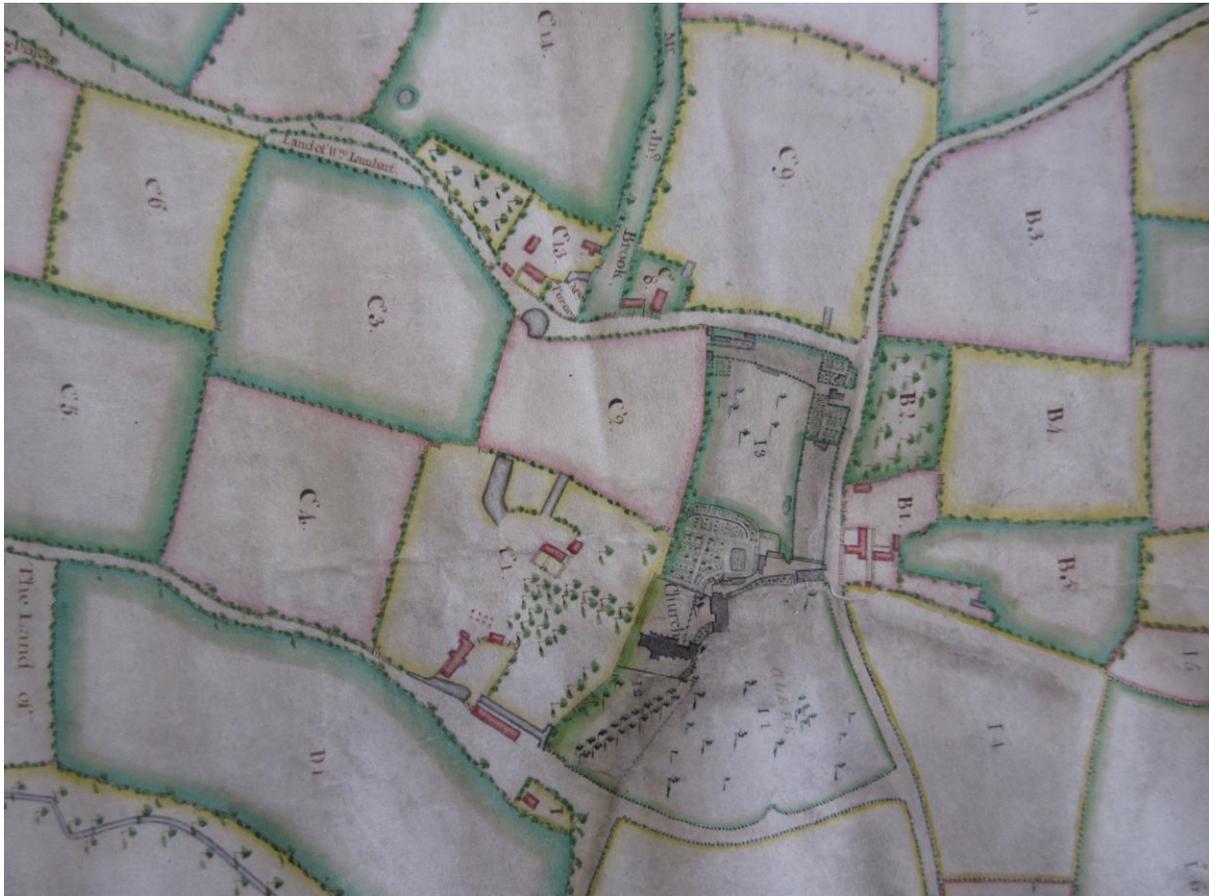
1763 Map of the Copinger Estate in Buxhall by John Parker, Land Surveyor (SROI FB218/A2/1)

The earliest map in the Record Office showing Cottage Farm is the 1763 map of the Copinger Estate. At this time the estate was owned by Rev. Henry Hill D.D. who was patron of the Rectory. The map extract shows the church with the Rectory to the NE, set in formal gardens and extensive grounds. The glebe land is coloured pale grey. The road pattern is recognisable and Cottage farm can be seen to the NW of the church, situated on the N side of a bend in Mill Road opposite a pond.

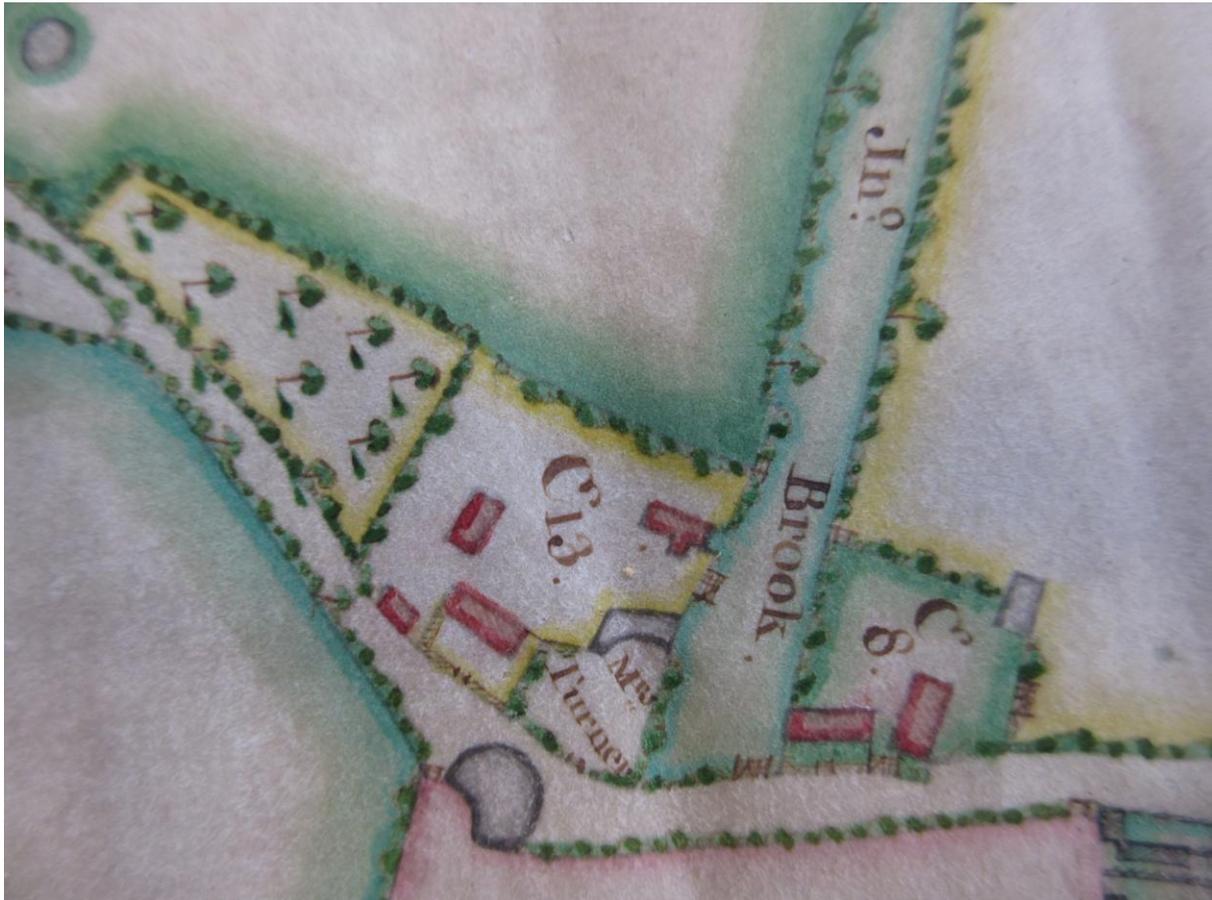
1763 Map of the Copinger Estate in Buxhall by John Parker, Land Surveyor (SROI FB218/A2/1) detailed extract showing Cottage Farm.

The detailed extract shows Cottage Farmhouse with a building (referred to a building A in this report) on an approximately N/S axis to the NW of the farmhouse and a building (building C) beside Mill Road to the SW of the farmhouse. There is a further building to the NE of the farmhouse; this was probably a threshing barn with a porch on the S side. The orchard mentioned in the reference book is to the W of the farmyard. To the E of the farmhouse is an enclosure owned by Mrs Turner and an adjoining long strip of land aligned N/S and owned by John Brook. To the E of this is C8 *'The Tenement & Yards called Hamblins'*. To the N of Cottage Farm is C14 *'The Sink, 9 acres 2 rods 16 perches'*.

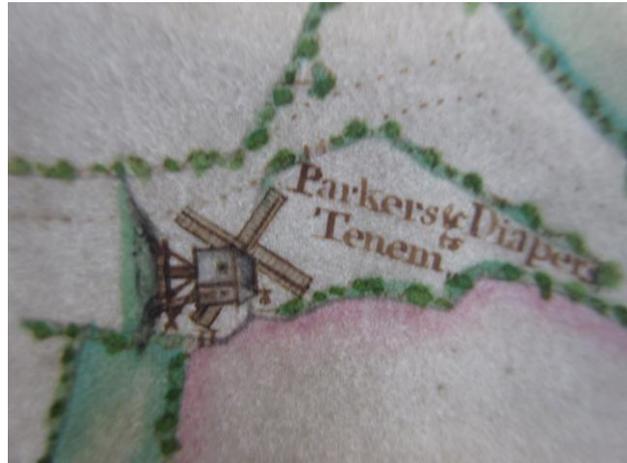
Left: 1763 Table of Reference extract (SROI V5/7/1.1); Right: Post Mill at Mill Green Buxhall (SROI FB218/A2/1) on Parkers & Diapers Tenement

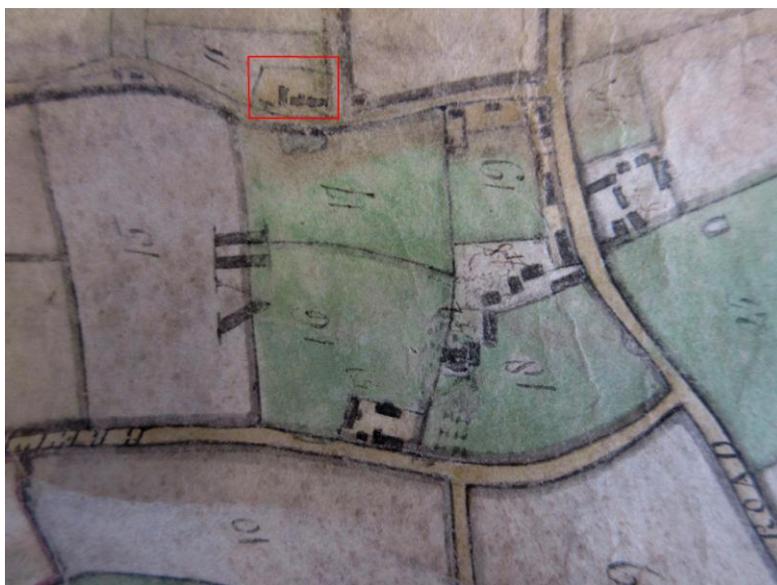
A map dated 1800 of lands in Buxhall is less detailed and there is no table of reference. Cottage Farmhouse and adjacent buildings are shown on the N side of Mill Road, opposite the pond.

1800 Map of lands in Buxhall (SROI FB218/A2/2), site within red rectangle

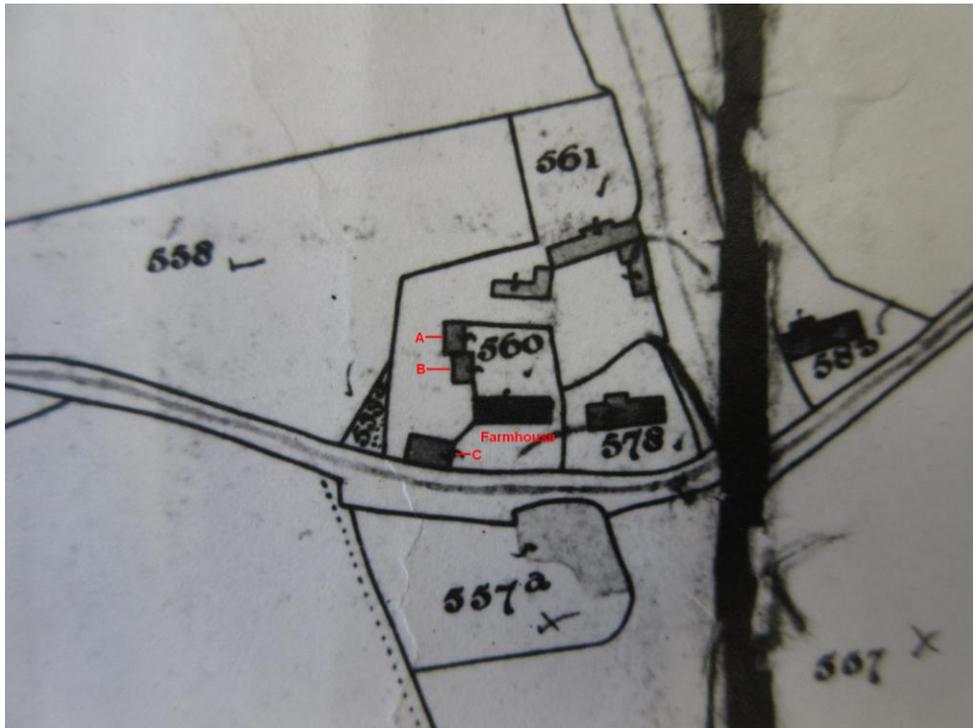
1839 Tithe Map (photocopy SROI P461/54); buildings marked in red

The 1837 Buxhall Tithe Apportionment (SROI FDA 54/A1/1a) shows Cottage Farmhouse and buildings on enclosure 560, owned by Rev. Charles Green and occupied by Rev. Copinger Hill. The Rev. Charles Green BA was referred to as 'resident gentry' in White's 1844 Directory of Suffolk. The Rev. Copinger Hill occupied a total of 54 acres and 10 rods in Buxhall belonging to Rev. Green and the land was subject to a rectorial tithe of £16 18s 9d.

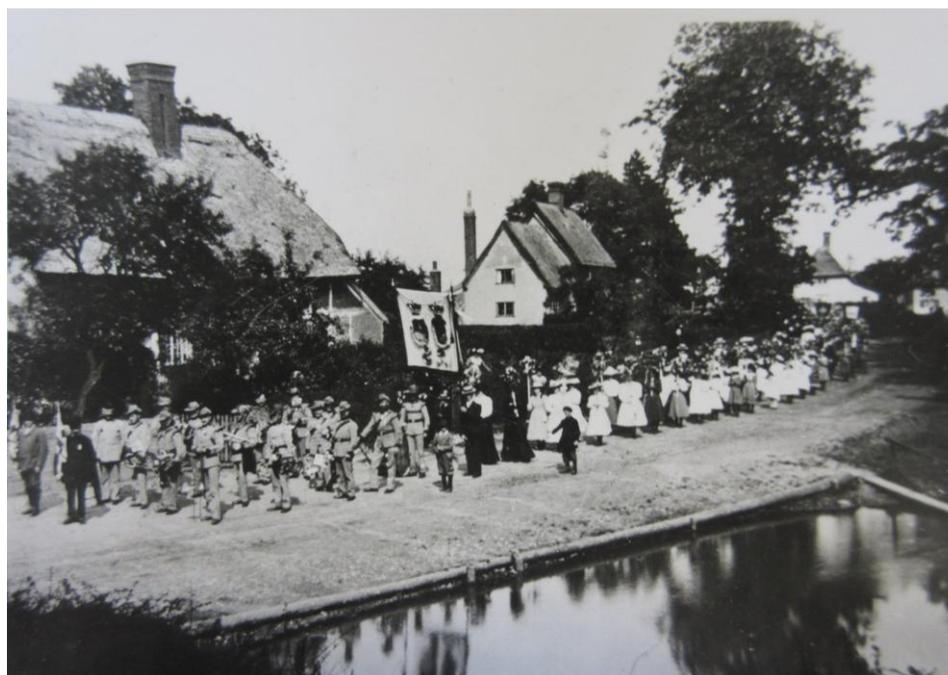
1902 Coronation Procession (Edward VII) passing Cottage Farm (SROI K681/1/83/1)

The 1902 photograph is labelled as passing Cottage Farm, it is in fact passing the thatched property now known as Highams Cottage Farm (originally two cottages) immediately E of

Cottage Farm. It can be identified by its brick chimney and the lean to addition on its E elevation. Benetts and Old Guildhall Cottage, is the thatched property on the right in the photograph. The pond opposite Cottage Farm has logs along the road edge to prevent erosion.

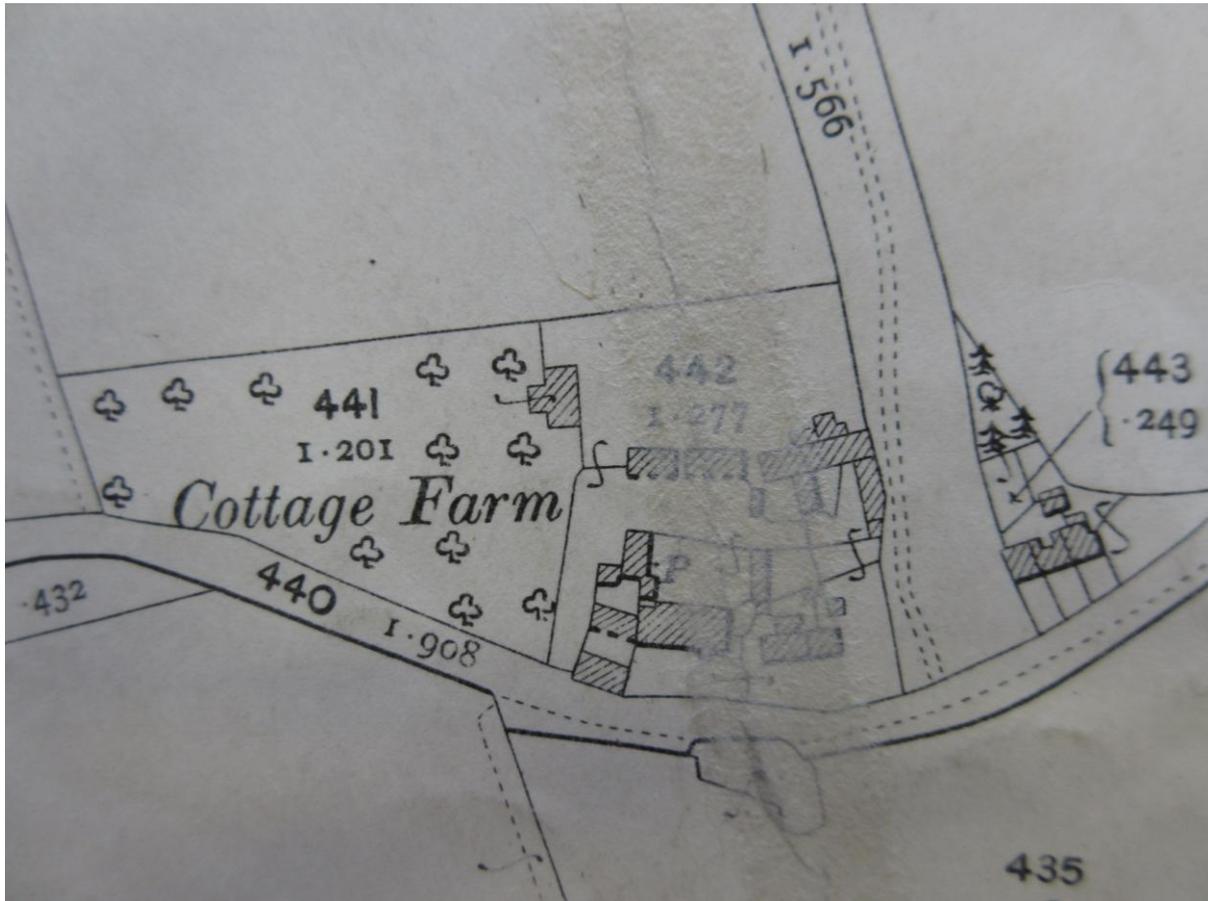
1904 OS 2nd edition, scale 25in : 1 mile (SROI 56/5)

The Record Office did not have a copy of the late 19th century first edition OS 25in map. Cottage Farm is named on the 1904 OS 25in map which shows detail of the buildings. The porch on the main S elevation is shown and there is an additional small building at the NW corner of the house, linking it to building A. The building attached to the SW corner of building A may be a precursor of building B. Building C is shown at the edge of the road. Adjacent to the W elevation of the farmhouse is an open-fronted shed and two more open-fronted sheds (probably cart lodges since they face into the open yard) have been built on the edge of the field to the N of the farmhouse. The barn to the E has several additions and there is an additional building on the E side of the orchard. The farmyard has been divided into several smaller yards for livestock. To the E of the farmhouse, the property now known as Highams is shown as two dwellings. Bury St Edmunds Record Office has a reference to a document catalogued as 'Reconditioning of Cottages at Cottage Farm Buxhall' (SROB HG500/694) but this document was in store at Bury and could not be produced. This may relate to a grant application to the West Suffolk Rural Workers Housing Scheme under the

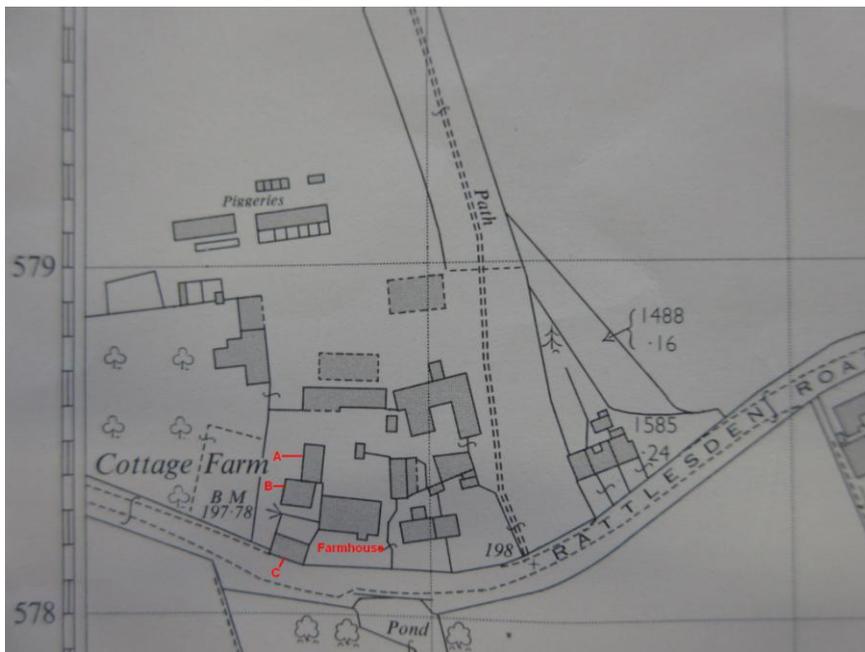
1967 OS TM0057, scale 1 : 2,500 (SROI), buildings marked in red

The 1967 OS map shows Cottage Farmhouse and buildings A, B and C with the same footprint as existing. Several buildings have been added to the N of the farmyard, including

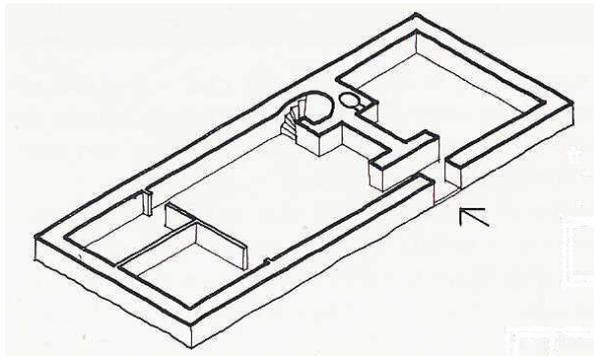
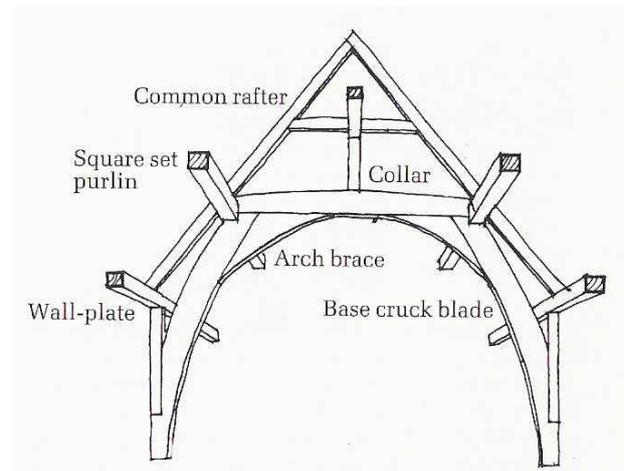
Left: basic plan form lobby entrance with central back to back fireplaces; Right: base cruck truss

The roof, now plain tiled, was originally thatched and hipped at the W end before the service cell was extended and the external stack was added to the W gable. The framing (jack and hip rafters) remain in situ in the roof space above the extended service cell chamber. The listing description (1955) mentions a pair of base crucks at first floor level at the E end, which formerly supported a half-hip, and a concealed mullioned window in the gable. It was not possible to access the E cell roof space during the site visit to confirm the existence of the

former mullion window but the base cruck was visible in the en suite shower room. There is smoke blackening on the upper ends of some of the rafters in the middle cell of the roof space. It is possible that there may have been a smoke bay in the 16th century before the main stack was built, with the smoke exiting via a gablet at the half-hipped E end.

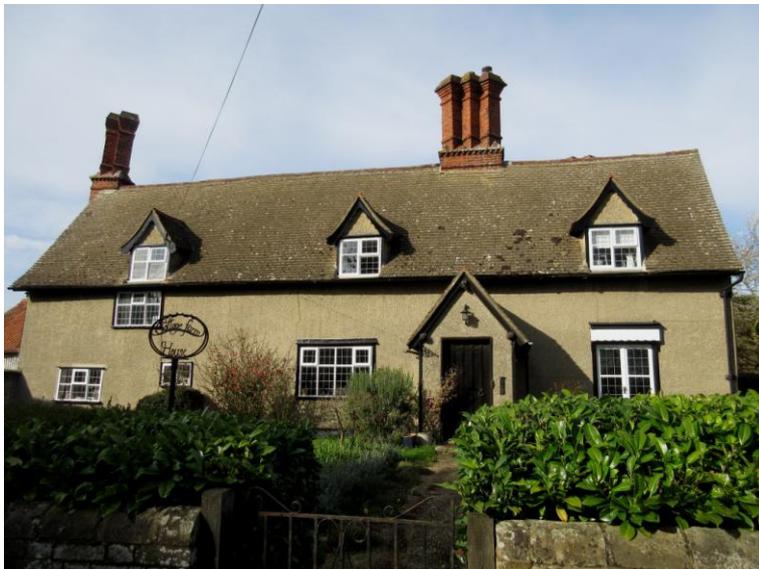
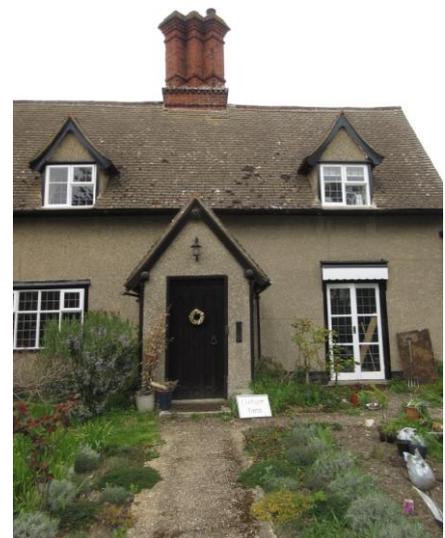
Left: main S elevation; Right: detail of porch and French windows at E end of S elevation

The farmhouse is aligned on an E/W axis, the main S elevation facing Mill Road. It is single storey with attics. The S slope of the roof has concrete plain tiles and there are three gabled dormers with small pane casements (lead comes) and cusped timber bargeboards. The W dormer lights the roof space but the middle and E dormers light bedrooms on the attic floor. The bedroom below the W dormer has a small pane casement with lead comes; this was probably inserted in an original window opening. All casements, including the French casements, in the S elevation are 20th century timber replacements with chamfered glazing bars. The French windows have a hood with scalloped edge and the rainwater goods are metal.

The main S entrance porch, which was added in the later 19th century when the rear extension was added, has a pitched, plain tile roof with cusped bargeboards. It is of timber framed construction with pebbledash exterior render and small pane windows E & W. The massive planked and battened door has exposed nailheads, strap hinges and an early lock. The listing states that the door is probably of 16th century date.

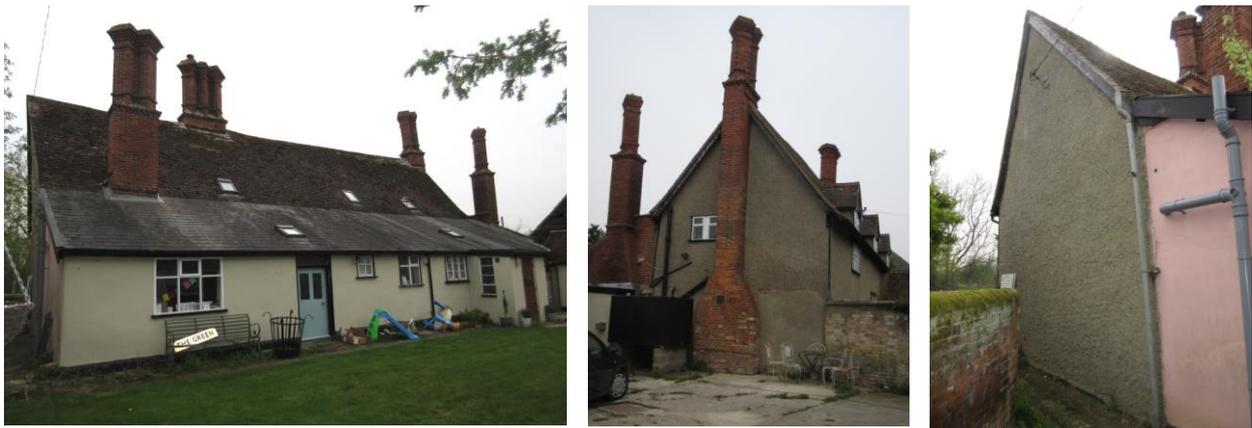
Left: N (rear) elevation showing lean to; Centre: W elevation showing external stacks; Right: E elevation showing junction of main building (pebbledash) with lean to extension (rendered)

The main building is timber framed and pebbledashed whilst the rear single storey extension is of colour washed, rendered brick construction with a slate roof. The rainwater goods are plastic. The N slope of the main roof has clay plain tiles with three small velux lights. The lean to has two velux lights and the N wall has three small pane casements (leaded comes) and a smaller obscured glass window (blocked on the inside) to the right of the E door. There is a larger 12 pane casement (no leaded comes) with cambered head to the right of the porch. The painted timber 19th century E door has glazed upper panels. The W porch, which was added in the later 20th century, is of rendered brick with a late 20th century varnished, panelled door. It has metal framed, Crittall design windows in the E and W walls.

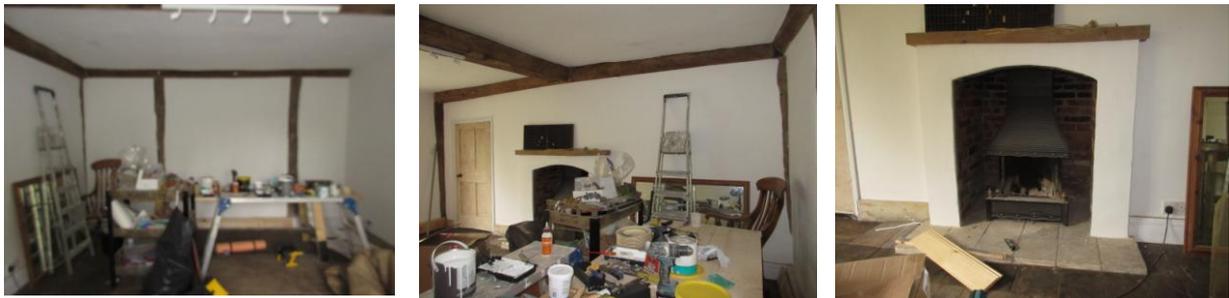
Drawing Room: Left: looking N; Centre: W wall with fireplace & door to hall; Right: fireplace

The drawing room has an exposed axial beam with broad chamfers and no stops. The N wall has two exposed studs and an exposed N wall plate. The tiebeam between this room and the hall has a massive chamfer with run out stops. The fireplace in the W wall has been remodelled and reduced in size in the 19th century, probably when the upper part of the stack was re-built. The brick chimneypiece, which has a cambered head supported underneath by

an iron band, has been plastered and there is an oak mantle shelf. The fireplace is mainly 19th century brick set in lime mortar; it contains a late 20th century grate with hood and the hearth is white pammments. The 4 panel door to the hall is early 20th century, stripped pine and the skirting is a recent replacement. The French doors are late 20th century 2 X 3 lights, small pane with lead comes and chamfered glazing bars. The floor is boarded.

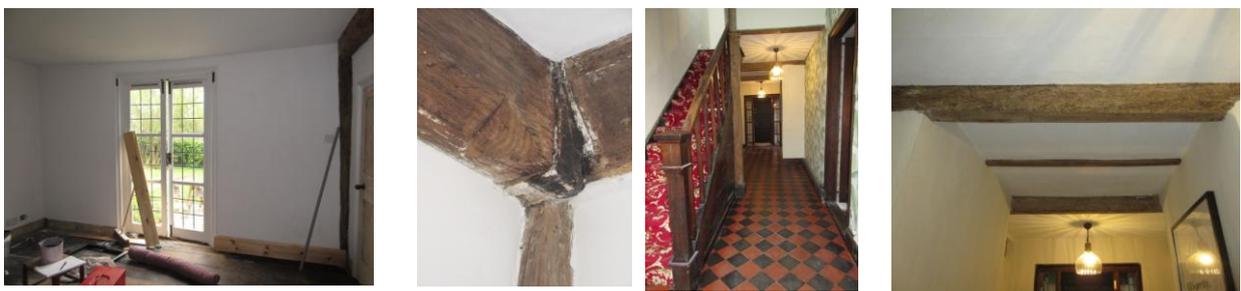
Left to Right: French windows in drawing room; run out stop at N end of chamfered tiebeam above fireplace; stair hall looking S towards front porch; exposed axial beam and joist in hall, looking S

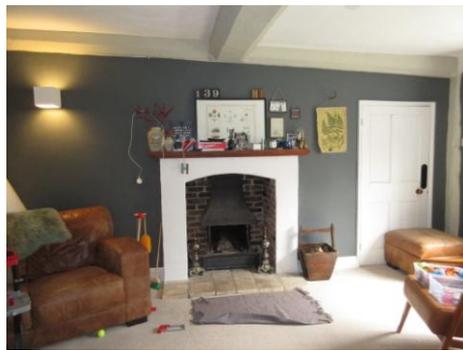
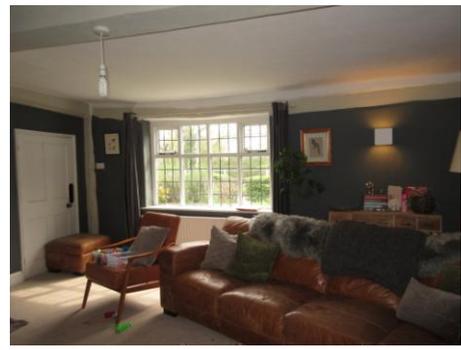
Left: porch interior showing 16th century door; Centre: living room looking E; Right: S window in living room

The living room (former hall) has a painted timber 4 panel 20th century door leading from the main entrance hall. The chimney piece is rendered brick, the same style as the one in the drawing room with a pamment hearth. There is a heavy, broad chamfered axial beam and the tiebeams at either end (E & W) have broad chamfers with flat stops on either side of the axial beam. The main posts in the corners are partly exposed and the wall plates are exposed. The floor is concrete with a carpet and the S window is a 20th century small pane casement with leaded comes.

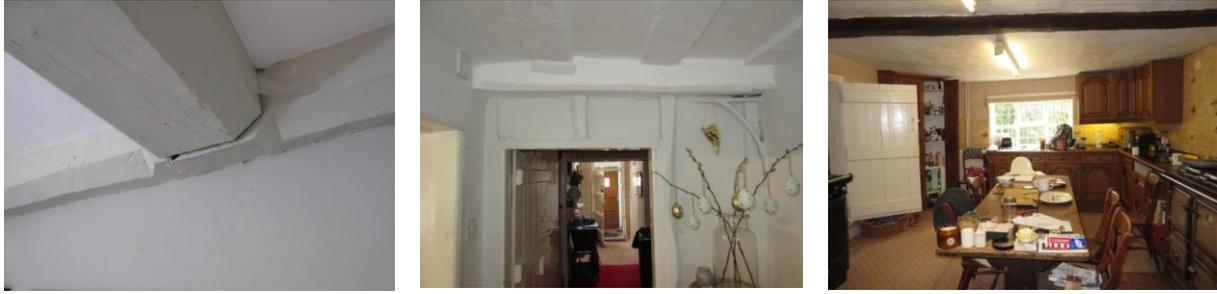
Left: living room axial beam with broad chamfers tennoned into W tiebeam with flat stops; Centre: study (former pantry) looking N through W hall to rear door; Right: kitchen looking S

The study (former pantry) is small and narrow, situated in a partitioned section of one of the former service rooms (now the kitchen). There are exposed unchamfered joists and axial beam (above the N studwork partition wall) is chamfered with straight cut stops. There is a small, 2 light S casement with leaded comes.

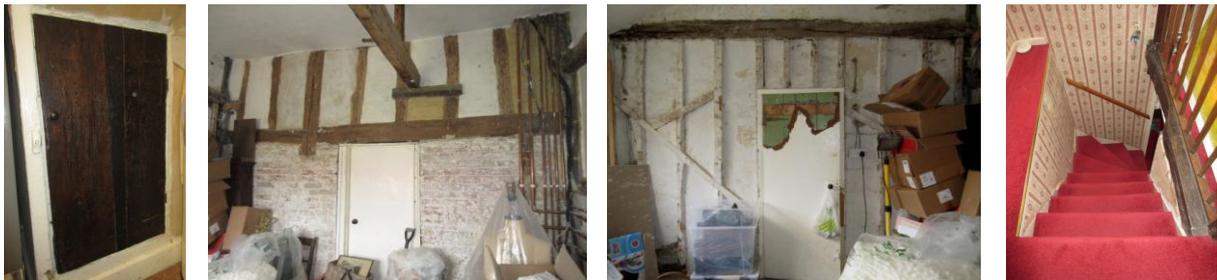
Left to Right: 18th century plank and batten door to understair cupboard in kitchen; N wall (former exterior N wall of main house) of utility room in lean to extension; E wall of utility room with flush door to W hall; W winder staircase with stained wood balusters

This was the former kitchen, situated at the W end of the lean to extension. There is a recess in the NW corner which has an angled exterior wall owing to the need for an outside passageway between the farmhouse and the coal shed. The recess probably housed a boiler or stove which used the single flue chimney. The plaster has been removed from the S wall, exposing brickwork beneath the wall plate and studs above. There is a doorway into

the existing kitchen. This was the exterior of the N wall of the farmhouse before the lean to was added. On the E side is a partition wall of slender studs and diagonal brace with a 20th century flush door leading from the W hall. The 20th century, 12 pane, N casement is wide with a cambered arch head.

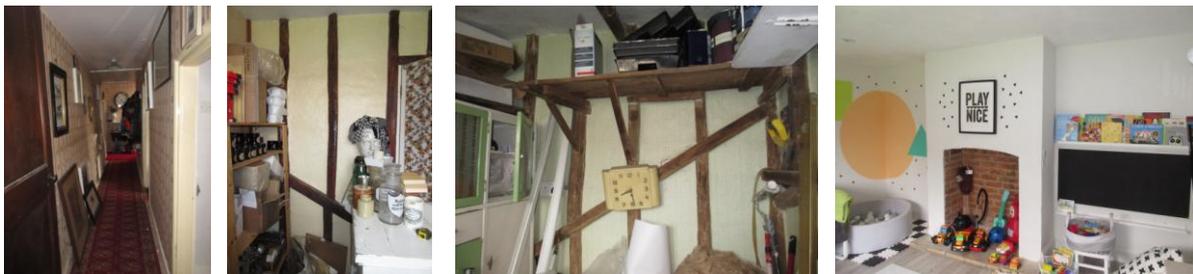
Lean to rear extension, L to R : corridor looking W with studwork wall on right; S wall of former bathroom; S wall of workshop (former larder); S wall of study with disused fireplace

The main hall (E) and the W hall are linked by a passage which runs along the outside of the original exterior N wall of the farmhouse (before the addition of the 19th century lean to). This central section of the lean to has three rooms with studwork walls. At the W end is a former larder with exposed studwork and ceiling hooks for meat/produce and shelving. This is currently used as a workshop/tool store. The middle room was formerly a bathroom but is now used as a store room. It has tiled walls and an obscured glass casement (N). The narrow E room is a shower room with WC.

To the E of the main staircase hall is the study/small sitting room. This has plastered walls, a timber interlock floor and a 20th century 6 pane (no comes) casement. There is a small fireplace (no longer in use) with plastered brick chimney breast.

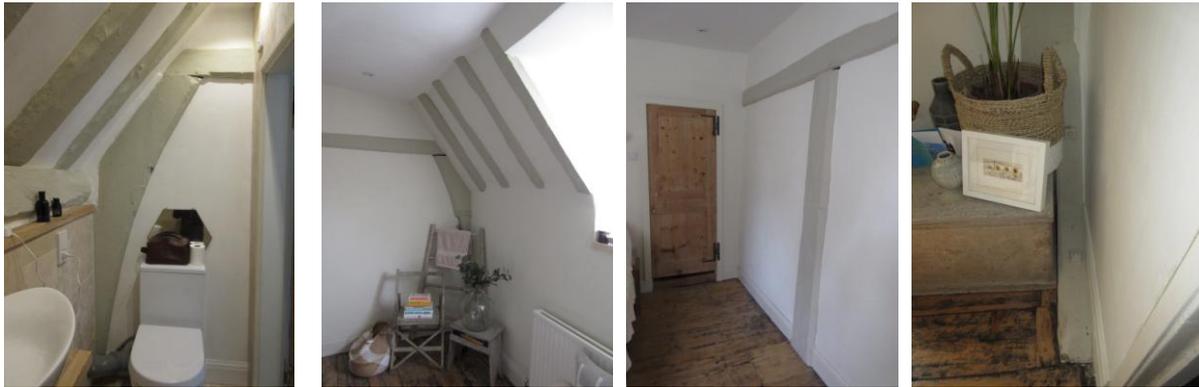
L to R: base cruck blade in E wall of en suite; SE corner showing exposed rafters E of dormer; exposed collar and stud (E) & door to en suite; SE corner with bolted knee between tiebeam and mainpost.

The principal E bedroom has exposed base cruck blades in the NE and SE corners. The cruck blade is more fully exposed in the en suite shower room (NE). The base cruck truss was a device to improve headroom in one and a half storey houses to enable full use of the upper floor. This room has a late 20th century partition wall on the N side, inserted to create a cupboard and a separate en suite shower room with WC. The doors are reclaimed, stripped pine, and the floor is replacement broad pine boards. There is no fireplace although the room would have had one in the 19th century. There is a timber dormer (S) with a new

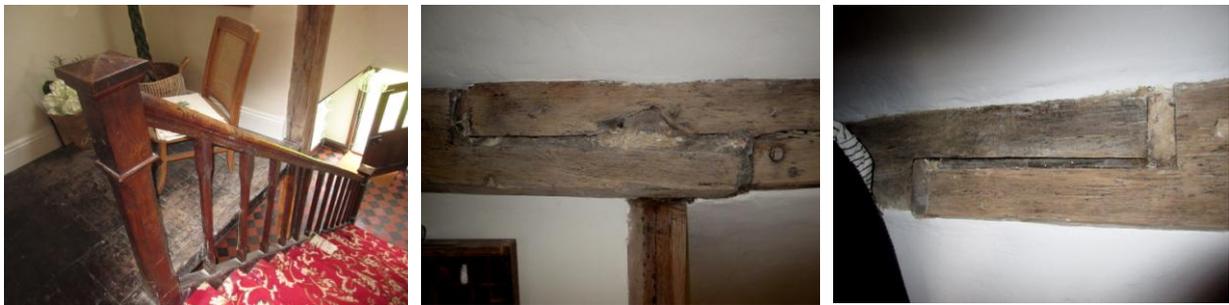
Left: main staircase; Centre: edge halved scarf on N wall plate; Right: edge halved scarf on S wall plate

There is a 19th century, closed string, straight run staircase of stained timber with moulded newel and balusters and carpeted treads and risers. The N and S wall plates have pegged edge halved scarfs and the W tiebeam is exposed. On the S side is a cupboard with reclaimed, stripped timber panelled doors. A door (W) leads into the middle bedroom (E).

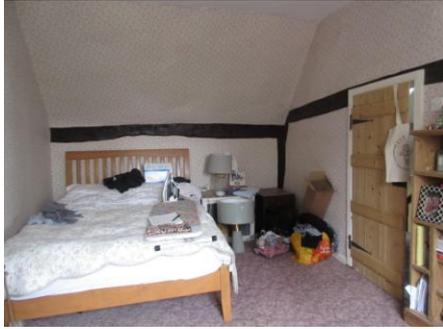
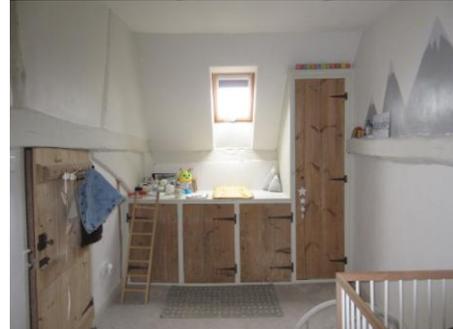
Left: looking N showing door frame let into E tiebeam; Centre: jowelled, adzed SE main post; Right: middle bedroom (W) looking N showing inserted velux and modern cupboards

The walls are papered but the N wall plate, E tiebeam, and NE and SE jowelled main posts are exposed and painted black. The walls and ceiling are papered and the floor is carpeted. The dormer is of the same construction as the other two on the S roof slope.

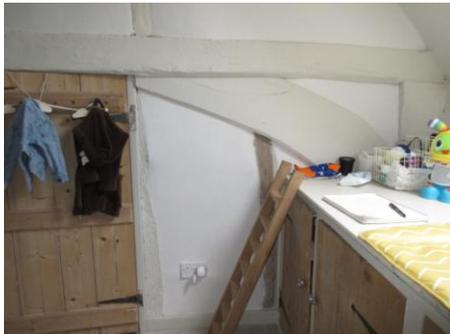
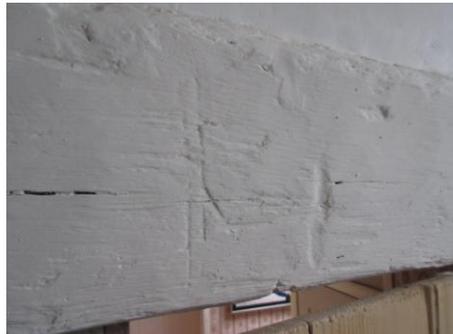
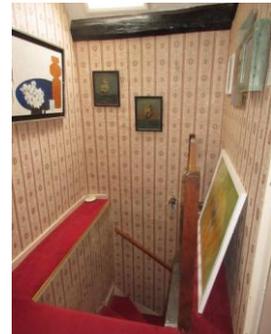
Left: arch brace at N end of tiebeam; Centre: witch marks and rush light burn; Right: W landing

This has a doors in the E & W partition walls, connecting with the middle bedroom E and the W landing. There is a velux window in the N roof slope and recent fitted cupboards with pine doors. The E and W tiebeams (painted) are exposed and the W tiebeam has two exposed massive arch braces with adze marks. There is a rush light burn and apotropaic (witch) marks on the E face of the W tiebeam near the doorway. These superstitious marks were inscribed above openings (doorways, fireplaces) to discourage evil spirits.

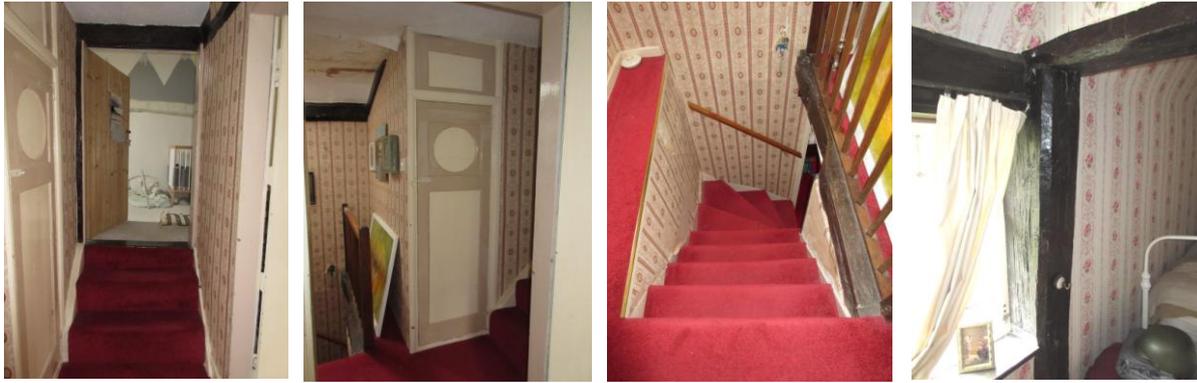
L to R: looking E towards middle bedroom W showing difference in floor level; 1930s panel door to linen cupboard; winder staircase; W bedroom showing exposed mainpost, tiebeam and S wall plate

The W landing has partition walls forming an linen cupboard (N), a passage up 3 steps to the middle bedroom W and separate access to the W bedroom on the S side of the landing and the bathroom in the NW corner. These rooms have all been created in the extended W service cell of the farmhouse by the insertion of partition walls.

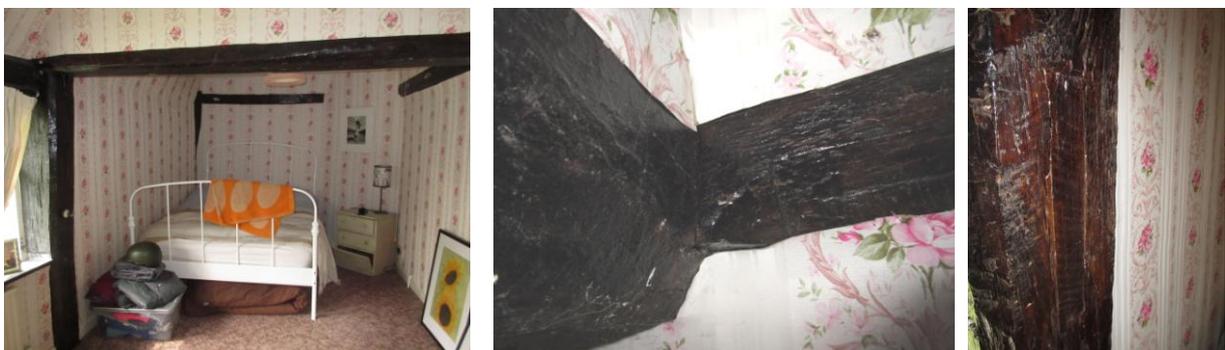
Left: looking W showing exposed tiebeam, S main post and angled NW corner where stack is positioned; Centre: run out stop on axial beam; Right: blocked slot for arch brace in main post

This bedroom has a small pane, leaded came casement instead of a dormer. This window may have been inserted in an original mullion window opening but no shutter grooves or rebates were visible. The W dormer is positioned in the roof space directly above. The exposed tiebeam to W of centre marks the original W wall of the farmhouse before this cell was extended and in the roof space above the jack rafters and framing for the original hipped roof survives. The arch brace at the S end of the tiebeam has been removed to create more headroom and the mortice slots in the tiebeam and main post have been blocked with timber inserts. The tiebeam is chamfered on the W face with a run out stop at the S end. The E face is unchamfered but has roughly hewn edge. The axial beam (against the N partition wall) is chamfered with run out stops. In the SW corner is a jewelled post and the tiebeam is partly exposed. The wall in the NW corner is angled owing to the addition of the external red brick stack to the W (gable) elevation. There may have been a small fireplace. The walls and ceiling are papered and the floor is carpeted.

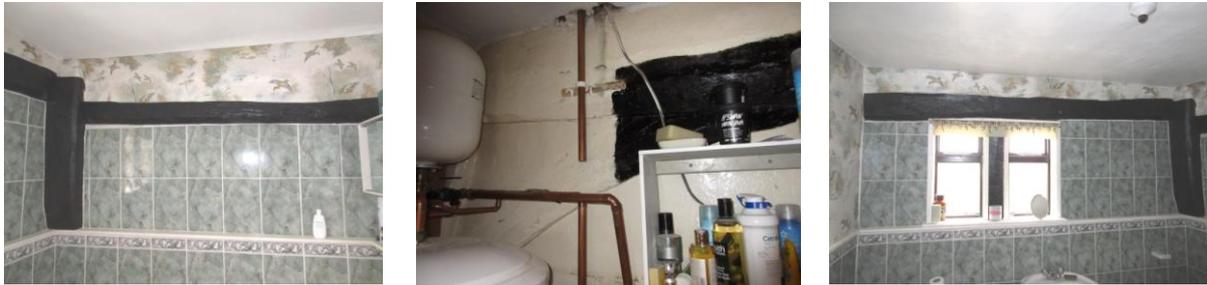
Left: NW corner post with exposed tiebeam (L) and wall plate (R); Centre: arch brace in airing cupboard; Right: 20th century stained timber casements inserted between studs in W gable

The NW corner post, N wall plate and W tiebeam are exposed; the W wall plate has a chamfer with a run out stop. Inside the airing cupboard (NE) the arch brace at the N end of the E tiebeam is visible (the corresponding one in the W bedroom has been removed). The walls are tiled and papered and the ceiling is papered.

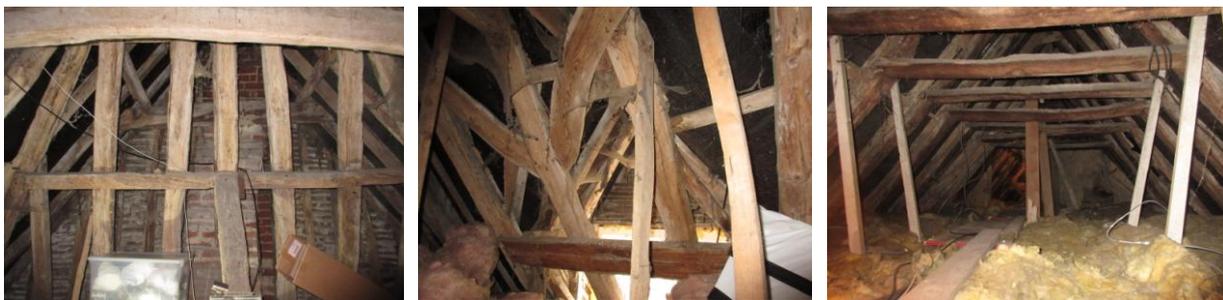
Left: hipped roof structure at W end; Centre: wind braces above dormer; Right: looking E in middle section showing collar rafter roof (no purlins), main stack at end

This is accessed via a hatch in the ceiling of the W bedroom. It is divided into three sections with wattle and daub partition walls, a small opening in the partition between the W and middle sections giving access to the middle and E sections. The floor is mostly unboarded. The jack and hip rafters of the original hipped roof remain in the W section which now has a gable. This section is lit by a dormer (S) with small pane casement which matches the other two S dormers. The roof (felted) is of collar rafter construction with clasped purlins in the W section only. There is some evidence of smoke blackening on the upper part of the rafters in the middle section near the stack. This indicates that there may have been a smoke bay in the 16th century before the brick stack was constructed.

The upper part of the main stack has been re-built in 19th century red brick when the farmhouse was extended and re-roofed. The S slope of the roof, which has pairs of wind braces (up braces), has been more recently re-roofed (concrete plain tiles) than the N slope. The rafters are original but the roof has undergone much repair with additional collars and struts added during the 20th century. The rafter feet are exposed beneath the eaves.

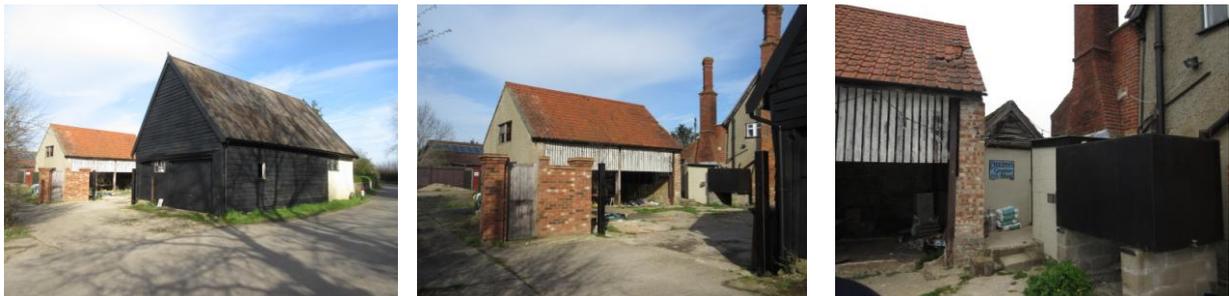
Left: looking N, showing access from Mill Road; Centre: yard and Building B; Right: passageway between Building B and farmhouse, coal store in centre, oil tank on right

There is a narrow passageway between the farmhouse and the buildings, leading from the yard to the rear garden. The boiler shed and heating oil tank are situated against the W elevation of the house.

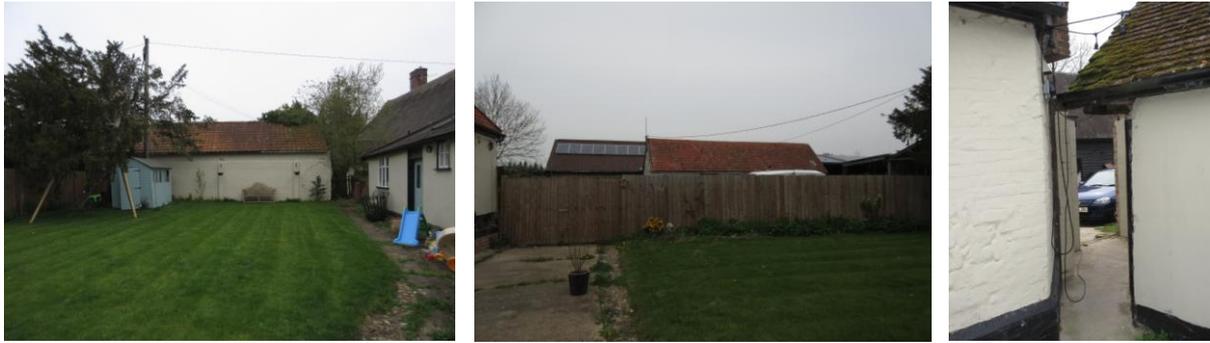
Left: rear garden looking E (building owned by Highams); Centre: looking N towards buildings in separate ownership; Right: passageway, looking SW between house (L) and coal store (R)

To the E of the property is Highams, a grade II listed former dairy farm. A single storey outbuilding with pantiled roof and rendered brick W wall forms the E boundary of the rear garden. To the E of the farmhouse is a path with an 18th century red brick wall on the E side, forming the plot boundary with Highams.

The N boundary of the rear garden is a boarded fence, beyond which are some of the farm buildings formerly owned by Cottage Farm. The W boundary of the Cottage farm plot is a metal fence which runs up the E side of the access drive leading to the buildings which are in separate ownership.

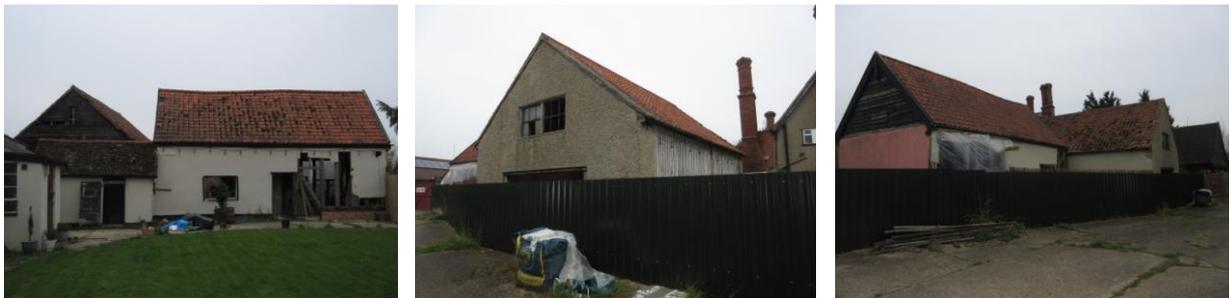
Left: looking W towards coal store (gable of Building B behind), Building A on right; Centre: looking N from access to adjacent property N of Cottage Farmhouse; Right: looking SE from access towards Buildings A & B, Building C visible on extreme right
