JOHN MOORE HERITAGE SERVICES

**HERITAGE IMPACT ASSESSMENT
AND ARCHAEOLOGICAL EVALUATION
ON
TALLY-HO COTTAGE, CONDICOTE,
GLOUCESTERSHIRE**

JANUARY 2022

JMHS Project No: 4664

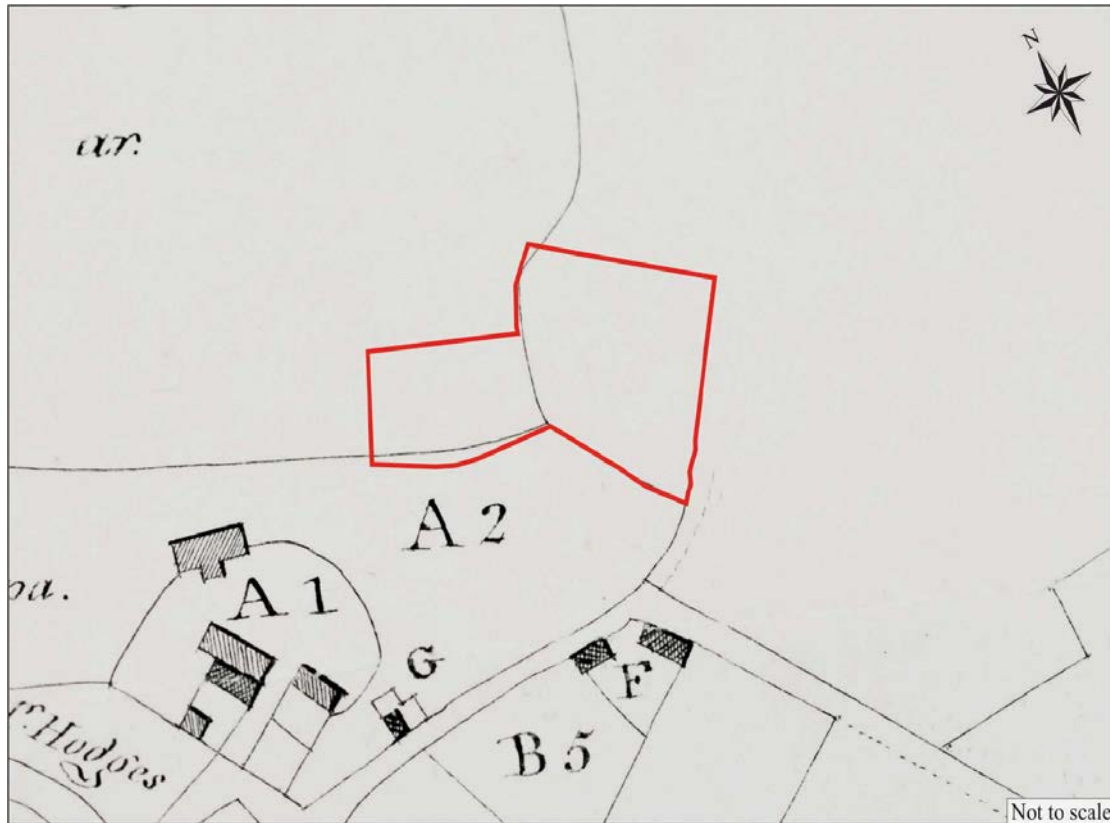
Figure 4: Sales map of the early 19th century of Condicote

The map of Condicote dated to the early 19th century (D6755/1/4/17) indicates that a Cotswold drystone wall was built along the western bank of the henge monument (Fig. 4). The date at which the stone wall would have been first placed along the line of the bank cannot be precisely determined; some agricultural land has been part of the parish through its recorded history. In the 14th century this is apparent from the economic assessment of the parish that states that much of the parish was down to pasture for sheep farming (VCH 1965, 62-73). In the early 17th century it is known

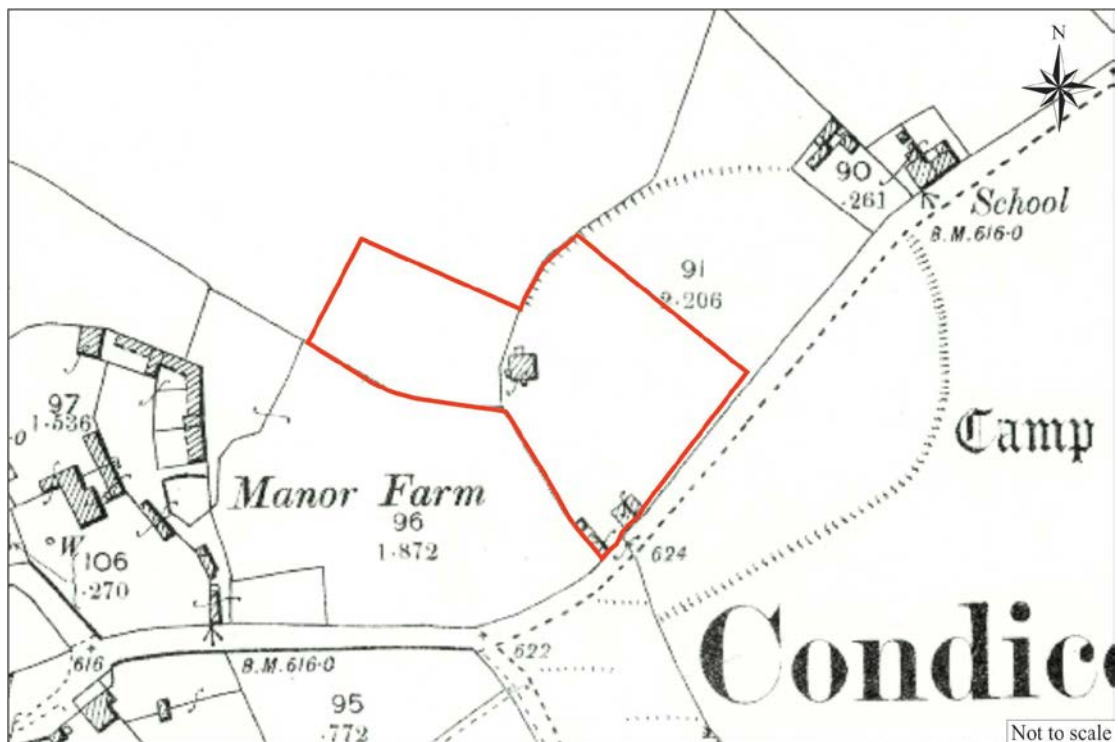
Figure 6: Second Edition Ordnance Survey Map of 1900

The second edition was surveyed in 1900 and published in 1902 (Glos XXI.8) (Fig. 6) and third edition surveyed in 1921 and published in 1922 (Glos XXI.8) (Fig. 7). Ordnance Survey maps show development on the north and east sides of Keepers Cottage. This is presumed to lie externally to the area of the henge monument.

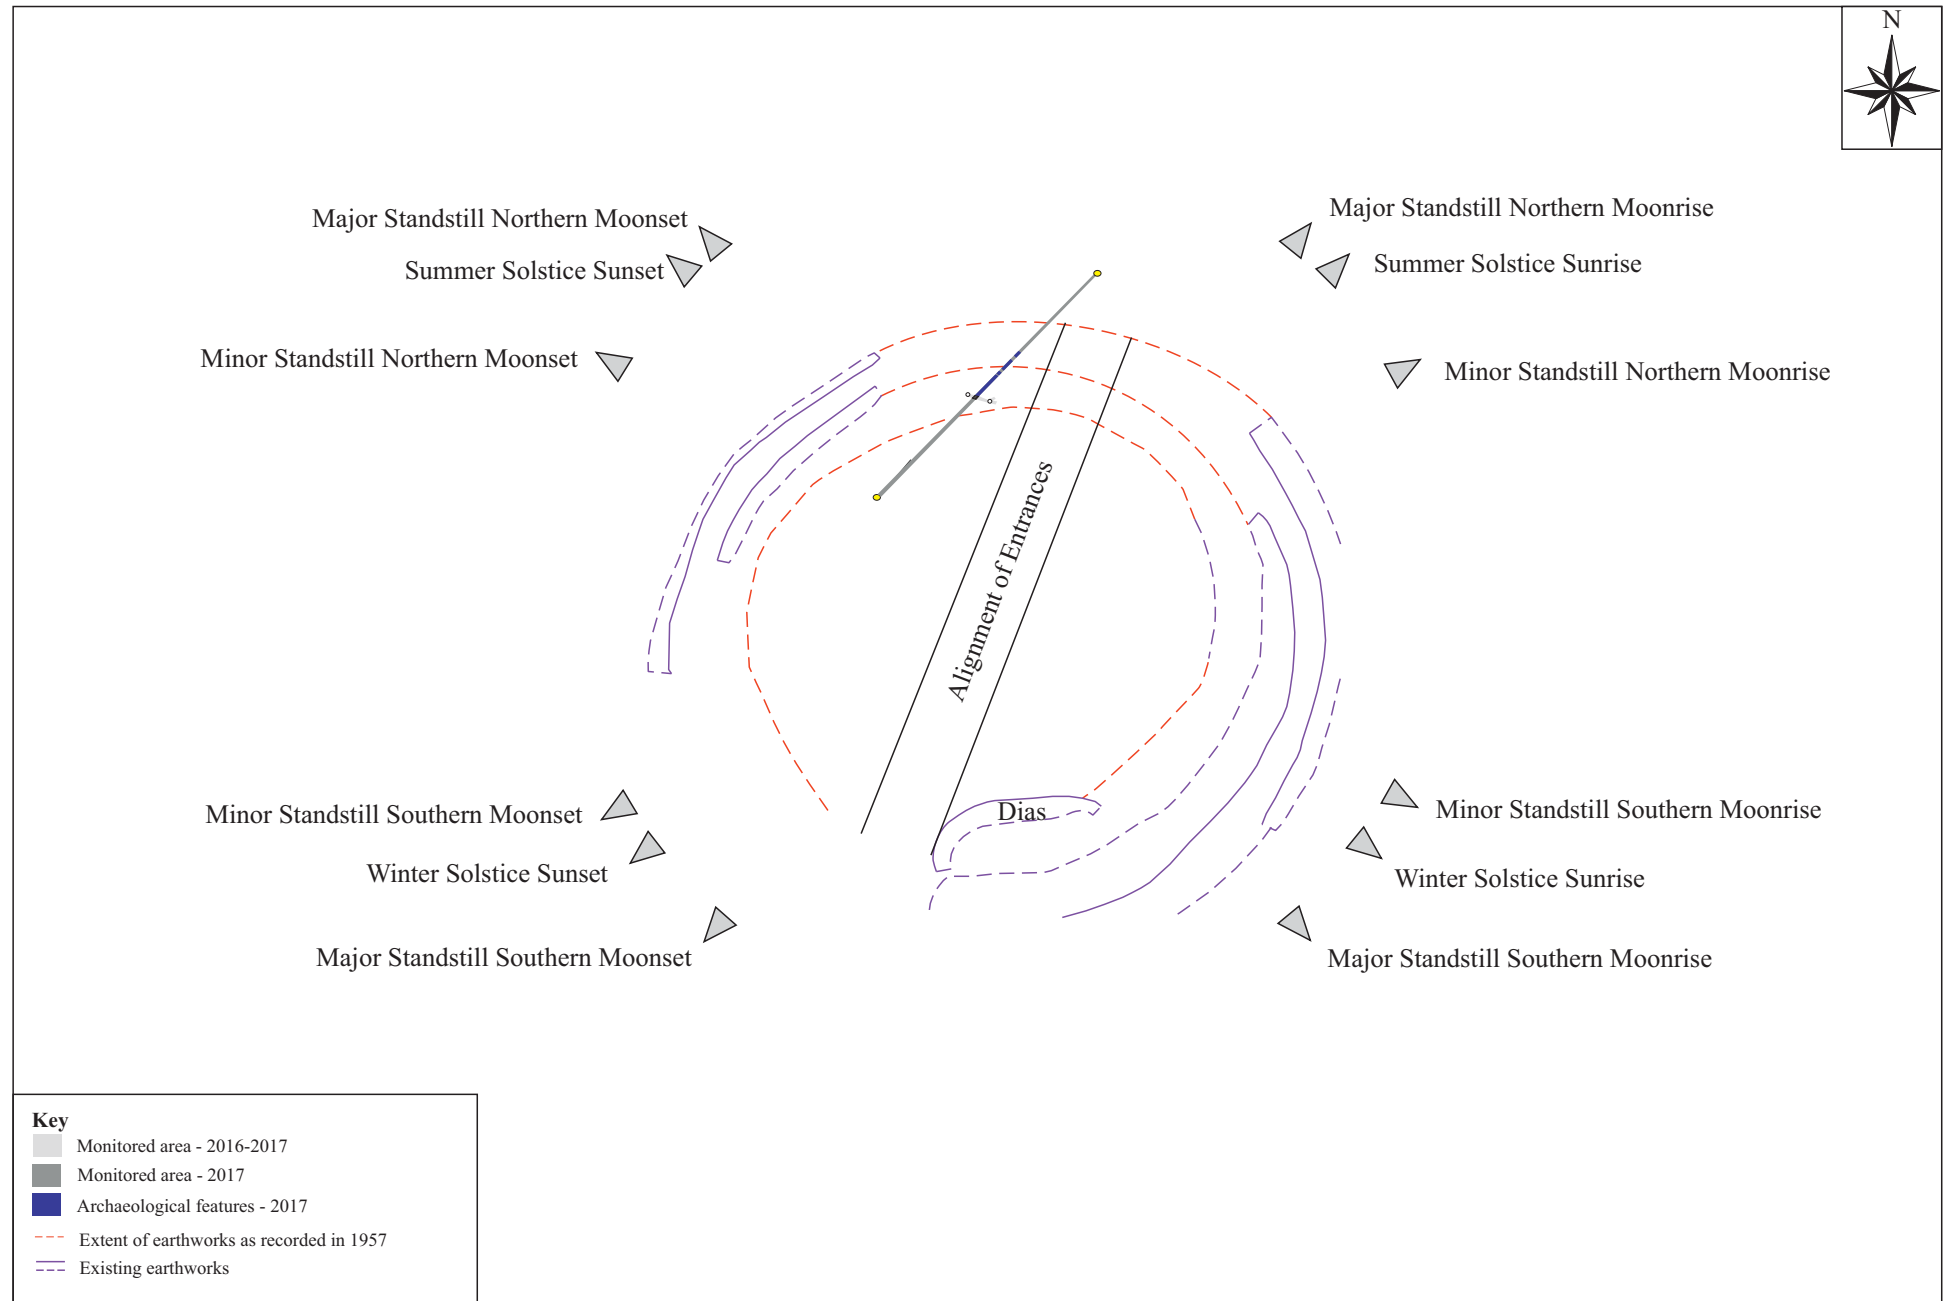
Figure 9: Henge Monument Showing Major Lunar and Solar Sets and Rises

Roman building located internally to the camp. A Bronze Age ring-ditch (JMHS 10, HER 39930: 415680 228830) believed to be the location of a former barrow lies roughly in line with the moon rise at the northern major standstill. It appears to be a northeast outrider for the henge. The tumuli to the southeast of Sezincote (JMHS 11, HER 133: 416800 2323059) lie in a location where the moon's major northern rise is located. The Summer Solstice sunrise would be in a location to the south of Sezincote called Golden Barrows, presumably an area named from some now degraded barrows, which presumably had a legendary tradition associated with treasure. The area of the moon's minor standstill rise would be in the location of Ganborough and Longborough from Condicote Henge.

The tumulus to the west of Swell Hill Farm in Old Furze Covet (JMHS 23, HER 194: 414946 226354) appears to be in the right location for the moon's movements. The Cow Common Longbarrow (JMHS 24, HER 183: 413520 226274) and the tumulus immediately to the south appear to be located where the moon's major standstill set would be located, and the entrance to the henge. There are a cluster of barrows around

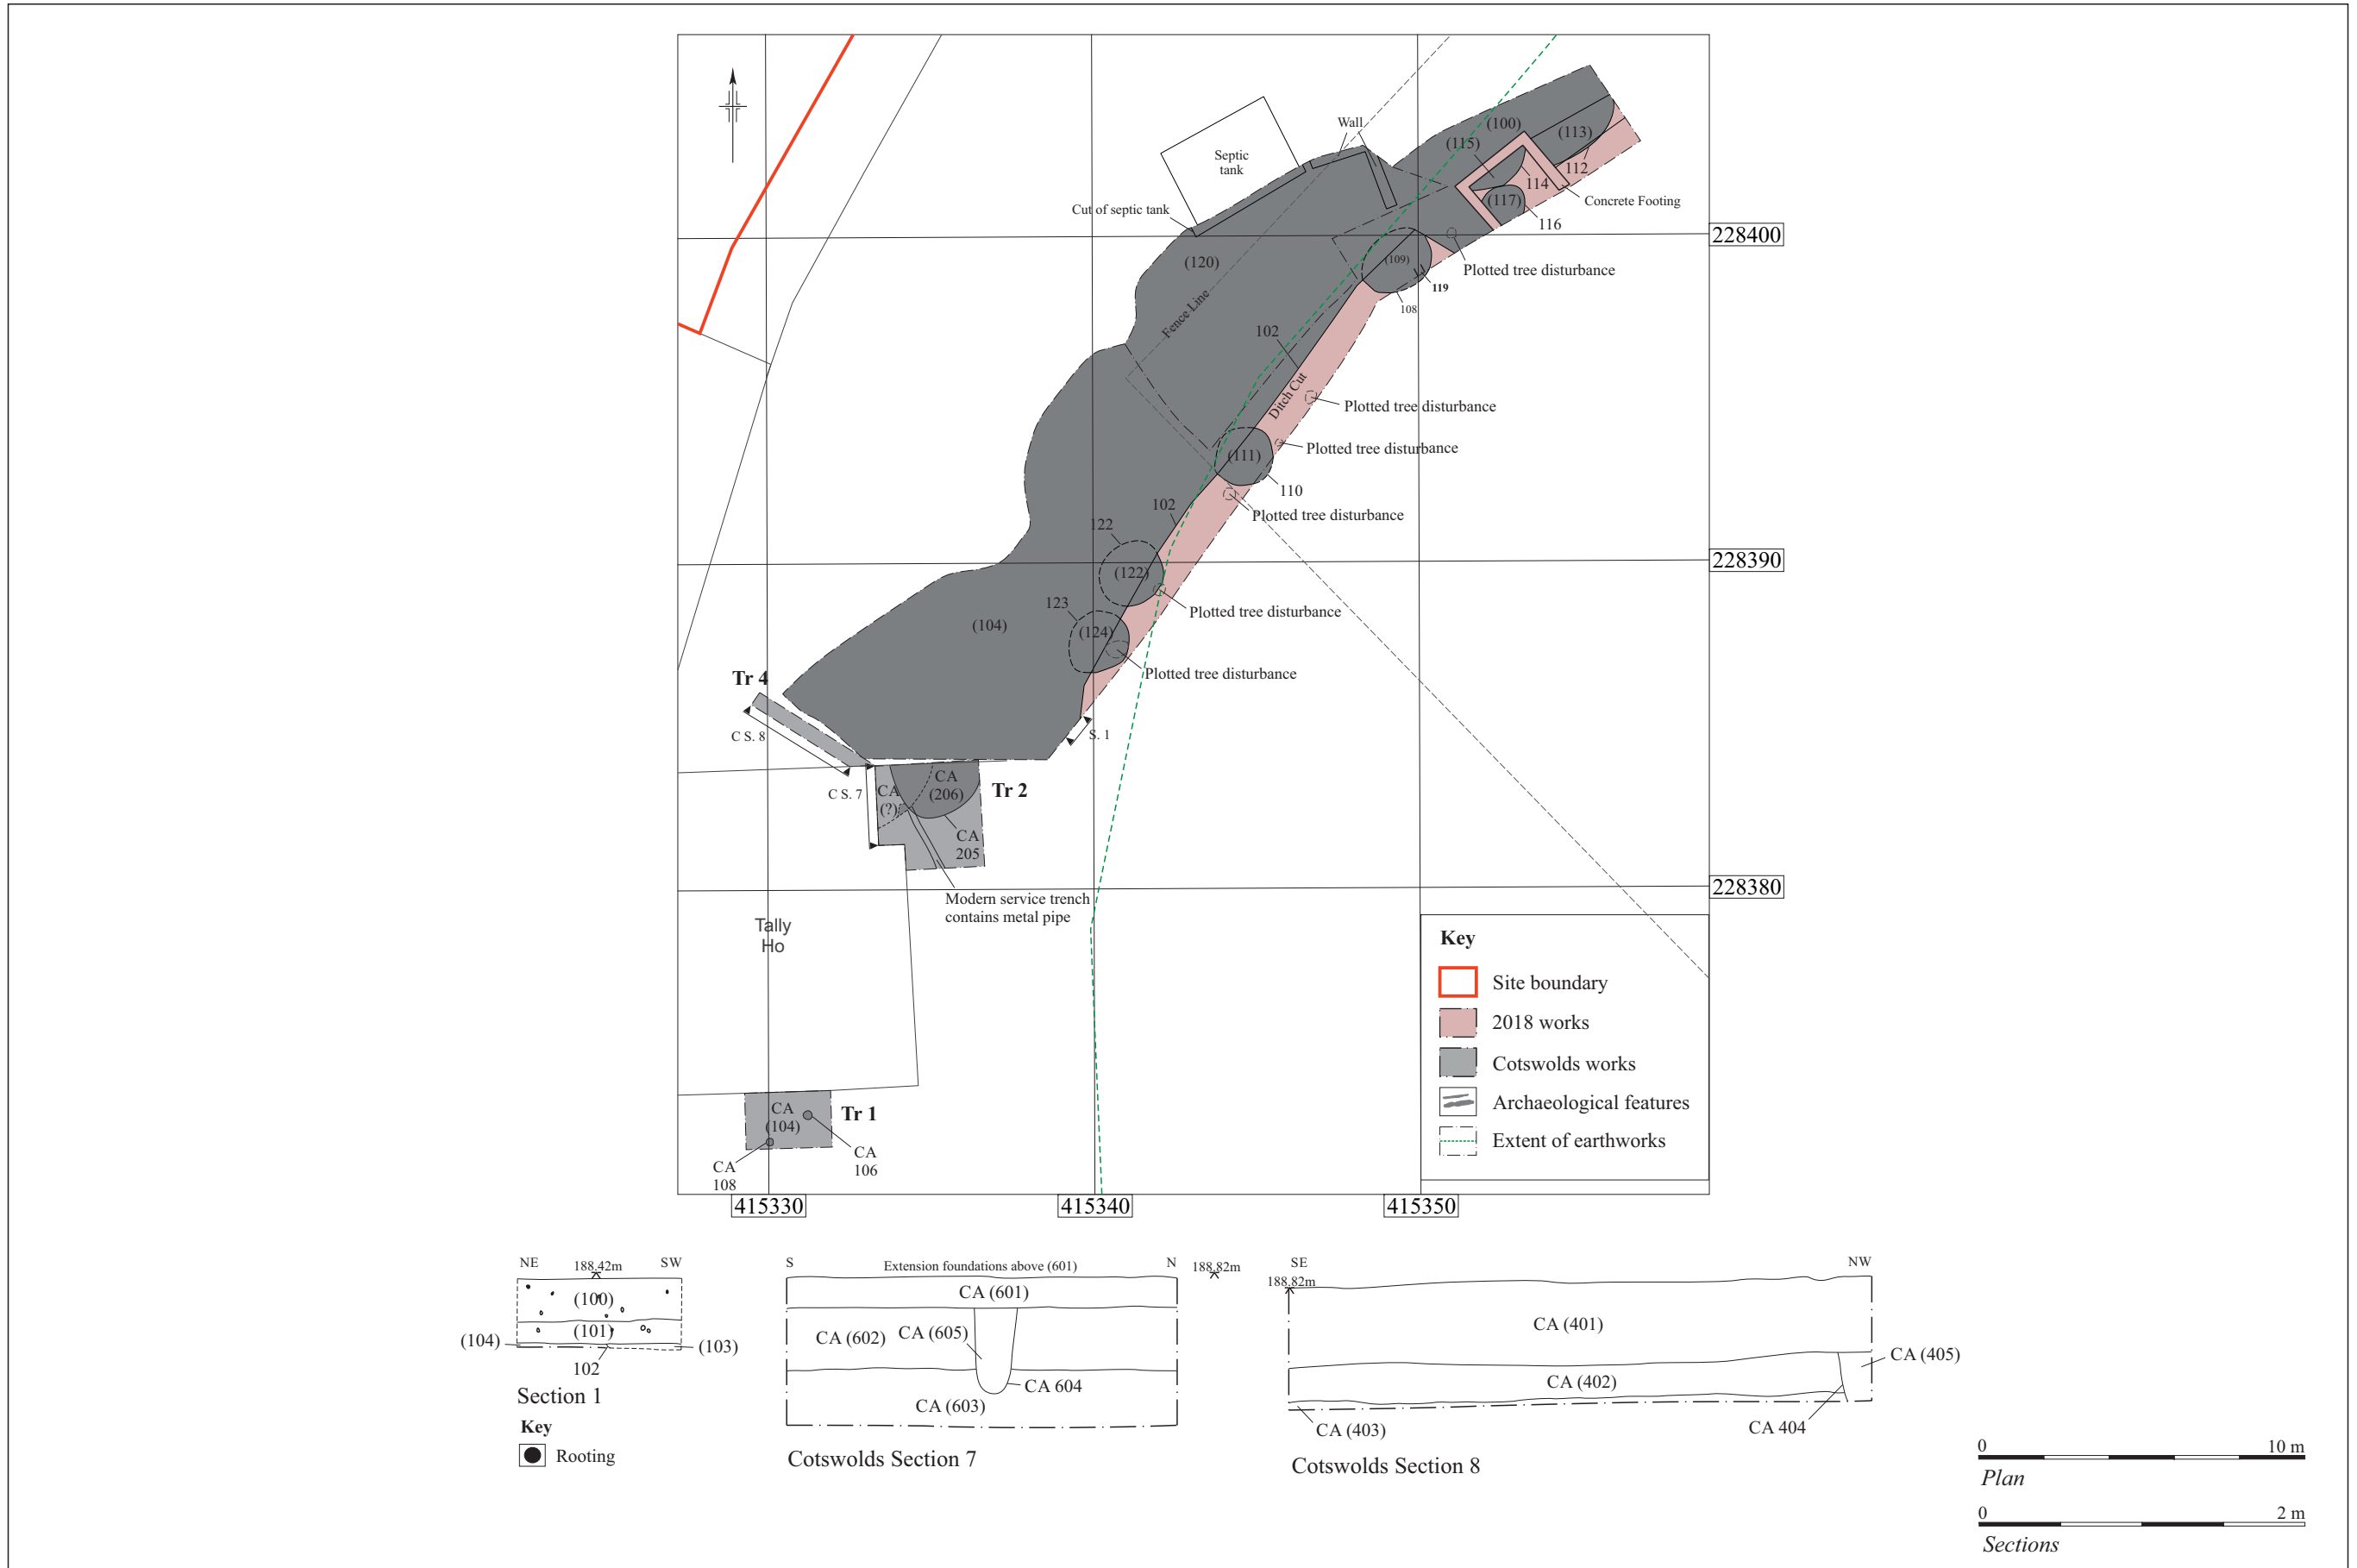
Figure 13: Investigated open areas and sections

Phase 3 saw the cutting of the main inner ditch of the henge. This was evident at Eubury Ring. The rough location of the inner edge of this ditch was identified in the open area stripped inside the henge monument at Tally-Ho in 2018 and was numbered 102. Our remit was not to intrude into material associated with the formation of the early monument so no section was placed across the ditch or into it.
