Barn at The Old Rectory Sculthorpe

Ecological Impact
Assessment

Prepared by
Glaven Ecology

July 2021

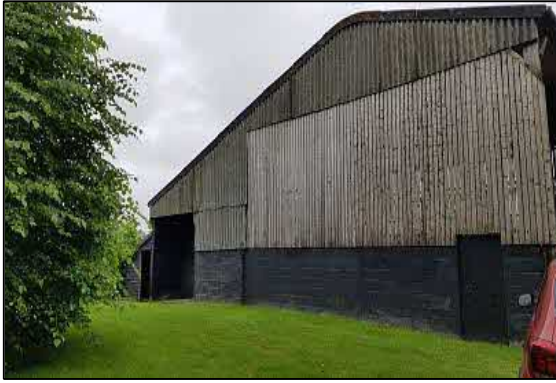
3.1.2 The barn was of a breeze block base and fibre board corrugated roof. The majority of the barn had wooden slatted walls with the rear being to corrugated walls (Figures 1 and 2).

Figure 1: Western aspect.

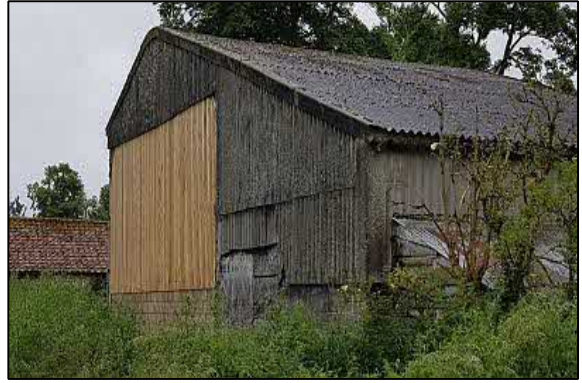
3.1.2 The corrugated walls of the rear were tightly sealed but there were gaps under the roofing material at the eaves. On inspection these were wide and blocked at the roof with no cavities noted.

Figure 2: Eastern and northern aspects.

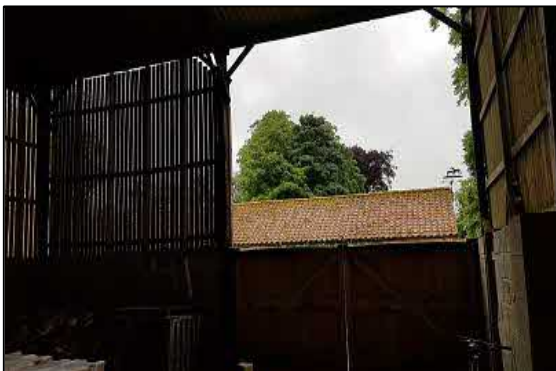
3.1.2 Internally the front space of the barn was light and draughty with the front being open to the south via 12 height doors (Figure 3).

Figure 3: Open fronted barn – viewed from inside

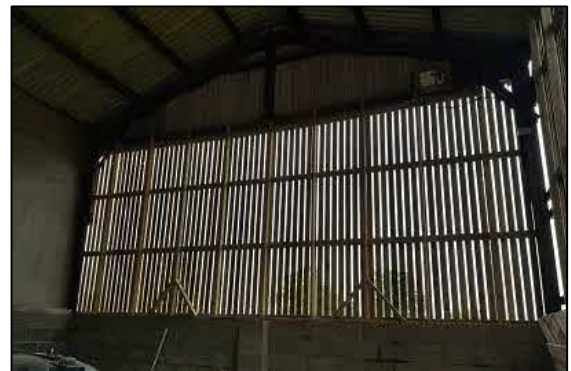
3.1.2 The wooden slats at the front were single ply with wide gaps in between.

3.1.2 The gaps within the wooden slatted walls were more visible from with the barn (Figure 4), letting in more light.

Figure 4: Single ply slatted walls viewed from inside.

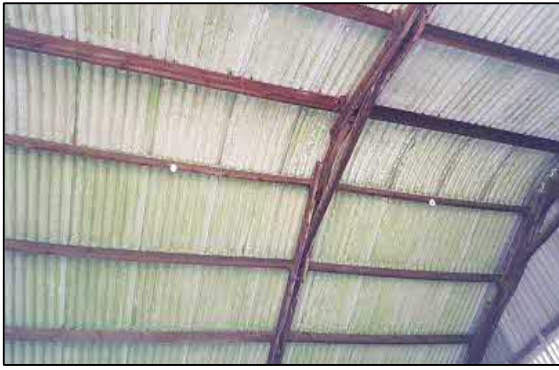
3.1.2 The roof throughout was unlined (Figure 5) and the narrow wooden beams and frame had no suitable splits or cracks for roosting.

Figure 5: Unlined roof throughout.

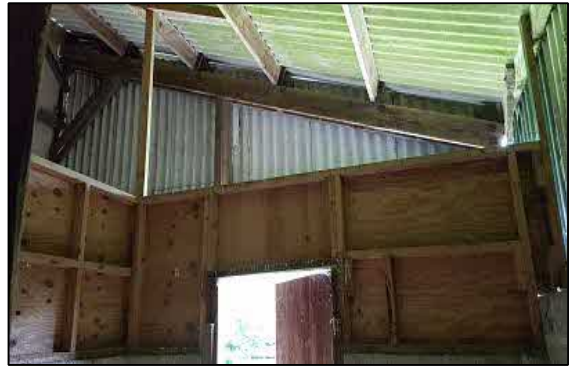
5.2.10 The rear of the barn was split into two rooms via $\frac{3}{4}$ height wooden divide (Figure 6). This space was darker than the front but there were still minimal roosting opportunities noted with the roof being unlined and the narrow beams and frame being of the same nature as the southern space.

Figure 6: Rear space with wooden partition and unlined roof.

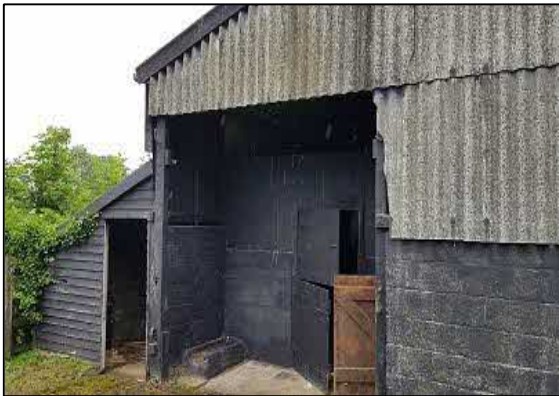
5.2.11 The wooden lean-to was a low building with a sloping tin roof (Figure 7). Internally the roof was unlined and the space was low and cramped (Figure 8).

Figure 7: Lean-to next to entrance to rear rooms.

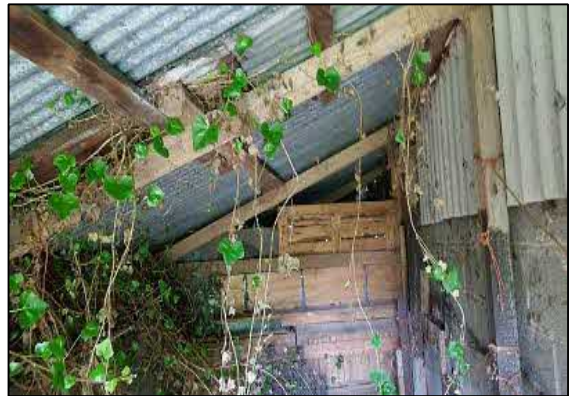
Figure 8: Internal view of lean-to.

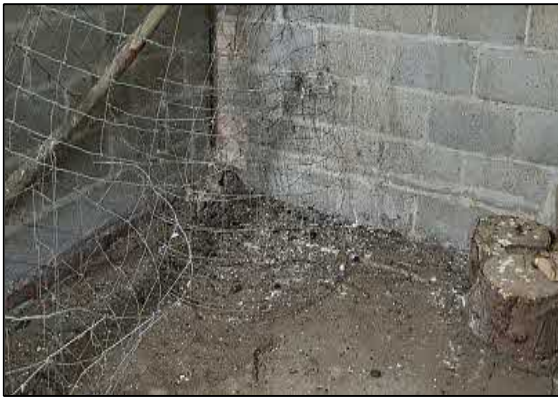
5.2.10 A barn owl flew out of the northern rooms when the surveyor entered. There were numerous barn owl pellets in the area (Figure 9). There didn't appear to be any suitable ledges for nest making.

Figure 9: Barn owl pellets in the rear rooms.

5.2.10 To avoid committing an offence under the Wildlife and Countryside Act 1981 (as amended), any site clearance will take place outside of the bird nesting period (i.e. outside of March to August), or failing that, following confirmation by a suitably qualified ecologist that nesting birds are absent from the habitats to be cleared.

5.2.11 A Barn Owl roosting/nesting box shall be provided within 200 metres of the development site at least 30 days before any development works commence. This provision must be kept free from disturbance and remain in place until at least 30 days after permanent provision has been made. The trees to the southeast of the site would be suitable. The box should face west, so the hole is visible from the field. [See Barn Owl Trust for information.](#)

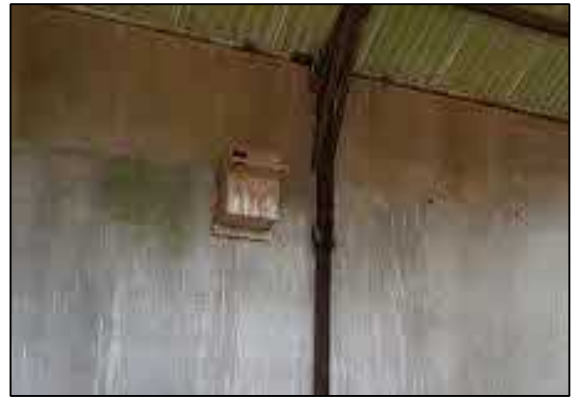
5.2.10 There was a barn owl box in the southern room (Figure 10), this has downy feathers under it, but the other feathers in the vicinity suggested it was being used by wood pigeons and not barn owl.

Figure 10: Barn owl box in southern room.

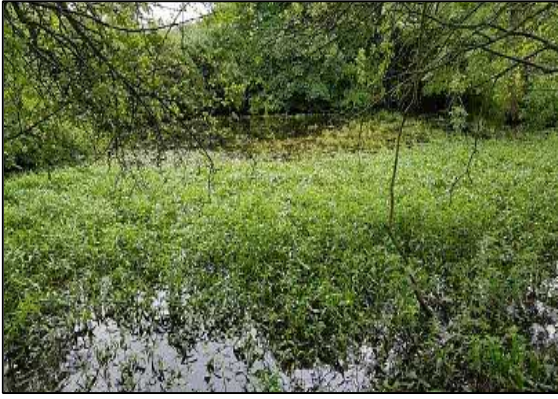
5.2.11 Pond 1 (see Figure 11) was assessed as offering average suitability for breeding great crested newts. The pond was well shaded by trees and had waterfowl but had a high macrophyte presence.

Figure 11: Pond 1.

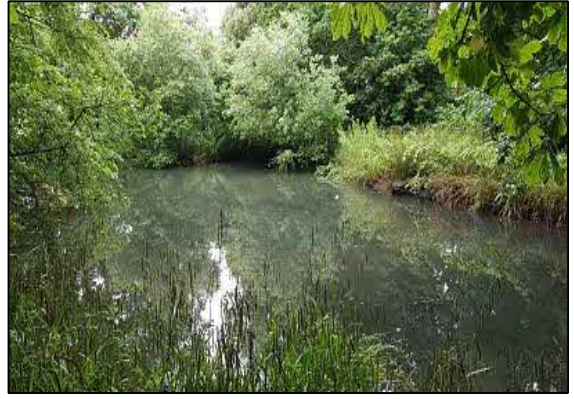
5.2.10 Pond 2 (Figure 12) was assessed as having poor suitability for breeding great crested newts. The pond was shaded by trees and there were no macrophytes present, the water appeared to of low quality.

Figure 12: Pond 2

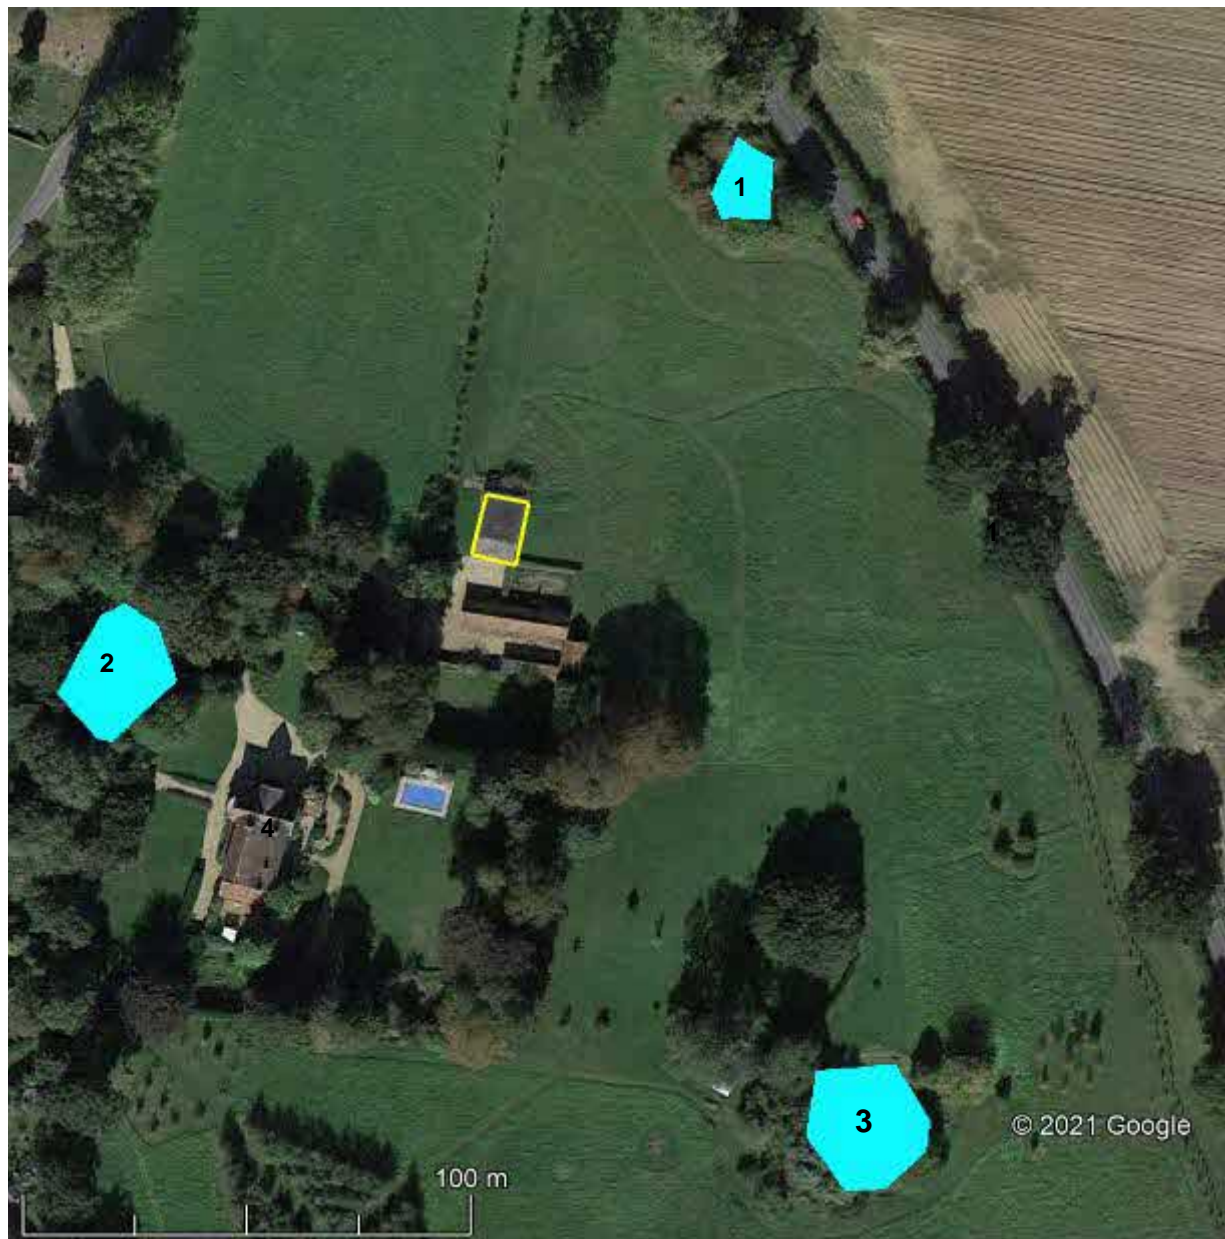
Appendix 4 – Ponds Map

5.2.10 There were 3 ponds within 250m of the site (Appendix 4).

5.2.10 Pond 3 (Appendix 4) which was not accessed during the survey was subjected to the Natural England Rapid Risk Assessment (Natural England, 2020; Appendix) and gave a result of 'Green: Offence Highly Unlikely'.

5.2.10 As a precautionary measure the grass to the north and west of the barn should be kept short prior to and throughout the development period by strimming/mowing. This will discourage wildlife from entering this area.

5.2.10 All demolition waste shall be placed directly into a skip so that rubble piles and therefore potential refuge areas for amphibians are not created.
