**HERITAGE, DESIGN AND ACCESS STATEMENT  
FOR REINSTATEMENT OF LARGER WINDOW AT  
SHELLEY HALL,  
SHELLEY,  
IPSWICH,  
IP7 5QX**

**Date:** January 2022

This statement is written to accompany an application for Listed Building Consent

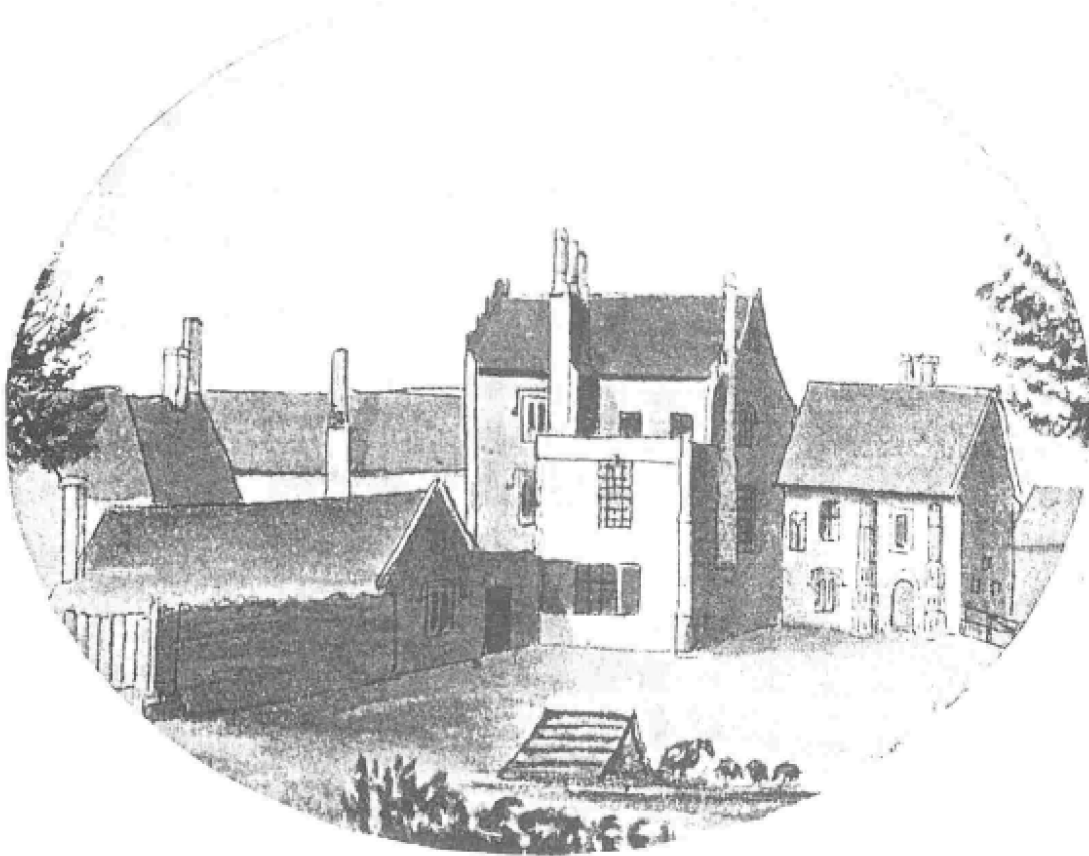
Figure 3: East View of Shelley Hall, copied from an Estate Map of 1786

The Kitchen Range originally had another floor with a crow'sfoot stepped gable (fig 3).

Although his son Thomas (d. 1743) is styled 'of Shelley Hall' on his widow's monument in Framlingham church, there are suggestions that the Hall was rented out in his time. It is therefore thought, that sometime in circa 1700 in the early C18th, the Great Hall, North range and South Kitchen link were all demolished. The etching of 1786, certainly show it demolish and house looking more like a farmhouse.

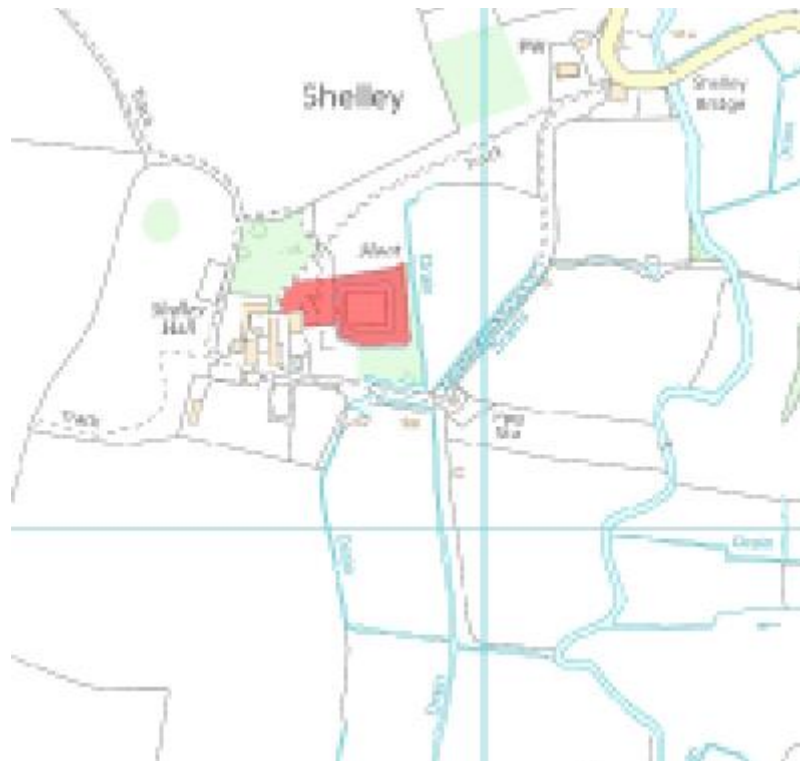
The red hatch denotes the Scheduled Monument area. None of the works within this application are within the scheduled monument site, which is north of the external garden wall onto the Dining Room.

Fig 6: Scheduled monument boundary in red

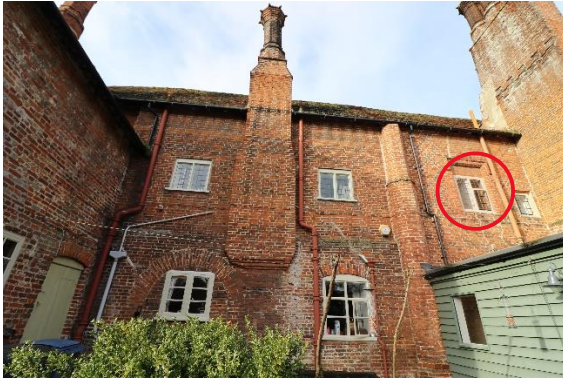
Photo 1. Shelley Hall east elevation. (Proposed window highlighted)

In the 17<sup>th</sup> Century the window was around 450mm taller. This is evident from brickwork infill above the window.

Mr and Mrs Scott would like to reinstate the former opening size to allow additional light into the new stairwell. The window is currently split by a partition forming the stairwell and the wc.

Reinstating the larger opening will help to restore the historic character of the east elevation.

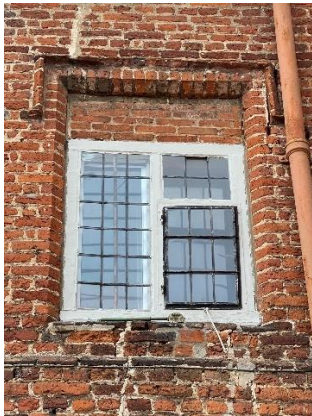
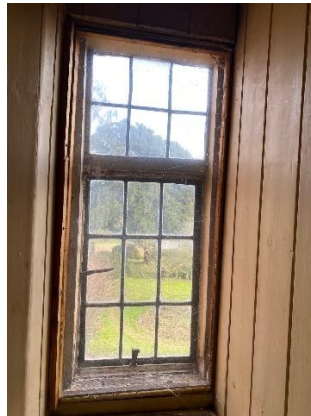
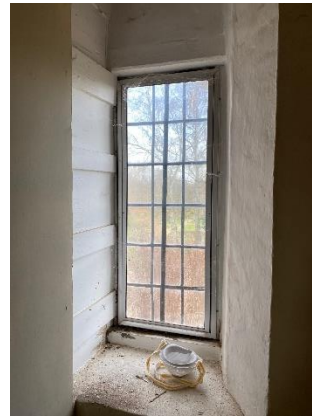
Photo 2, 3 & 4. Window elevations externally & internally.

There is modern aluminium secondary glazing, which will be removed.

The window will be taken off site to be restored and brickwork/plaster infill will be carefully removed. The materials used to restore and increase the window size will be to match the existing.
