# Midland Ecology

Prepared for: Mrs Hartog

**Bat Surveys - Presence/Likely-Absence**

July 2021

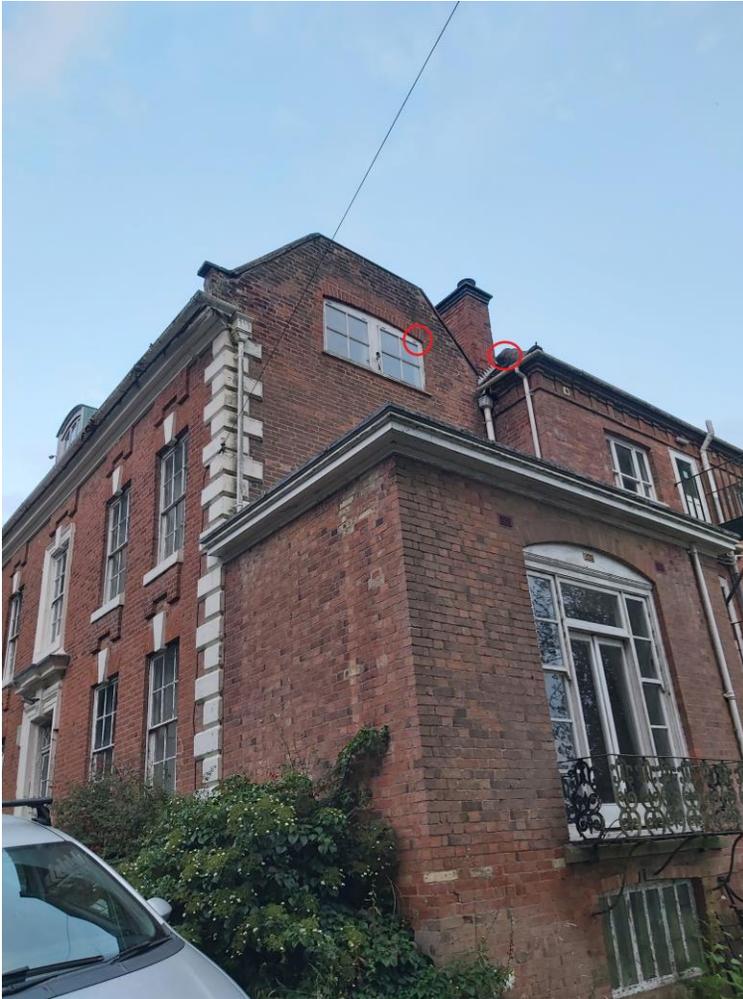
Re-entry locations within the main part of B1:

F	As above	<p>21:59 x1 CP flew from south west, foraged around the south of B2, headed north</p> <p>22:10 x1 CP flew south along treeline at rear of garden</p> <p>22:11 x1 CP commuted east to west over B2</p> <p>22:11 x1 CP foraged around B2</p> <p>22:24 x1 CP commuted south over B2</p> <p>22:25 x1 CP commuted north west</p> <p>22:29 a SP was heard but not seen</p> <p>22:32 and 22:58 a Noctule was heard but not seen</p> <p>22:41 and 22:48 a SP was heard but not seen</p>
Conclusion: No bat activity seen associated with the house.		
A	<p>26/07/2021</p> <p>03:17 - 05:47</p>	<p>03:33 – A Brown Long Eared (BLE) <i>Plecotus auritus</i> was heard foraging behind the surveyor.</p> <p>04:12 – An unknown bat (no call heard but likely a CP) was seen flying north past the surveyor.</p> <p>04:21 - An unknown bat (no call heard but likely a CP) was seen flying south-west past the surveyor and over the roof of B1.</p> <p>04:25 - An unknown bat (no call heard but likely a CP) was seen flying east past B1 and the surveyor.</p> <p>04:25 - An unknown bat (no call heard but likely a CP) was seen flying east from behind B1.</p> <p>04:27 - An unknown bat (no call heard but likely a CP) was seen foraging over the roof of B1.</p> <p>04:29 – An unknown bat (no call heard but likely a CP) was seen flying north-west from the direction of the roof of B1.</p> <p>04:32 – A CP was seen flying east towards the surveyor then north towards the fields adjacent.</p> <p>04:33 - An unknown bat (no call heard but likely a CP) was seen flying north parallel to B1 then west along the driveway.</p> <p><b>04:34-04:50 – Multiple CP (a minimum of three) were seen foraging over the roof of B1, displaying re-entry behaviour until 04:50 where three re-entered the building around the ridge tile and the chimney</b></p>

<b>within the hipped roof within the north-east of the building (location shown in Appendix 1). One CP was also seen landing on the wall next to the window within the northern gable end of B1. This CP re-entered the building between the top right of the window frame and the wall.</b>
B	As above	<p>03:25-03:35, 03:48, 03:56, 04:00, 04:12, 04:16 – A CP was heard but not seen.</p> <p>03:30 – A CP was seen foraging between B1 and the surveyor.</p> <p>03:43, 03:45, 03:52, 03:58, 04:04 – A SP was heard but not seen.</p> <p>03:48, 04:20 – A <i>Myotis</i> species was heard but not seen.</p> <p>03:56 – A Noctule was heard but not seen.</p> <p>04:10 – A BLE was heard but not seen.</p> <p>04:26 – An unknown bat (either Leisler's <i>Nyctalus leisleri</i> or Serotine <i>Eptesicus serotinus</i>) was heard but not seen.</p> <p>04:35 – Multiple bats (minimum of two) were seen foraging by the north-east of B1, no calls heard but likely CPs.</p> <p>04:39 – Two CPs were seen flying east along B1.</p> <p>04:42 – An unknown bat (no call heard) was seen flying west along B1.</p> <p>04:44 – A CP (no call heard) was seen foraging over the north-west gable of B1 (main house).</p> <p>04:46 – Two CPs were seen flying south-west over the single-storey part of B1.</p> <p>04:49-04:53 – A CP was seen foraging over the main part of B1 (north-west gable in particular).</p>

The findings suggest the presence of a summer roost for a low number of male and/or female common pipistrelle bats within the main part of B1; as well as a maternity roost of soprano pipistrelle within the butterfly roof of B1. It is also known (from previous surveys) that a brown long-eared feeding perch is present on the west side of the main part of B1.

- Supervision of the stripping of the existing roofs by a suitably experienced and licensed Ecologist
- Replacement roosting provision for the common pipistrelle roost that will be lost; in the form of crevice bat boxes (made from woodcrete or similar) and bat-adjusted tiles on the main building

- Provision of an artificial feeding roost for the brown long-eared bats, in replacement of the existing one, which will be lost

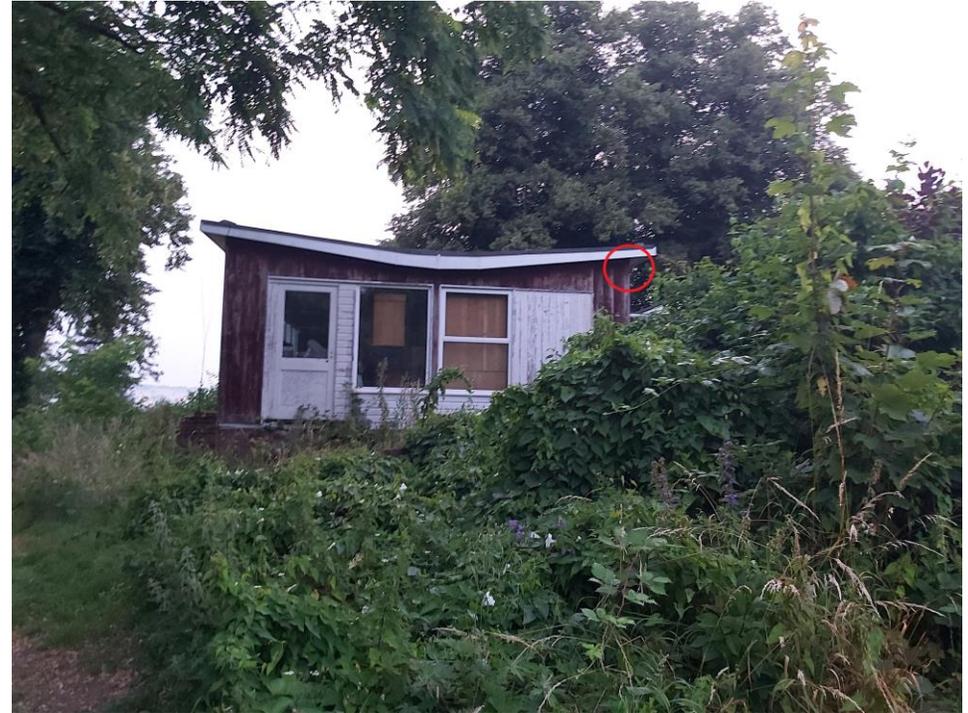
Re-entry location within the butterfly roof of B1:

<p>04:27 – A BLE was seen flying north-west behind the surveyor.</p> <p><b>04:36-04:55 – Sixteen SP were seen swarming by the butterfly roof section of B1, before re-entering the building within the south-east corner underneath the soffit box. These bats were heard after re-entering, indicating a maternity roost.</b></p>
D	As above	<p>03:14-04:20 – Pipistrelle species were heard throughout this time period, possible CP &amp; SP, quick passes meant ID was difficult.</p> <p>03:22 – A Noctule was heard but not seen.</p> <p>03:39 &amp; 03:43 – A <i>Myotis</i> species was heard but not seen.</p> <p>03:44 – A CP was seen flying north behind B1 heading towards surveyor C.</p> <p>03:59 – A CP was seen flying east in front of the surveyor.</p> <p>04:24 &amp; 04:25 – An unknown bat (no call heard but likely a CP) was seen flying by the roof of the main part of B1.</p> <p>04:25 – A CP (no call heard) was seen flying north towards the main part of B1.</p> <p>04:26 – Two CPs were seen foraging over the roof of the main part of B1 for a minute before suddenly disappearing.</p> <p>04:28 – A CP was seen flying south over the single-storey of B1, from the main part of B1 over the head of the surveyor.</p> <p>04:31 - An unknown bat (no call heard but likely a CP) was seen flying east past the surveyor.</p> <p>04:33 – A CP was heard but not seen.</p> <p>04:33 - An unknown bat (no call heard but likely a CP) was seen flying west over the roof of the main part of B1.</p> <p>04:34 - An unknown bat (no call heard but likely a CP) was seen foraging over the roof of the main part of B1. This CP was then joined by another at 04:36.</p> <p>04:37 – A CP was seen flying east from where the CPs were foraging. This bat flew under the eaves of the main roof before disappearing.</p> <p>04:38 – A CP flew over the single-storey next to the surveyor, heading towards the foraging CP over B1.</p>

Compensation for impacts to the soprano pipistrelle maternity roost, and enhancement of the site for bats in general, will be provided through the construction of a bat loft; specifically one suitable both for pipistrelle maternity roosts, and for brown long-eared bats (see accompanying document: *Brown long-eared mitigation*). The bat loft (as shown on the accompanying document: *Offa House site plan - mitigation measures*) measures approx. 4m x 4.5m, and approx. 2m in height.
