## **Preliminary Ecological Appraisal at 1 Park Villa, Thornham Parva, Suffolk**

**Prepared for Geoffrey Hunter**

**October 2021**

<b>Site Name</b>	1 Park Villa, Thornham Parva
<b>Report Type</b>	Preliminary Ecological Appraisal
<b>Client</b>	Geoffrey Hunter

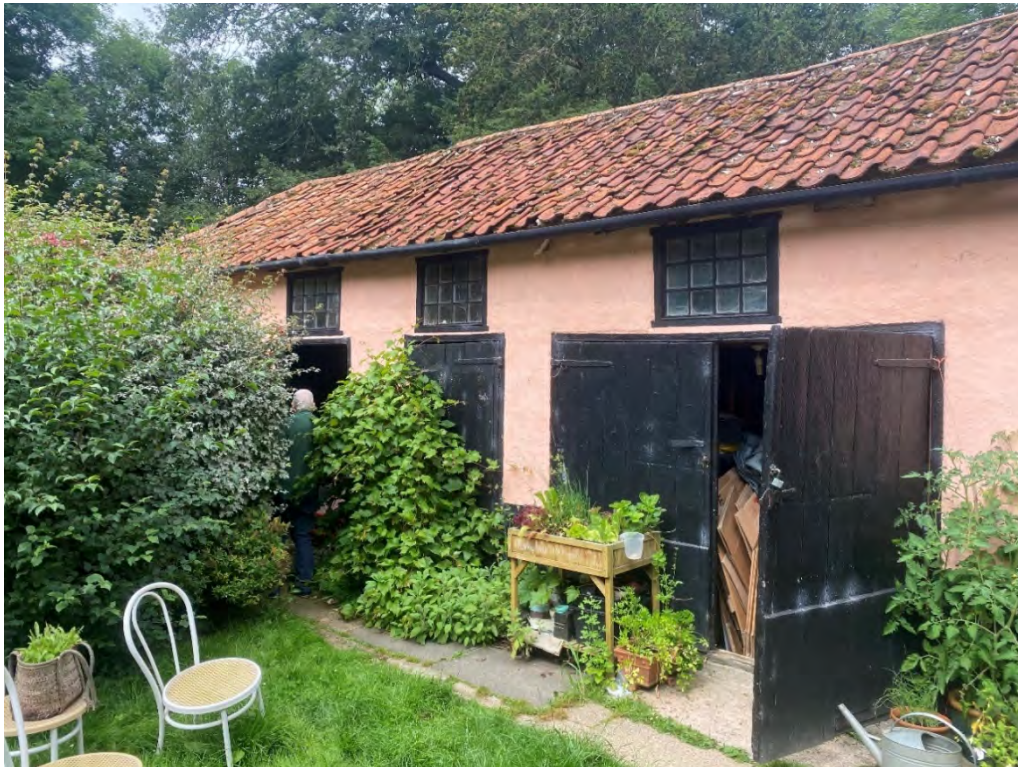
**Plate 1 Building - External**

<b>Building Name/Number</b>	1			
<b>Building Grid Reference</b>	TM1066572241			
<b>Type of Building</b>	Barn			
<b>Age of Building</b>	Circa 1800's			
<b>Condition of Building</b>	Poor			
<b>Wall Construction</b>	Wattle and Daub			
<b>Roof Construction</b>	Pantile			
<b>Roof Type</b>	Gable			
<b>Potential Access Points for Bats</b>	Holes in the roof			
<b>Roof Void</b>	<b>Yes</b>		<b>No</b>	X
<b>Insulation</b>	<b>Yes</b>		<b>No</b>	X

<b>Structure of Roof</b>	Collar beam
<b>Roof Lining</b>	None
<b>Estimated Dimensions of Roof Void</b>	Not applicable
<b>Suitable Roosting Features</b>	None
<b>Evidence of Bats</b>	None
<b>Evidence of Birds</b>	None
<b>Evidence of Barn Owl</b>	Not applicable
<b>Potential to Support Roosting Bats</b>	Negligible
<b>Suitable for Hibernating Bats</b>	No

5.4 The building assessment for potential bat roosts recorded the building as having negligible potential to support roosting bats with an absence of suitable roosting features and no evidence of bat usage.

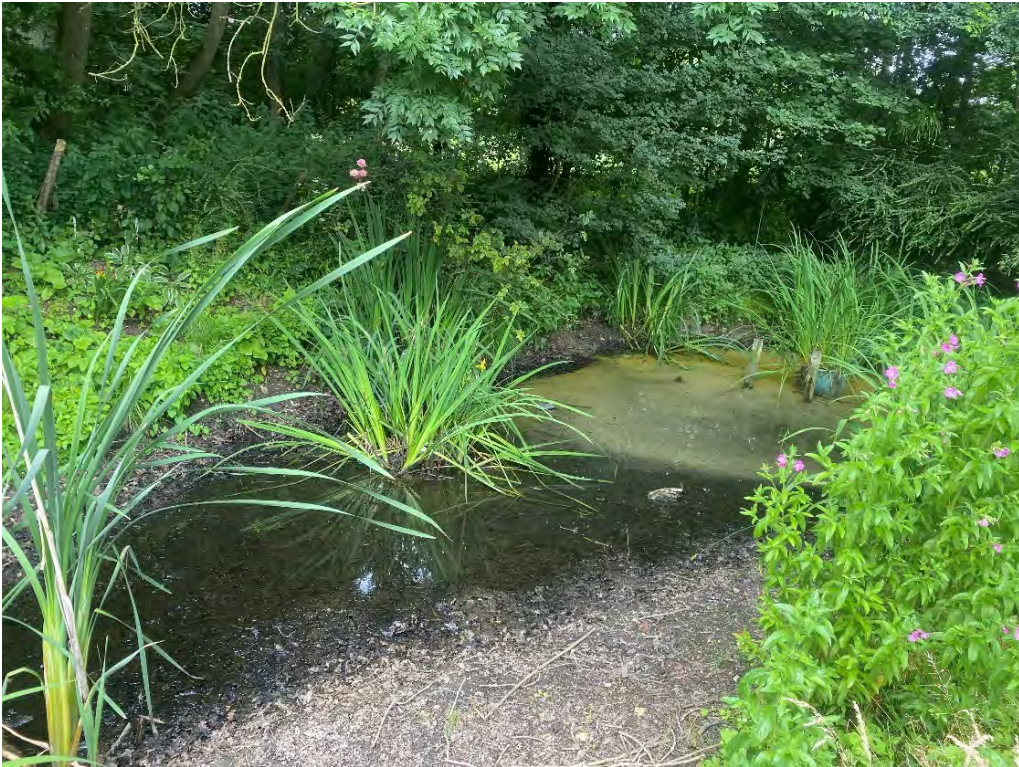
**Plate 9 Pond 1**

1.13 Habitat Suitability Index (HSI) assessments of the two ponds on the site were carried out; Pond 1 resulted in an HSI of 0.58 and Pond Suitability (PS) of Below Average, Pond 2 had an HSI of 0.48 and a PS of Poor.

<b>Indices</b>	<b>Pond 1</b>	<b>Pond 2</b>
Location	1.0	1.0
Pond area	0.5	1.0
Pond drying	0.1	0.9
Water quality	0.67	0.33
Shade	0.2	0.6
Fowl	1.0	1.0
Fish	1.0	0.01
Ponds	1.0	1.0
Terrestrial habitat	1.0	1.0
Macrophytes	0.6	0.4
<b>HSI</b>	<b>0.58</b>	<b>0.48</b>
<b>Pond suitability</b>	<b>Below average</b>	<b>Poor</b>
<b>Predicted pond occupancy</b>	<b>0.2</b>	<b>0.03</b>

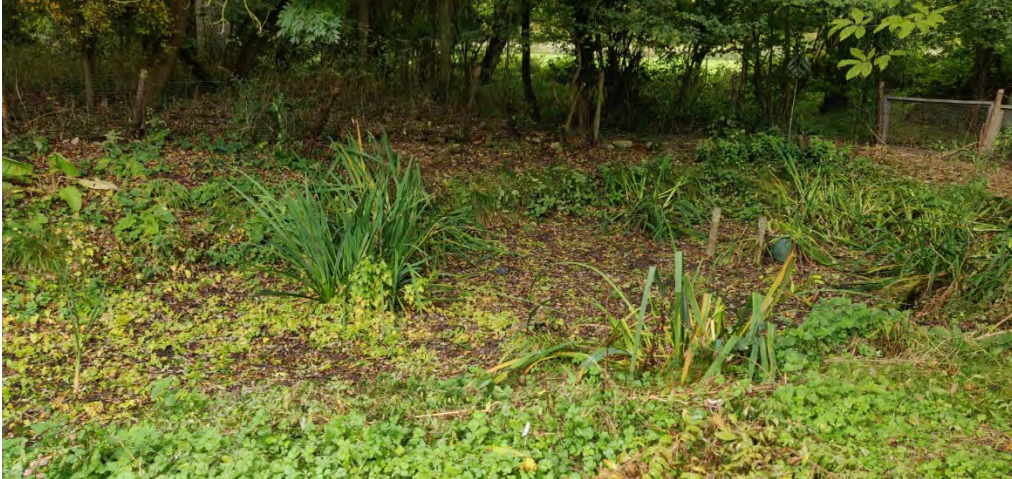
**Plate 10 Pond 1 October 2021**

7.8 The Habitat Suitability Index assessments suggested that Great Crested Newt are unlikely to be using the ponds on and adjacent to the site; the site pond dries annually and the off-site pond supports dense populations of fish, both factors have a significant impact on actual presence of Great Crested Newt beyond the HSI scores and in combination the likelihood of Great Crested Newt being present is negligible.

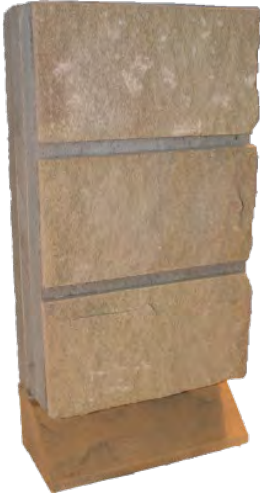
#### Habibat Built In Bat Box

The Habibat Bat Box is a large, solid box made of insulating concrete which provides an internal roost space, and can be seamlessly integrated into the fabric of a building as it is built or renovated. Suitable for most species commonly found in the UK, this single chambered unit features an integrated V system to increase the surface for bats to roost against, whilst allowing them to move around. The Habibat Bat Box can be faced with a number of products to suit the design build. This includes, brick, block, stone, wood or a rendered finish, ensuring the box is unobtrusive and aesthetically pleasing.

Dimensions: 215 x 440 x 102 mm plus facing bricks

Material: Concrete plus facing

8.1 Two built in bat boxes should be installed, these will be best located in a south facing position in the new garage at heights not less than three metres.

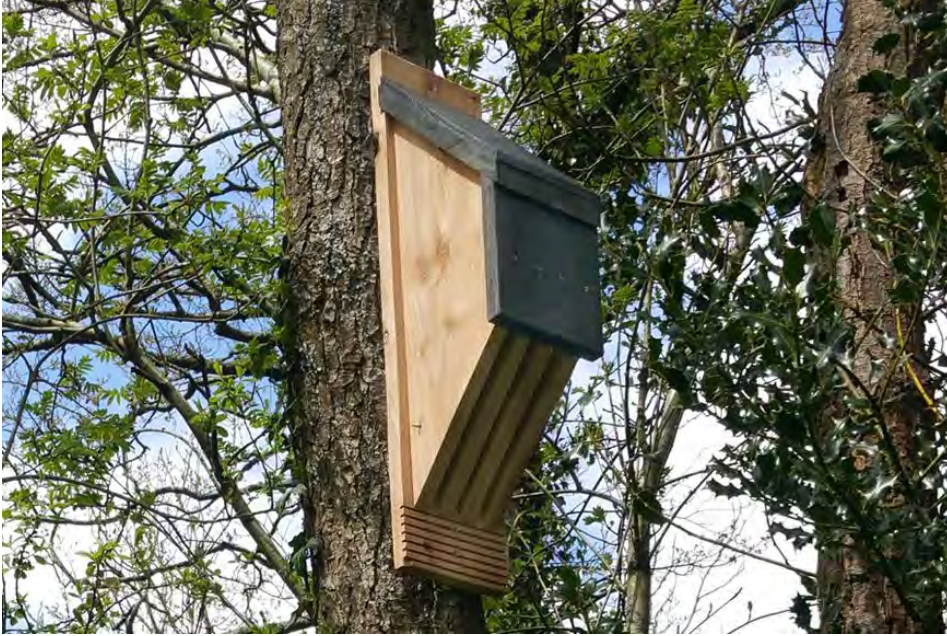
**Vincent Pro Bat Box (May be installed on trees in addition to built in options)**

A highly effective bat box which has been proven through usage of at least 7 different bat species: Barbastelle, Leisler's, Common pipistrelle, Soprano pipistrelle, Brown long-eared, Natterer's and Whiskered (confirmed) and possibly Brandt's.

- Comparative trials proved excellent performance and bat occupancy rates
- This bat habitat has 3 vertical chambers of varying sizes for attracting different species of bat
- Rough landing surface with bat access ladder
- Reduced cleaning requirements, bat droppings fall to the ground
- Dark roof / front elevation to absorb heat. *Please note that wood joints may move / expand with heat and dry/wet weather conditions, this is quite normal*
- FSC certified timber with recycled plastic chamber top

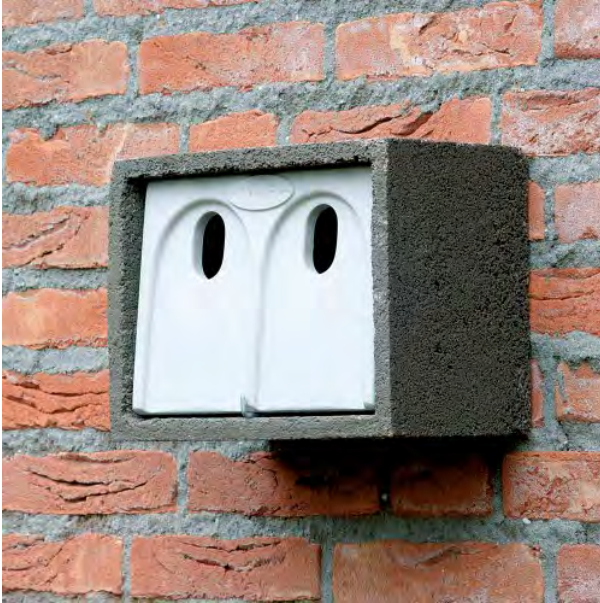
### Woodstone Sparrow Nest Box

The House Sparrow Nest Box is from the Vivara Pro range and is manufactured from WoodStone - a mix of concrete and FSC wood fibres. This material is strong and highly insulating which helps to provide a thermally stable environment within the box. It also protects against damage from predators such as woodpeckers, squirrels and cats. It has two breeding chambers making it particularly suitable for house sparrows as they prefer to nest in colonies.

8.4 A variety of nest boxes catering for House Sparrow and Swift should be installed in the new garage facing between north and east and at heights of two to five metres; one House Sparrow nest box and a group of three Swift nests are suitable for the proposals.

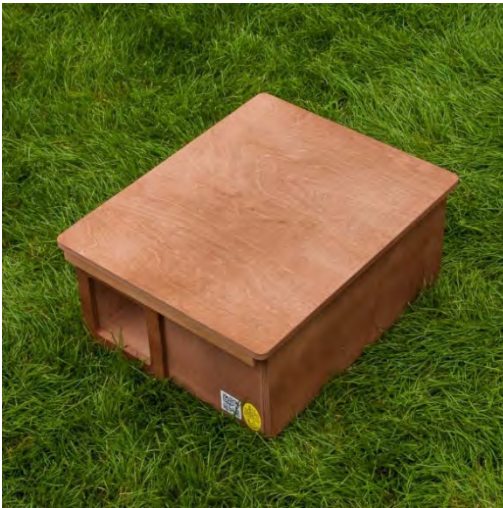
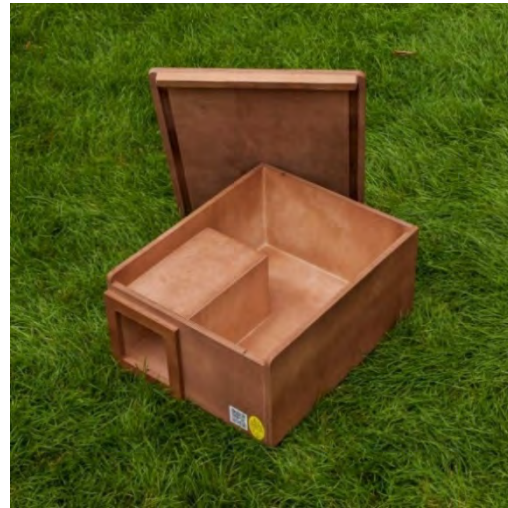
A completely redesigned hedgehog nest that incorporates all the best features of previous nests, is far safer for the hedgehog, and eliminates loose entrance tunnels and plastic pipes by building all these features into one robust design.

- \* Fully built-in tunnel with 5" square access for even the largest hedgehog to avoid unwanted visitors.
- \* Raised 'step' at entrance to enable the box to be partly buried.
- \* Totally safe nesting area well away from the tunnel entrance.
- \* Lower roof to enable the hedgehog to build a snug nest.
- \* Specially designed inbuilt "unlockable" ventilation to provide just the right temperature and humidity without draughts.
- \* Totally removable roof for easy inspection and cleaning.
- \* Underfloor runners letting air to the underside of the box but allowing the box to be pushed easily into place in undergrowth, etc.
- \* Reinforced and strengthened corners making a sturdy nest box.
- \* One compact unit easy to position.

Exterior quality 12mm resin bonded ply. The box remains untreated on the inside. Best situated in a quiet corner of the garden and covered with leaves and other garden debris. Removable lid for cleaning purposes and reinforced corners, manufactured with surface sunk nails to resist rusting.

8.5 To offer enhancements a Hedgehog home should be installed in the garden.
