Householder and Listed Building
Consent Planning Application for
Alterations and Extension to:
Rookery Farm, Daisy Green

DESIGN ACCESS
AND HERITAGE
STATEMENT

Ref: 5686_DAS
February 2022

Rookery Farm, Daisy Green, Bury St Edmunds, IP31 3HW

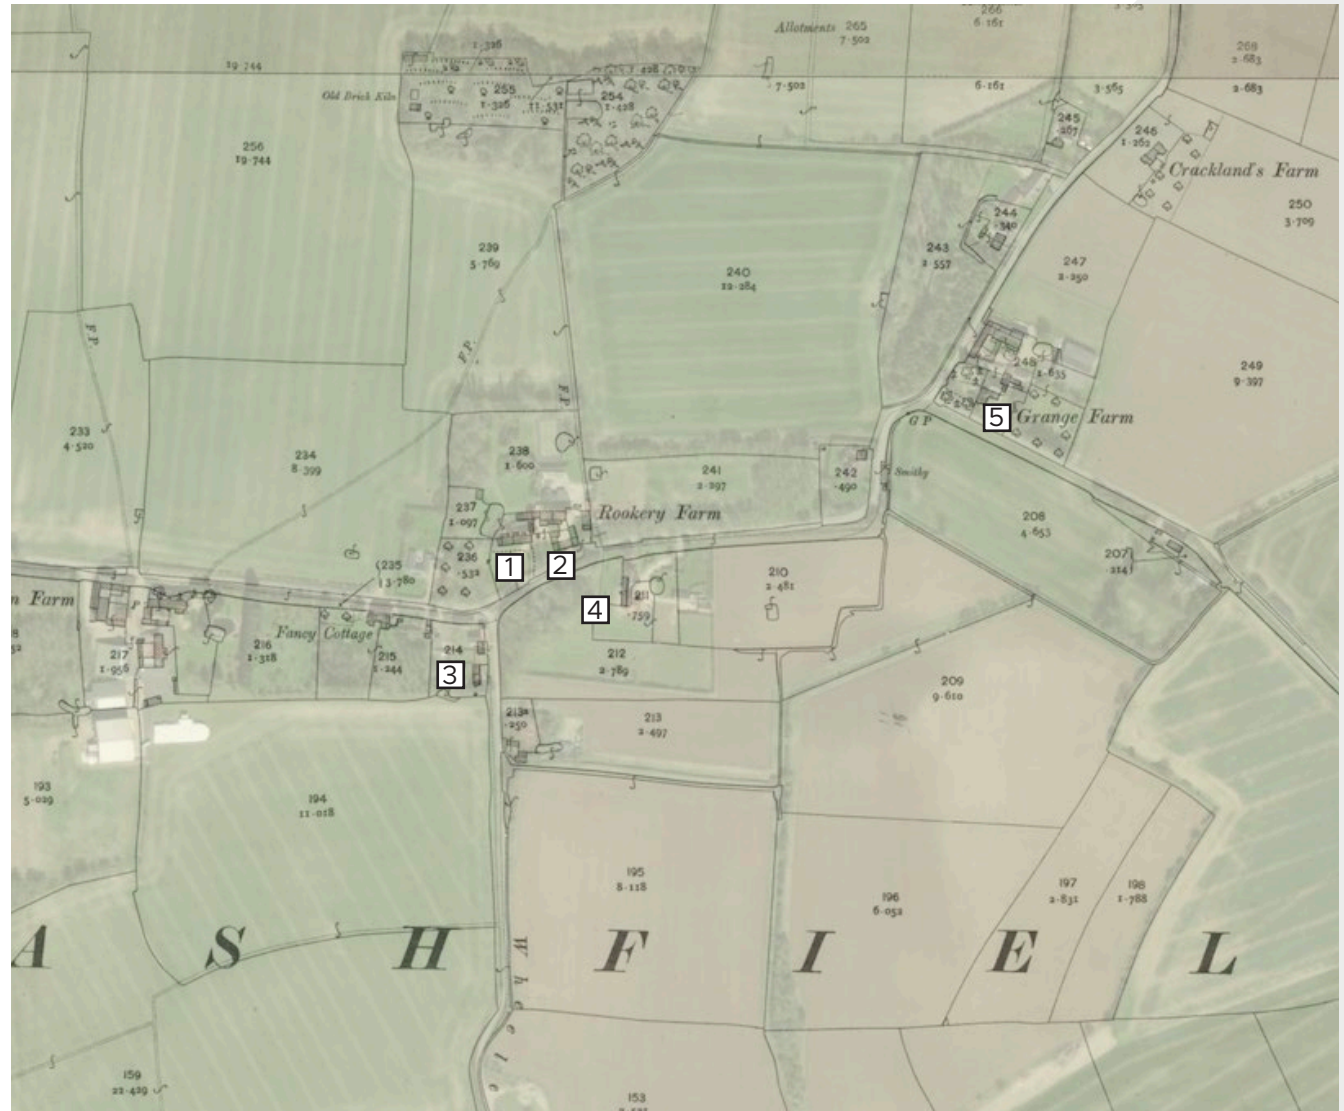
Rookery Farm is circa 17th Century with additions added over the years. It is clustered with a number of listed buildings in the area, these are shown on the adjacent map:

- 1) Rookery Farm (Grade II Listed)
- 2) Barn 20 metres north east of Rookery Farmhouse (Grade II Listed)
- 3) Rookery Cottages (Grade II Listed)
- 4) Dassia Cottage (Grade II Listed)
- 5) Grange Farmhouse (Grade II Listed)

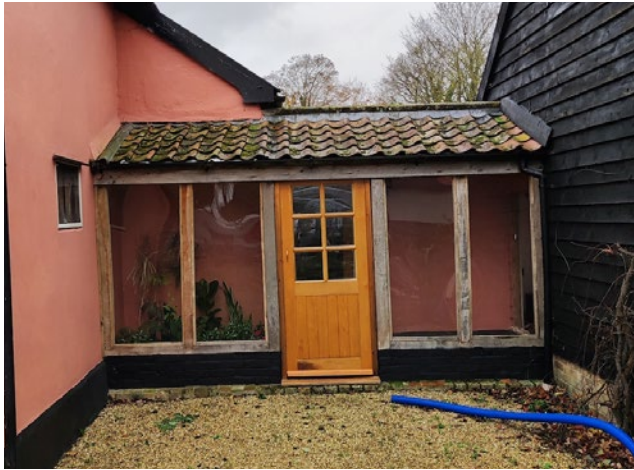
Retrospective: Glazed infill lobby created.

Retrospective planning permission is also being sought for the glazed enclosure of an existing timber walkway between the existing Garden Room and the Host Dwelling.

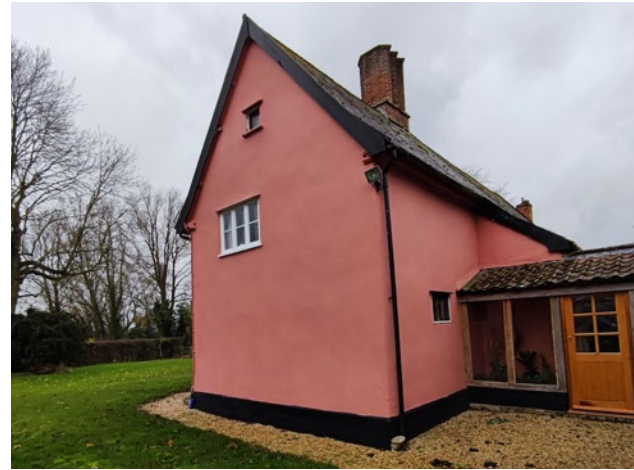
Infilled window to ground floor to be re-instated.

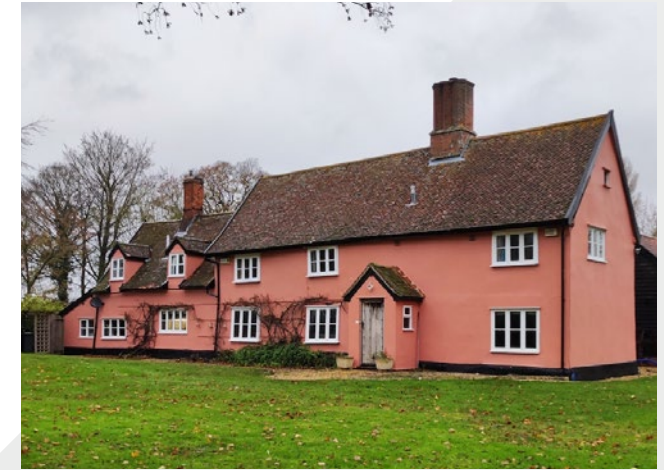
Front elevation of Rookary Farm.

The proposal also includes for the removal of the poor quality front door to be replaced with a timber door in keeping with the vernacular of the dwelling.

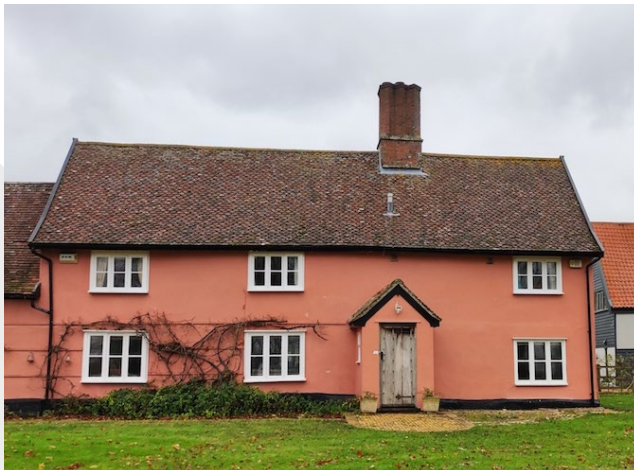
Timber front door to be replaced.

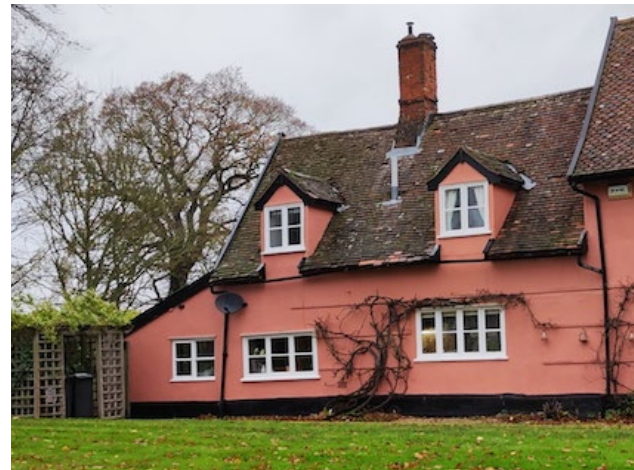
First floor dormer windows to be replaced with timber flush casement slimlite glazed windows. Roof repairs proposed to deal with leaks on this section of roof.

New timber flush casement slimlite glazed windows are to replace the existing poor quality front elevation dormer windows.

External repairs to the one & half storey roof are proposed. Existing tiles are to be removed and retained. Leaks repaired and roof re-laid with existing tiles.

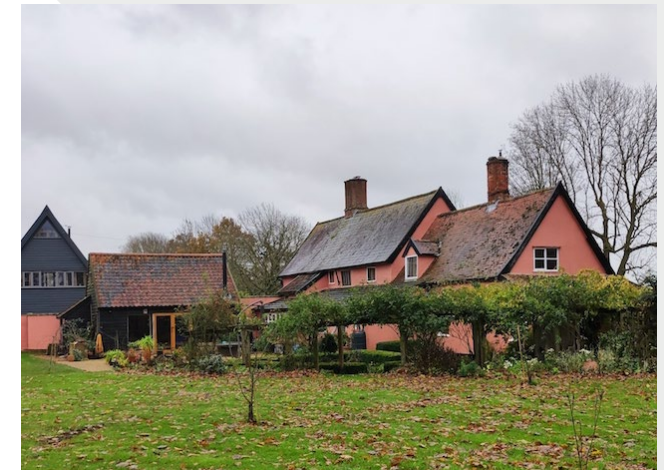
Rear of Rookary Farm.

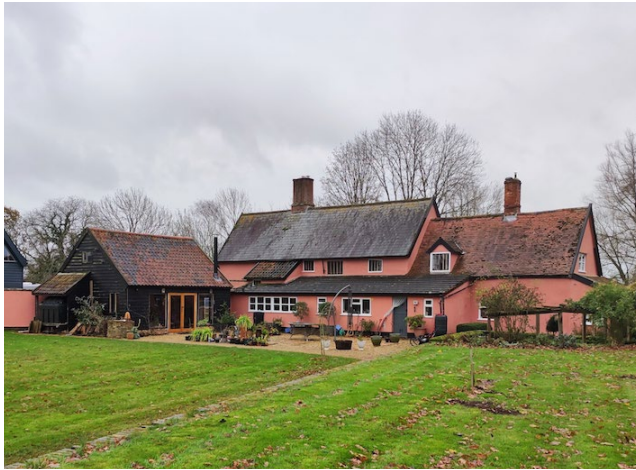
Later lean-to extension to be altered and extended. Retrospective: Reinstatement of historic first floor window.

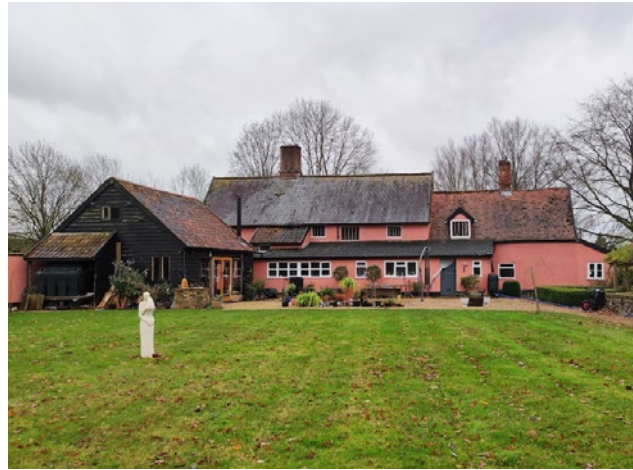
Later lean-to extension to be altered and extended. Retrospective: Reinstatement of historic first floor window.

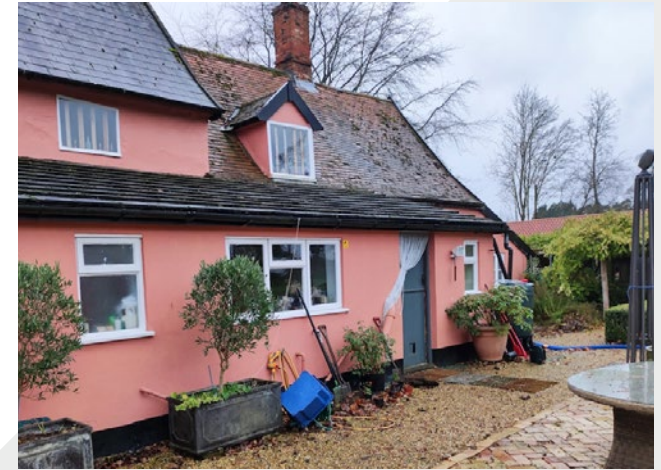
Utility window and door to be removed and replaced with glazed french doors and fixed glazed screens. Concrete roof tiles to be removed and replaced with natural slate.

The existing lean-to extension includes the removal of the poor quality concrete roof tiles that are to be replaced with natural slate and incorporate the proposed extension's roof. It is also proposed to include the insertion of 2no. conservation rooflights within the existing lean-to roof. Within the lean-to the proposal includes for the removal of windows and door to be replaced with glazed french doors and fixed glazed screens.

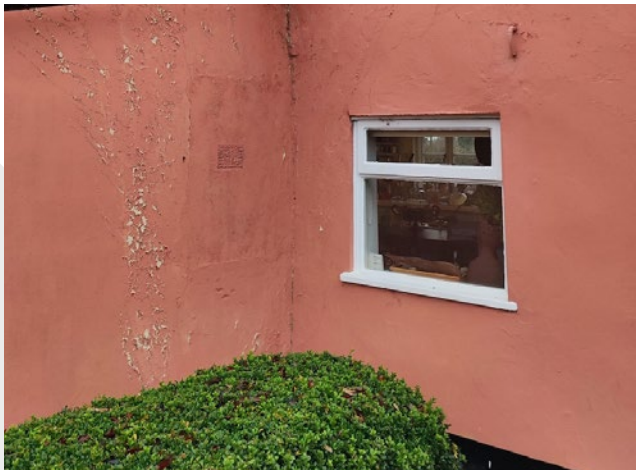
Later addition window to be removed and opening increased to allow for door access to proposed Larder.

A modern rear window within the Kitchen is to be removed and enlarged to provide access into the proposed relocated Larder.

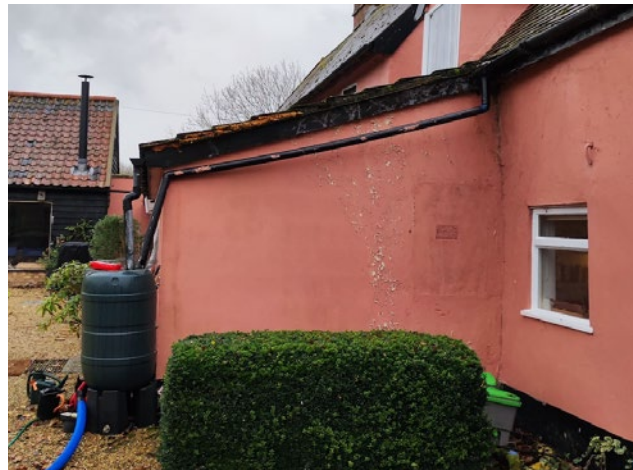
Partial demolition of lean-to to allow for proposed extension.

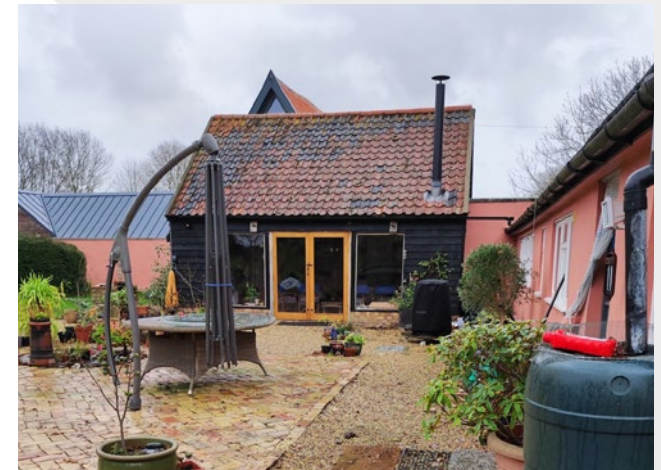
Garden Room alterations include the proposed insertion of dormer windows and replacing existing timber doors.

External changes include the insertion of two gable dormer windows within the existing first floor store. Historically, the site had received approval for the insertion of a dormer window and roof light under application DC/17/03652 & DC/17/03654.

Other changes to the Garden Room addition include the removal of the existing poor quality timber french doors and replaced with new timber french doors.

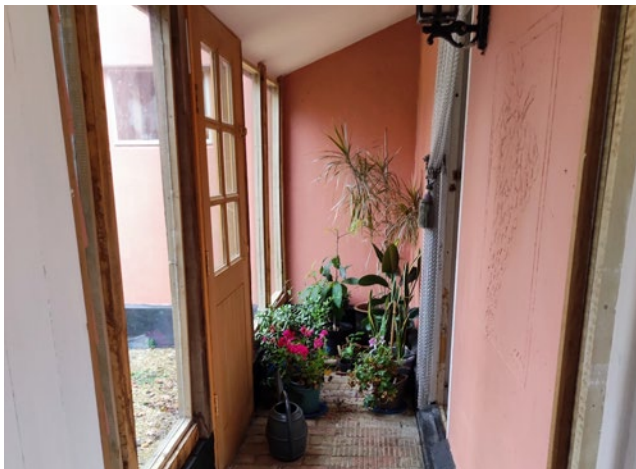
Retrospective: Infill glazed link creating lobby.

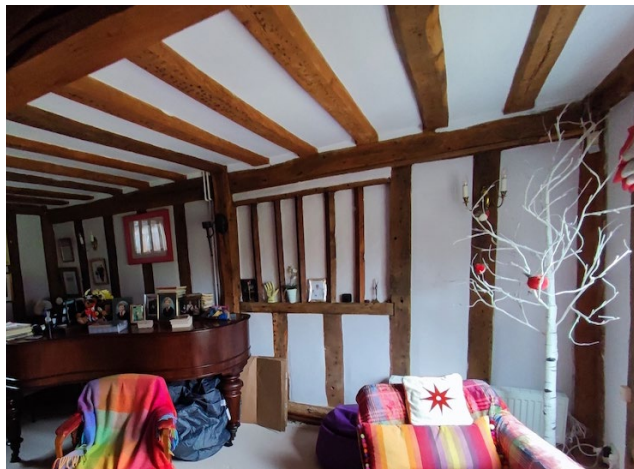
Existing blocked 6-light diamond-mullioned window in Snug to be re-instated.

- Blocked 6-light diamond-mullioned window within the Dining Room
- Blocked 6-light diamond-mullioned window within the Snug.

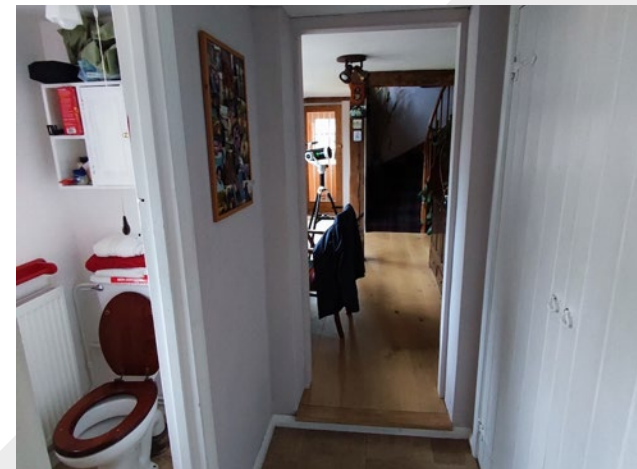
Existing modern cupboards and partition walls to be removed. WC to be altered.

The existing WC is to be enlarged to incorporate the existing Shower Room.

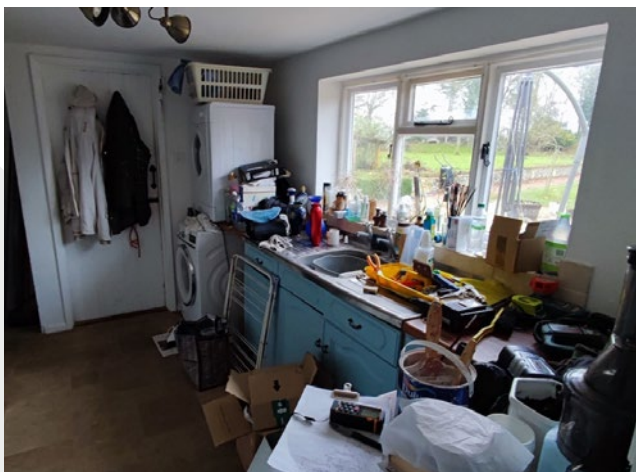
Utility to be relocated. Existing window to be removed and opening extended to provide glazed french doors and fixed glazed screens.

Within the re-configuration of the lean-to extension the Utility will now be re-positioned within the new addition to also include the Larder.

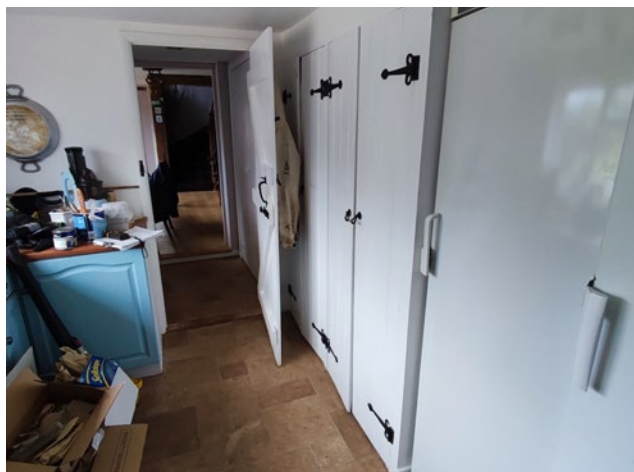
Modern stud walls to be removed to create proposed Garden Room.

The proposed inclusion of the Garden Room will require a number of modern walls to be removed, with the insertion of full length glazed french doors and fixed glazed screens to optimise views to the private garden area.

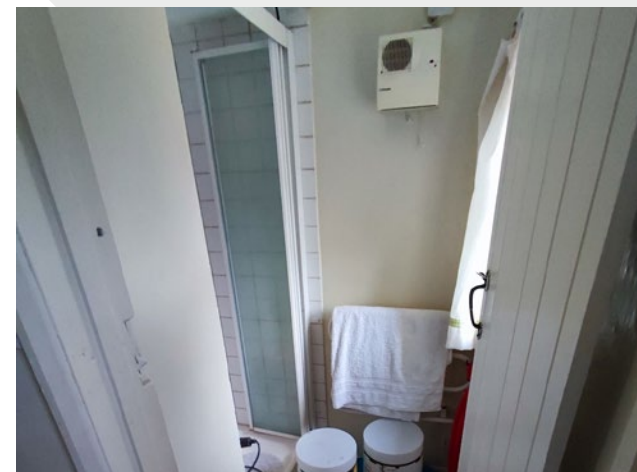
Existing Shower Room to be demolished.

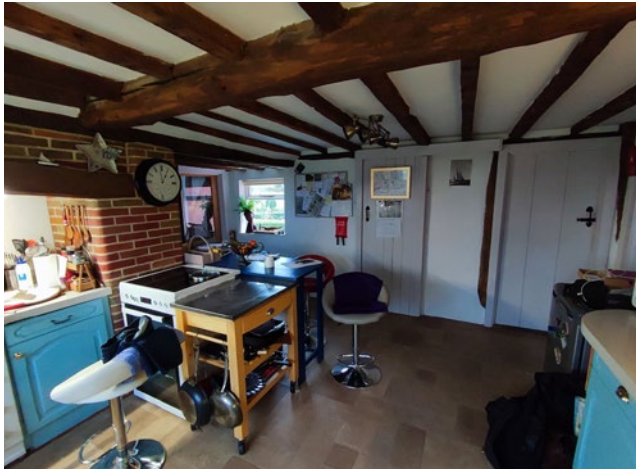
Alterations made to north wall, including removal of modern window and replaced with door opening, existing historic studs to be exposed and doors removed.

Existing wall between the Kitchen and the newly proposed Garden Room is to be opened up to expose the existing stud work, mimicking the appearance within the Living/Dining area.

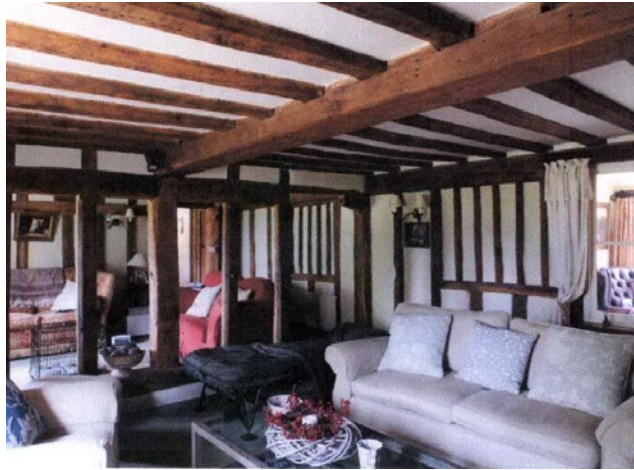
Window to be reinstated in blocked 6-light diamond-mullioned window to dining room.

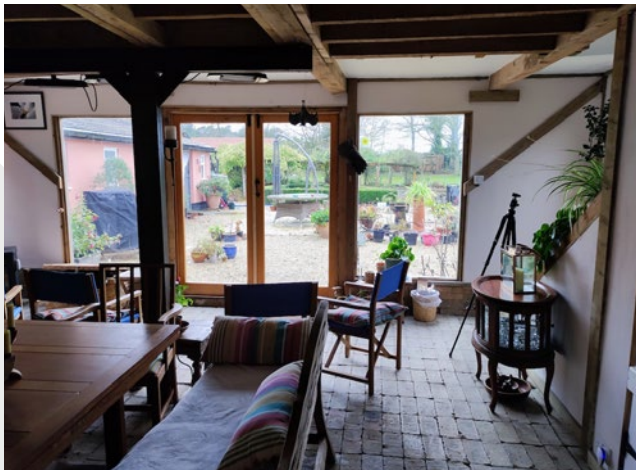
Timber doors to Garden Room to be replaced.

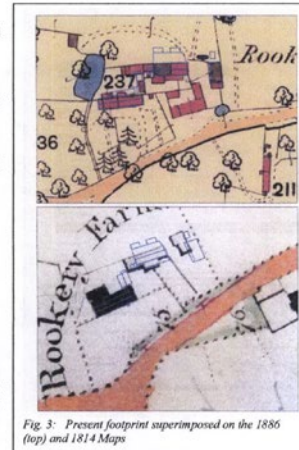
Fig. 3: Present footprint superimposed on the 1886 (top) and 1814 Maps

- 1.4 The next map is the first of the modern Ordnance Survey Maps issued at a scale of 25" : 1 mile in 1886, surveyed in 1885. This shows that there now were three carriageways from the road and the house is definitely divided into two separate properties, all still owned by Lord Thurlow. The overall footprint is much the same as it was in 1848 except at the west end a narrow extension had been added which relates to the present garden room. The south porch has still not appeared but the northern extensions remain, as they do on the 1904 O.S. Map and by the time of the 1977 map reproduced in the sales particulars of 1984 the situation was the same. A porch had not yet been built according to a photograph of c. 1900 at the house³. Also present is the big pond immediately north-west of the house which was first recorded in 1848 and was still there in 1977 but has now gone.

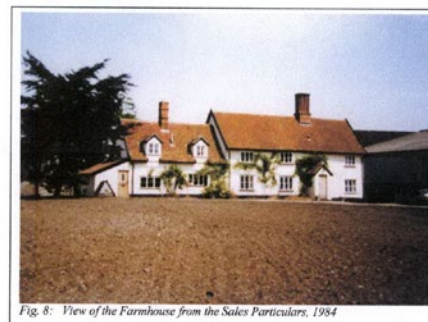
The sale particulars give us more information, such as the fact that the house had been extensively modernised within the last two years and this seems to include the whole of the northern extension. The particulars also advance the information that the farm was sold bit-by-bit from November 1942 to August 1970. In the end Lot 1 was not sold at auction, but by a private sale in the sum of £270,000 to the family of the present owners.

Fig. 8: View of the Farmhouse from the Sales Particulars, 1984

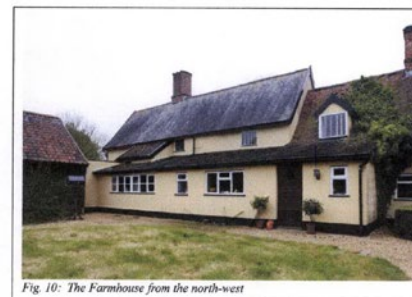
- 2.4 The **west gable end** is represented only by a silver of colourwashed render above the ridge of the roof of Rookery Cottage but the **east gable end** is complete, rendered and colourwashed as before. The tarred brick plinth is more regular than that to the south elevation and there are no ground-floor windows but there is a three-light casement to the first floor dating to 1982. It is off-set to the south because right next to it inside is a genuine four-light diamond-mullioned window, blocked but of the late fifteenth-century. Above this was a small square single-light casement to the attic room, but this has gone and the opening blocked with a piece of board nailed on (but falling off).

Fig. 10: The Farmhouse from the north-west

- 2.5 To the north of this gable, and recessed back from it, is another 1982 addition in the form of a porch which shelters what is now the main entrance to the house. It has a pitched pantiled roof resting on a bressumer which in turn is carried on two square timber posts. The roof structure is just a simple rafter affair and the door is a stable type with a plain glazed panel.

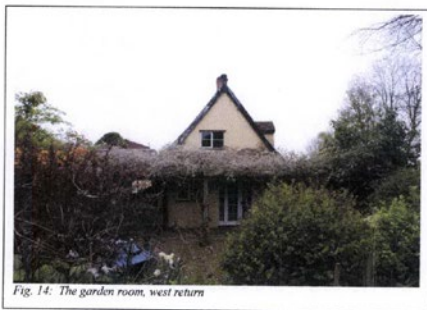
- 2.8 Lastly is the **garden room** added in about 1860 as a single-storey outshut under a sloping pantiled roof. The **south side** has only a two-light casement added after the 1984 sale - it does not figure in the photograph on the Sales Particulars but there was then a stable door, now gone. A similar casement adorns the **north side**. The **west return** has more panache in the form of glazed French windows with margin glazing and a two-light casement to their left, all post-1984. In front is a new timber pergola on square posts which does no harm at all.

Fig. 14: The garden room, west return

- 3.11 The fifth building phase is just the single-storey brick garden room G14 added in c. 1860 which has no particular interest, and the main staircase to the east which replaced an earlier staircase in a similar outshut shown on the

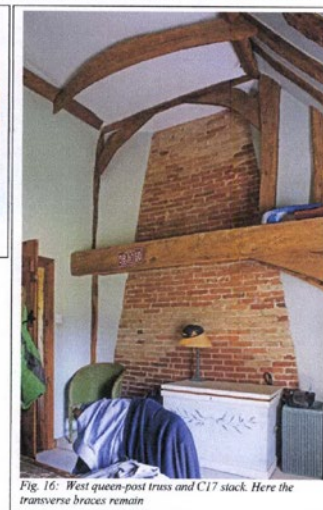
Fig. 16: West queen-post truss and C17 stack. Here the transverse braces remain

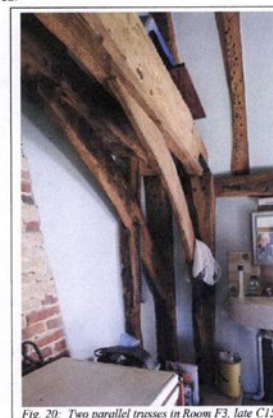
Fig. 20: Two parallel trusses in Room F3, late C15 and early C17

- 3.7 The meeting of the old and new is evident in the first floor in room F3, where truss No. 3 of the fifteenth-century work, set immediately east of the new chimneystack, was allowed to stand. No connection with the new was made but instead another truss mimicking the old was built in parallel right through the house (one must ignore the early nineteenth-century partition wall designed to create a passageway for the sake of privacy)¹⁰. Even the wall plates are separate pieces of timber and certainly the roof structure above has nothing of the tight, crafted, quality of the fifteenth-century master's efforts. Details in the form of diamond-mullioned windows in rooms F1, F2 and in the corridor F4 remain of the fifteenth century but not a single one of them is open to the light and they have to be distinguished from the false versions put up in 1982.

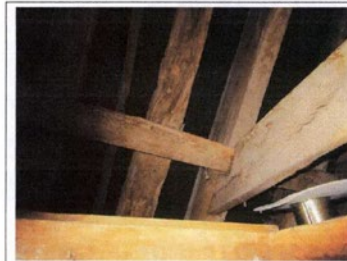
Fig. 22: Mid C18 roof detail
