BRYN CELYN CARETAKER'S HOUSE

BAT SURVEY REPORT

DECEMBER 2021

DATE ISSUED: DECEMBER 2021
JOB NUMBER: CA12265
REPORT NUMBER: 001
VERSION: V1.0
STATUS: FINAL

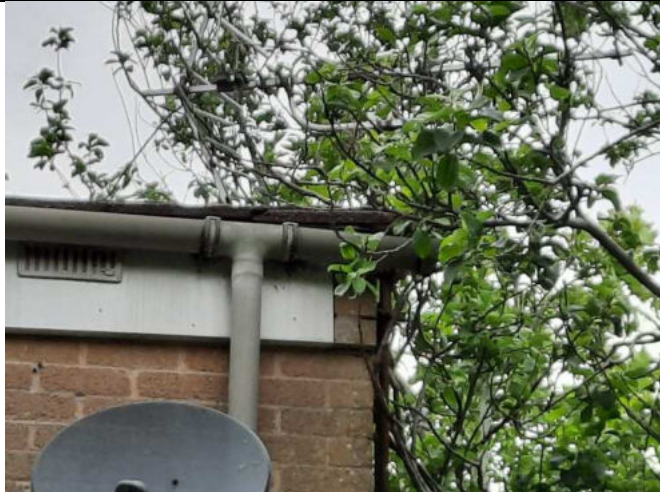
<p>Lifted tiles</p>

<p>Tiles at the north eastern corner of the roof have begun to lift upwards. The gap under the tiles is approximately 2cm x 3cm.</p>
<p>Missing mortar</p>

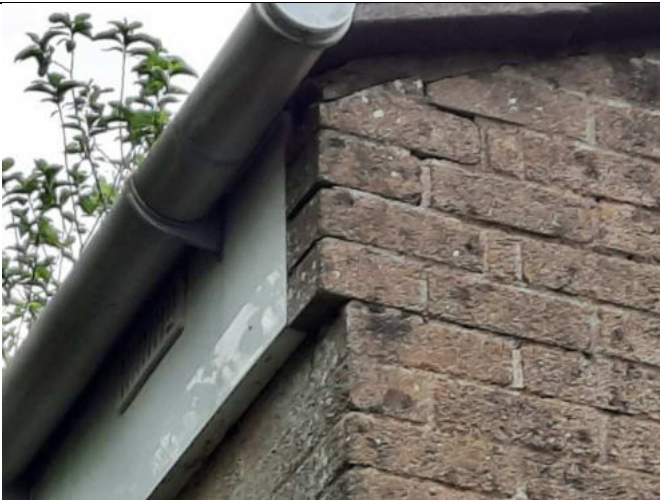
<p>Area of missing mortar under the corner tile and adjacent to the fascia at the south western corner of the building. Approximately 2cm x 4cm in size.</p>

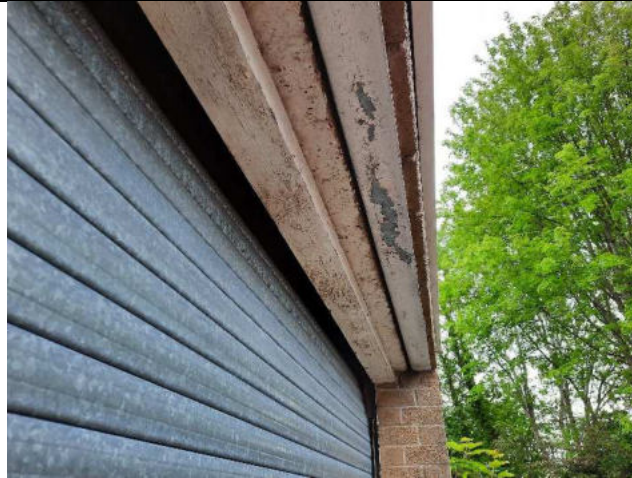
Gap above garage door and between lintels. Approximately 2m x 2cm and 2m x 6cm both are 2m long.

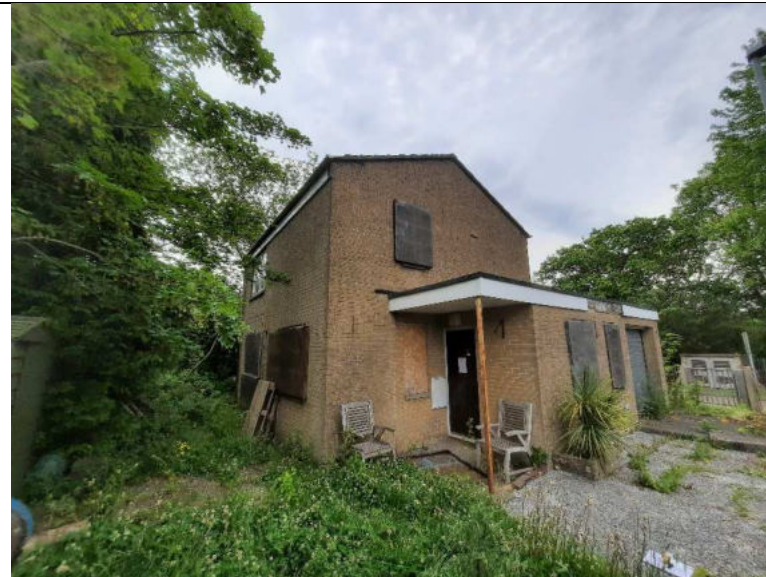
General view of the building's southern aspect

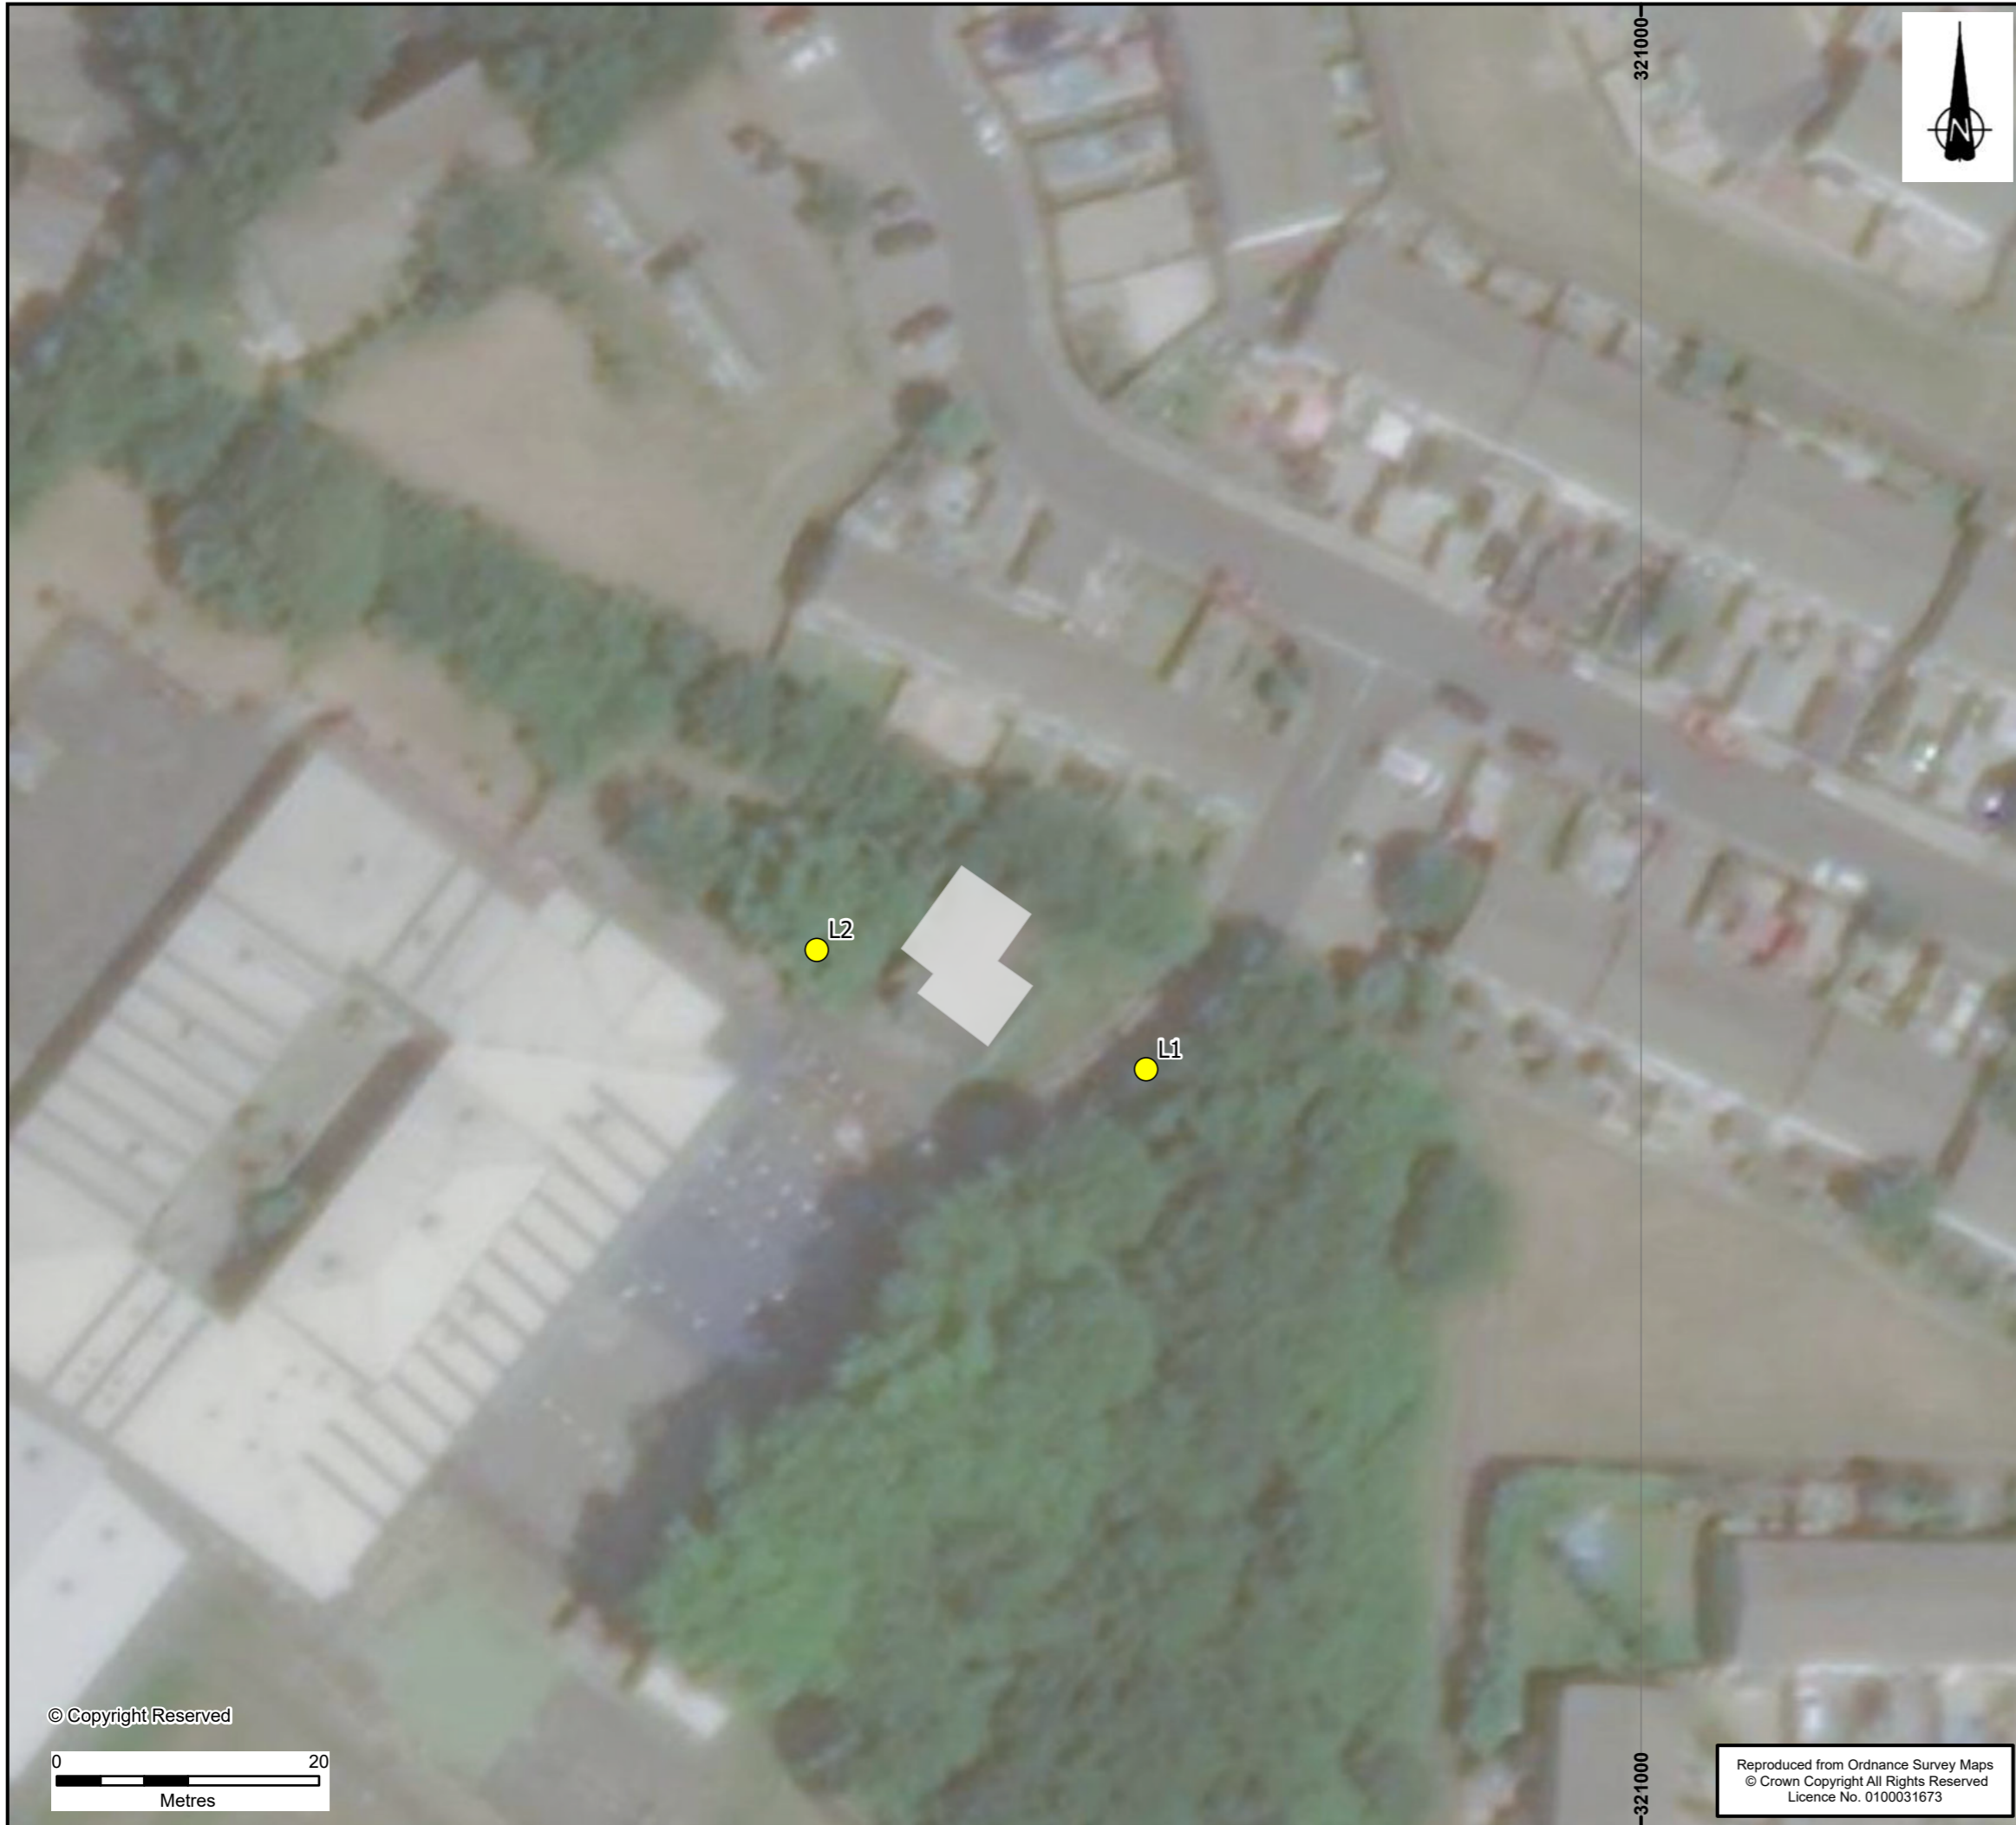
3.1.1 The building was subject to one dawn re-entry survey. The two surveyor locations were positioned to cover views of all four corners and faces of the building as shown on Drawing Number CA12265-002 (Surveyor Locations). The weather conditions and times of the surveys are provided in Appendix 3.

- Building
- Surveyor Location
