# WINGFIELD PRIORY, SUFFOLK

## HERITAGE STATEMENT

**WINGFIELD PRIORY  
WINGFIELD  
SUFFOLK**

**HERITAGE STATEMENT**

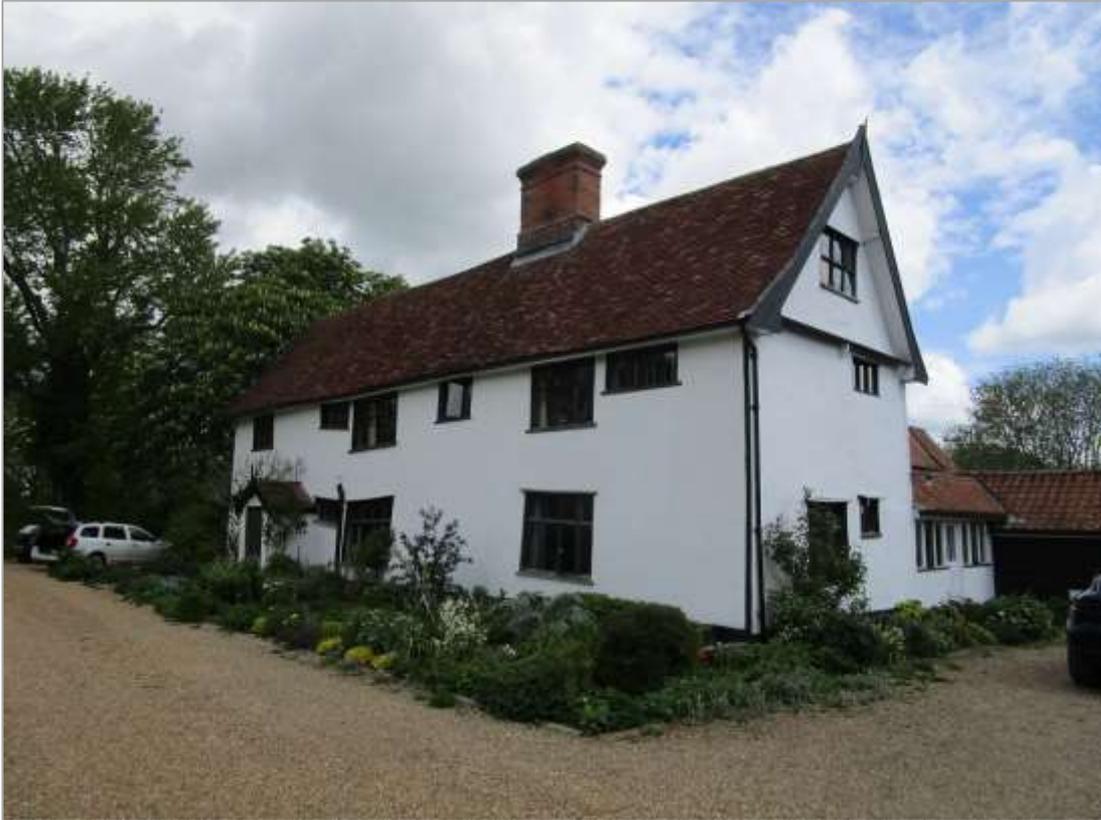
Fig. 1: Main range from southwest

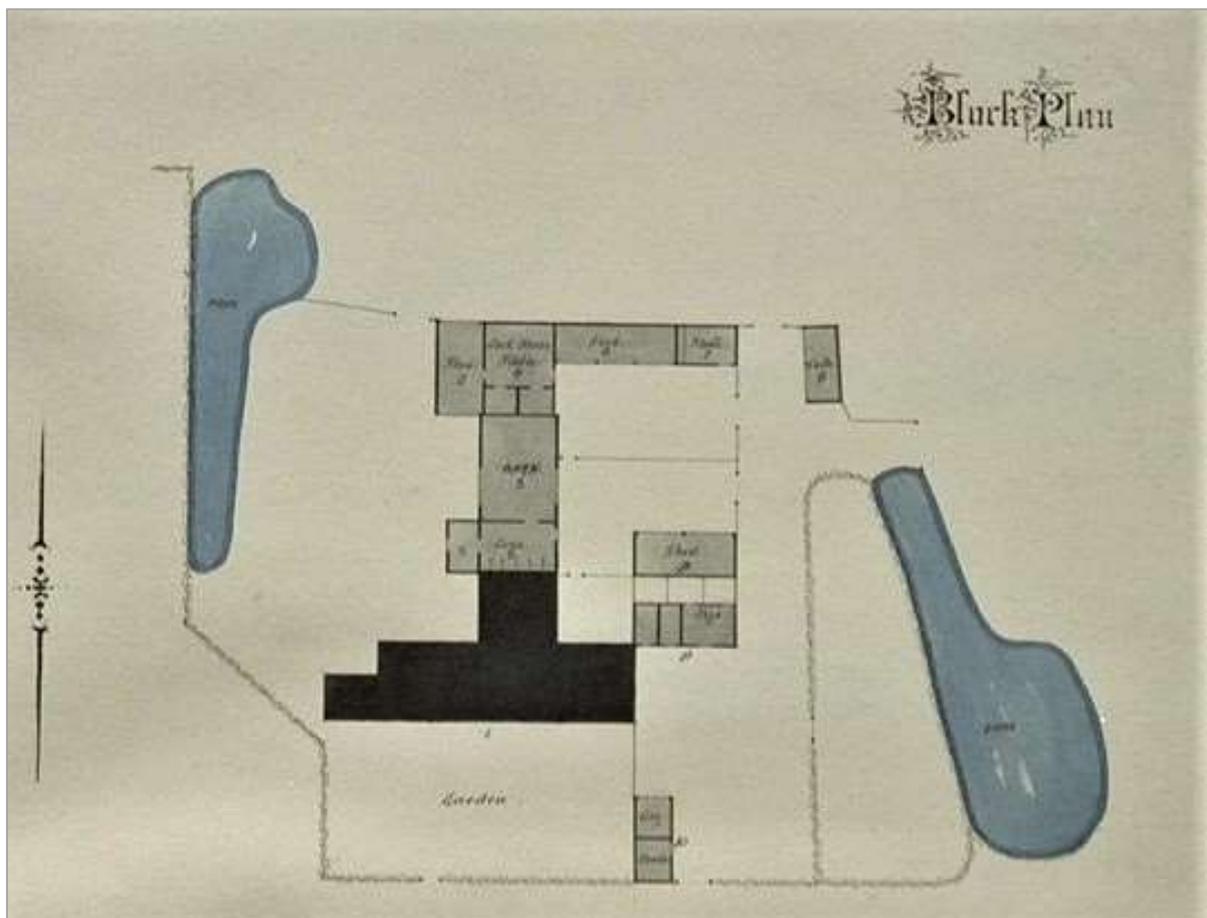
Fig 2: Plan showing farmhouse (shaded black) attached and adjacent farm buildings, c.1870 (owners' file)

2.4 From 1785 the property was owned by the Adair family, who had extensive estates in Suffolk, Norfolk, London and Ireland. Between 1831 and 1871 the farmhouse was occupied by William Brighton, hence the later name of Brighton's Farmhouse. A survey document dating from about 1870 (copy in the possession of the current owners, extract from text included at appendix 3) describes the farmhouse as of 'mud and plaster' and 'rapidly becoming dilapidated'. The farm buildings are described as 'joined up to the house in an inconvenient manner and are generally of an inferior description'. Accompanying plans identify the use of the main ground floor spaces in the farmhouse and the use of the attached or adjacent farm buildings. The farmhouse (fig. 3) was an inverted 'T' on plan, with the large spaces on either side of the great central stack used as a living room and a wash house. Giving off the living room to the north were cellars and a store, and beyond this (in a lean-to structure, no longer extant) was a hen house. In the projecting stub to the east was a dairy. Attached to the east of this were the farm buildings, forming an extended T. These are shown at fig. 2 and in enlarged detail at fig. 4. They included:

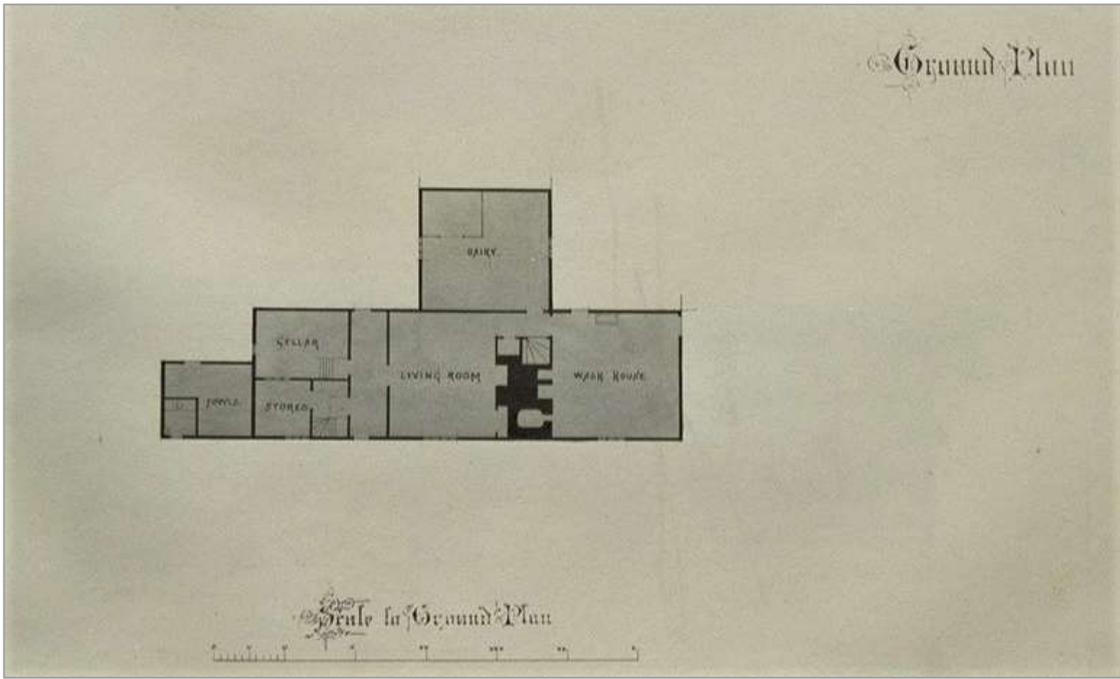
Fig. 3: Ground floor plan of farmhouse, c.1870 (owners' file)

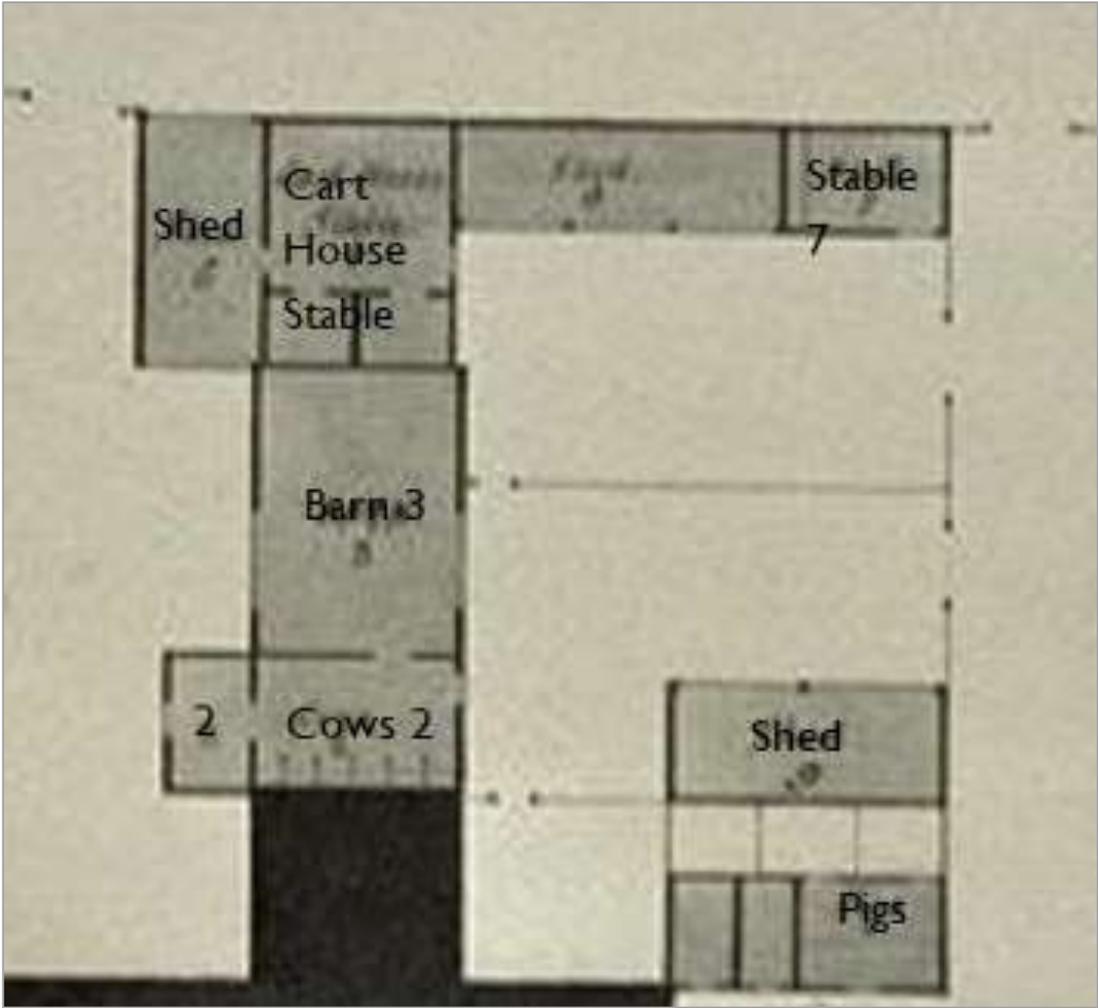
Fig. 4: Enlarged detail of fig. 2, with annotation clarified. Note barn doors.

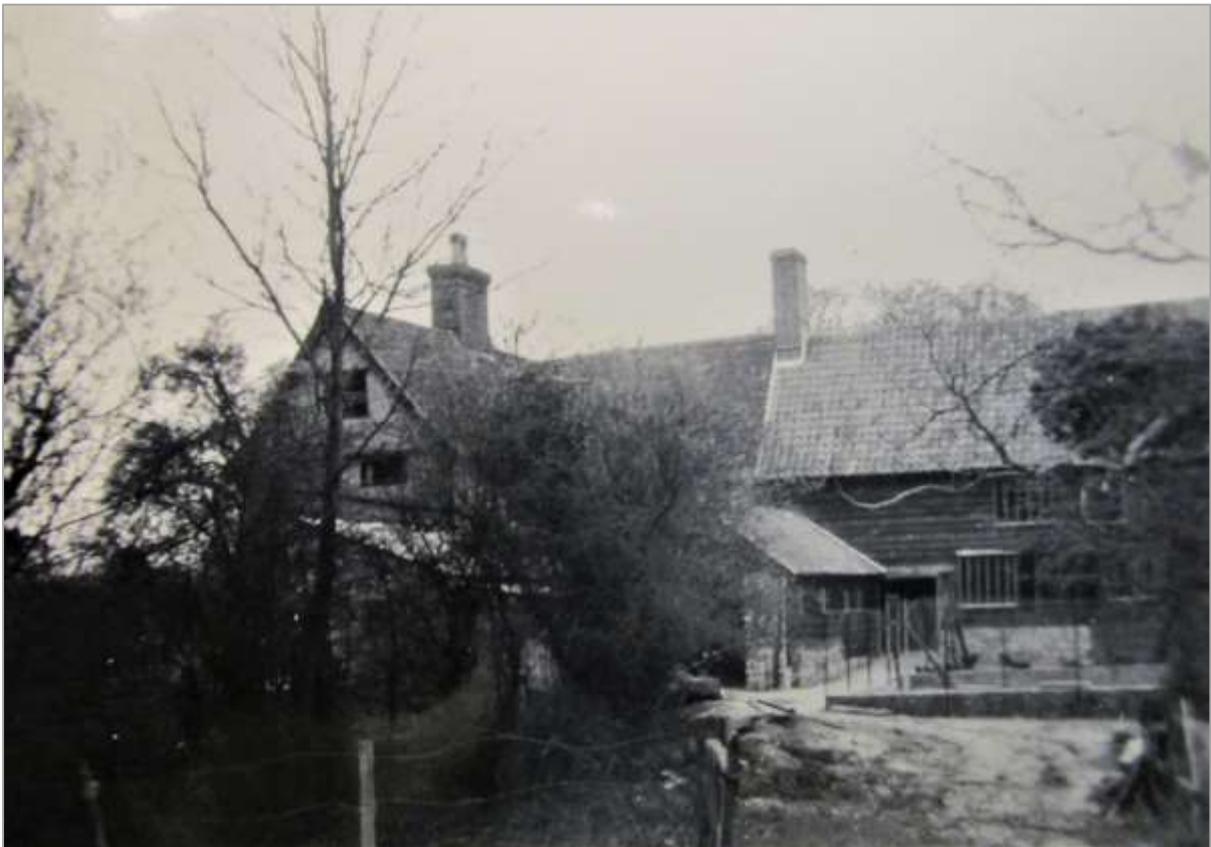
Fig. 7: Undated, probably mid-C20th photograph, showing the barn weatherboarded (SPAB file)

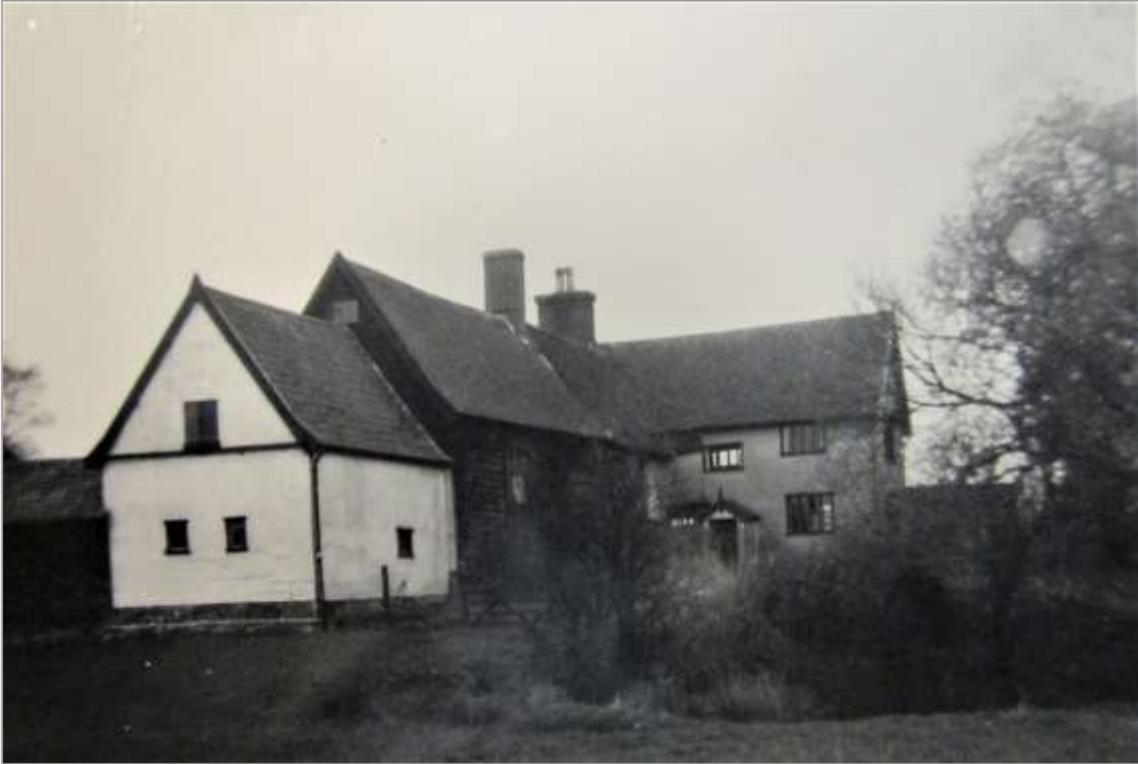
Fig. 8: Undated, probably mid-twentieth century photograph, showing the barn clad in weatherboard and the lower range to the east rendered, possibly over weatherboard (SPAB file)

- 2.11 In 1966 a condition report was prepared by David Evelyn Nye & Partners of Guildford; this commented that ‘Mrs Norris purchased the house before the last war and carried out extensive repairs and alterations. The interior remains attractive with the framing exposed in most rooms, though ‘features’ have been introduced from other buildings. (A fairly complete record of these exists). Unfortunately the external appearance has been completely ruined by being covered with a hard rendering and by the windows which are of poor design and out of scale’.<sup>4</sup> The report described the condition of the barn as ‘good’, but noted that the rendering on the gable end of the eastern extension was ‘in part at least, on expanded metal lathing fixed over old weatherboarding’ (see figs. 8 and 12).

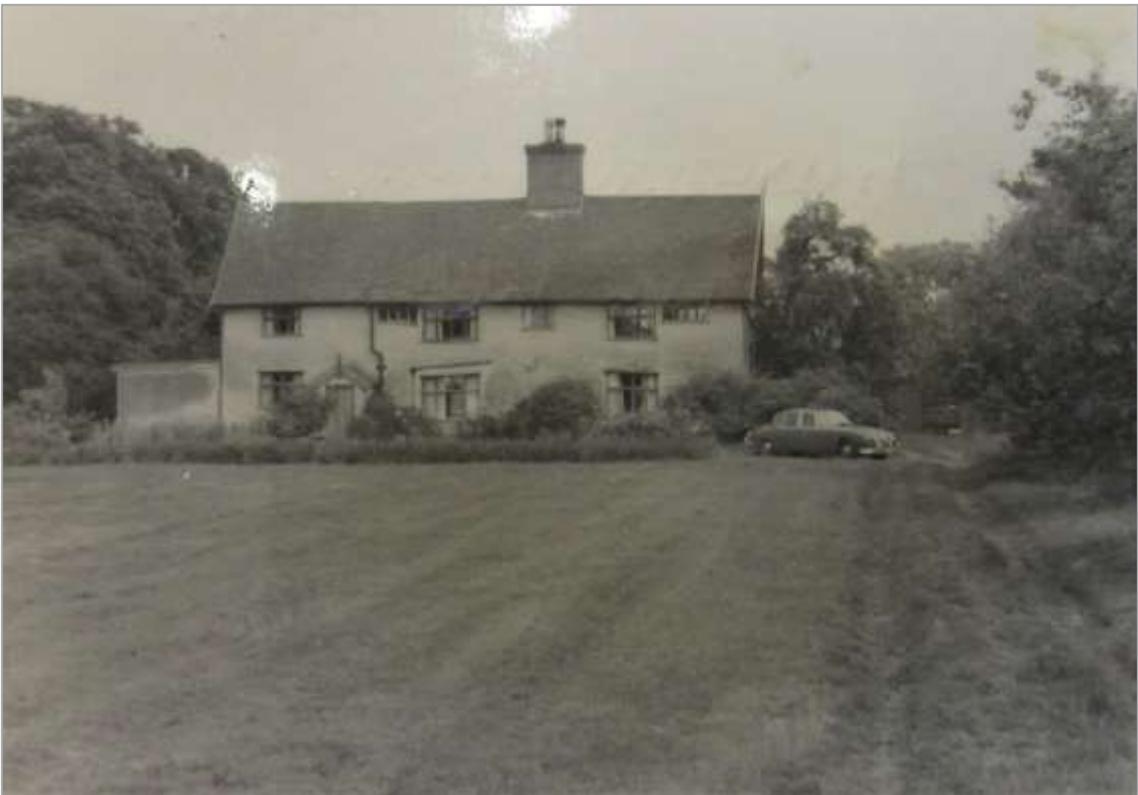
Fig. 9: Wingfield Priory in 1965, at the time of the SPAB's acquisition. The old lime render had been replaced with a more cementitious render. The lean-to structure to the east may have been that shown on the nineteenth century plans and maps (SPAB file)

2.10 By the time the property came to the SPAB, the house had been refaced in cementitious render (fig. 9) and the weatherboard on the barn replaced with render over expanded metal lath, at least on its north elevation (fig. 10). An interior view of the barn probably taken at this time (looking south towards the stack of the former dairy) is at fig. 11. The southern return of the eastern outbuilding was still partly weatherboarded (fig. 12). Further outbuildings on the south side, since demolished, are shown at fig. 13.

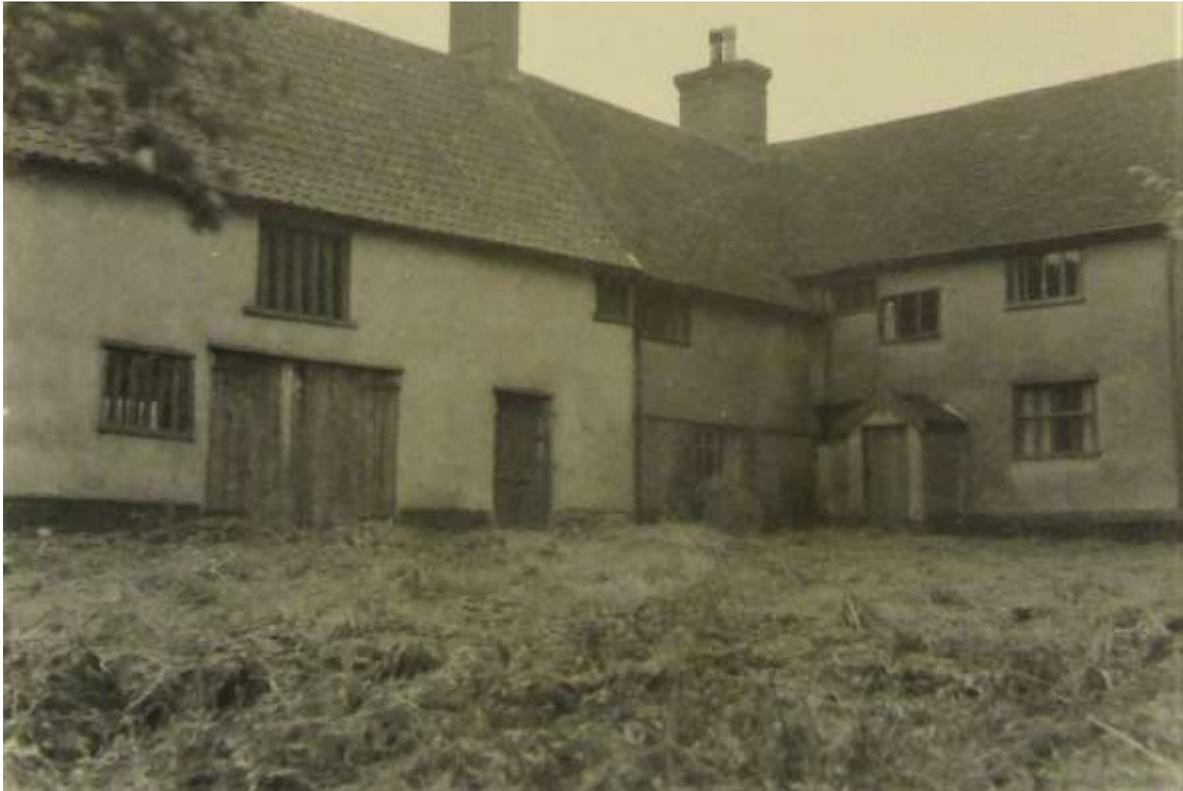
Fig. 10: The rear elevation of the front range and the north elevation of the barn, at the time of the SPAB's acquisition in 1965. By this time the weatherboard on the barn had been replaced with cementitious render. Note the door at the top end of the barn (SPAB file)

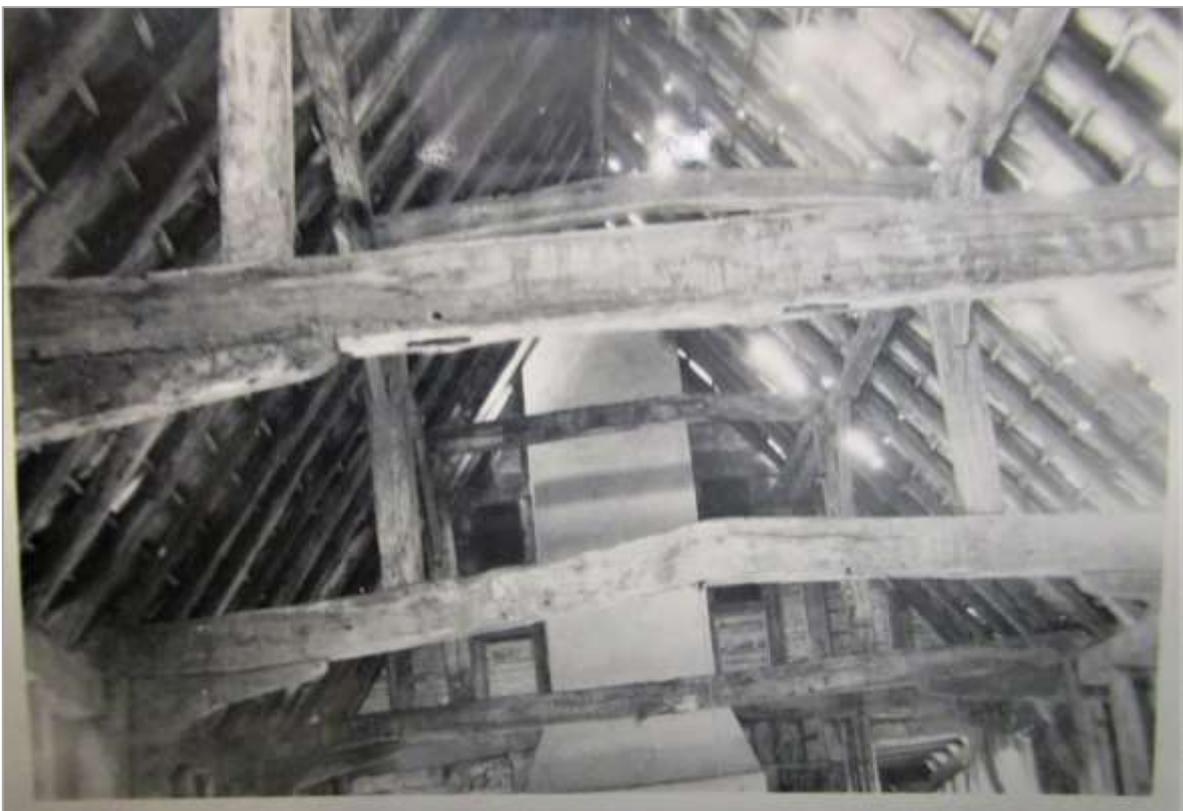
Fig. 11: Barn interior, looking south towards stack of former dairy, c.1965? (SPAB file)

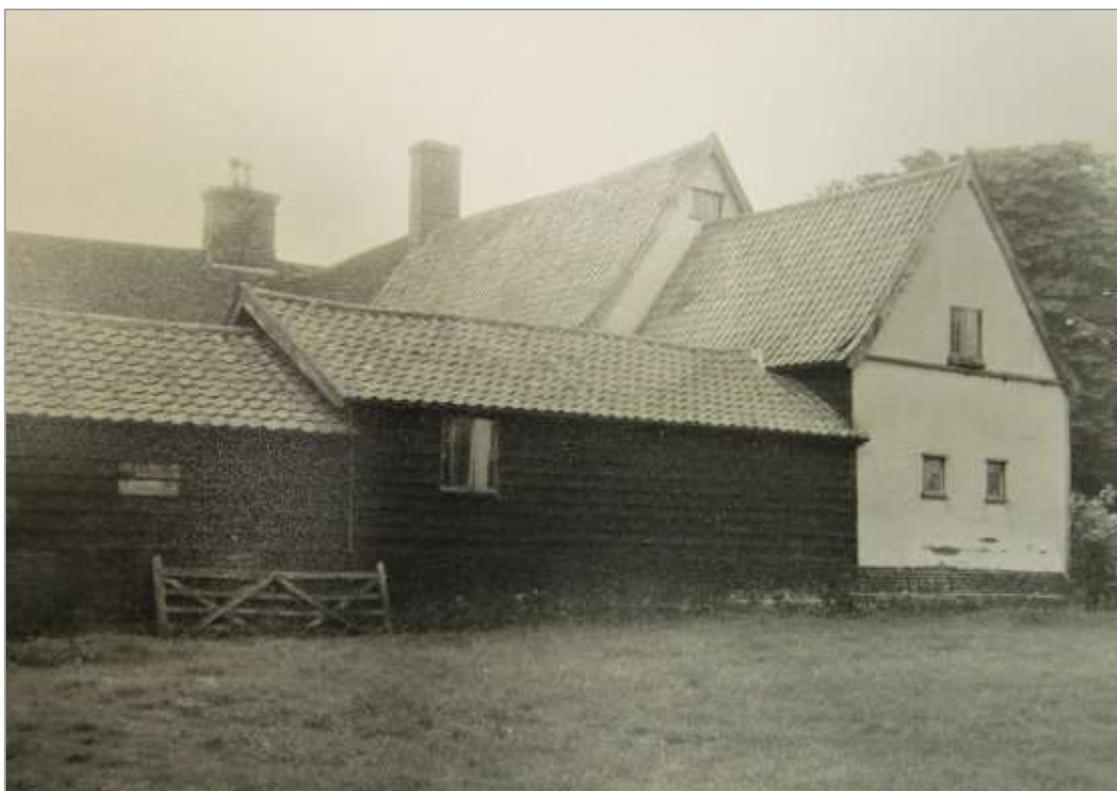
Fig 12: Photo with verso inscription 'Back of barns and outbuildings, July, 1965'. The weatherboard survived in part on the southern return of the eastern outbuilding and beneath plaster on the eastern gable end elevation. Note windows on this elevation and high level window in barn gable (SPAB file).

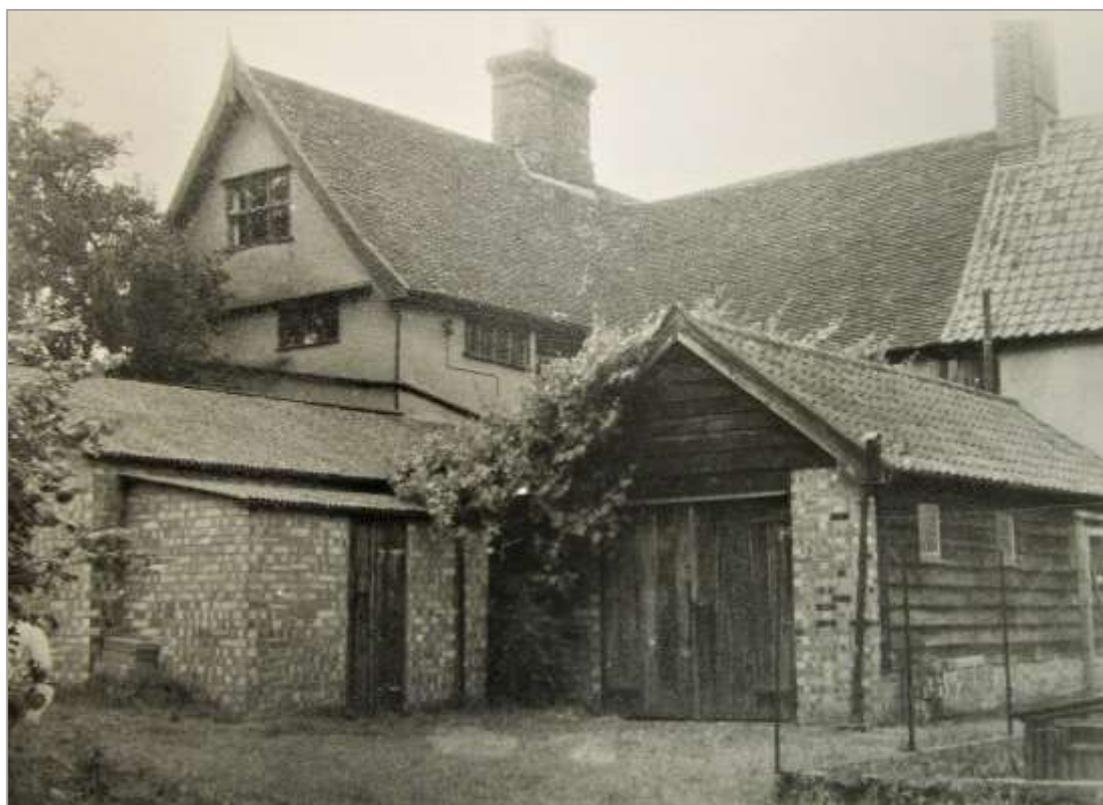
Fig. 13: Photo with verso inscription 'Kitchen end at back of house, site of barn, garage and fuel stores, July 1965'. The left hand forebuilding has been demolished, the right hand one remodelled as the present utility room (SPAB file).

- Erection of a detached garage to the south of the house (approved in June 1992);
  - Demolition of the twentieth century outbuilding shown at figs. 13 and 22 and replacement with a new glazed and pantiled entrance lobby, linking the utility room and kitchen and creating a small courtyard behind (approved in December 1992 and carried out in 1993, figs. 23 and 24);

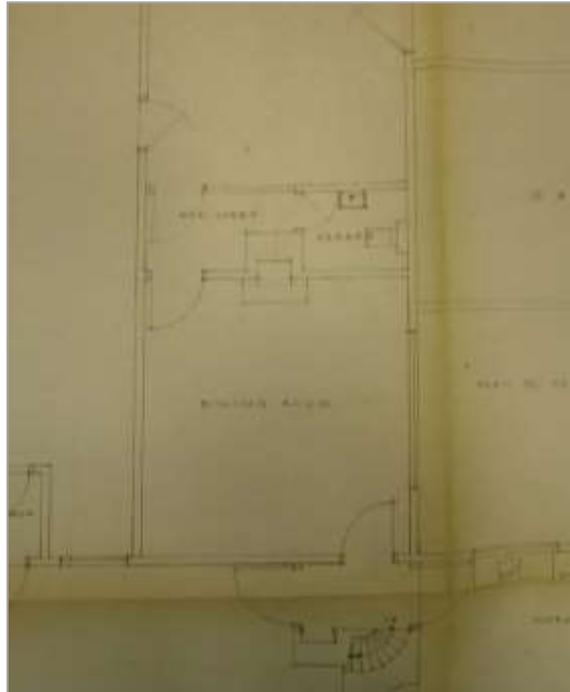
Fig. 14: Detail of drawing by Feilden & Mawson, dated March 1966, showing cloak room and proposed lobby between dining room and barn (SPAB file)

- 2.12 During 1966, repairs and minor improvements to the house were undertaken by David Mawson ARIBA of Feilden & Mawson. Alterations included the creation of a lobby under the gallery, with an existing WC separating this area from the space of the barn beyond (fig. 14). Above this, a bathroom was formed beside the chimney stack, giving off the rear bedroom (fig. 15). Only basic repairs were carried out to the barn and the attached outbuilding to its east; this included Sandtex painting of the external render, as also applied to the rest of the property.

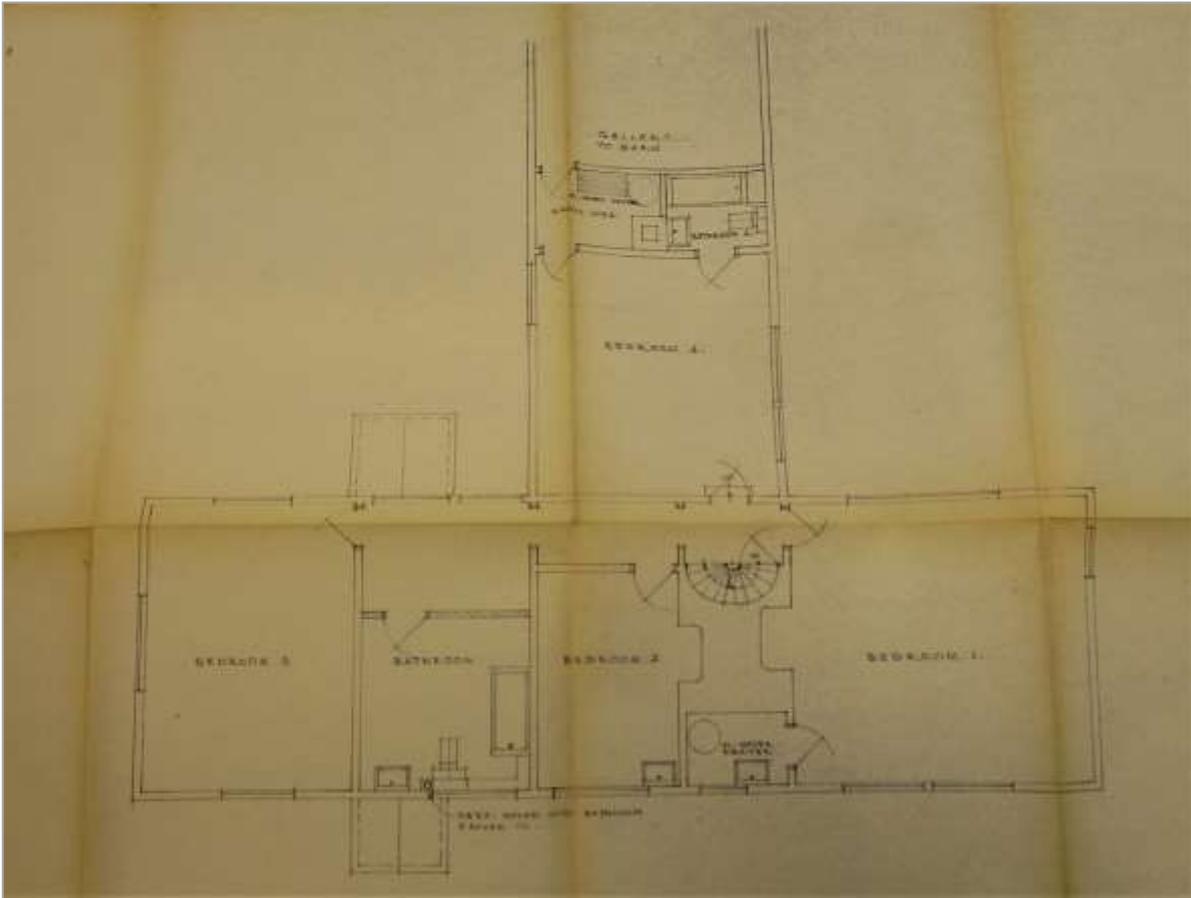
Fig. 15: Detail of drawing by Feilden & Mawson, dated March 1966, showing proposed WC and airing cupboard on either side of stack separating bedroom 4 from barn gallery (SPAB file)

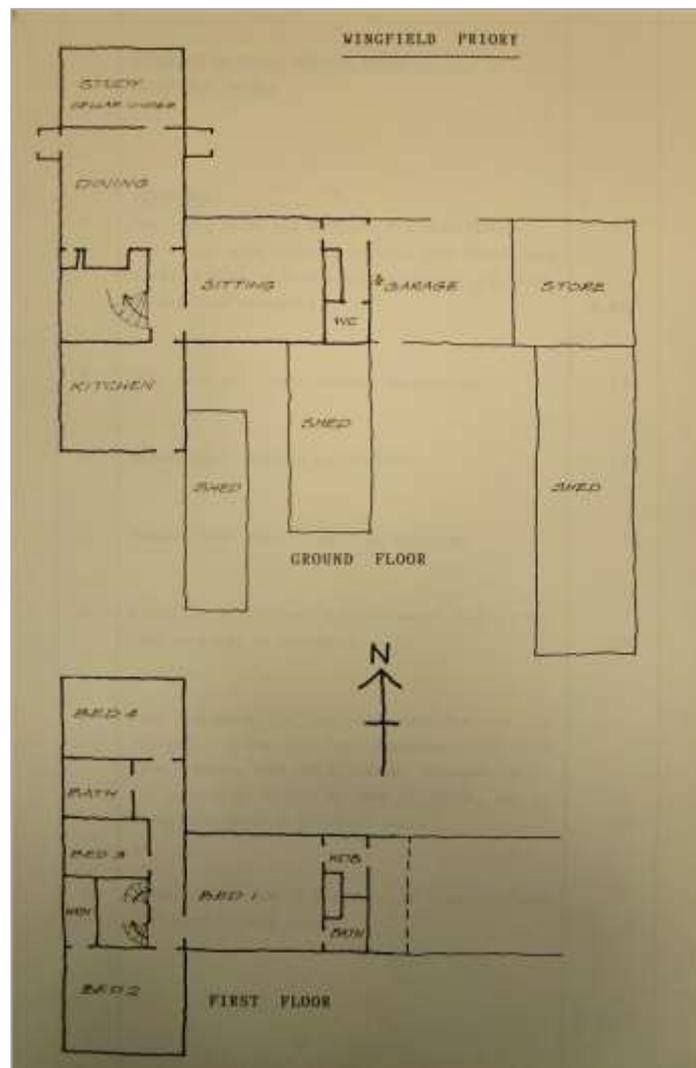
Fig. 16: Floor plans by Hollins, 1986 (SPAB file)

- 2.14 In 1986 a schedule of works was prepared by Hollins, surveyors of Woodbridge. Their schematic plan indicates that at this time the former barn was in use as a garage, with the building to the east a store (fig. 16). Proposed repairs to these buildings included re-roofing (with underfelt) and the repair of a window on the south side of the barn/garage (‘take out decayed studwork below window and renew in timber of size and species to match’). Also to ‘fix galvanised expanded metal lath as necessary and re-render to match’. It is not certain that all these works were carried out, for at this time the SPAB was engaged in lengthy negotiations with the tenant over an extension to the lease. The former barn was re-roofed (with underfelt) and emergency repairs carried out by the Society in 1989, but they did not have the funds to carry out all that was

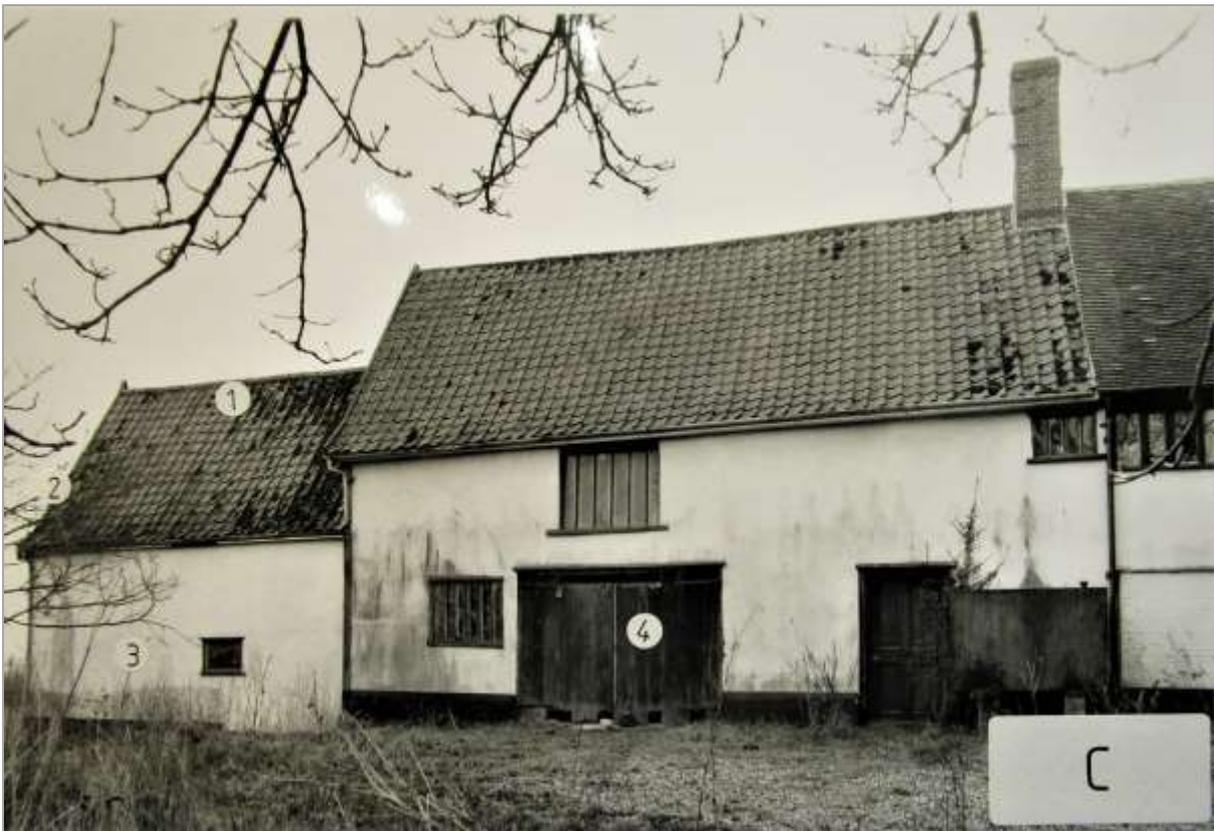
Fig. 20: North elevation of former barn, 1990 (SPAB file)

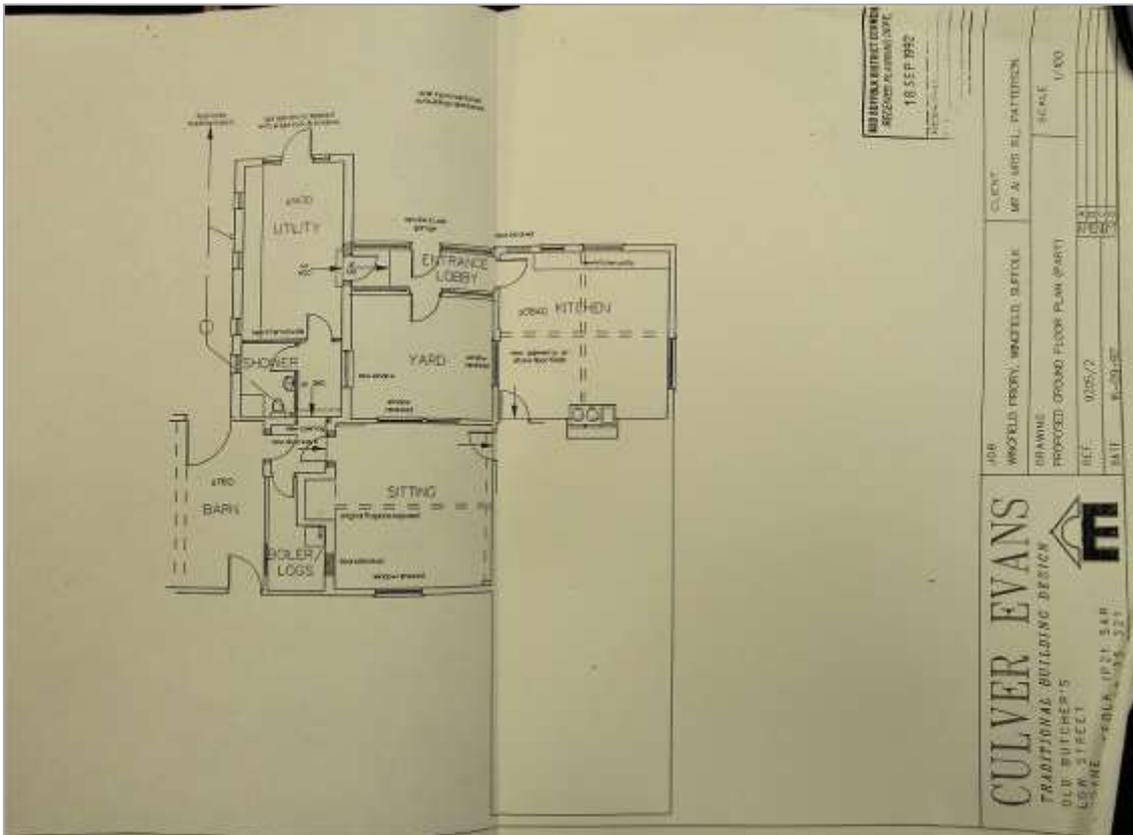
Fig. 23: Plan by Culver Evans, 1992, showing proposed entrance lobby and alterations to former garage and space below barn gallery (SPAB file)

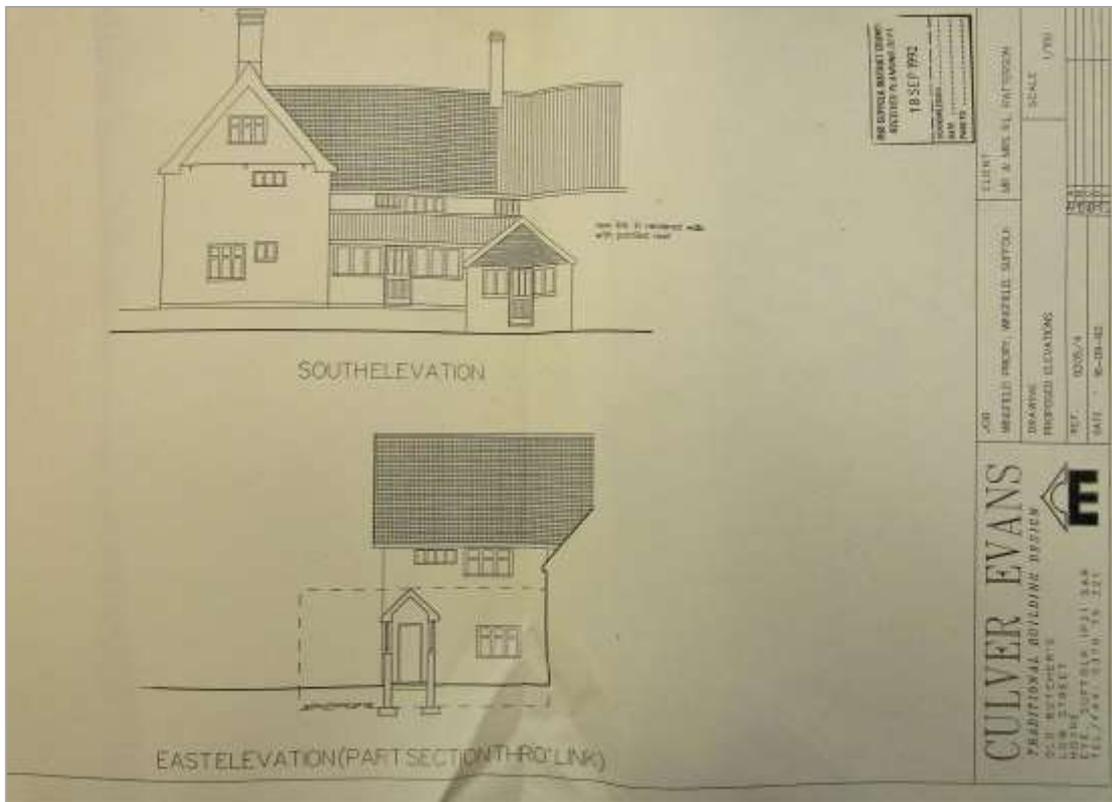
Fig. 24: South elevation and section of proposed entrance lobby, Culver Evans, 1992 (SPAB file)

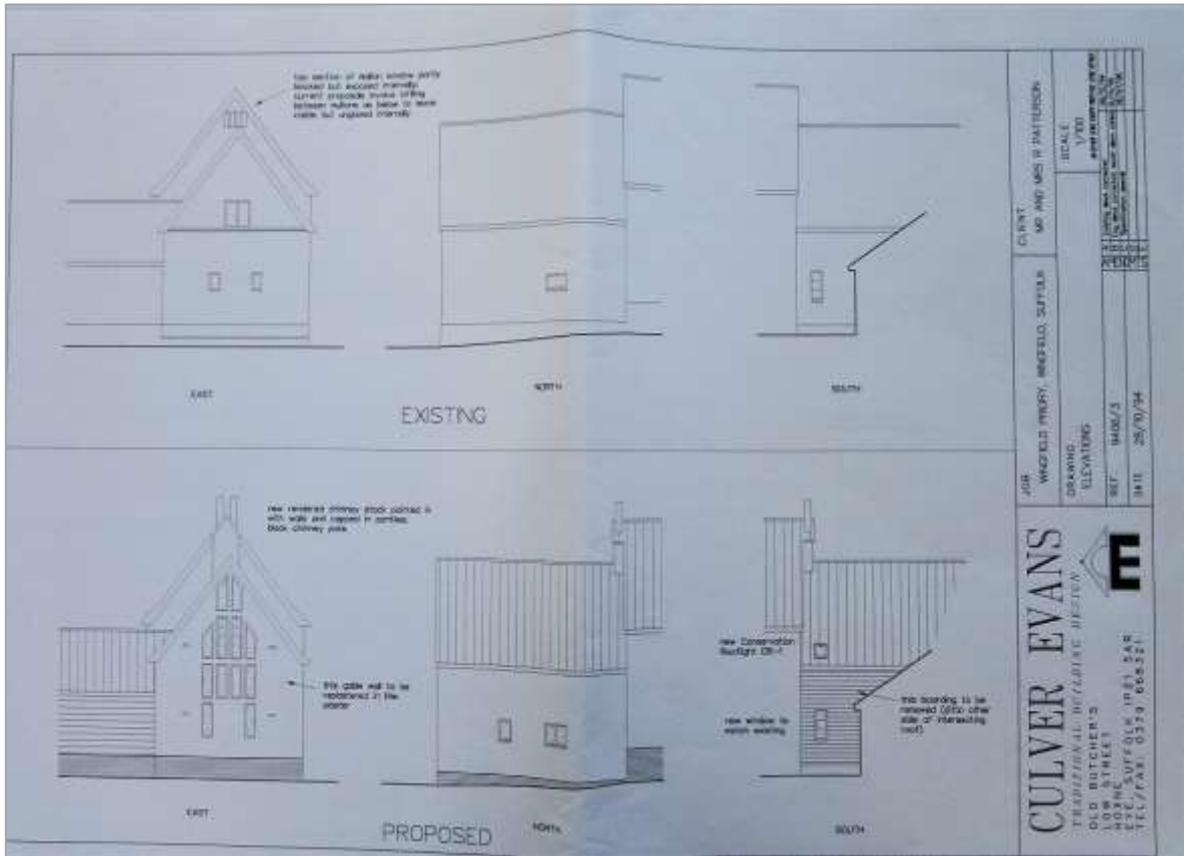
Fig. 25: Elevations for conversion of eastern store, Culver Evans, 1994 (SPAB file)

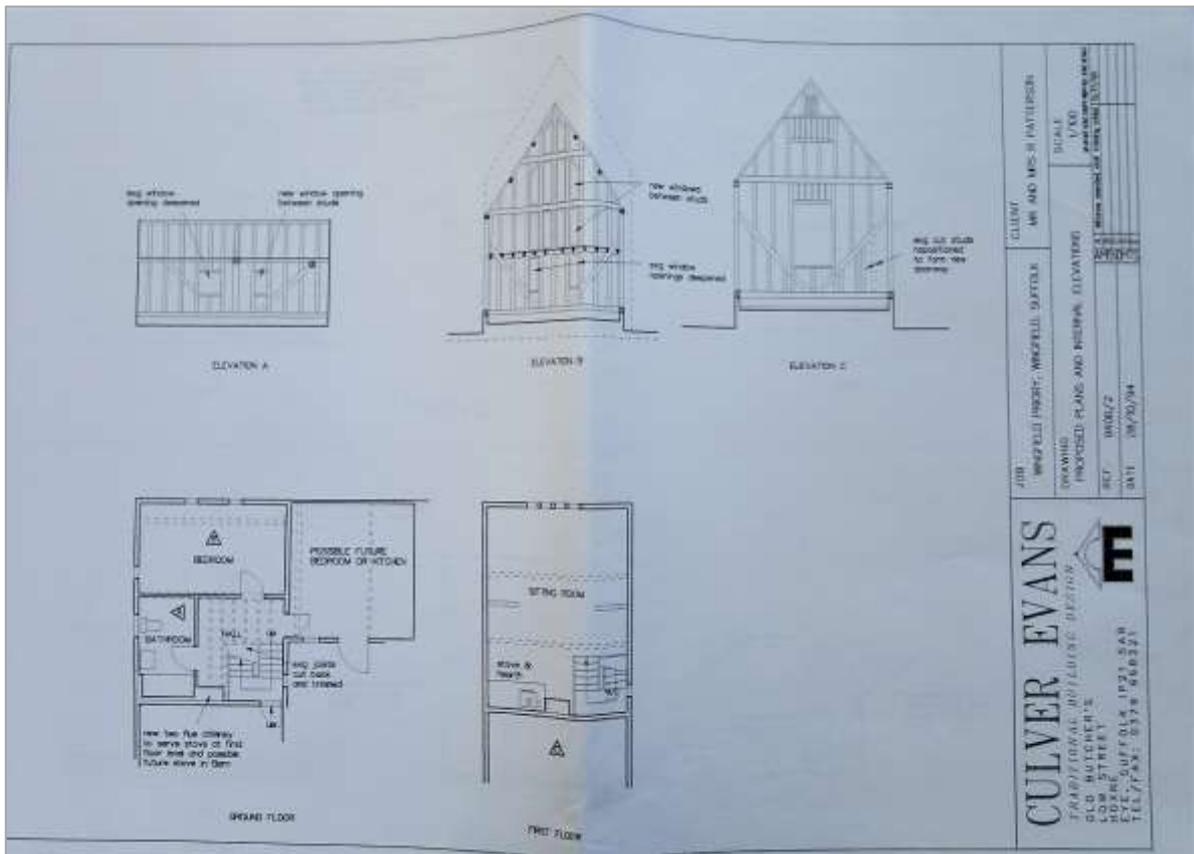
Fig. 26: Plans and internal elevations for conversion of eastern store, Culver Evans, 1994 (SPAB file)

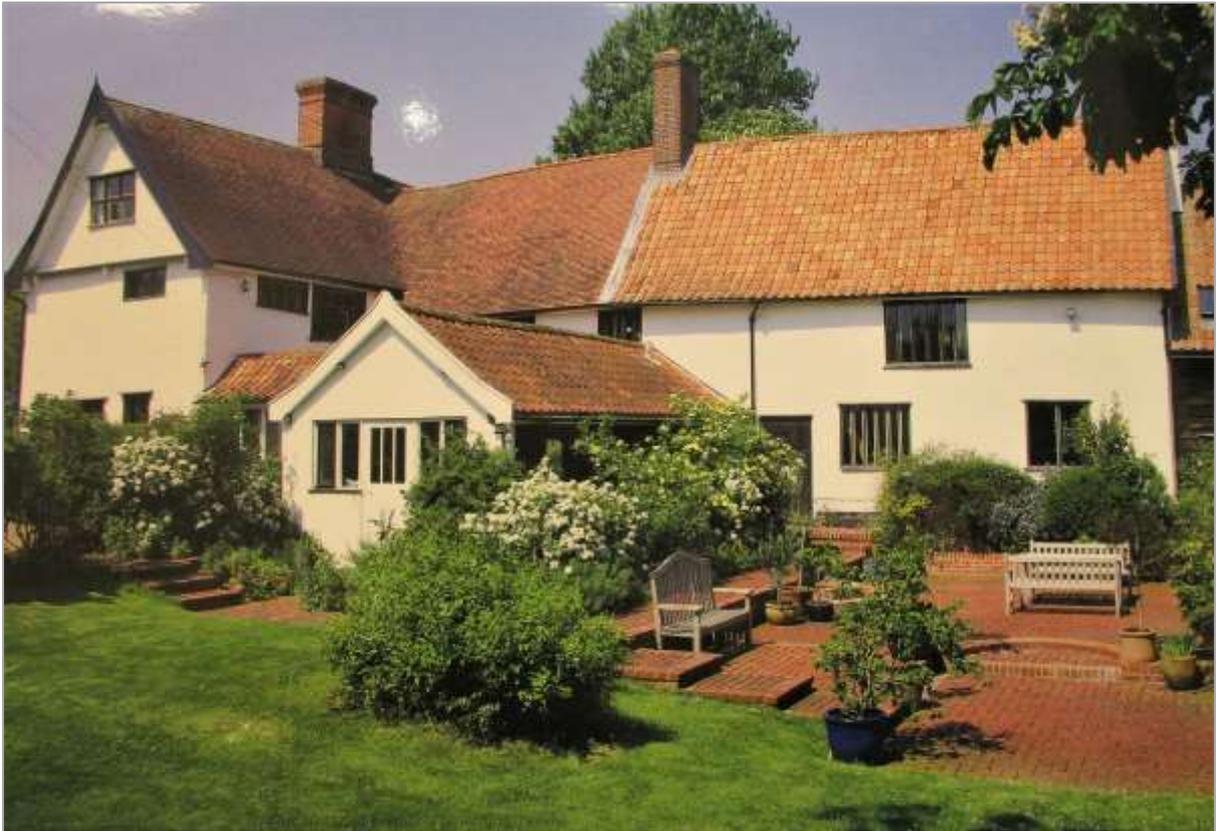
Fig. 27: Photograph from Jackson-Stops & Staff sales brochure, 2009, showing the new (1993) link between the utility room and kitchen and new brick terrace to south of former barn. The lower right hand window in the barn is probably that installed in 1979 (see para. 2.12) (SPAB file)

- 2.13 In 1979 an invoice was received from C. Hugman & Sons, builders of Stradbroke, for various works including ‘constructing new opening light to barn, glazing and hanging same’.<sup>5</sup> This must refer to the lower right hand window on the south elevation (see fig. 27).

- 2.19 When Wingfield Priory was put back on to the market in 2009 (fig. 27), the former barn was described as a ‘function barn’ which ‘provides flexibility and scope for a variety of uses, including function room, games room, workshop or studio, as well as having the potential to be formalised to provide further accommodation if required’.<sup>8</sup> However, none of these uses has come about, mainly because the space is inadequately heated and poorly insulated and therefore not easily habitable in the winter months.

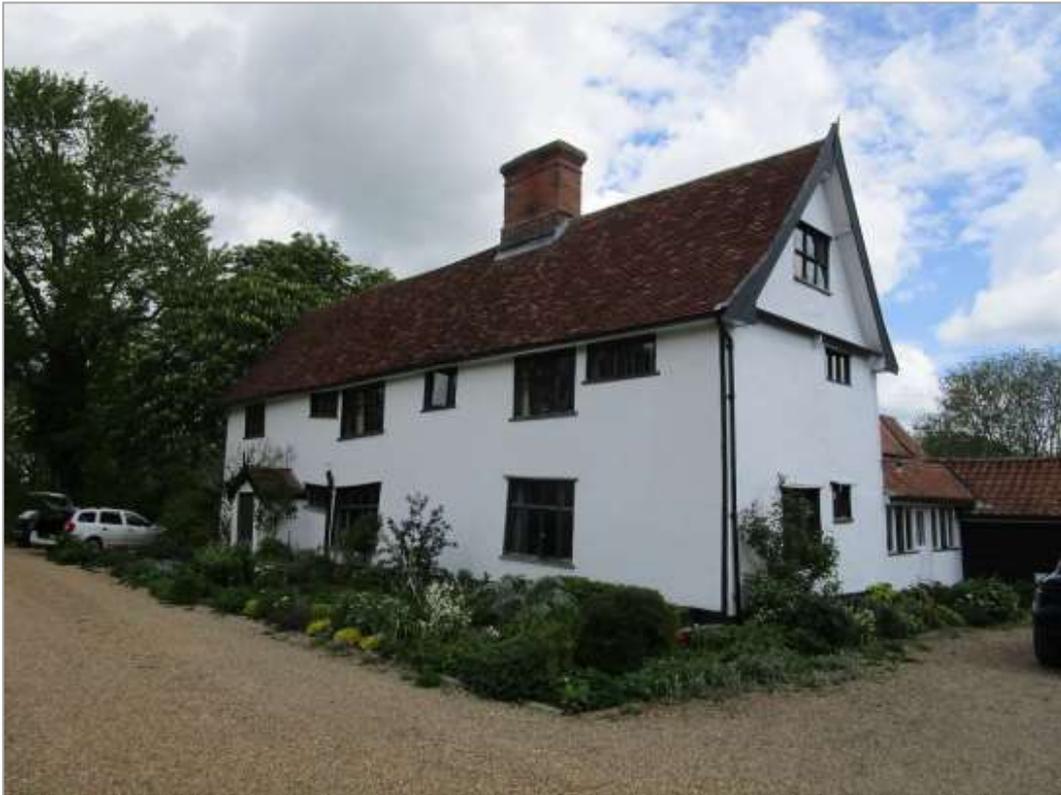
Fig. 28: The front range from southwest. Visible to the rear is the low single storey link building of 1993, which will be removed under current proposals.

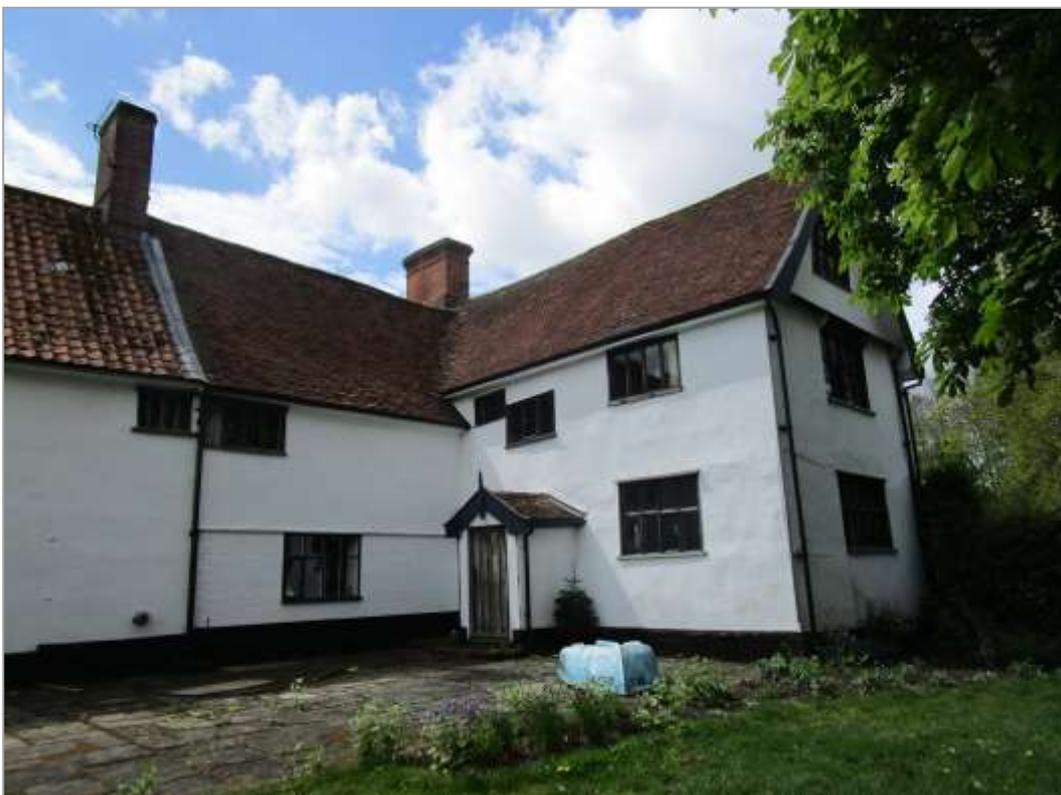
Fig. 29: The front range and former dairy form a T-plan; the attached former barn (with pantiles) is to the left.
