# WINGFIELD PRIORY, SUFFOLK

## HERITAGE STATEMENT

**WINGFIELD PRIORY  
WINGFIELD  
SUFFOLK**

**HERITAGE STATEMENT**

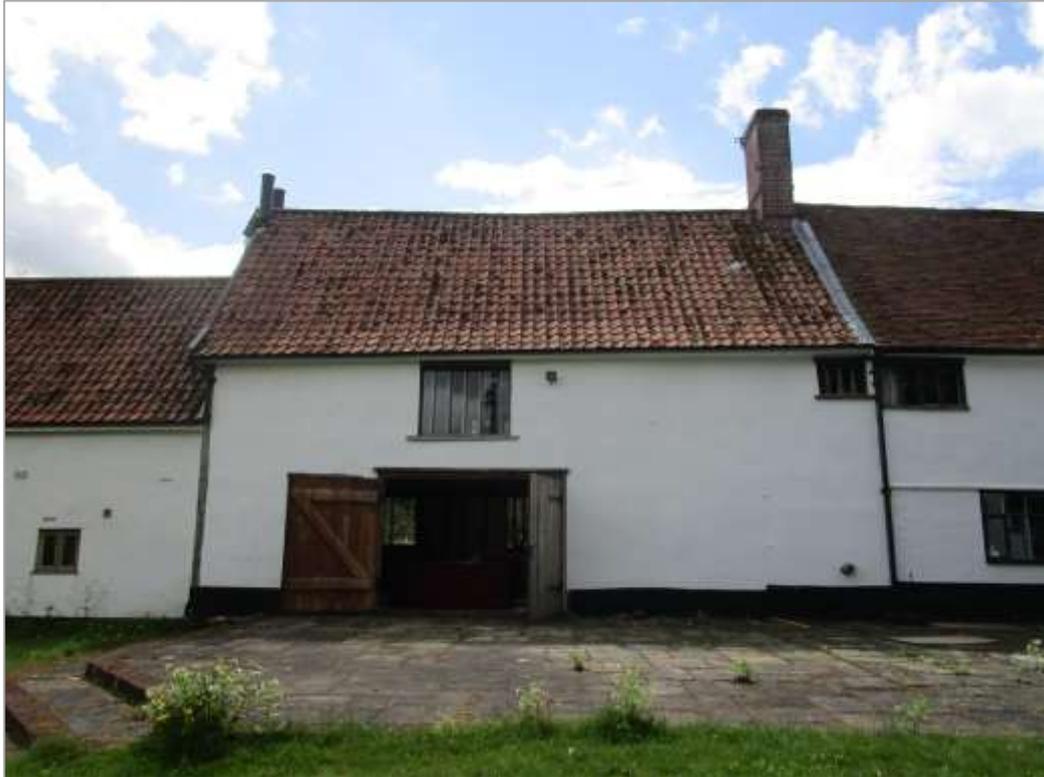
Fig. 30: North elevation of the former barn. Since 1990 (fig. 20) a door opening to the right has been blocked, and the barn doors replaced. Under current proposals the blocked opening will be partially re-opened as a mullion window and new barn doors provided.

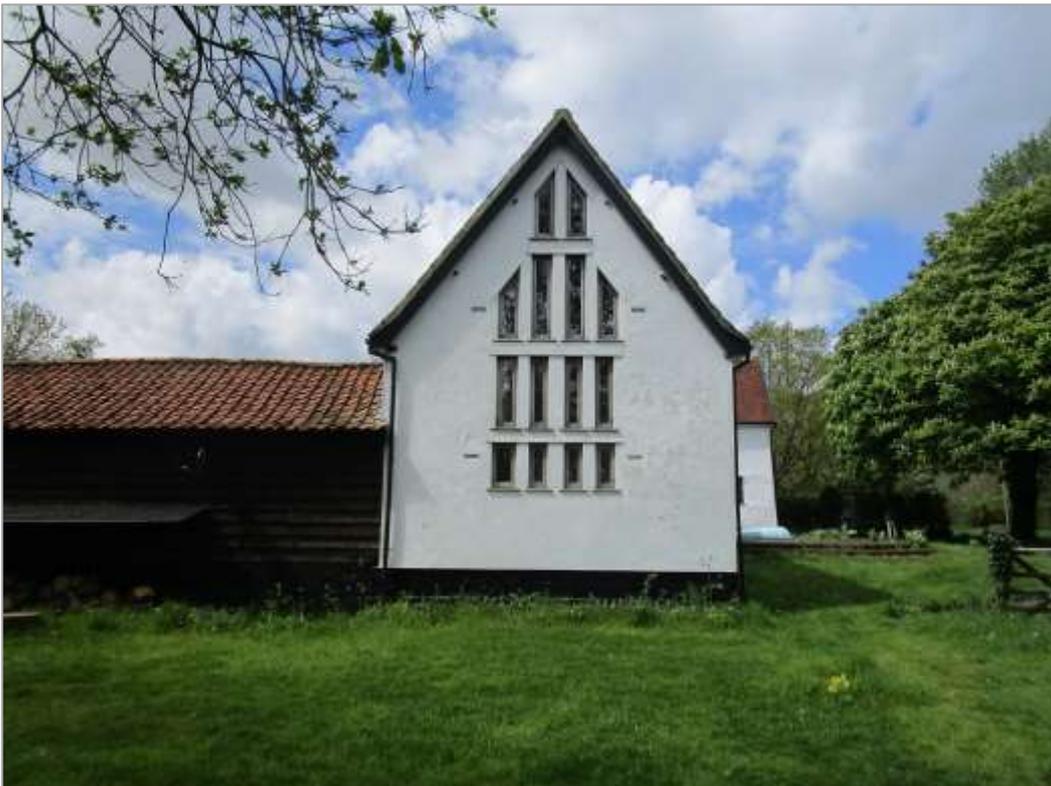
Fig. 31: East elevation of the lower former farm building, converted to residential use in 1998, when the present 'ecclesiastical' glazing was installed between the timber studs. These openings will be simplified and the detailing refined under current proposals.

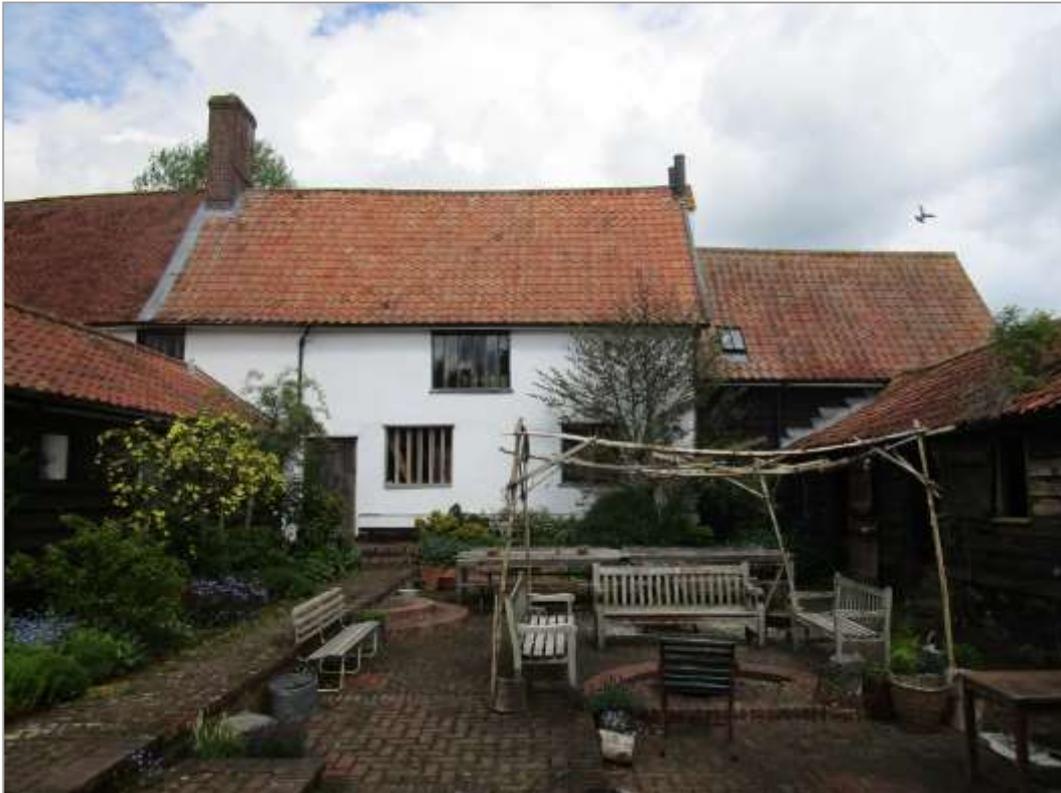
Fig. 32: South elevation of the former barn. The door shown to the left of the mullion window will be blocked and the brick plinth and sole plate reinstated. Central barn doors will be reinstated (as shown on old plans and as evidenced by the fabric). The plate glass casement window lower right dates from 1979; it will be replaced by a diamond mullion window.

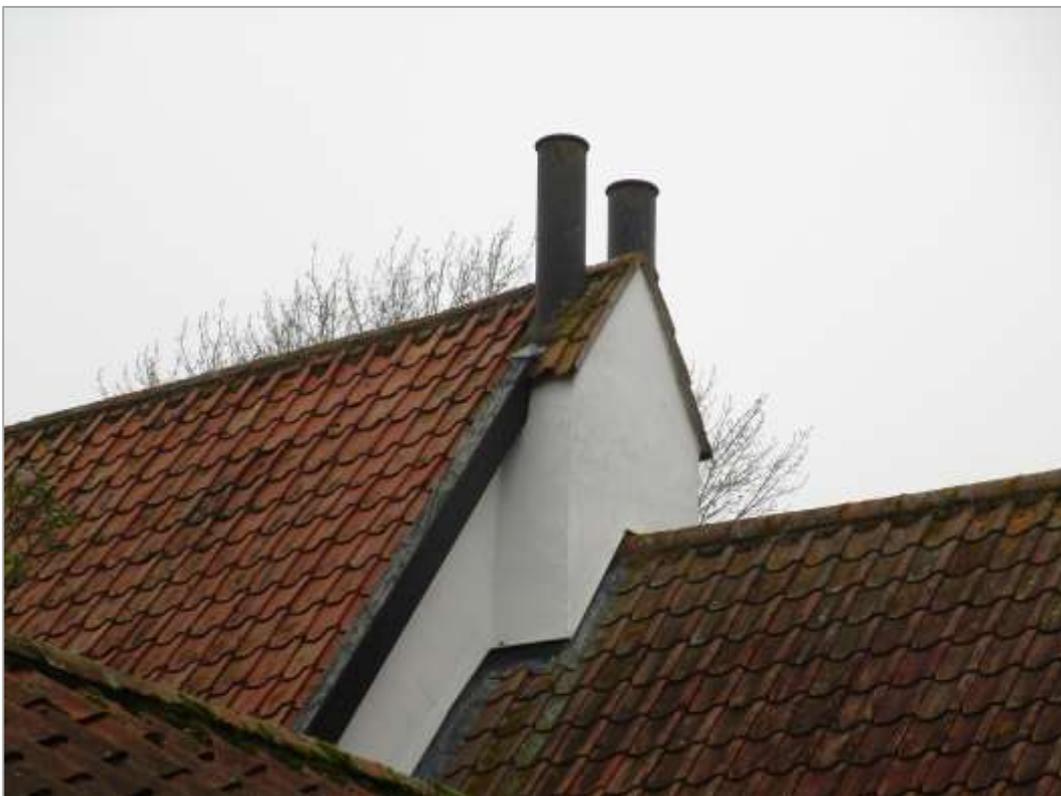
Fig. 33: The external stack on the east gable end of the former barn was built in 1998; it will be retained to house the heating flues.

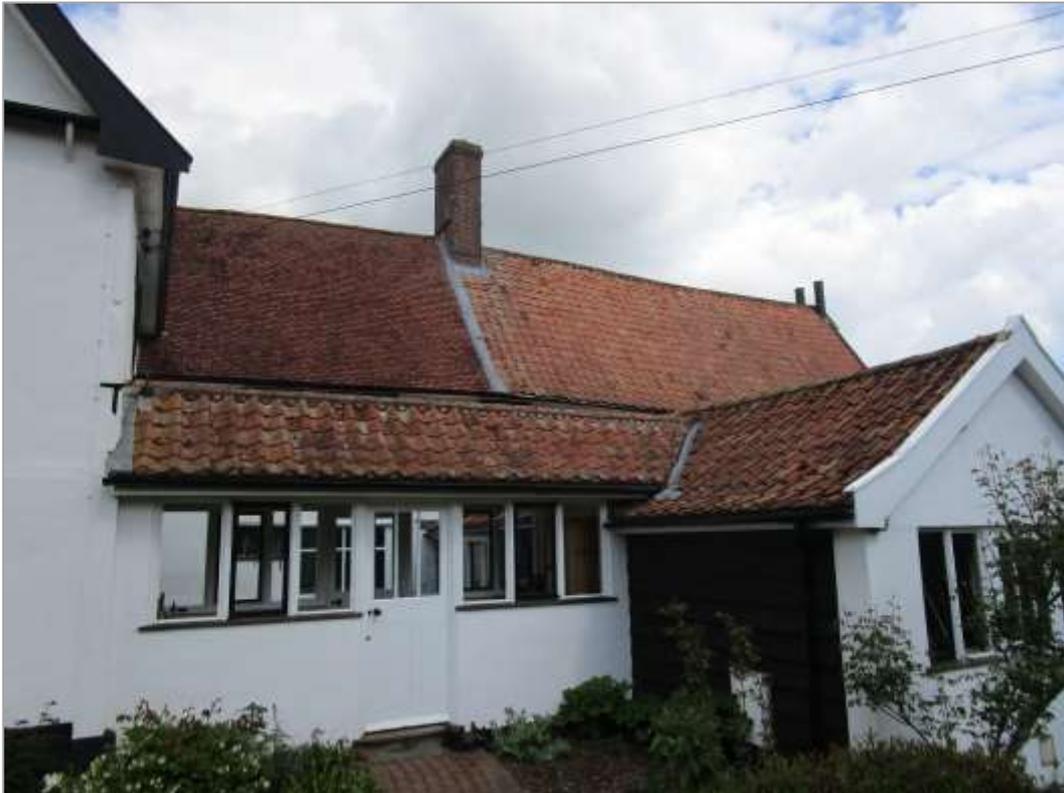
Fig. 34: The entrance lobby and link, built in 1993. This will be removed, and a new open-sided, gabled porch built in front of the present utility room (right).

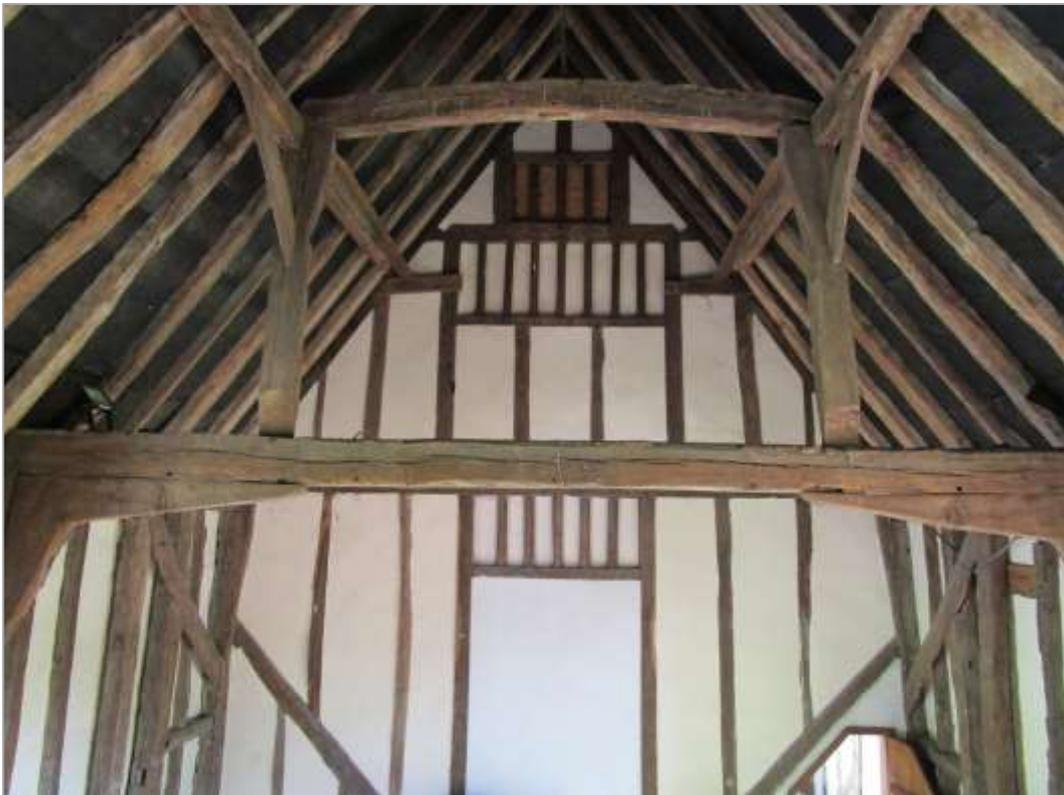
Fig. 35: Former barn interior, looking east from the gallery. The timber framing of the walls and the mullion windows are largely a twentieth century confection, although the tie beams and queen post roof are likely to be historic. Note the exposed roofing felt; there is currently no roof insulation.

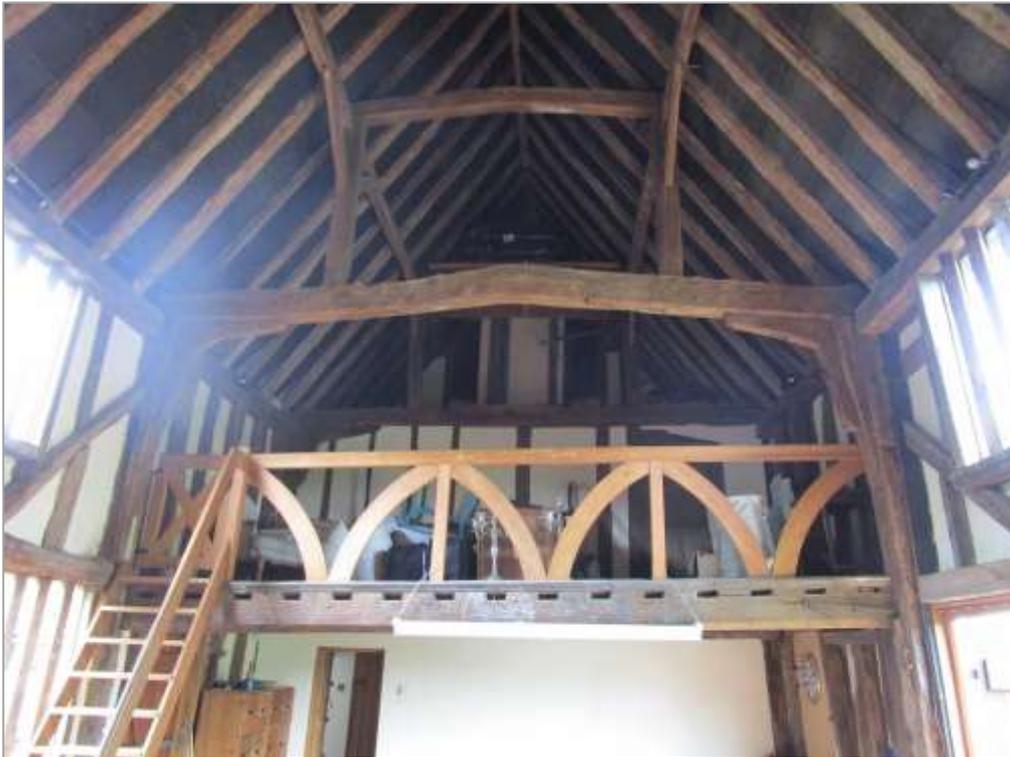
Fig. 36: Former barn interior looking west. There may historically have been an intermediate floor at this end, but the present gallery appears to be of mid-twentieth century date, re-using a chamfered beam (with mortices now on the vertical side). The gallery front and steep stair access date from the 1990s; they are hazardous and non-compliant with building regulations; the stair will be removed and more suitable balustrading provided in the gallery front. The gallery space will be an office area accessed from the bedroom beyond.

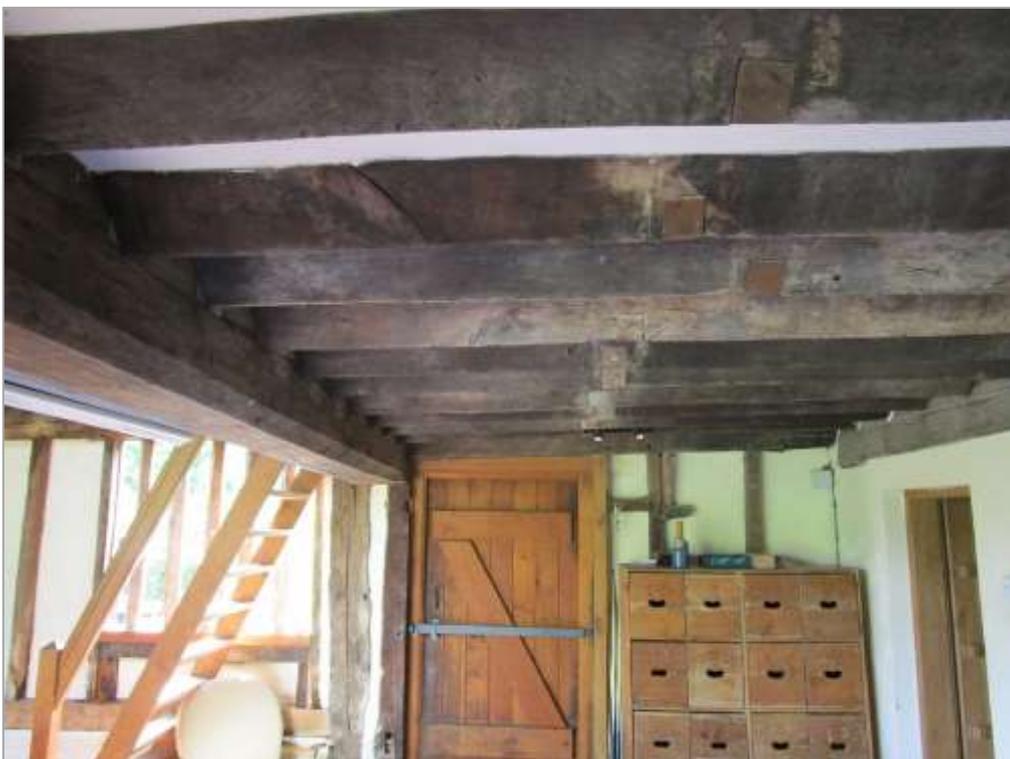
Fig. 37: The underside of the gallery has joists placed on the diagonal. Also shown here is the modern south door which will be removed under current proposals, with the opening blocked.

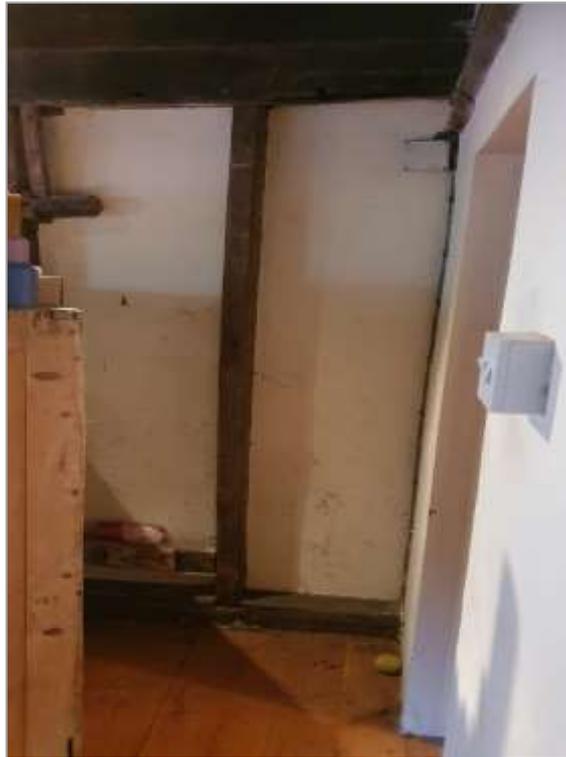
Fig. 38: A closer view of the wall shown in fig. 37, with the furniture removed. A single slender stud (not pegged into the sole plate or mid-rail and not original) will be removed in order to form an opening to the proposed larder. The sole plate will remain in situ.

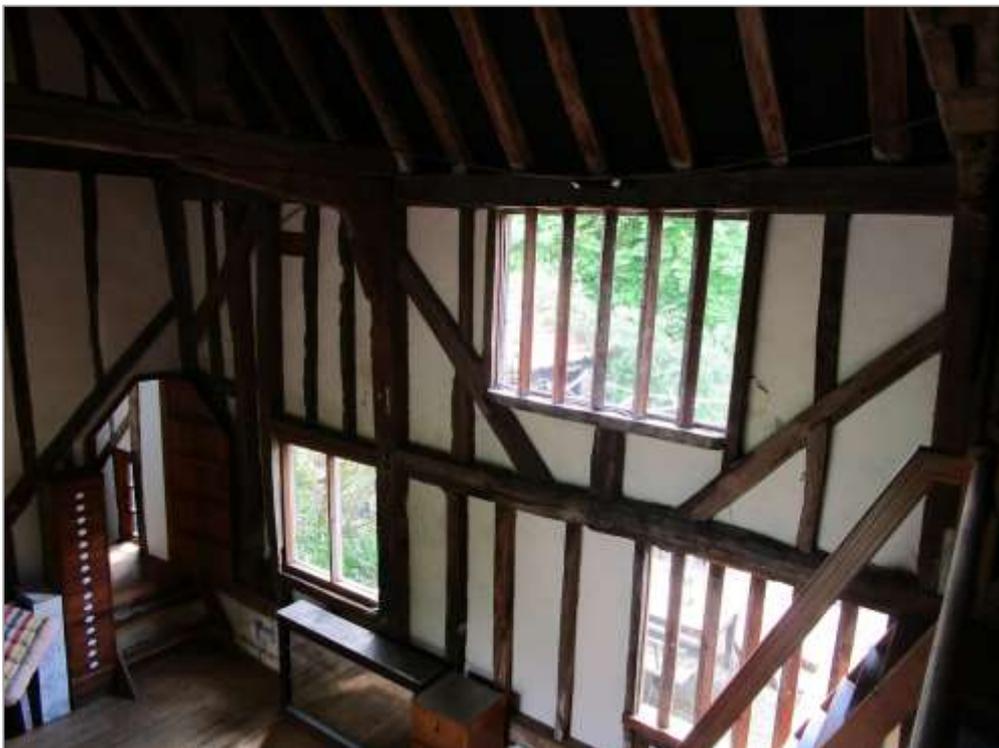
Fig. 39: The south wall of the former barn, viewed from the gallery. All the timbers of the central bay (between the two wall posts) are re-used and installed in the mid-twentieth century, when the brick plinth was also extended. It is proposed to form an opening below the mid-rail of this bay and reinstate barn doors, as shown on the c.1870 plan. Note also the 1979 ground floor window to left and the 1990s opening in the studwork of the east wall, connecting the barn to the accommodation in the eastern range.

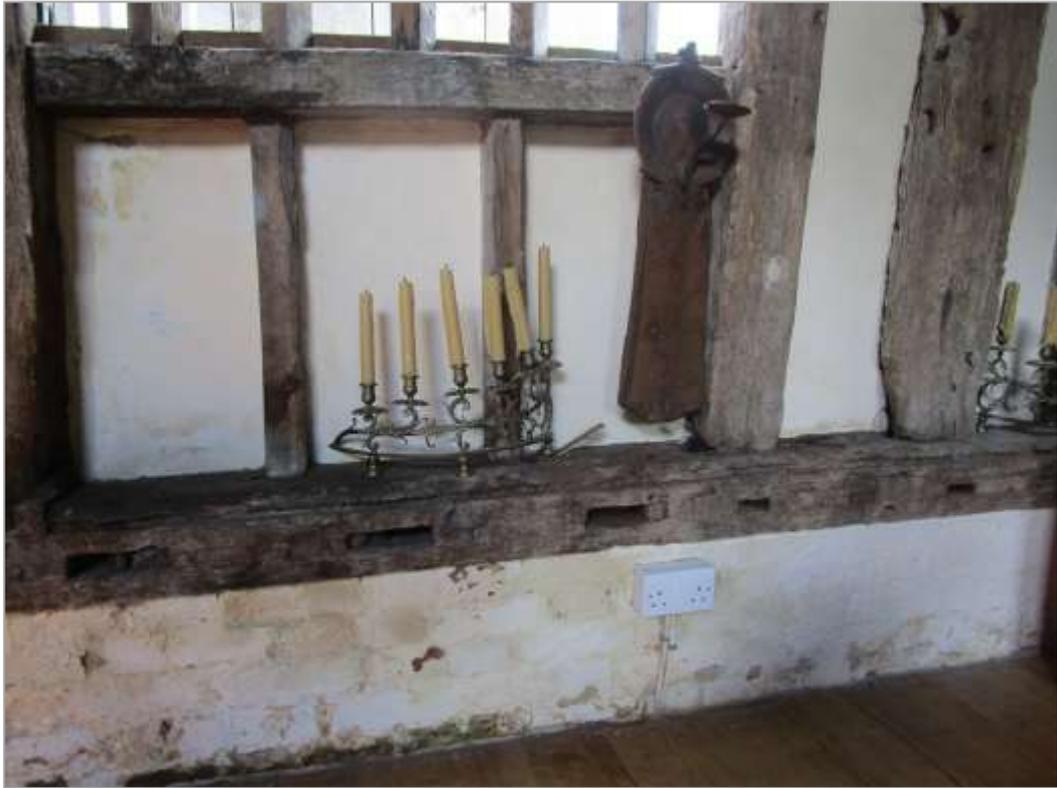
Fig. 40: Re-used sole plate and studs in the centre bay of the former barn, south side

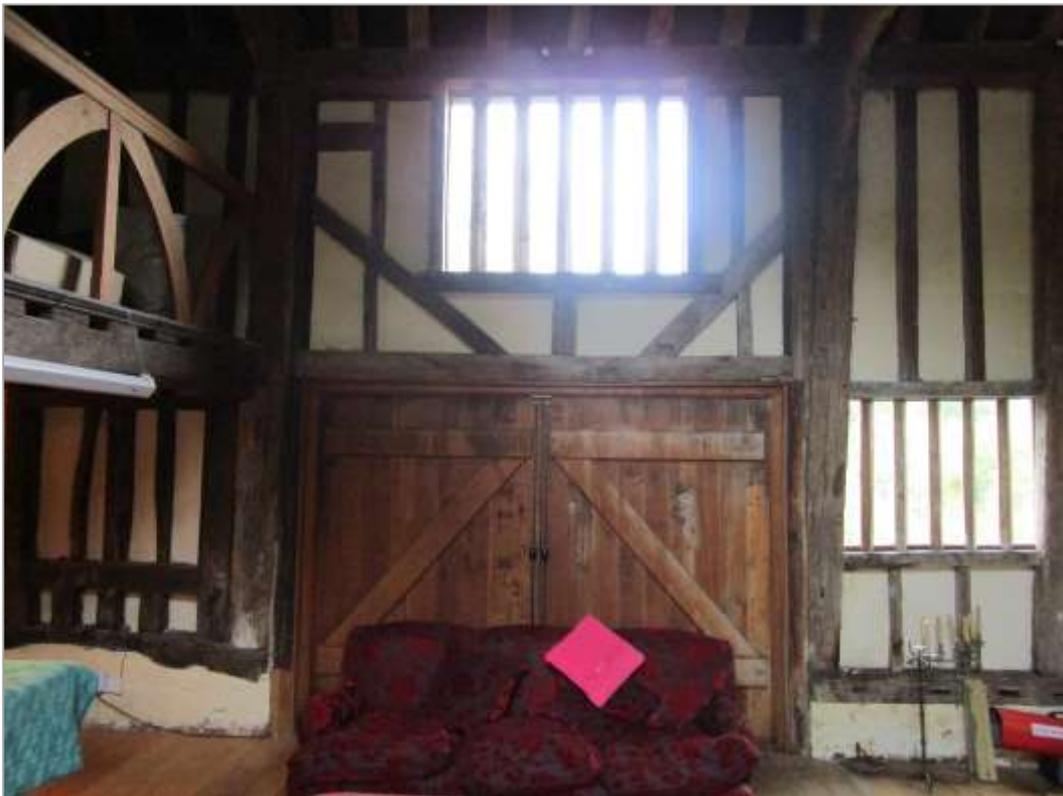
Fig. 41: The north wall of the former barn, showing the 1990s barn doors. These will be replaced like-for-like (on account of the floor lowering), and augmented by inner doors. To the left, a mullion window is proposed in the blocked door opening below the gallery.

- On the north side, new inner doors of the same design as proposed on the south will be installed. The 1990 outer doors need to be replaced (on account of the floor lowering), but will be replaced like-for-like.

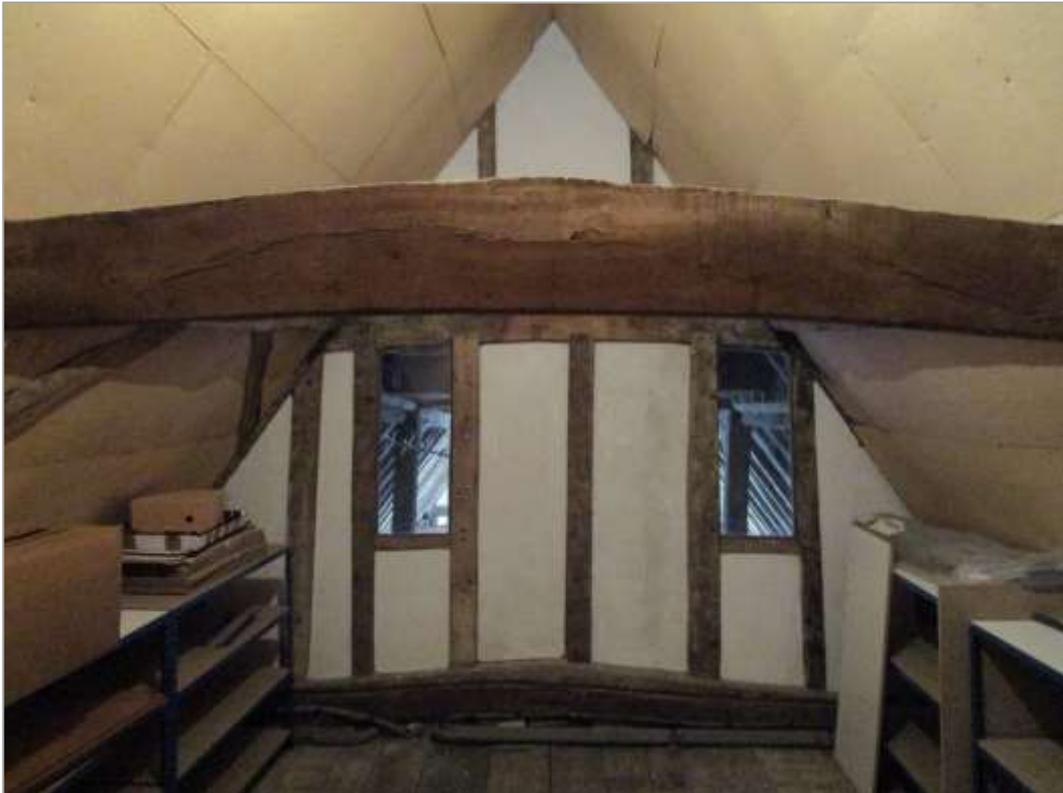
Fig. 44: A second view of the second floor space at the back of the main range, where it is proposed to form a bathroom. The roof timbers will be exposed, with insulation provided between. The boarded floor will be retained with a raised floor for the bathroom, to conceal the plumbing and spread the additional load of the bath.

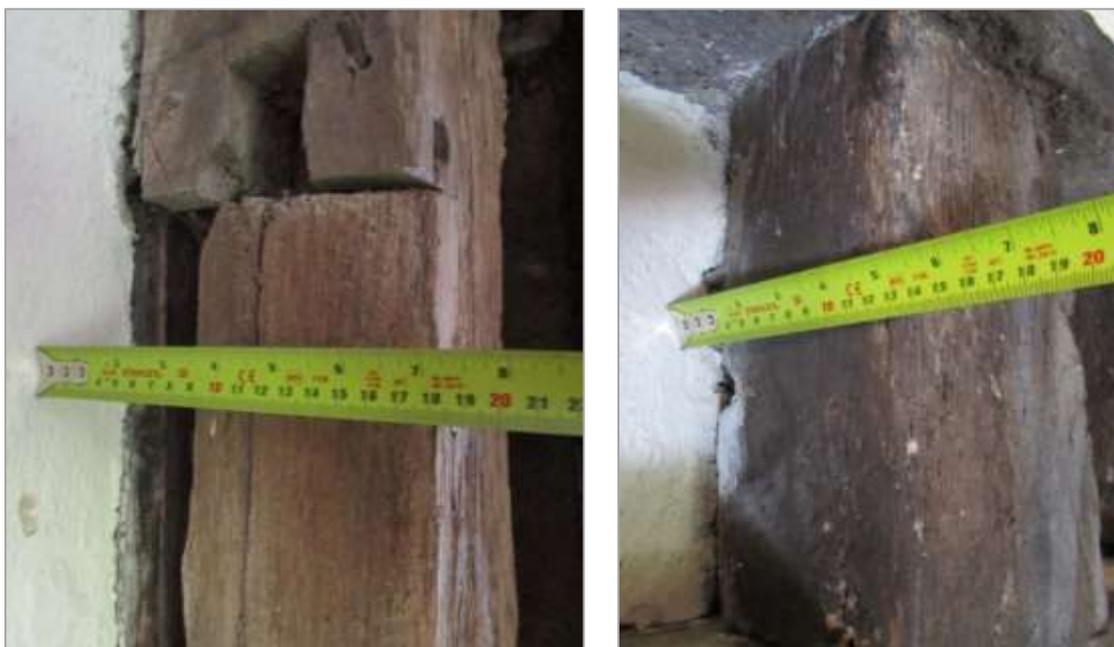
Figs 45 and 46: Typical variations in depth of studs in former barn
