Bat Survey Report

Site: Grange Farm, Horn Lane, Evenlode, Moreton-in-Marsh, GL56 0NT

Client: Rupert Holdsworth Hunt

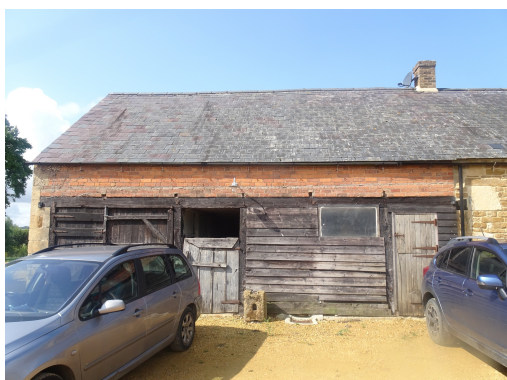
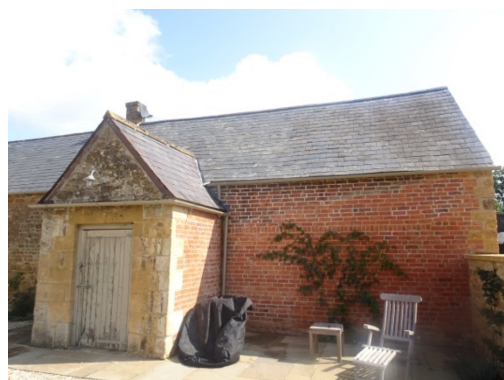
Figs. 1 & 2 Southern end of stable building

The survey site comprised the southern end of a brick and stone stable building with a pitched tile roof (Figs. 1 and 2).

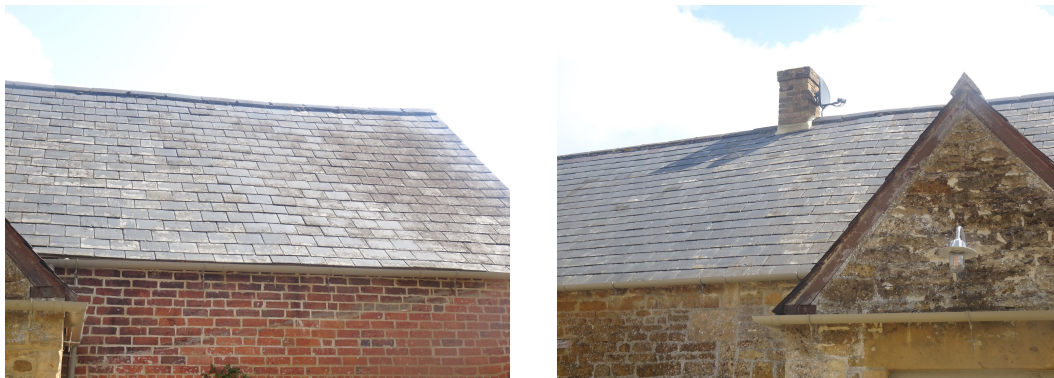
Figs. 3 & 4 Ridge and roof tiles

The slate ridge and roof tiles were all in good condition and tightly overlapping, with none raised, broken, missing or dislodged (Figs. 3 and 4).

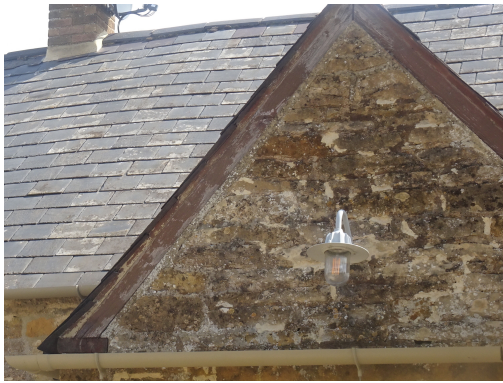
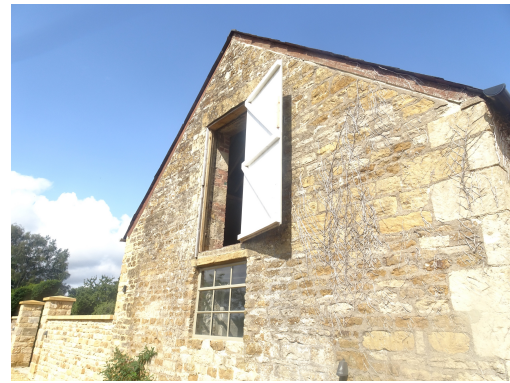
Figs. 5 & 6 Gable ends

The gable ends were finished with the roof tiles sealed to the end rafter which was exposed (Figs. 5 and 6). These were tight, with no gaps.

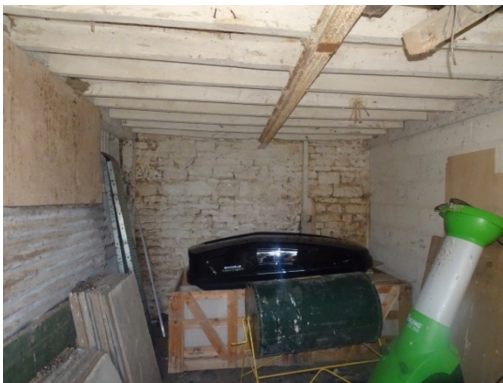
Fig. 7 Interior downstairs

The eaves were clipped and sealed, whilst the stone and brickwork was sound throughout, with no gaps or cracks. The window casements and doorframes were all tightly fitting and were all kept closed at all times, other than a gap above the stable door leading into the downstairs room (Fig. 7).

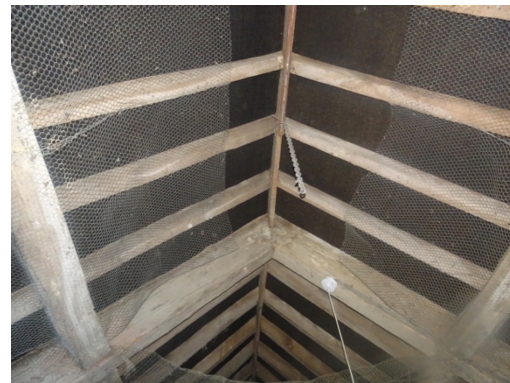
Fig. 8 Roof space

The upper floor could only be accessed by a ladder to the external hay door which was kept closed and sealed. Upstairs the room was open to the underside of the roof which was lined with tarred felt and chicken wire (Fig. 8).

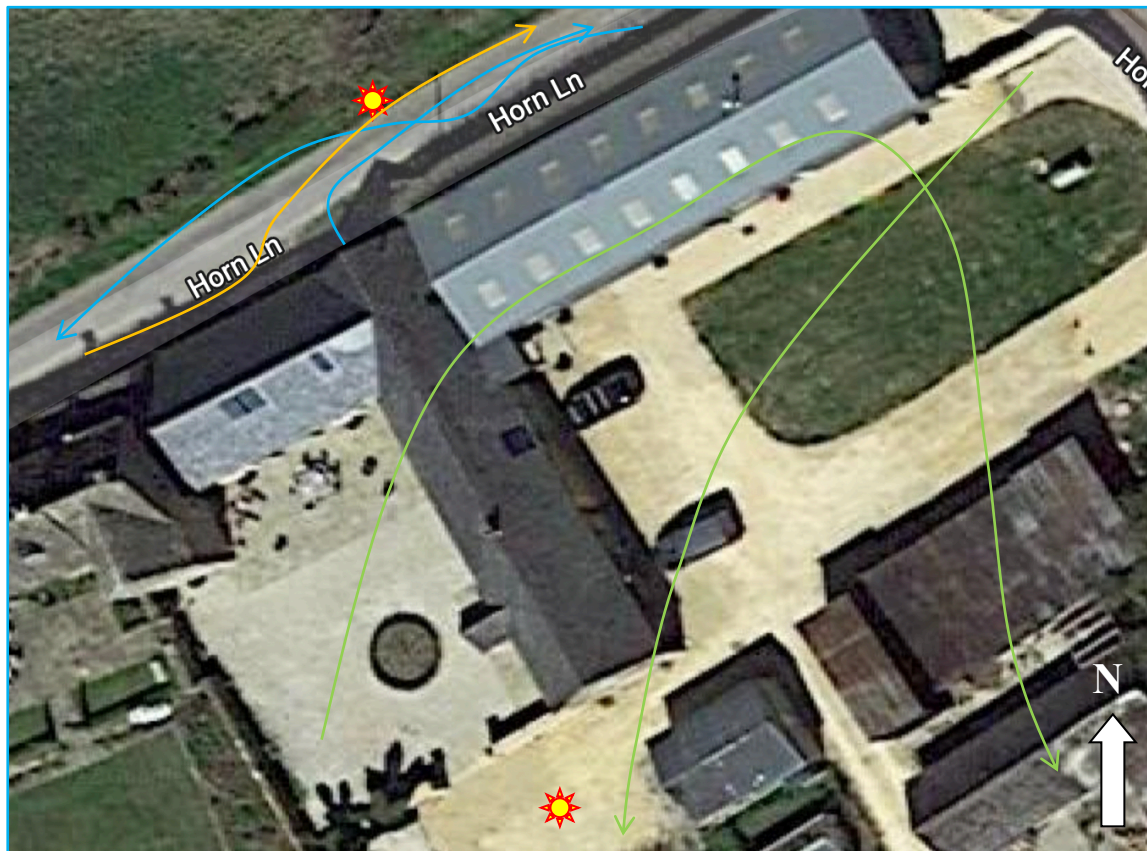
Plan 1 Bat flight paths at 1st emergence on 10th August 2021

A single Lesser Horseshoe Bat was seen to emerge from the bat loft entrance at the northern end of the building. No bats emerged from the southern section of the stables. Other species recorded in the area included Noctule, Whiskered/Brandt's and Daubenton's.

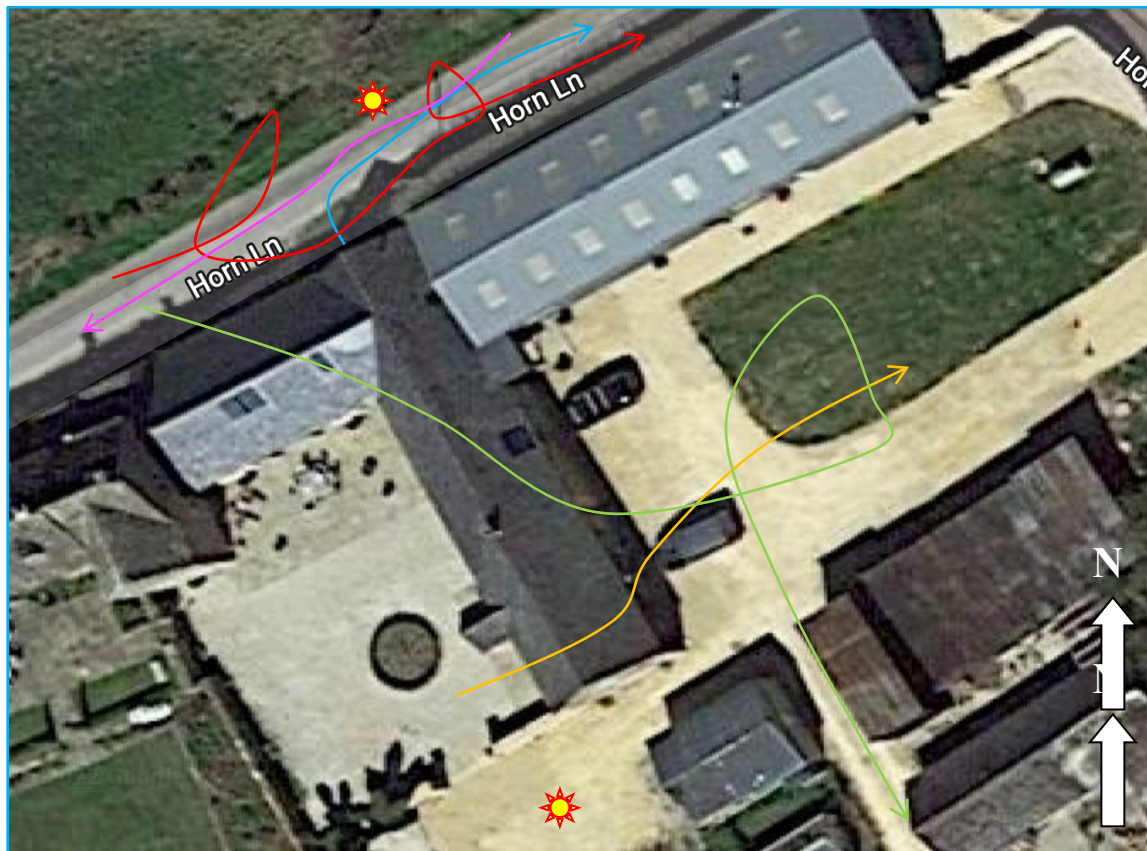
Plan 2 Bat flight paths at 2nd emergence on 24th August 2021

A single Lesser Horseshoe Bat was seen emerging from the entrance of the bat loft on the north gable wall, whilst low levels of Common Pipistrelle, Soprano Pipistrelle, Natterer's, and Brown Long-eared Bats were recorded foraging around the site.

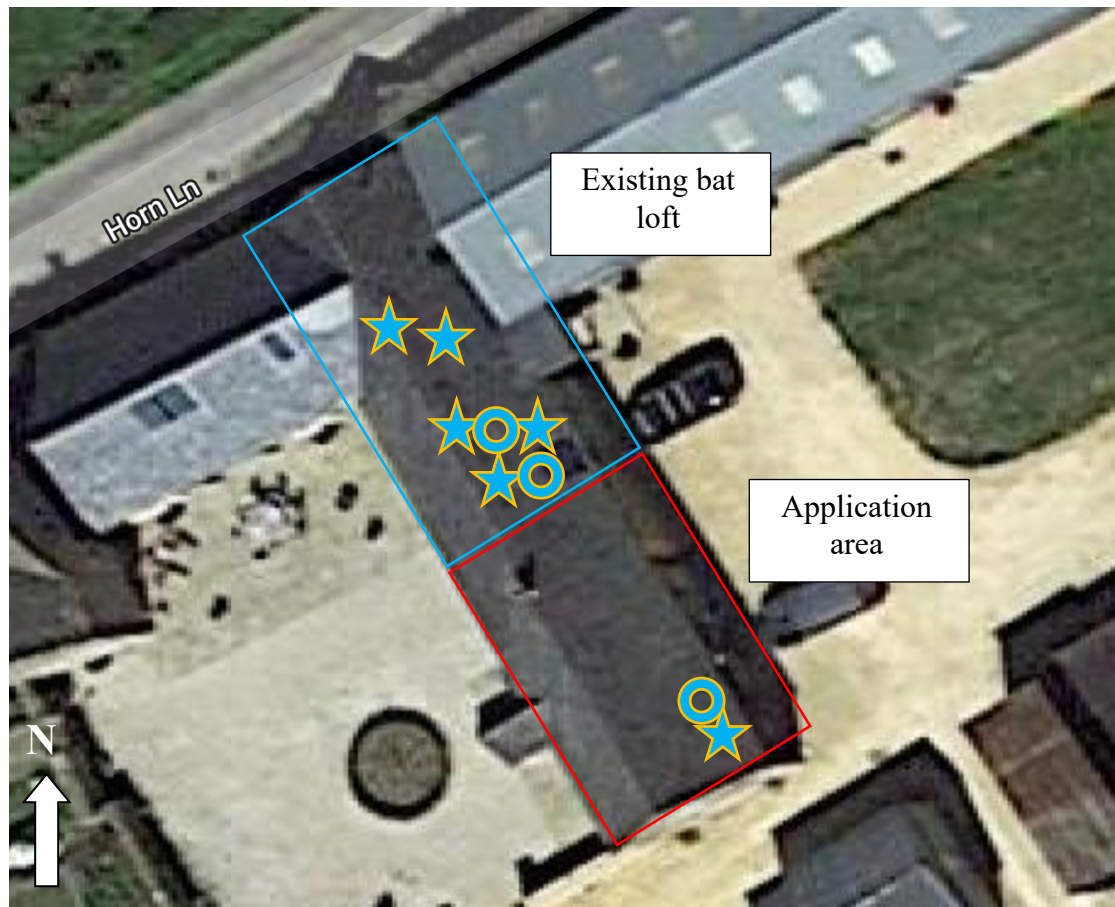
Appendix 3: Locations of bat droppings and roosting bat

Lesser Horseshoe Bat droppings

Location of roosting Lesser Horseshoe Bats
