**Barn at Duntisbourne House  
Duntisbourne Abbots**

## **1.0 INTRODUCTION**

In accordance with your instructions, AA Environmental Limited (AAe) carried out bat surveys (visual inspections only) at the above barn (B5 in AAe's Ecological Report January 2021) on Wednesday 12 August 2020 and Wednesday 23 February 2022. The purpose of the surveys was to determine the use of the building by bats so that appropriate and proportionate mitigation could be provided. An annotated plan and a series of photographs have been attached for reference. For the impacts on the wider proposals for the site please refer to AAe's Ecological Report dated January 2021 – NB initially no works were proposed to Buildings B4 and B5.

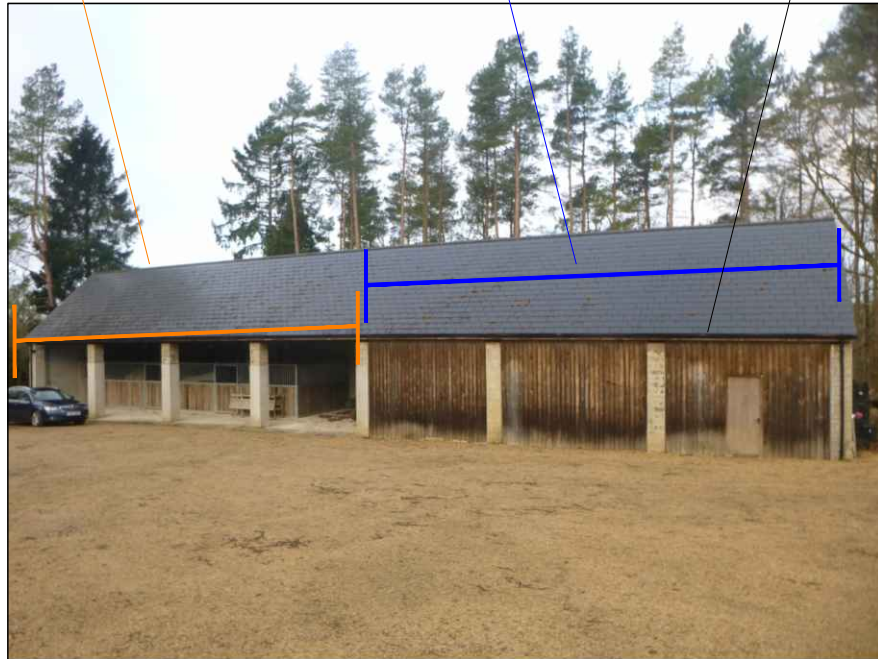
The barn was of breeze block construction and had a pitched slate roof lined with a bitumen based membrane. The southern section of the barn was used for stabling and was open fronted. The northern section of the barn had been modified to provide a dedicated bat roost for a variety of species (understood to have been constructed to mitigate for works completed on the adjacent Duntisbourne House and completed under European Protected licence EPSM 2011-3234). The bat roost had a loft space with an open access hatch and a bare earth floor with a breeze block chamber to vary roosting opportunities. Access into the roost for bats was provided with an opening on the western elevation and gaps around the overhanging eaves. The timber frame and cladding on the front of the bat roost section was beginning to rot and would need repairing/replacing.

Section to be converted for storage.

Bat roost section to be retained and protected.

Access gaps under eaves to be retained and protected.

Photograph 1: Showing the eastern elevation for the barn.

The proposals are to convert the stable section of the barn as a storage unit for garden equipment and to clad the barn with a mix of stone fascias and timber cladding. No internal works will be carried out on the northern section of the barn which is a confirmed bat roost. The existing access points to the roost (gaps around the eaves and an access hole on the western elevation will be retained and protected). Sections of the new cladding are required for the bat roost in order to repair over existing cladding which is rotting, ensuring the continued protection of the roost.

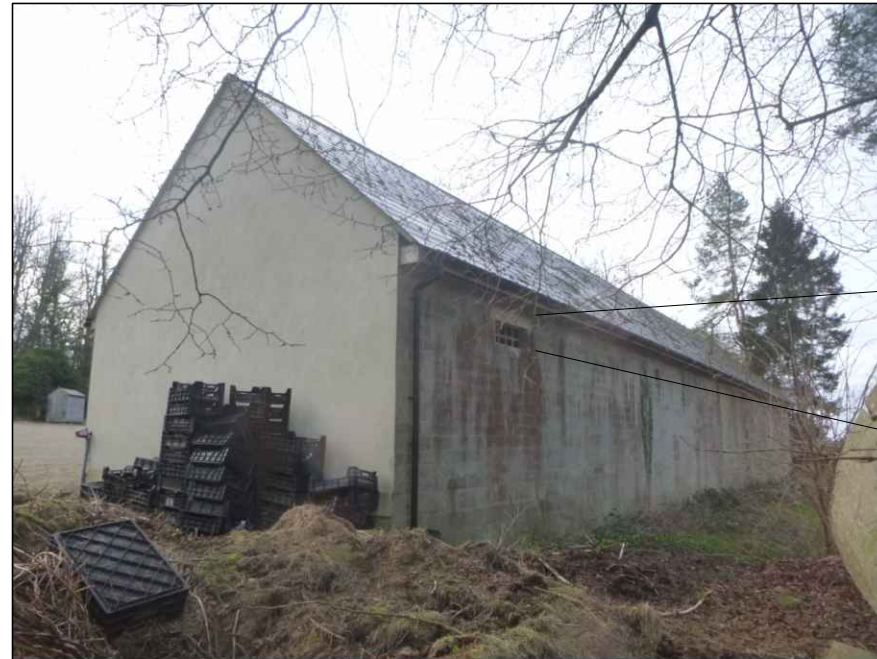
Photograph 2: Showing the western (rear) and northern (gable) elevations for the barn.

Access gaps under eaves to be retained and protected.

Access hole to be retained and protected.

horseshoes and potentially other species of bat). The existing access points to the roost (gaps around the eaves and an access hole on the western elevation) will be retained and protected. The new timber cladding will also ensure the continued protection of the bat roost.

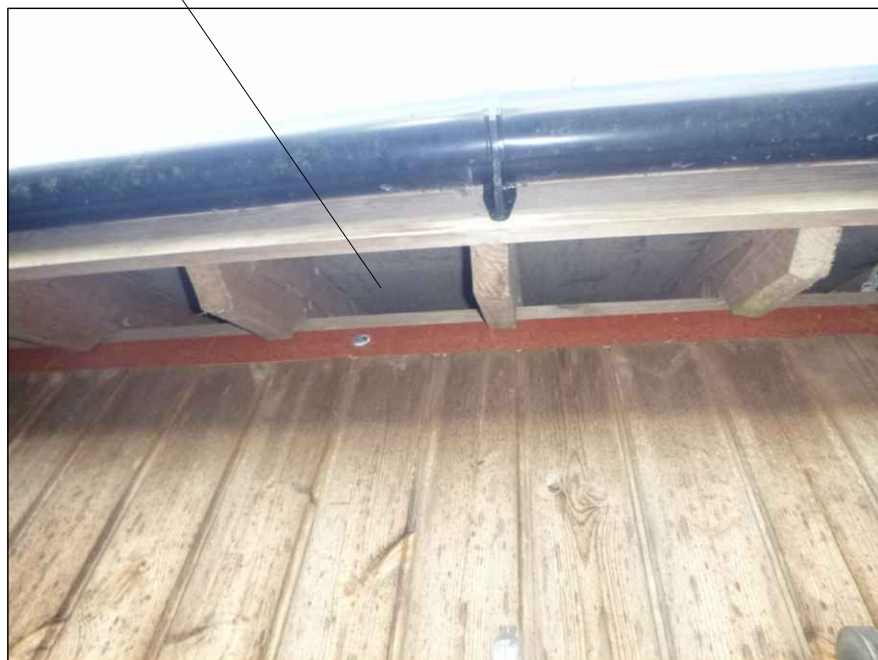
Access gaps under eaves to be retained and protected.

Photograph 3: Showing access gaps under the eaves which will be retained and protected.

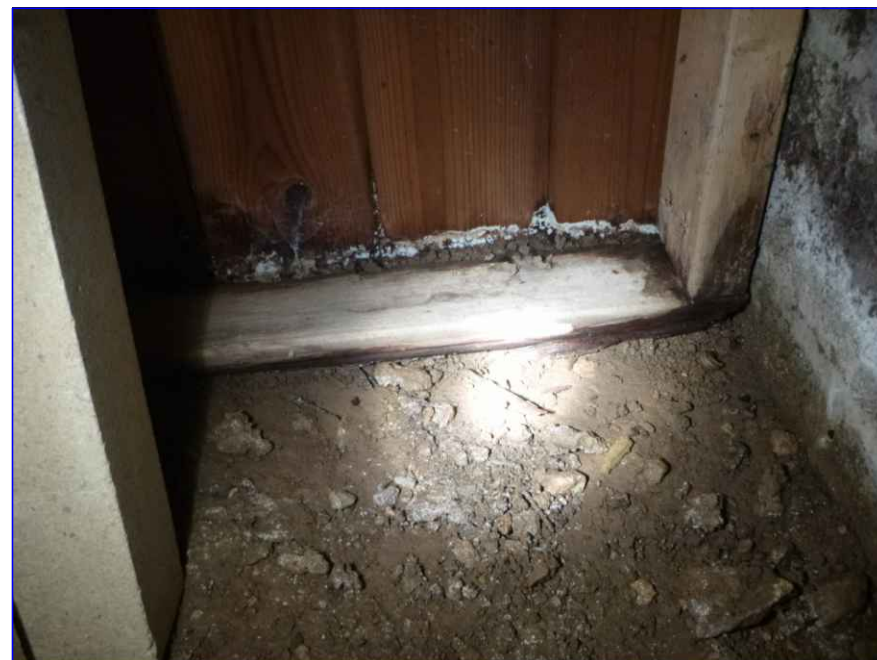
Photograph 4: Showing the timbers at the front of the bat roost which are beginning to rot.

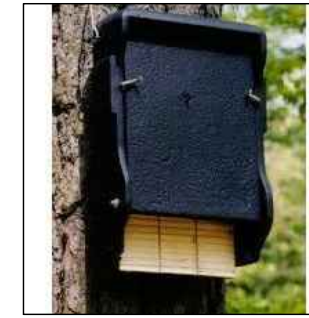
Schwegler 2FN Bat Box

In order to ensure there are alternative roosting opportunities for bats during the works, a Cathedine Night Roost (a copy of the design has been attached at Appendix A for reference) will be positioned in the adjacent woodland to the west of the site and two bat boxes installed on trees in the same woodland (e.g. x1 Schwegler type 1FF and x1 Schwegler type 2FN).

The bat boxes will be installed on suitable trees in the woodland adjacent to the barn.

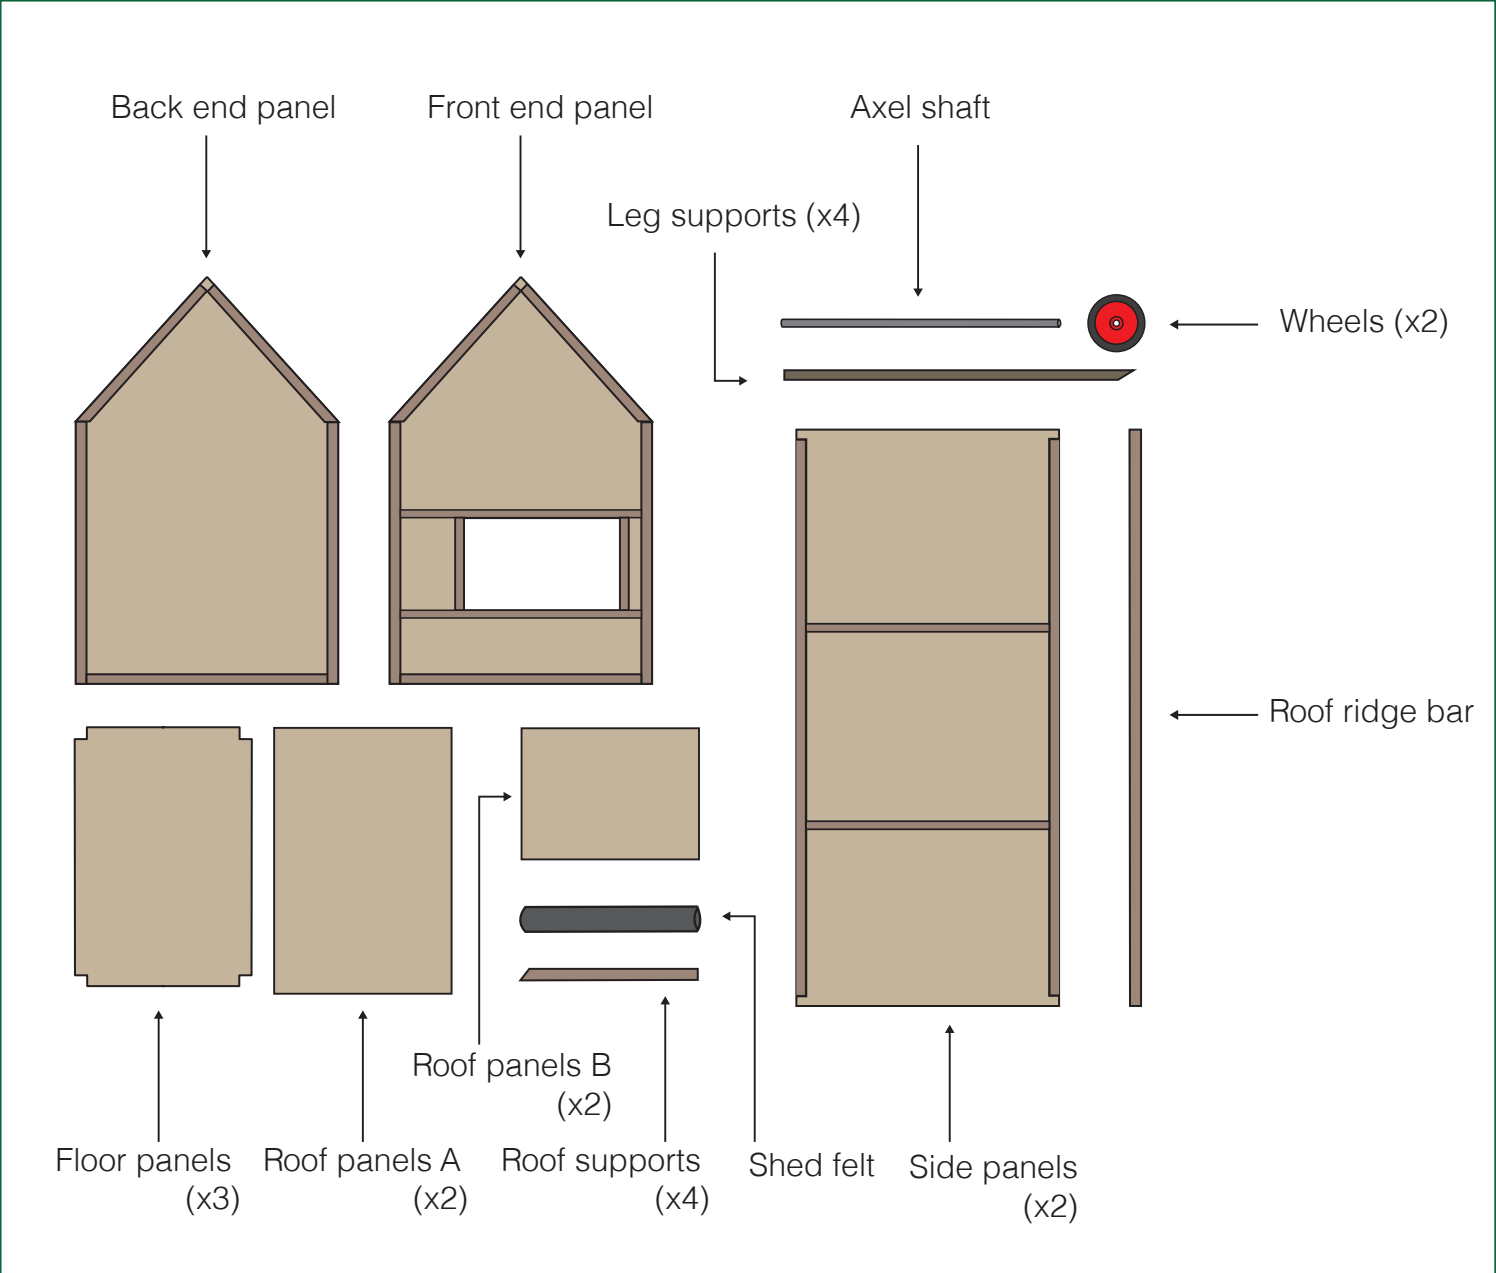
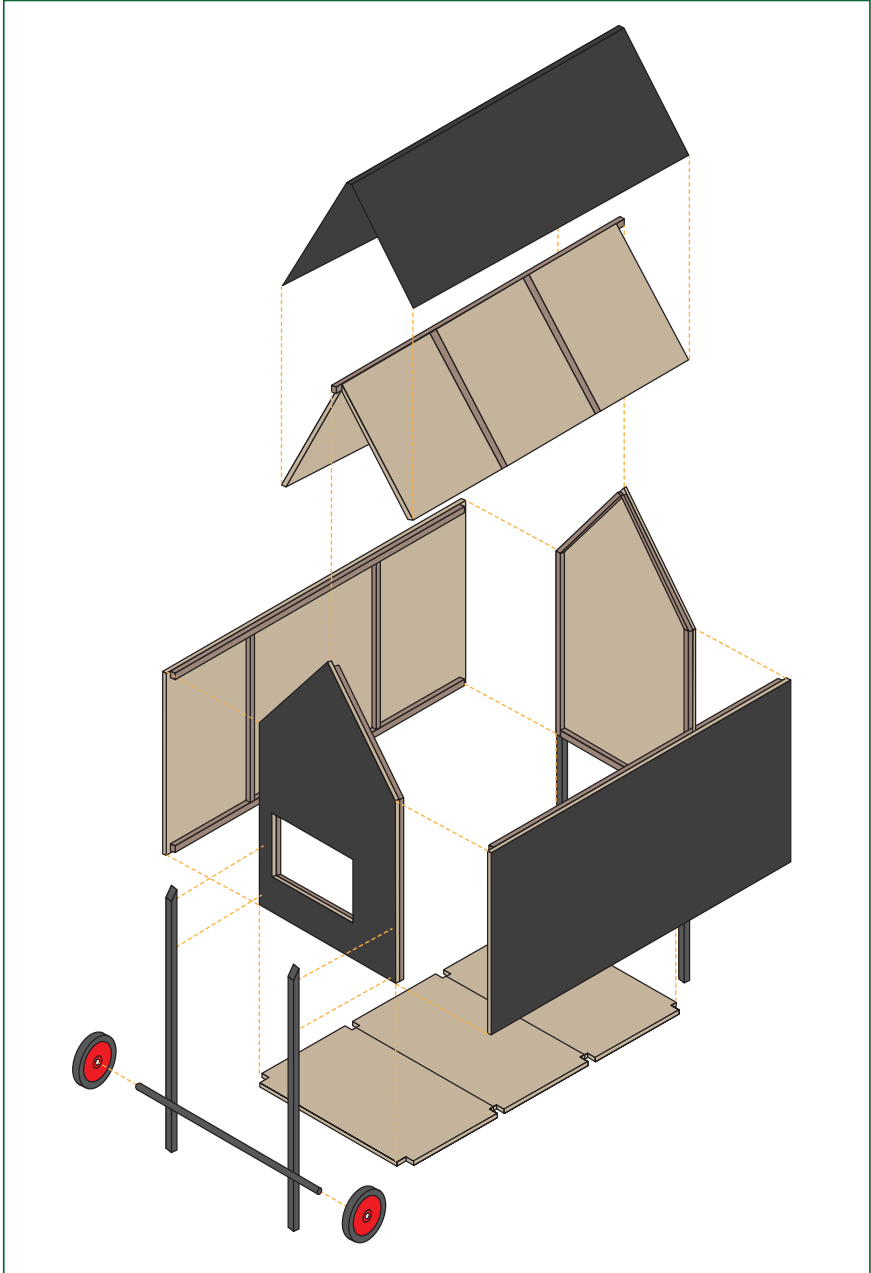
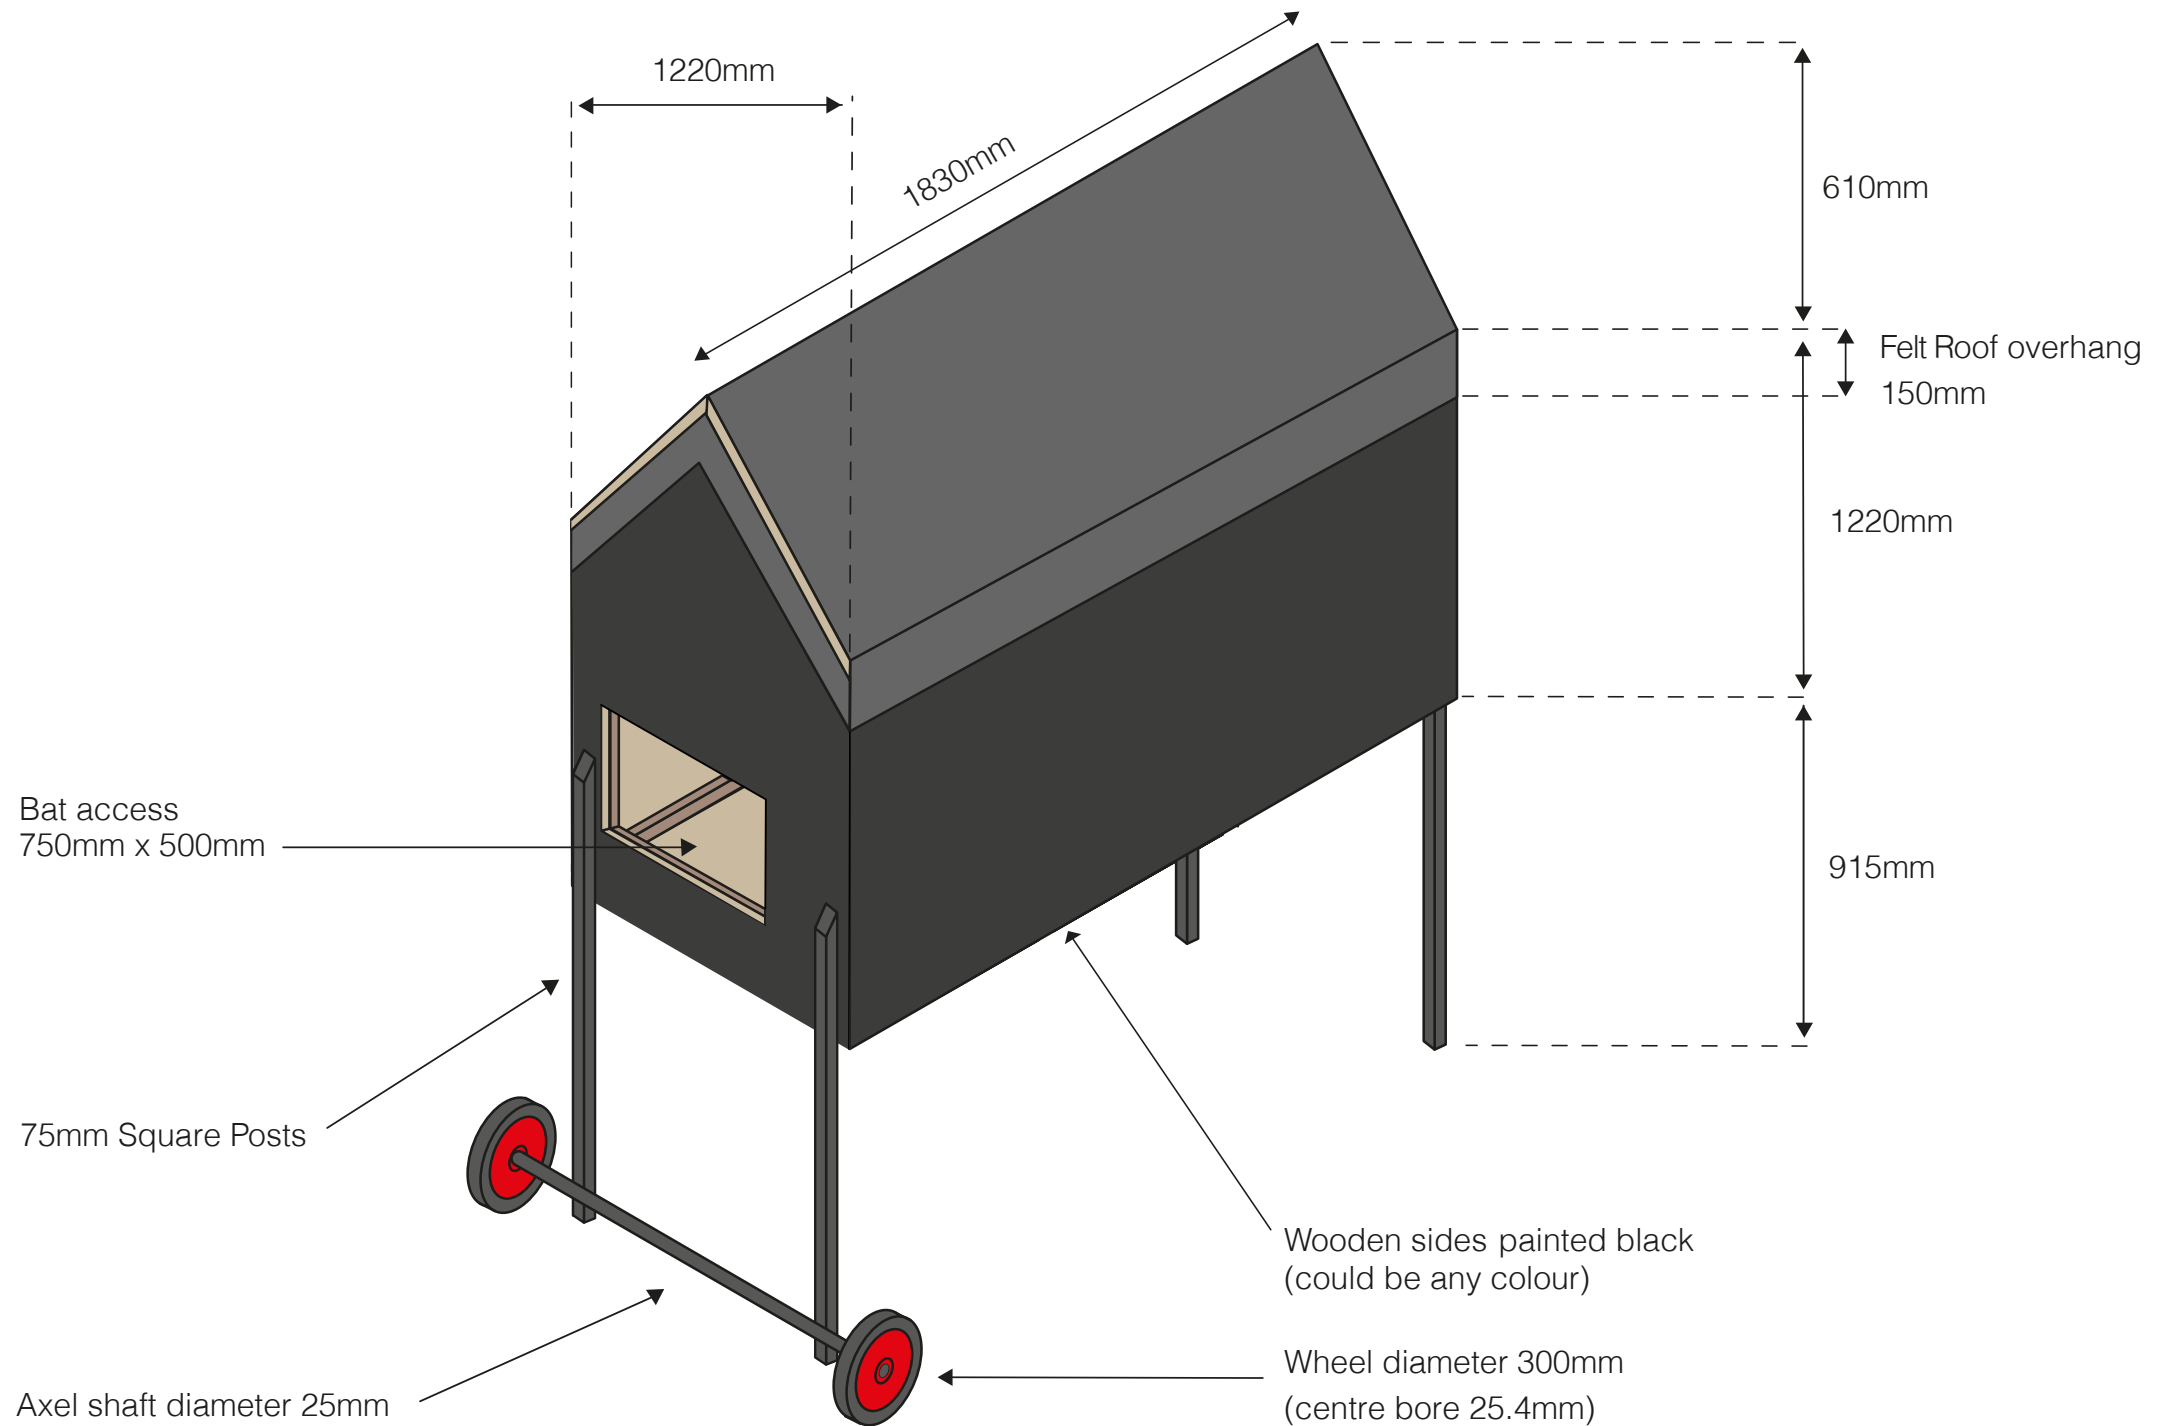
# Cathedine Night Roost Design

x1 Cathedrine Night Roost will be installed in the woodland adjacent to the barn.
