**Factual GI Report
for
42 Durham Road,
Coatham Mundeville**

Report title: SEP Rail Services
42 Durham Road,
Coatham Mundeville
Factual Ground Investigation Report

Issue Date: 21 March 2022

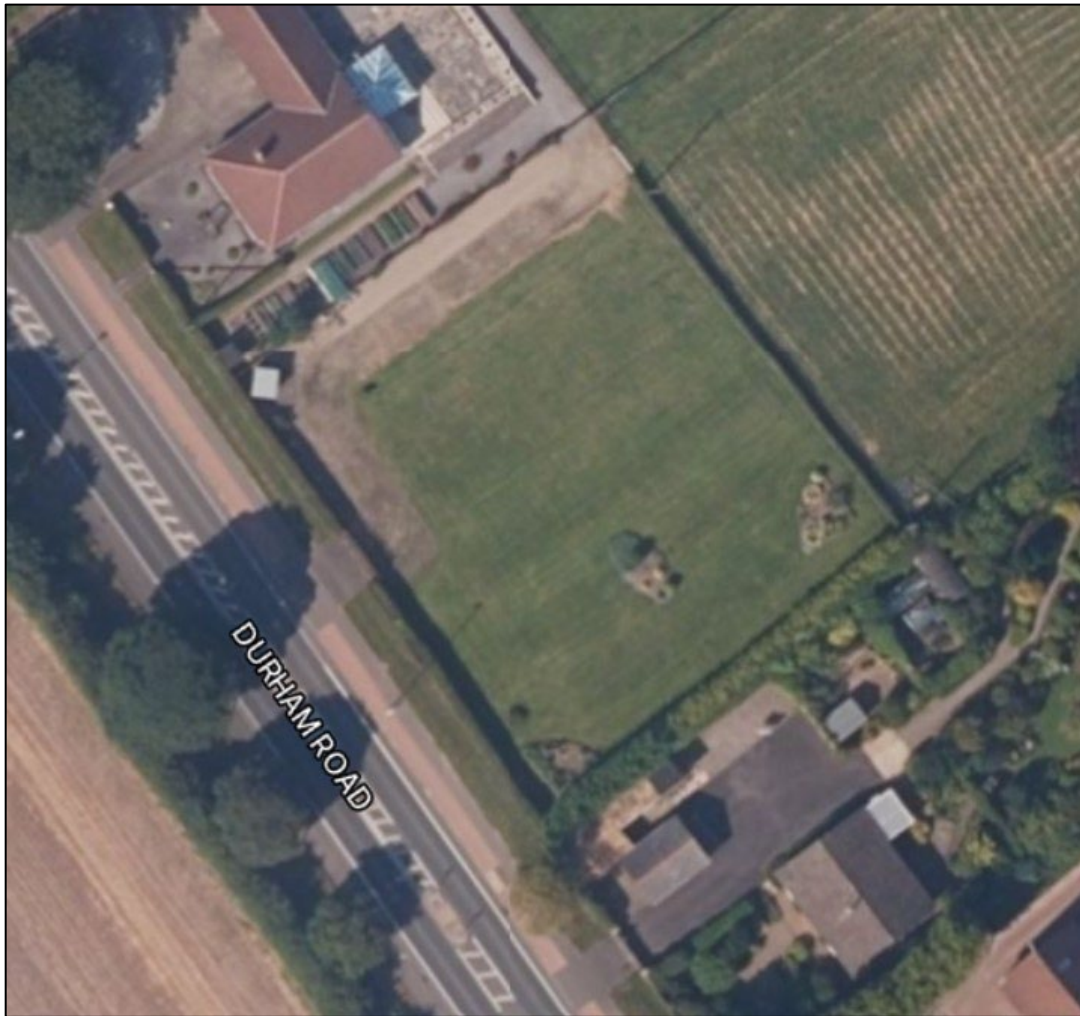
FIGURE 2 – EXPLORATORY HOLE LOCATION PLAN

The locations of the exploratory holes were determined on the Site by the SEP Technical's (SEP) geoenvironmental engineer. The approximate locations of the exploratory holes are shown on the site plan presented as **Figure 2**.

See Topographic Survey below for as-built borehole locations.

Four window sample boreholes referenced BH1 to BH4 inclusive were advanced using a Dando Terrier window sampling rig to a maximum depth of 6.45mbgl. The site investigation was carried out on Saturday 15th January 2022 under the supervision of SEP Technical's (SEP) geoenvironmental engineer. Specific hole details are as follows:

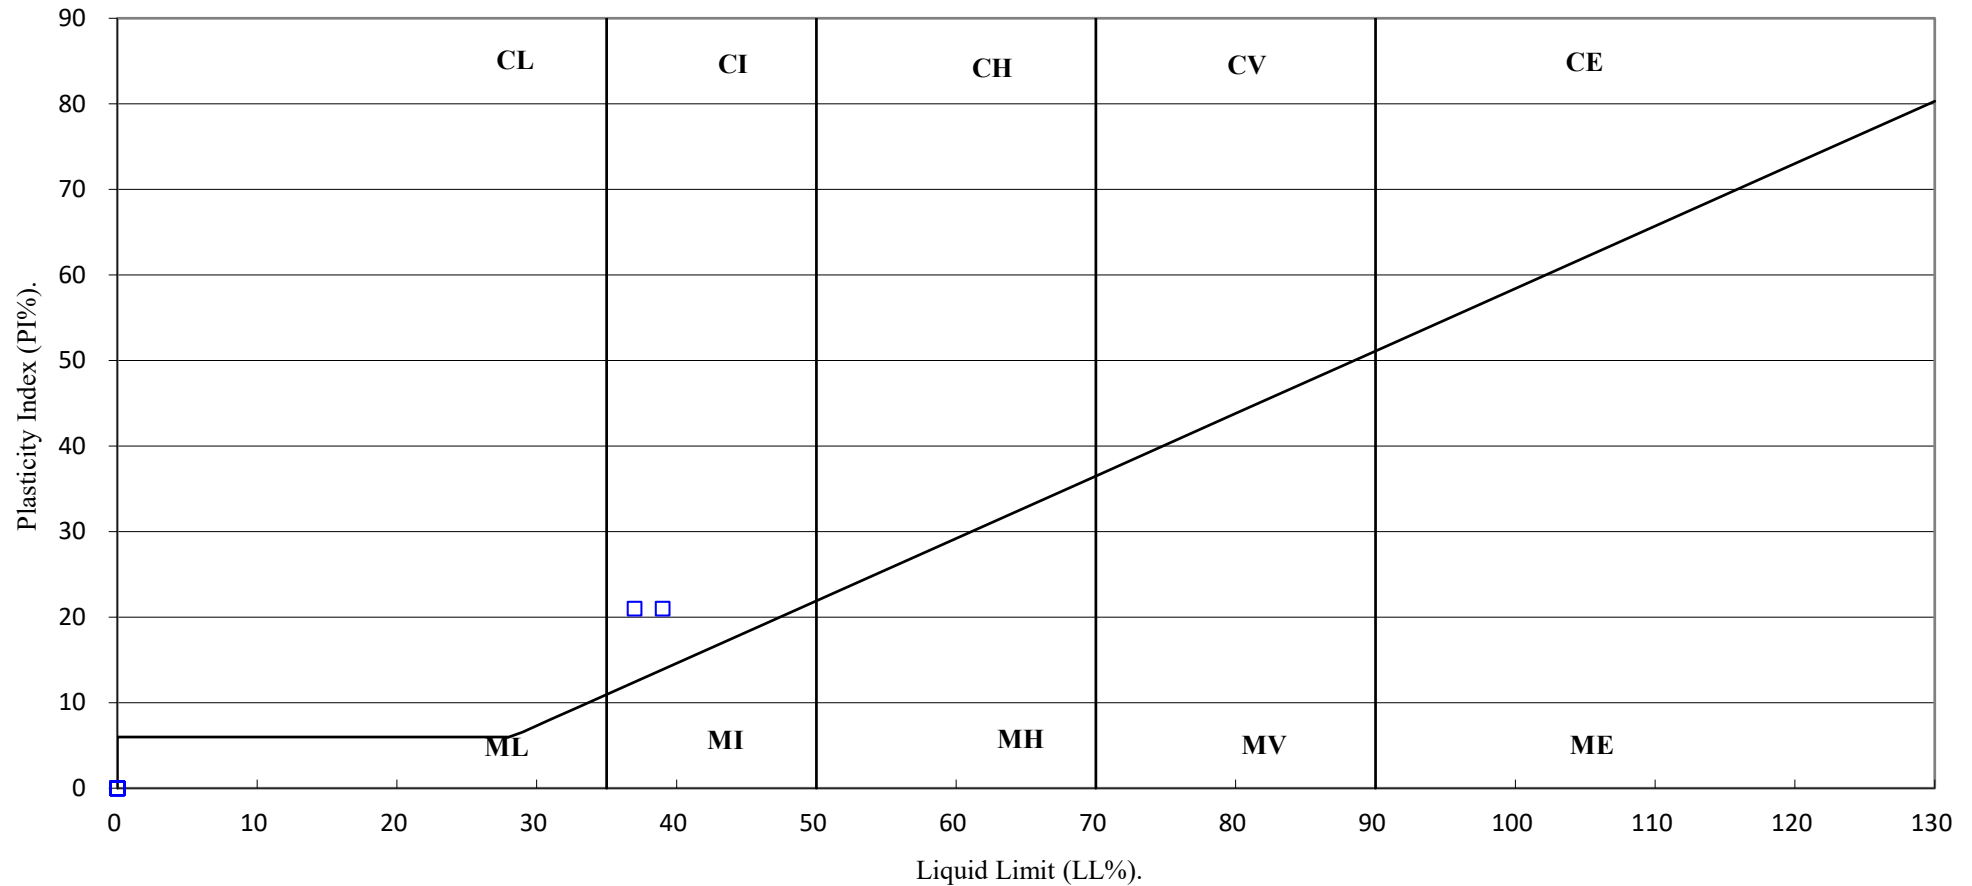
PLASTICITY CHART FOR CASAGRANDE CLASSIFICATION.

Hole Number	Sample Number	Sample Type	Top Depth m	Base Depth m	Moisture Content % <small>Clause 3.2</small>	Linear Shrinkage % <small>Clause 6.5</small>	Particle Density Mg/m ³ <small>Clause 8.2</small>	Liquid Limit % <small>Clause 4.3/4</small>	Plastic Limit % <small>Clause 5.3</small>	Plasticity Index % <small>Clause 5.4</small>	Passing .425mm %	Remarks
BH1	1	U	2.00	2.45	14			37	16	21	97	Intermediate Plasticity CI
BH3	1	U	5.00	5.30	15			39	18	21	96	Intermediate Plasticity CI

Sample ID	Sample Depth (mbgl)	Strata	Plasticity Index	Plasticity
BH1 U	2.00 – 2.45	Clay	21%	16%
BH3 U	5.00 – 5.30	Clay	21%	18%
