Ecological Impact Assessment of land and
buildings at Hill Farm

All Stretton
Church Stretton
Shropshire
SY6 6LQ

By Churton Ecology
(Mr. R.G. Thorne BA [Hons] MRSB and Dr A.K. Thorne MCIEEM | Contact 01743718270)
Commissioned by Batch Valley Design
January 2022

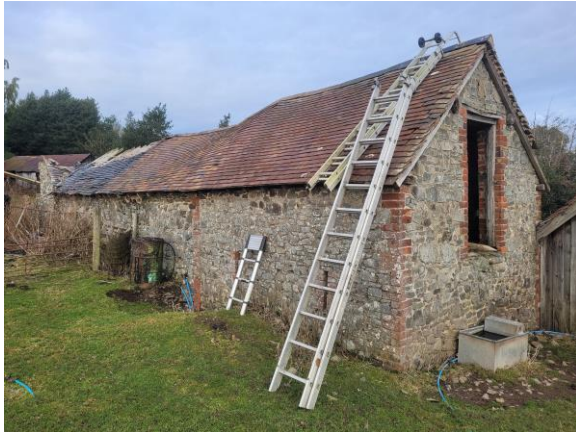
The most southerly of the outbuildings (Building A) is used as a sheep shelter. The west end has collapsed and would have linked with an annexe of the main farmhouse (which has now also collapsed). The east end supports ground and first-floor areas. Due to the presence of a

number of permanently open windows and doorways (and its state of partial collapse), the interior is extremely light and draughty. The walls are random laid stone and rubble construction with some brick detailing – small numbers of cracks and crevices are present throughout the building, particularly around the widow and doorway lintels and their bearings.

P1: Building A: S + E elevations, viewed from the SE

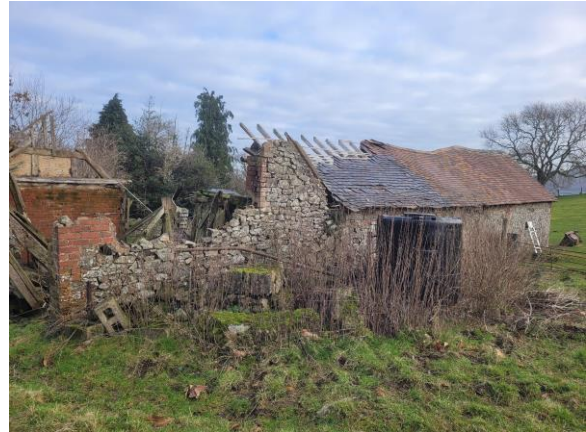
P2: Building A: W + S elevations, viewed from the SW

The roof, which is not lined, is covered with small clay roof-tiles and a mix of half-round and angled clay ridge-tiles. The ridge-tiles are in poor condition, so much so that the ridge-tunnel is exposed and draughty. The east roof-verge is also damaged in places and there is potential flight access up and under the exposed end-rafter (i.e. with potential roosting habitat on top of the gable wall, under the tiles).

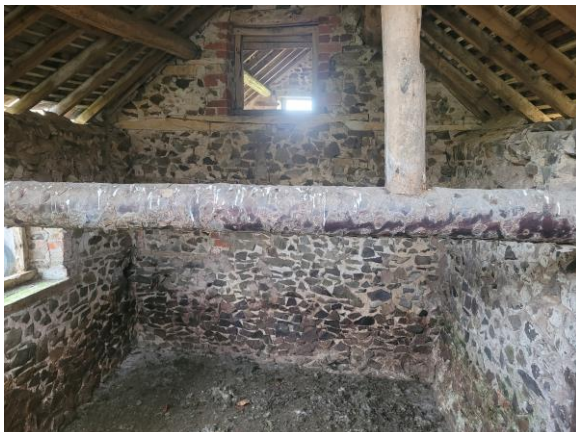
P3: Building A: Interior, W-end; looking E

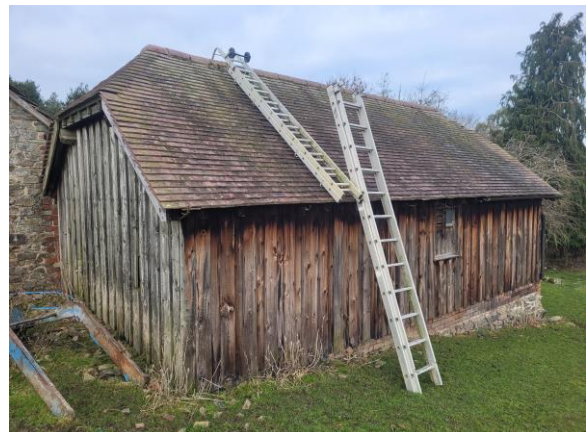
P4: Building B: S + E elevations, viewed from the SE

The second outbuilding (Building B) to the east is used as a sheep shelter and shearing shed. The walls are vertical timber batten-and-board construction supported on a narrow gauge timber frame. The cladding passes cleanly over the structural members and there are no tight (potential roosting) niches typical of other types of cladding systems. The roof, which is not lined, appears to have been re-roofed relatively recently with flush-fitting small clay roof-tiles and half-round ridge-tiles. With the exception of two gaps, the ridge-tiles are

securely bonded and tight-fitting. The roof is also hipped on both gables and a few of the hip-tiles contain gaps suitable for bats to access.

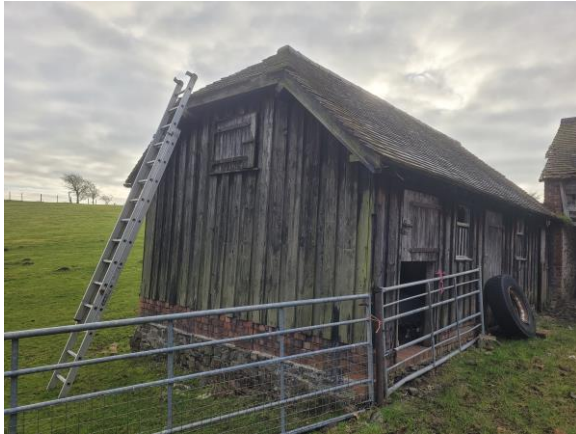
P5: Building B: N + W elevations, viewed from the NW

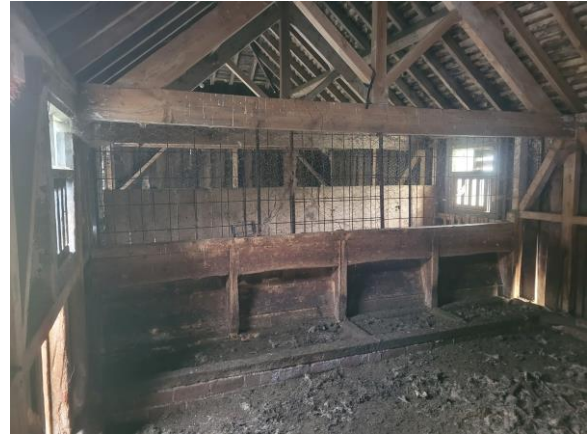
P6: Building B: Interior, S-end; looking N

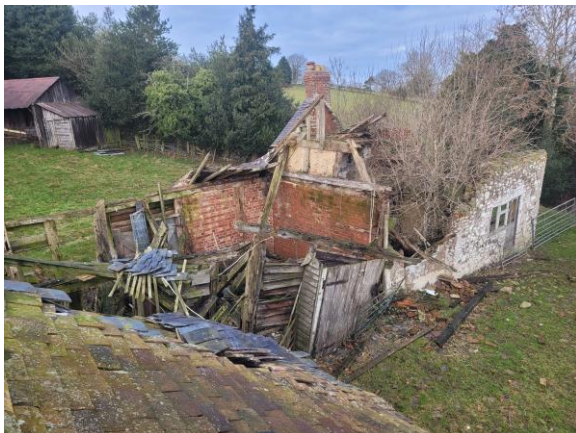
The derelict farmhouse (Building C) to the west burned down in 2002, or thereabouts. All that remains are the free-standing walls in their various stages of collapse. The original walls are random laid stone and rubble construction but the more modern south-annexe is of brick and timber-frame construction.

P5: Building C: E elevation, viewed from the SE

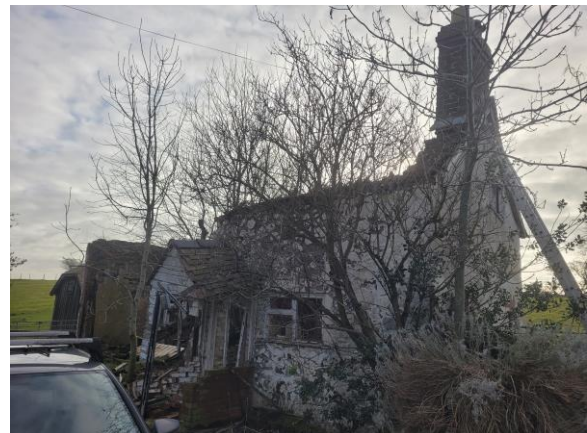
P6: Building C: W + N elevations, viewed from the NW

Small sections of the ground-floor roof remain on the west elevation. There are various cracks and crevices associated with the walls; however, there is now water ingress from the exposed wall-plates which has resulted in a pasty residue of dissolved lime mortar being present in much of the rubble matrix.
