# LAND LOCATED AT THE FORMER TVR FACTORY, BRISTOL AVENUE, BLACKPOOL

## Site Investigation & Ground Assessment

Report Ref: BEK-21924-1

October 2021

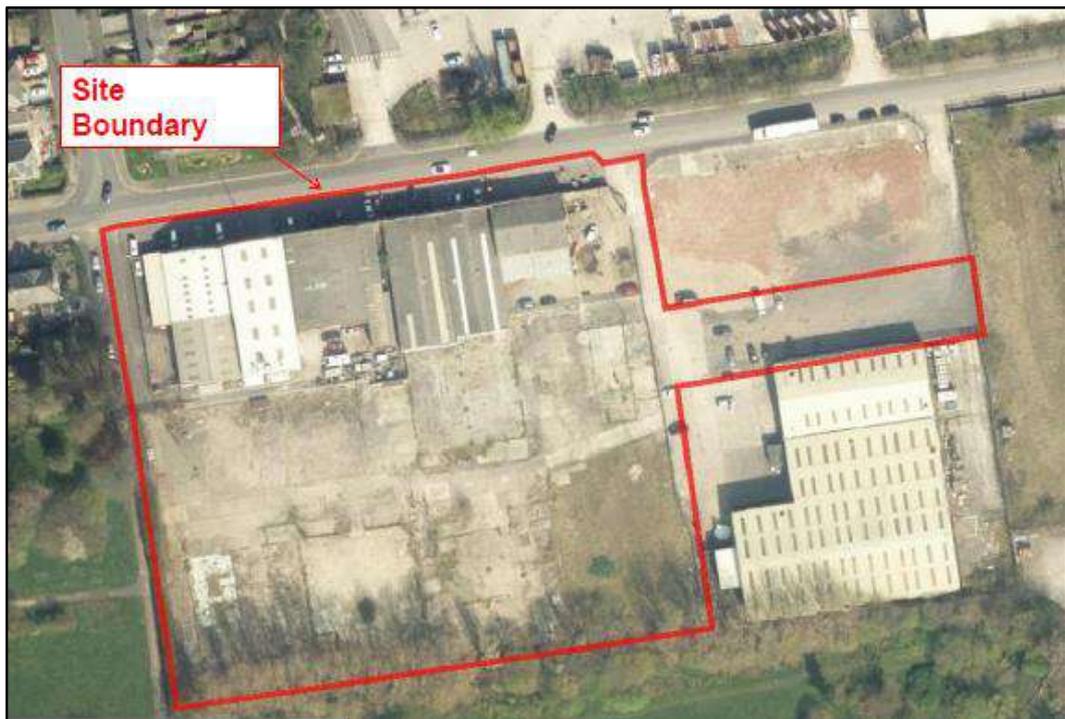
- 2.1.7 Within the rear yard of the northern building is a small electricity sub-station. In addition, a small structure within the north-western area of the site houses a National Grid gas installation.
- 2.1.8 Surrounding land uses are mixed, with a large recycling depot to the north, parkland to the south, housing to the west and electricity sub-station to the east.
- 2.1.9 Site has a mix of secured steel fencing with padlocked gates, plus walled and hedged boundaries.

*Figure 1: Site Layout at Time of PSA Site Walkover (taken from PSA Report)*

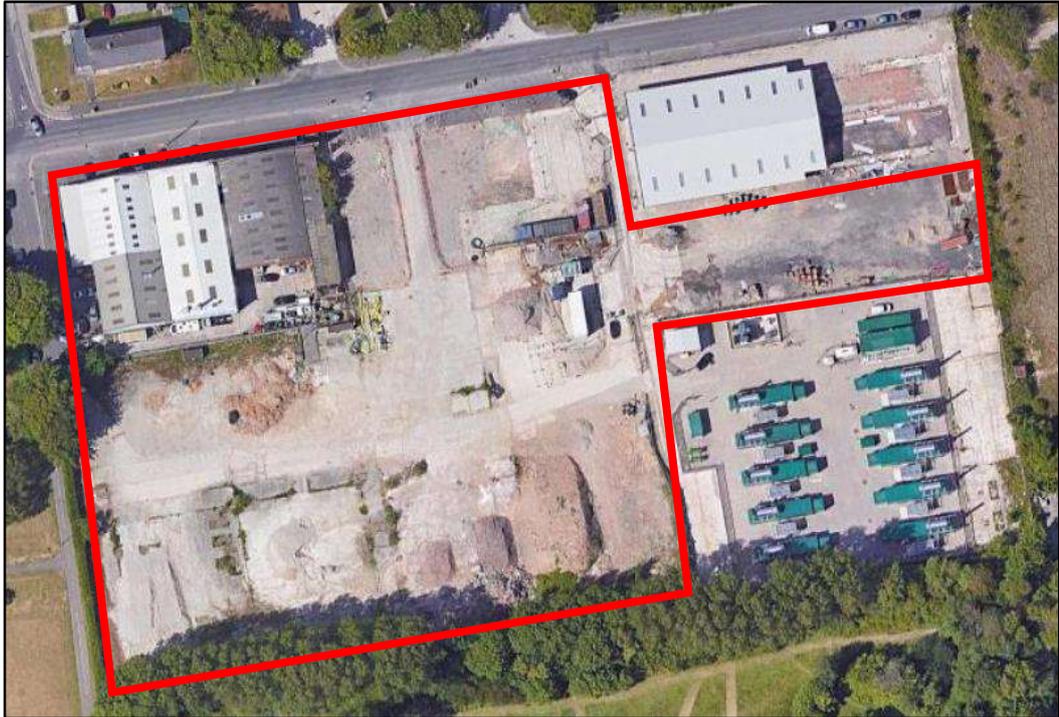
- 2.7.2 However, BEK notes that further buildings have been demolished in the north of the site since the walkover carried out by PSA with the only buildings remaining residing in the north-west of the site. Moreover, a series of stockpiles of spoil are located near the centre of the site from recent excavations carried out by United Utilities (UU). These are to be removed by UU in due course.

*Figure 2: Site Layout Following Demolition of Further Buildings in the North of the Site. (Taken 2021)*

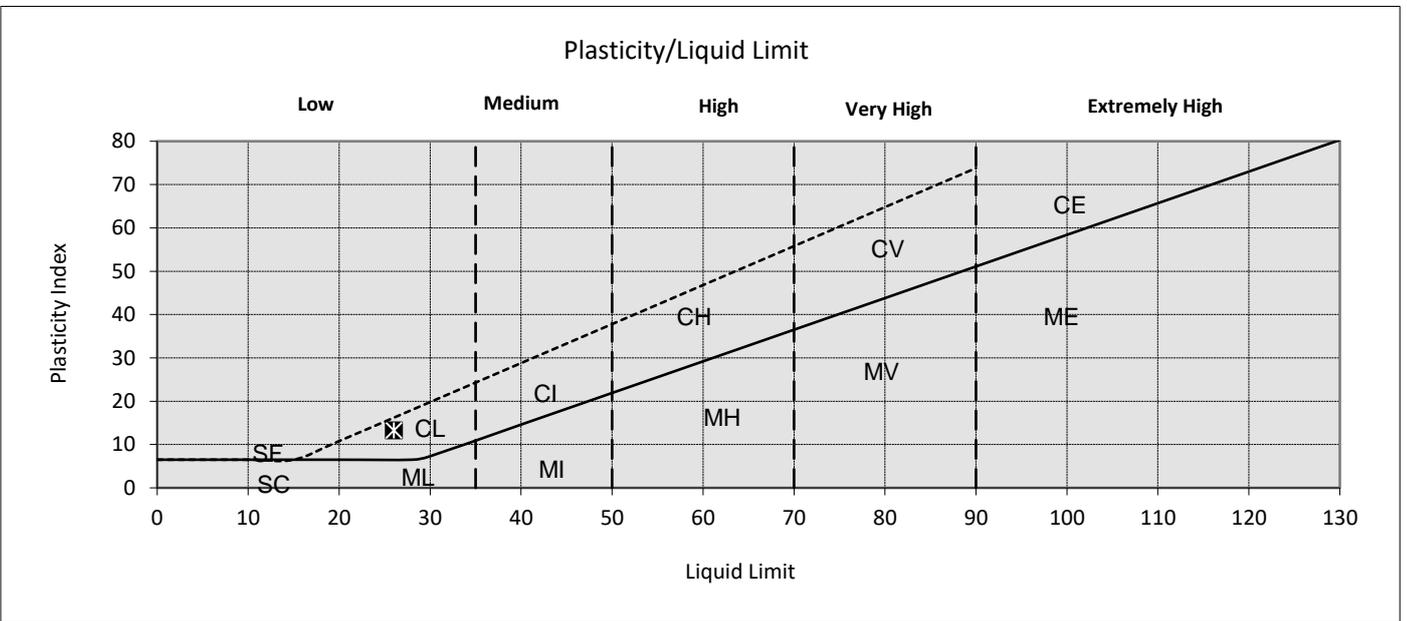
Sampling Certificate	Yes
Sampled By	Client
Sample Type	Bulk
Sample Preparation Method	As Received
MATERIAL	Red Brown CLAY
Retained 425 micron (%)	5
Natural Moisture Content (%)	15
Liquid Limit (single point)(%)	26
Plastic Limit (%)	13
Plasticity Index	13

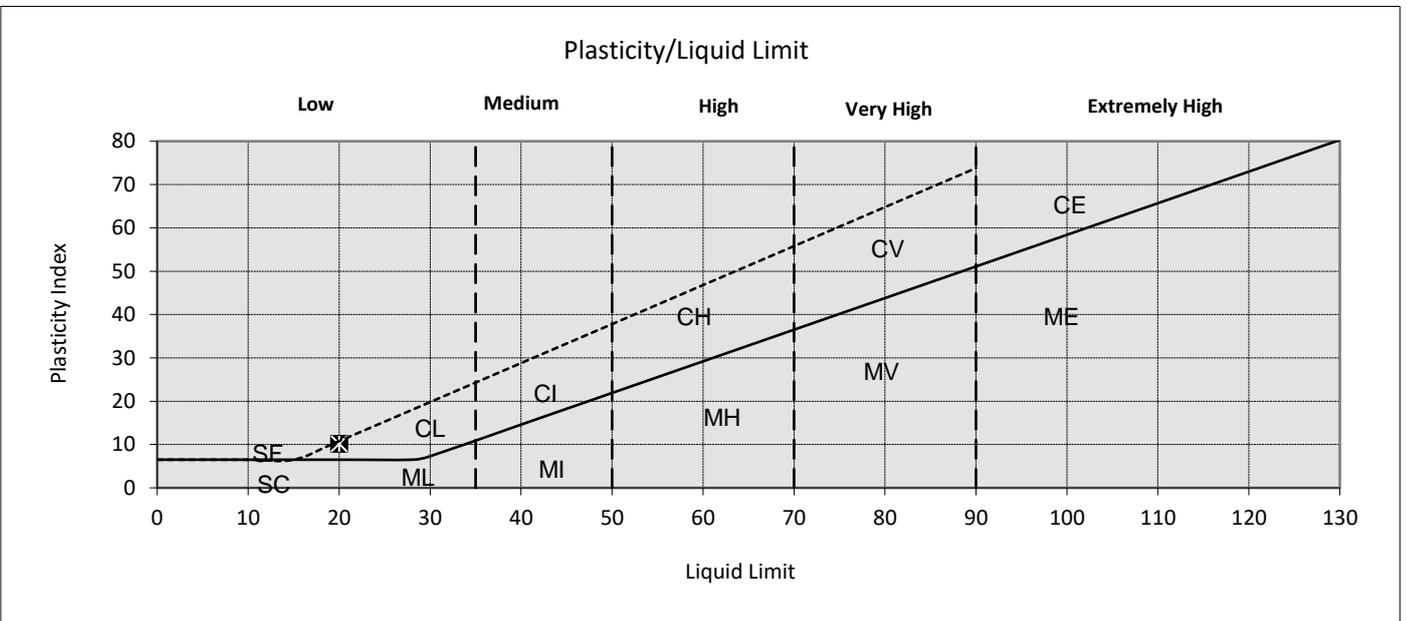
Sampling Certificate	Yes
Sampled By	Client
Sample Type	Bulk
Sample Preparation Method	As Received
MATERIAL	Red Brown CLAY
Retained 425 micron (%)	7.1
Natural Moisture Content (%)	12
Liquid Limit (single point)(%)	20
Plastic Limit (%)	10
Plasticity Index	10

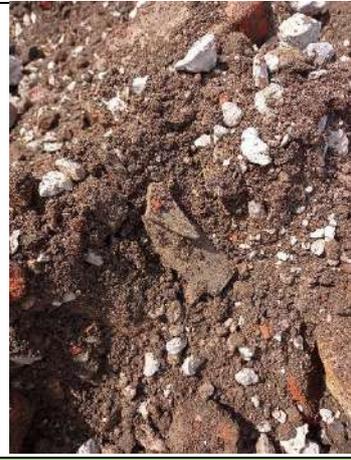
**P2: Trial Pit No 1 (ACM)**

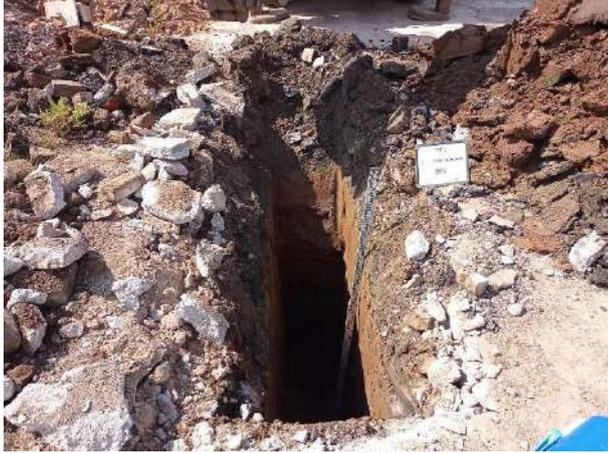
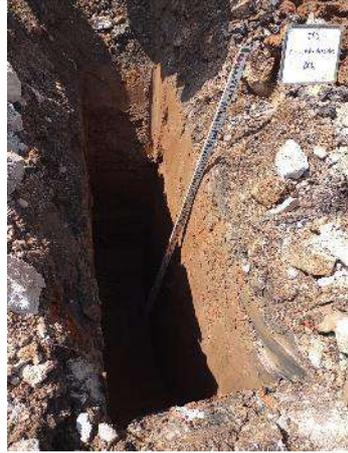
**P3: Trial Pit No 2**

**P4: Trial Pit No 2**

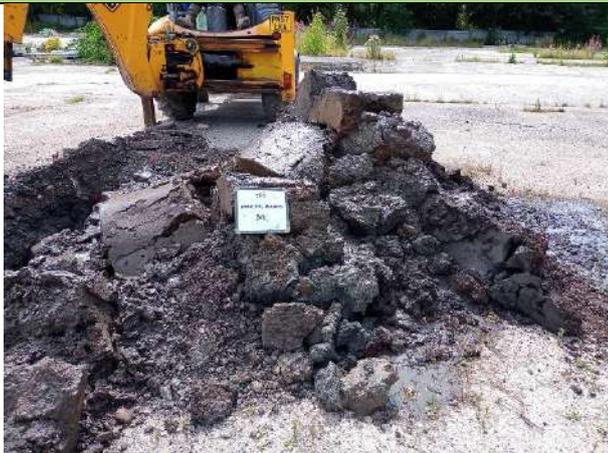
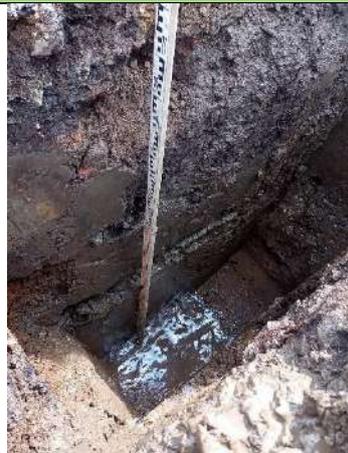
3.5.3 Standing groundwater was encountered within Trial Pit No 5 at 1.7 m. A ‘moderate water ingress’ was encountered within Trial Pit No 6 at 0.5 m. A ‘slight water ingress’ was encountered at depth 0.9 m within Trial Pit No 3 which was assigned to the presence of a broken land drain in this location.

**P5: Trial Pit No 3**

**P6: Trial Pit No 3**

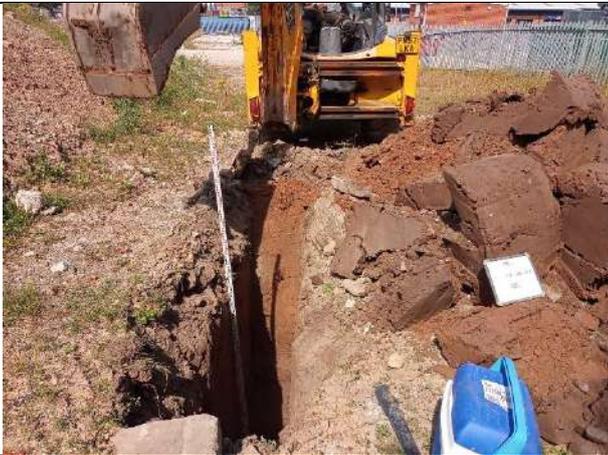
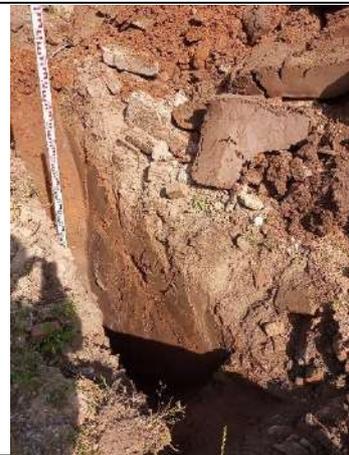
P7: Trial Pit No 4

P8: Trial Pit No 4

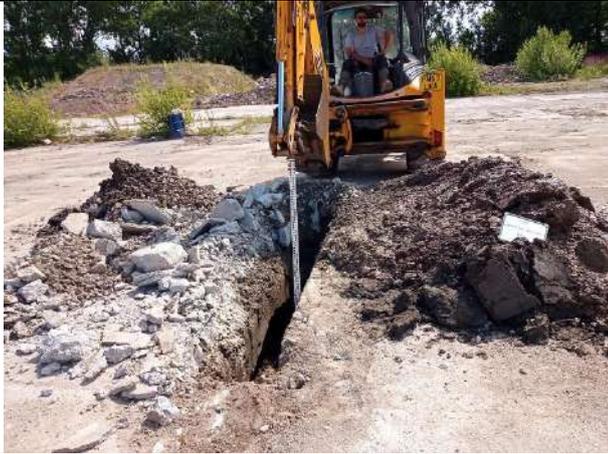
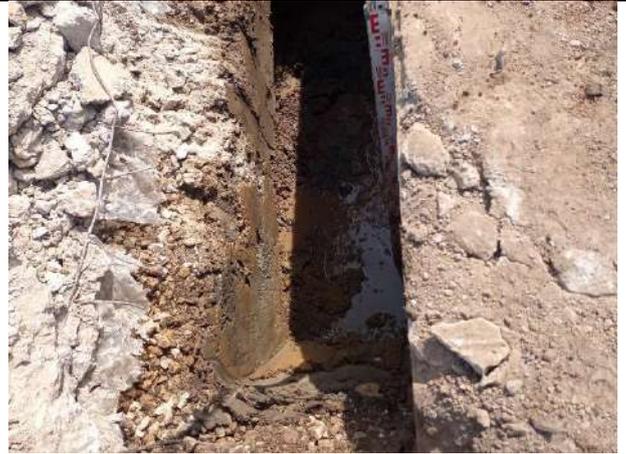
P9: Trial Pit No 5

P10: Trial Pit No 5

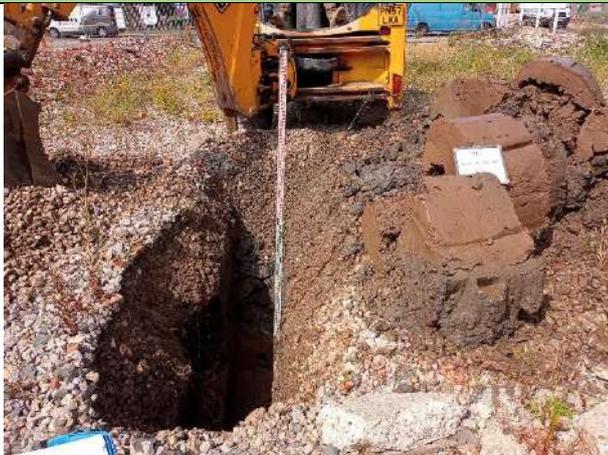
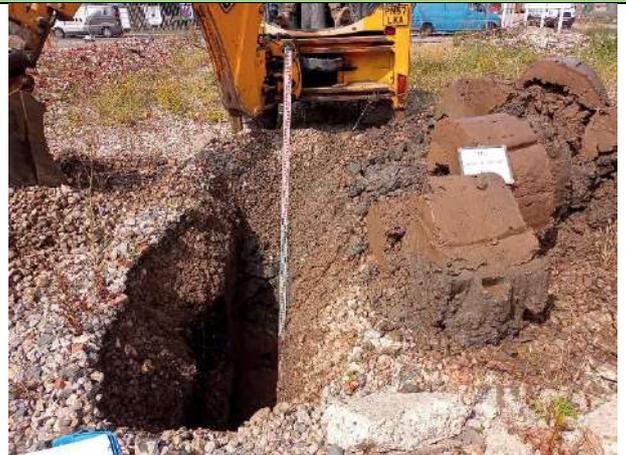
P11: Trial Pit No 6

P12: Trial Pit No 6
