BAT SURVEY REPORT

The Sun Inn
Church Lane
Skirlaugh
East Riding of Yorkshire
HU11 5EU

Date: 26th July 2019

Reference no: CE0635

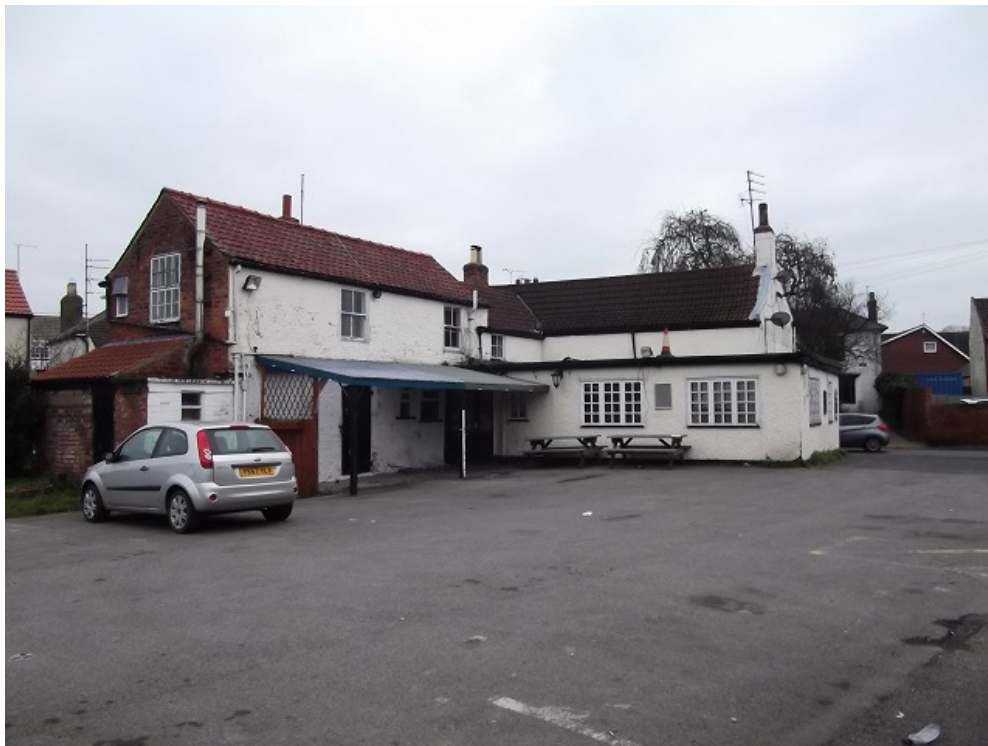
Plate 1. Looking toward the public house from the North West corner of the site.

The external walls of the public house are built from solid brick, with the southern wing, which fronts Church Lane, having an external cement render/pebble dash finish. The single storey flat roofed extension has a cavity brick wall, with the external finish, again in cement render/pebble dash. All the cement rendered walls were generally in reasonable condition, although there were several holes/missing half bricks noted on the south elevation just below the eaves. There was also occasional spoiling of the brickwork on the eastern elevation, along with two holes in the mortar, noted on the eastern gable above the adjoining property. Several holes were also noted in the northern mono pitched outbuilding, along the fascia board.

The glazed windows and timber external doors were in reasonable condition, with the timber frames being a good fit to the surrounding brickwork, apart from the small first floor window in the north gable where there was a gap between the frame and surrounding brick work on the left hand side. The mineralised felt on the flat roof was in good condition and the fascia boards were a good fit to the external wall. The roof of the single storey mono pitched outbuilding attached to the eastern elevation of the public house was covered with concrete roof and ridge tiles which were all a good fit with no obvious lifted tiles noted. The roof structure of the other mono-pitched outbuilding attached to the north gable of the public house had been renewed recently and was constructed from timber rafters, with Breathable Roofing Membrane, roofing lathes all of which was covered in new Marley type pantiles. The roof covering was generally in good condition with no lifted tiles noted, and both the verges were pointed up.

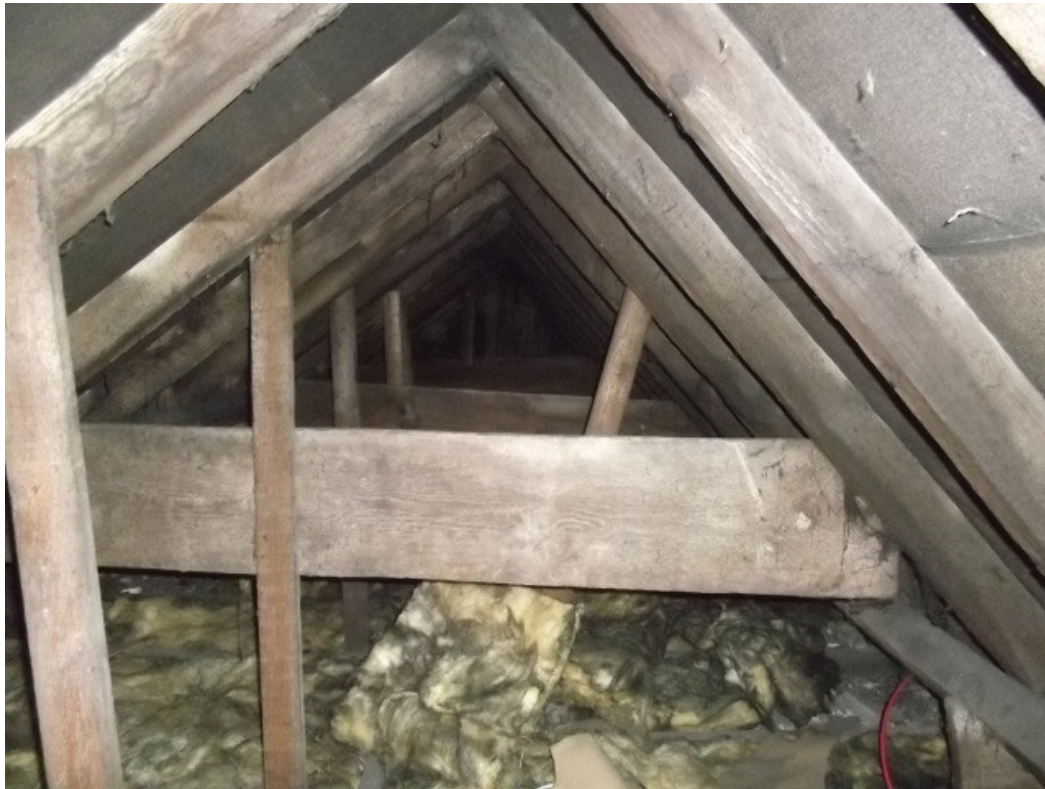
Plate 6. The roof void over the southern part of the public house

The roof structure over the main body of the public house were constructed with a series of A framed trusses with timber purlings and rafters, with no central ridge board visible. All the roofs were under drawn in traditional bitumastic roofing felt which was generally in reasonable condition. However the roof void in the two storey eastern wing could only be assessed from the small pop hole, as it was too small to enable entry into the whole of the void. The roof over the eastern wing was covered externally with Roman tiles some of which were lifted slightly or a poor fit, especially towards the ridge line. The ridge tile along this part of the building had several areas where the bedding mortar was also missing. The double Roman tiles on the southern part of the public house appeared to be well fitted with no obvious gaps noted, however missing bedding mortar was noted along the ridge line in several places. The verge on the northern gable had the occasional gap just below the tile in two locations and the lead flashing at the base of the western chimney stack was lifted on the northern roof aspect, as well as on the right side of the eastern stack. The brick built chimneys stacks themselves were in reasonable condition with no deep holes in the brickwork apparent.

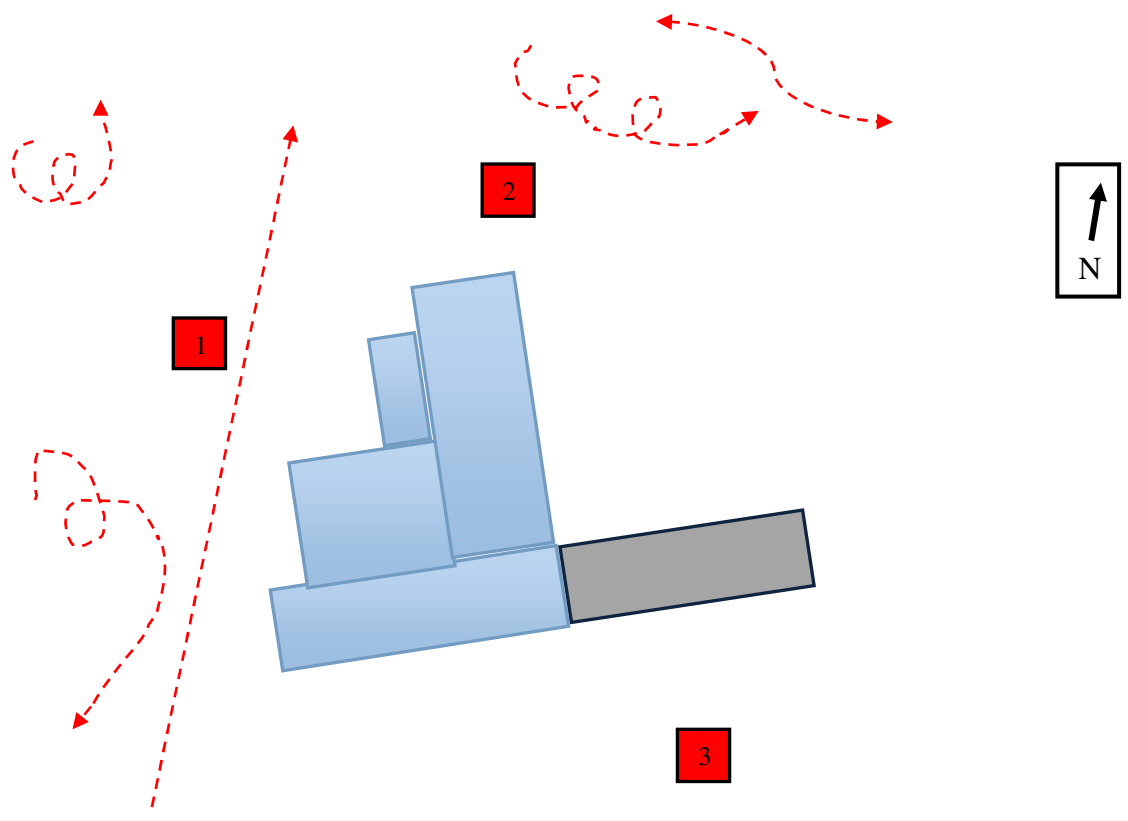
Dusk bat activity plan 26th June 2019

Location	Time	Observations made
	21.15	Survey start
1 & 2	22.22	1 Common pipistrelle foraging to the north of the study site
1 & 2	22.24	1 Common pipistrelle heard briefly, direction not ascertained
1, 2 & 3	22.25	1 Common pipistrelle seen commuting south to north
2	22.29	1 Common pipistrelle foraging around the houses to the north of the study site
1 & 2	22.28 - 22.40	1 - 2 Common pipistrelle heard periodically foraging, to the north
2	22.41 - 23.10	1 - 2 Common pipistrelle heard periodically foraging, to the north
1	22.42	1 Common pipistrelle foraging to the west of study site
1	22.46 - 22.56	1 Common pipistrelle periodically foraging to the west of study site
1	22.57	1 Common pipistrelle foraging in car park to south of study building before flying off south
1	23.00	1 Common pipistrelle heard foraging; direction not ascertained
1	23.03	1 Common pipistrelle heard foraging; direction not ascertained

1	23.04 - 23.09	1 or 2 Common pipistrelle heard periodically foraging, direction not ascertained
3	23.06	1 Common pipistrelle heard foraging; direction not ascertained, unseen

During the dusk survey undertaken on the 26th June 2019, the first recording was at 22:22hrs which was 52 minutes past sunset, for a single Common pipistrelle *Pipistrellus pipistrellus* foraging to the north of the site. At 22:24 hrs a single Common pipistrelle *Pipistrellus pipistrellus* was recorded foraging but the direction could not be ascertained. A single Common pipistrelle *Pipistrellus pipistrellus* commuted over the site at 22:25 and a single bat of the same species was foraging over the gardens to the north at 22:29 hrs. Between 22:28 and 23:10 hrs, one and occasionally two Common pipistrelle *Pipistrellus pipistrellus* were recorded foraging, periodically around the gardens to the north of the study site. For the remainder of the survey period single Common pipistrelle *Pipistrellus pipistrellus* were recorded periodically foraging or commuting either around or over the study site.

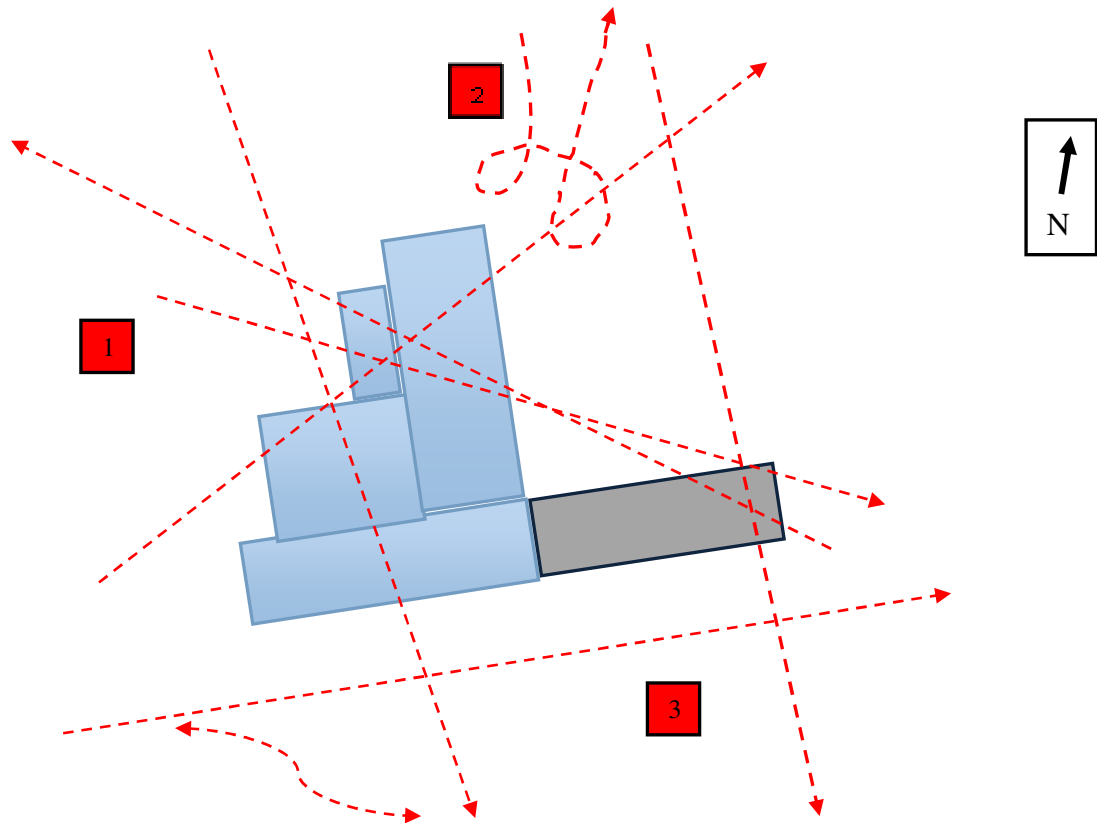
Dawn bat activity plan 12th July 2019

Location	Time	Observations made
	02.50	Survey start
3	02.56	1 Common pipistrelle foraging in garden to the south west
1 & 2	02.58	1 Common pipistrelle heard foraging briefly; faint echolocation direction not ascertained bat unseen
1, 2 & 3	02.59	1 Common pipistrelle commuting east to west over study building
1 & 2	03.01	1 Common pipistrelle heard foraging briefly; direction not ascertained
2 & 3	03.07	1 Common pipistrelle heard commuting quickly, north to south
1, 2 & 3	03.28	1 Common pipistrelle heard faintly; direction not ascertained
1 & 3	03.41	1 Common pipistrelle commuting east to west
1 & 3	03.43	1 Common pipistrelle heard foraging briefly; direction not ascertained
2 & 3	03.49	1 Common pipistrelle commuting from the north
2	03.53	1 Common pipistrelle can from north brief foraging in pub garden then went north again
1, 2 & 3	03.57	1 Common pipistrelle commuting towards the north east
3	03.59	1 Common pipistrelle commuting west to east

1, 2 & 3	04.14	1 Common pipistrelle commuting north to south; over the study building.
	05.00	Survey End

During the dawn survey undertaken on the 12th July 2019 a single Common pipistrelle *Pipistrellus pipistrellus* was foraging in the gardens to the south west at 02:56 hrs. At 02:58 hrs a single Common pipistrelle *Pipistrellus pipistrellus* was briefly foraging with a faint echolocation which resulted in the direction not been ascertained. A Common pipistrelle *Pipistrellus pipistrellus* commuted east to west over the site at 03:01 hrs and a second bat of the same species commuted north to south over the site at 03:07 hrs. For the remainder of the survey period single Common pipistrelle *Pipistrellus pipistrellus* were recorded periodically foraging or commuting either around or over the study site.
