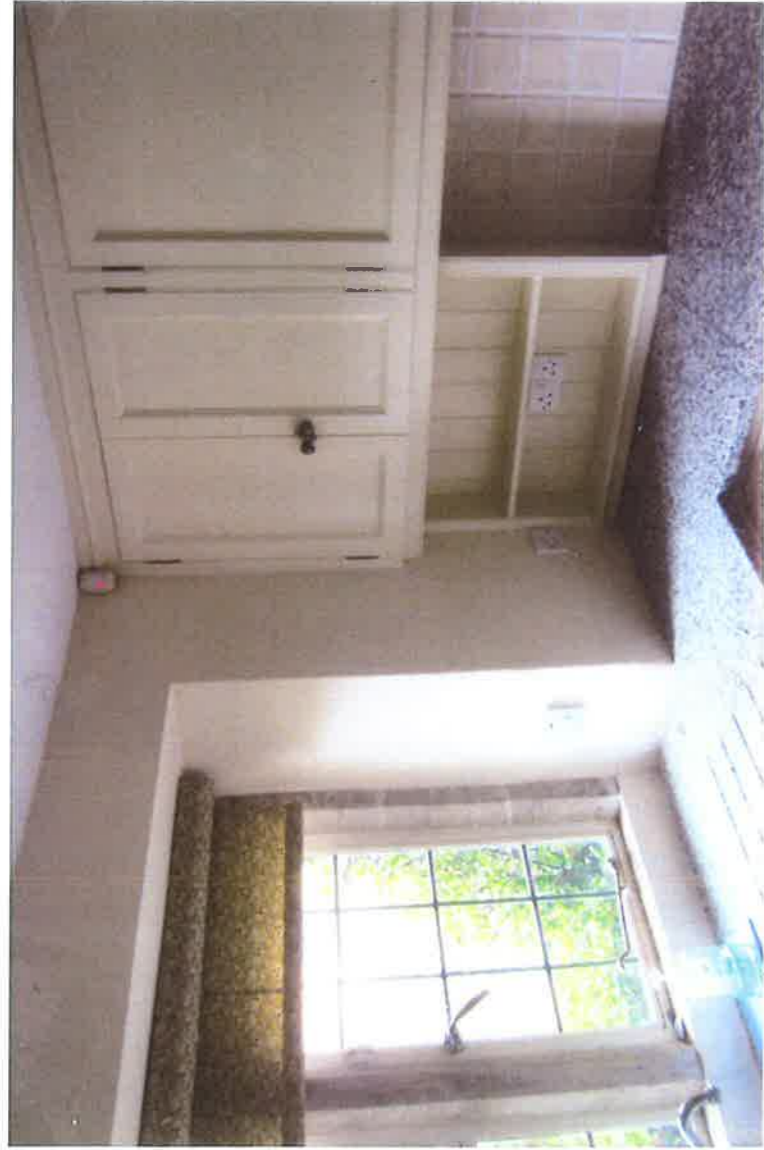
Photograph 9

**Location** - Ground floor kitchen intersection of north and east external walls.

**Detail** - Existing cupboard fittings, plastered wall, window as previously detailed with plastered ceiling.

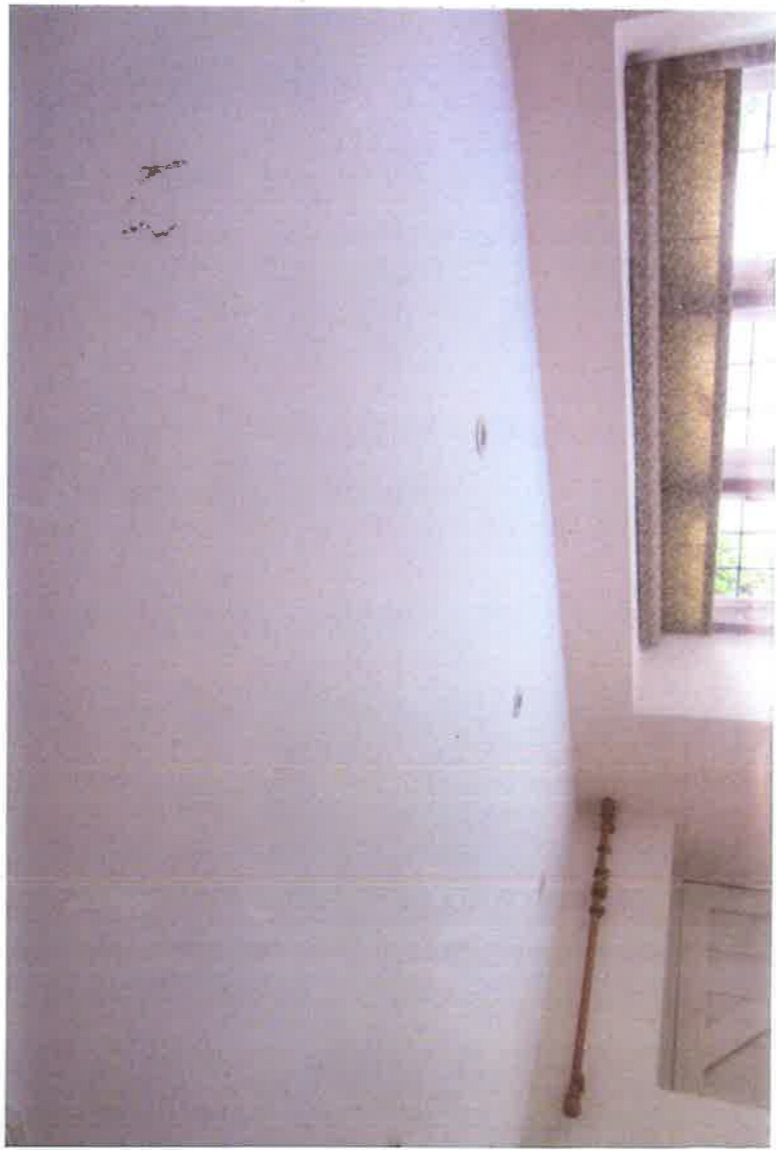
Photograph 10

**Location** - Existing kitchen.

**Detail** - Plastered ceiling with recessed low energy downlighting.

**Proposal** - Whilst forming the small extension to the kitchen and forming a roof lantern in the position shown and described we will take the opportunity to slightly raise the ceiling which will be finished with plaster to plaster lath to match the existing with similar downlighting and the inclusion of a low profile roof lantern.

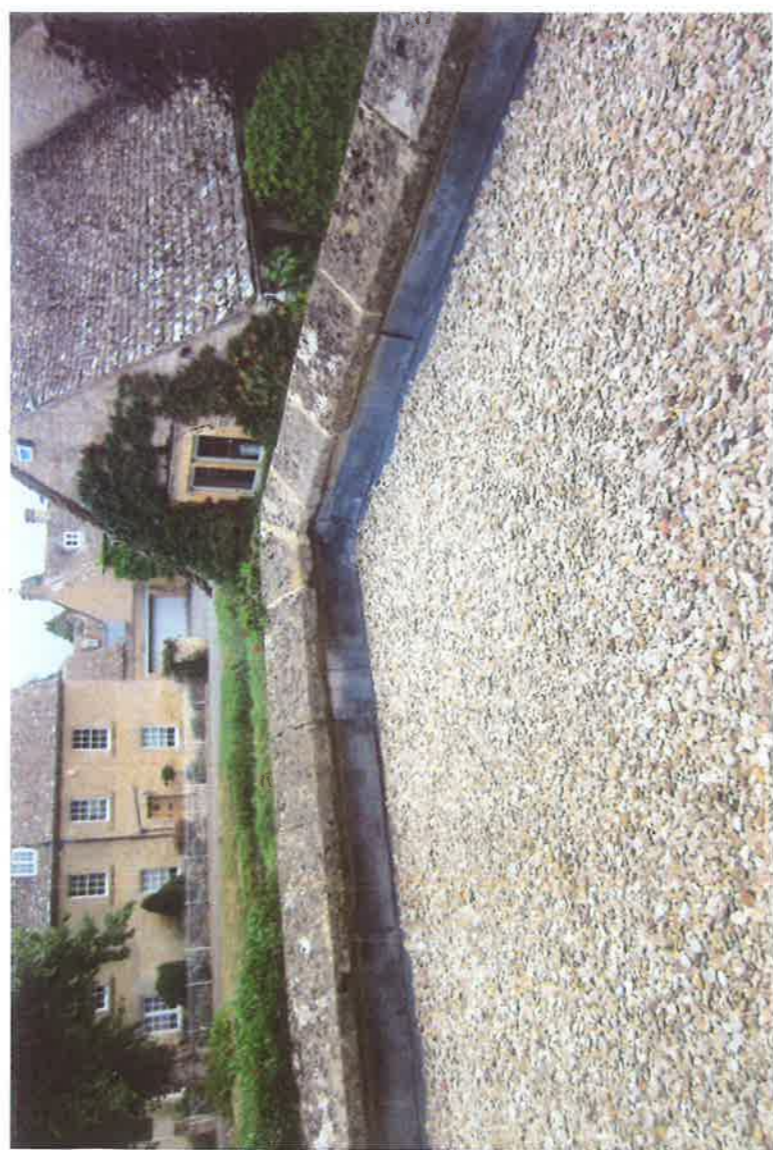
Photograph 11

**Location** - Existing flat roof with low parapet wall to rear existing kitchen facing north east

**Detail** - Flat roof with plastic resin waterproofing finish with lead flashings under stone copings and limestone spar chippings cover for solar protection.

**Proposal** - We will extend the roof in like fashion maintaining the profile of the coping stones introducing a low profile roof lantern and raising the roof height 150mm.

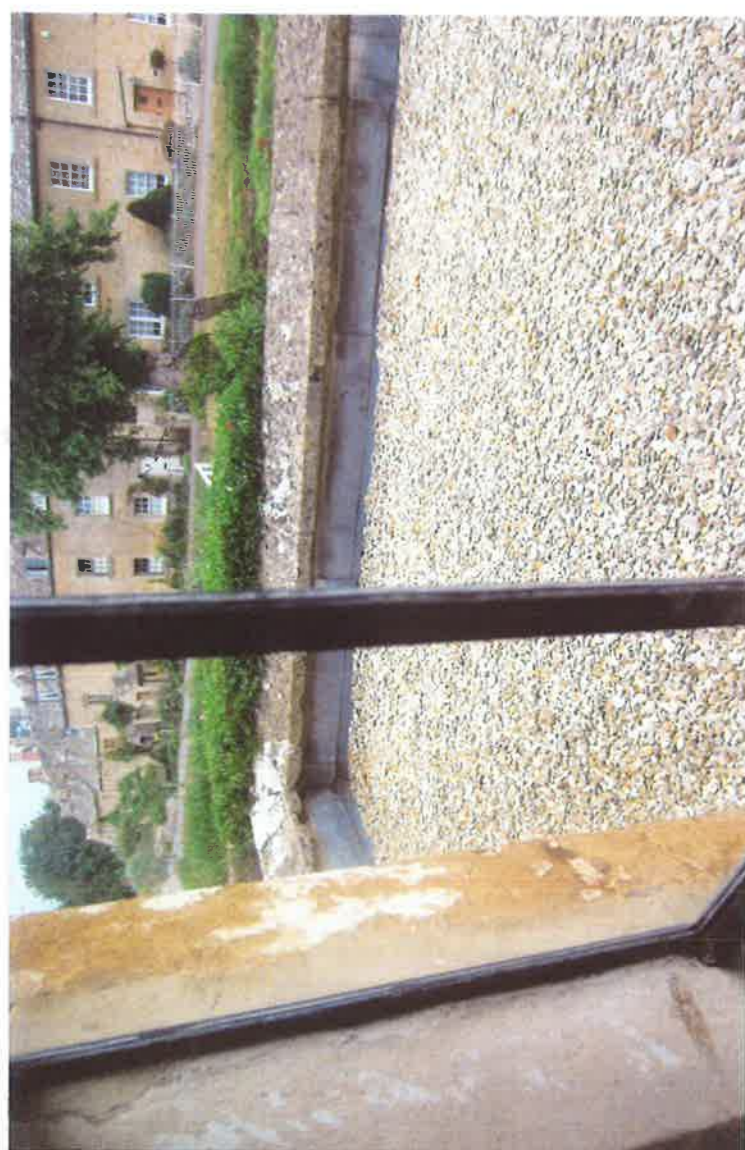
Photograph 12

**Location** - View from bedroom 2 northward over flat roof to kitchen
