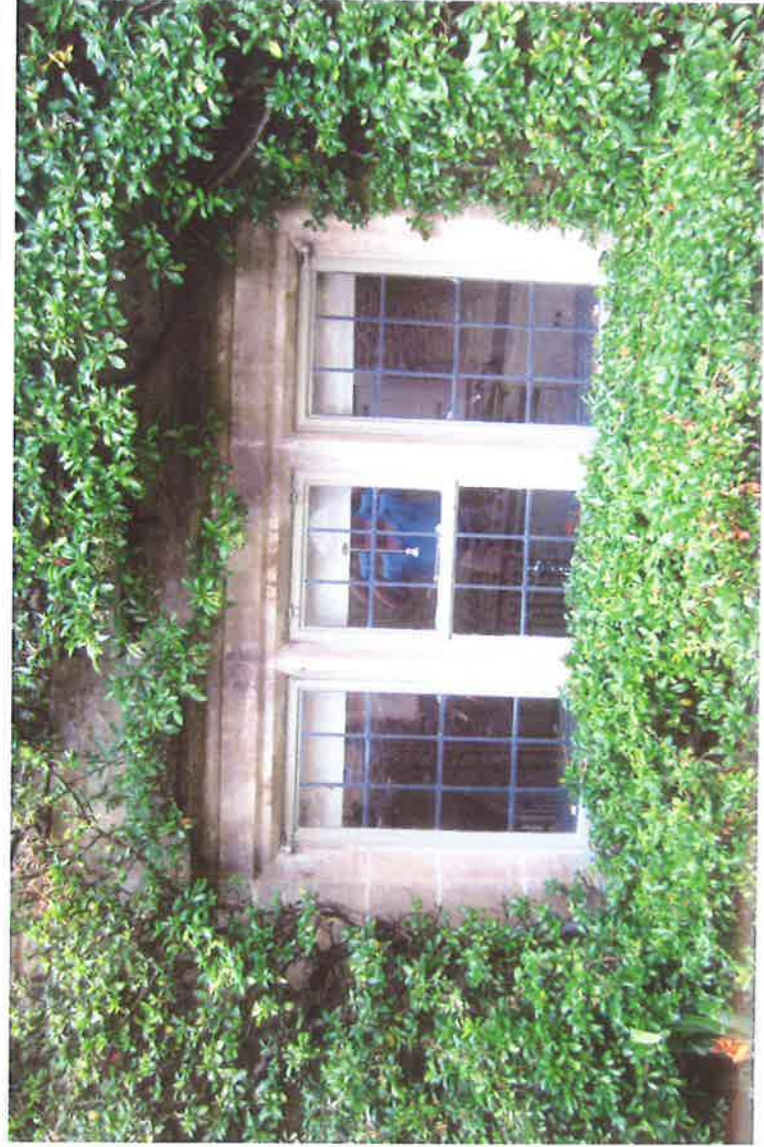
Photograph 1

Location - North external wall to ground floor kitchen.

Detail - Divided metal frame windows set to natural stone mullions and surround sets with projecting label mould cornice over set in natural limestone random rubble wall with sawn stone quoins to opening surrounds and at corner reveals with sawn stone copings at parapet level with a flat roof to the single storey finished in spar chippings.

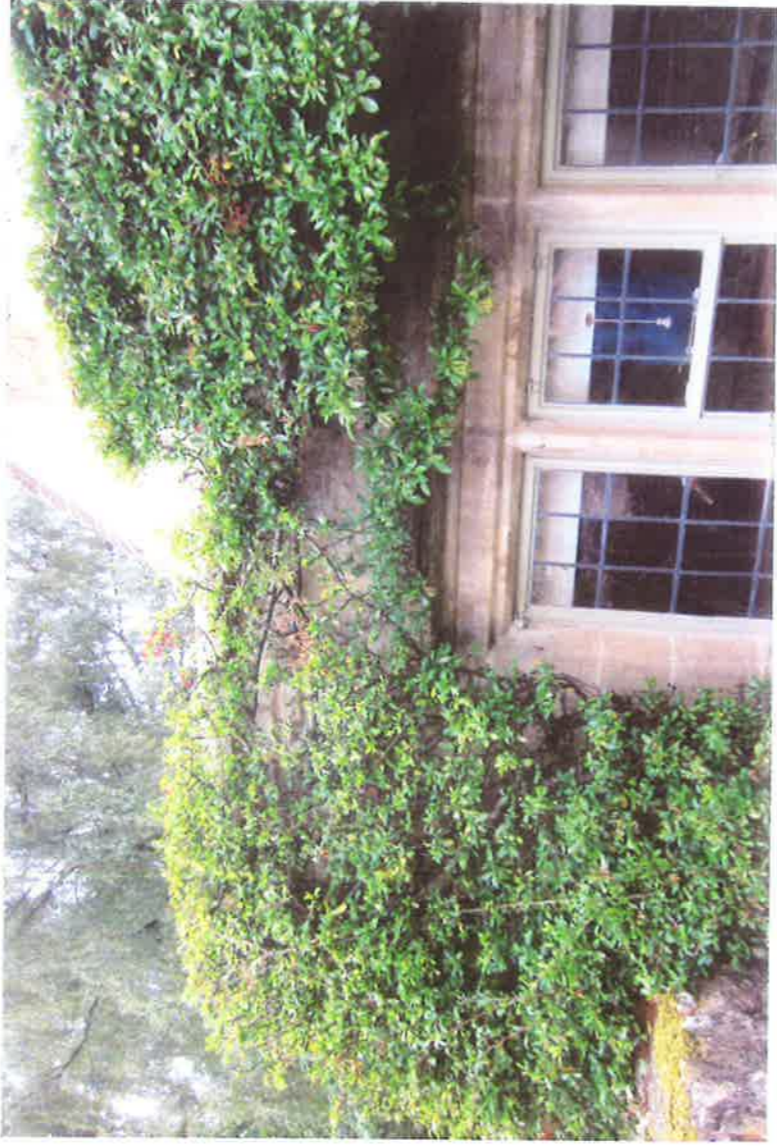
Photograph 2

As above.

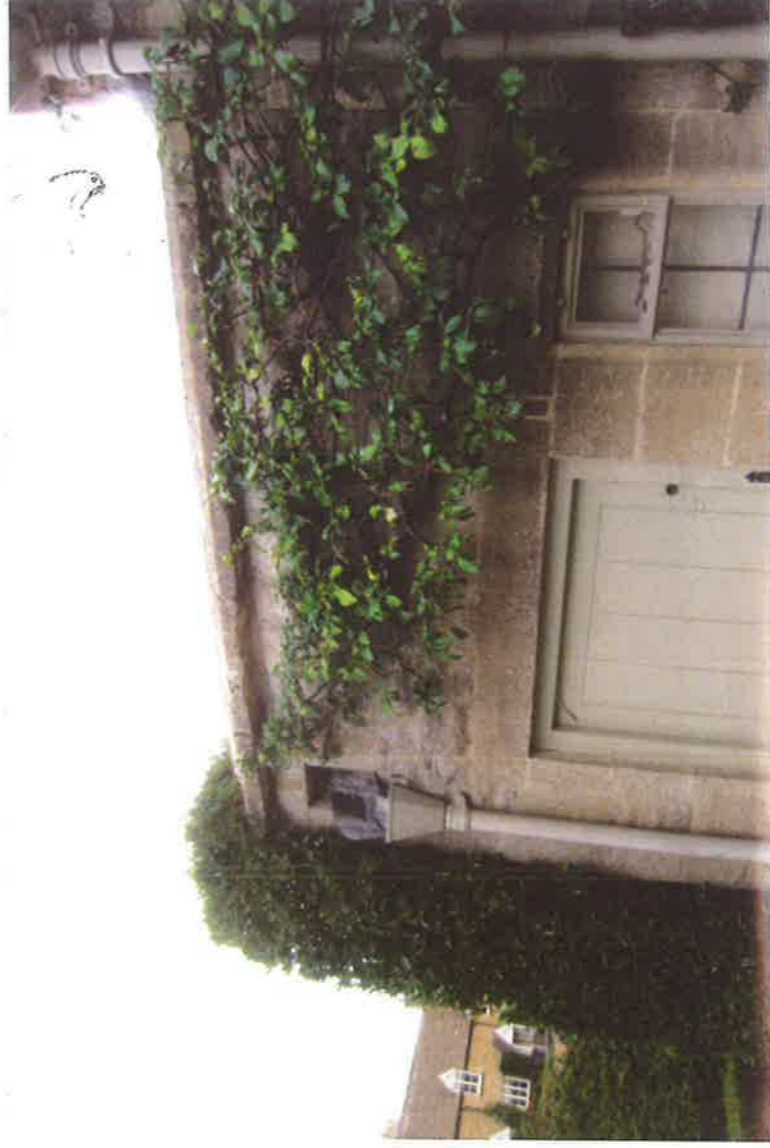
Photograph 3

Location - External west wall to the kitchen

Detail - Showing the natural limestone wall random rubble brought to course with sawn stone window heads and quoins reveals and demonstrating the flat roof to the single storey structure with natural stone projecting copings.

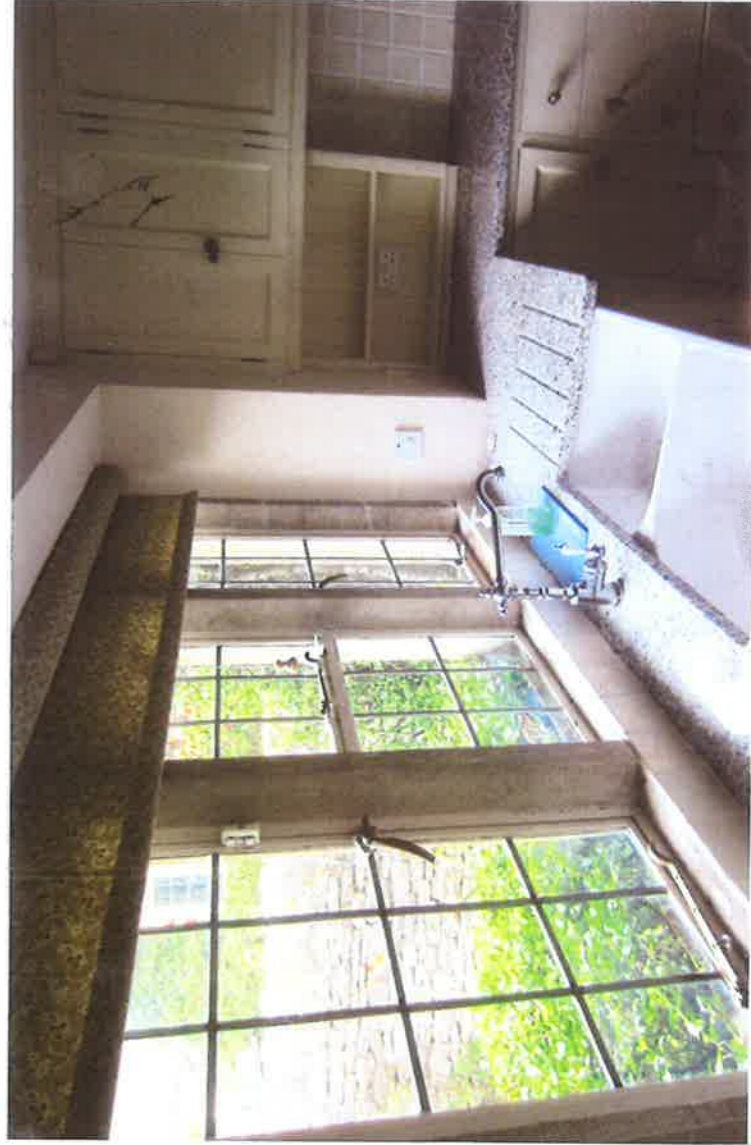
Photograph 4

Location - Ground floor to kitchen showing north external wall

Detail - as described above with plastered internal walls, flagstone floor and plastered ceilings.
