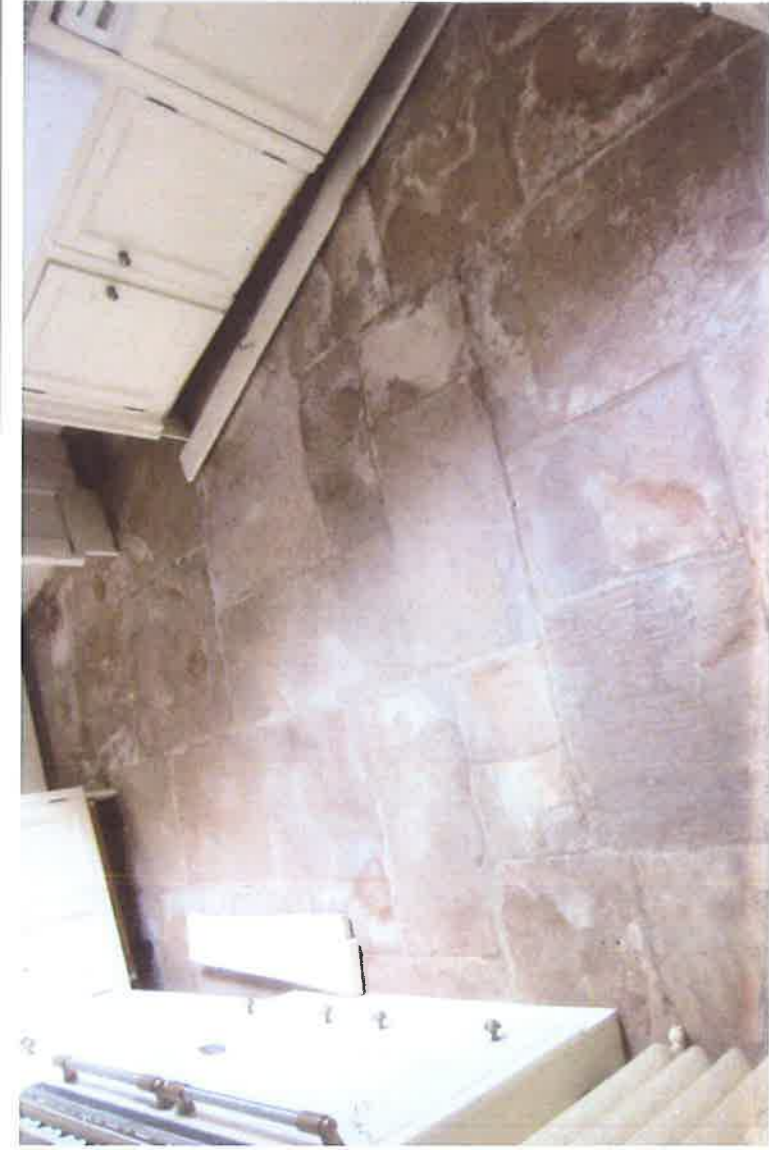
Photograph 13

**Location** - Existing kitchen ground floor.

**Detail** - Existing flagstone floor.

**Proposal** - To extend matching flagstone finish into the extended area.

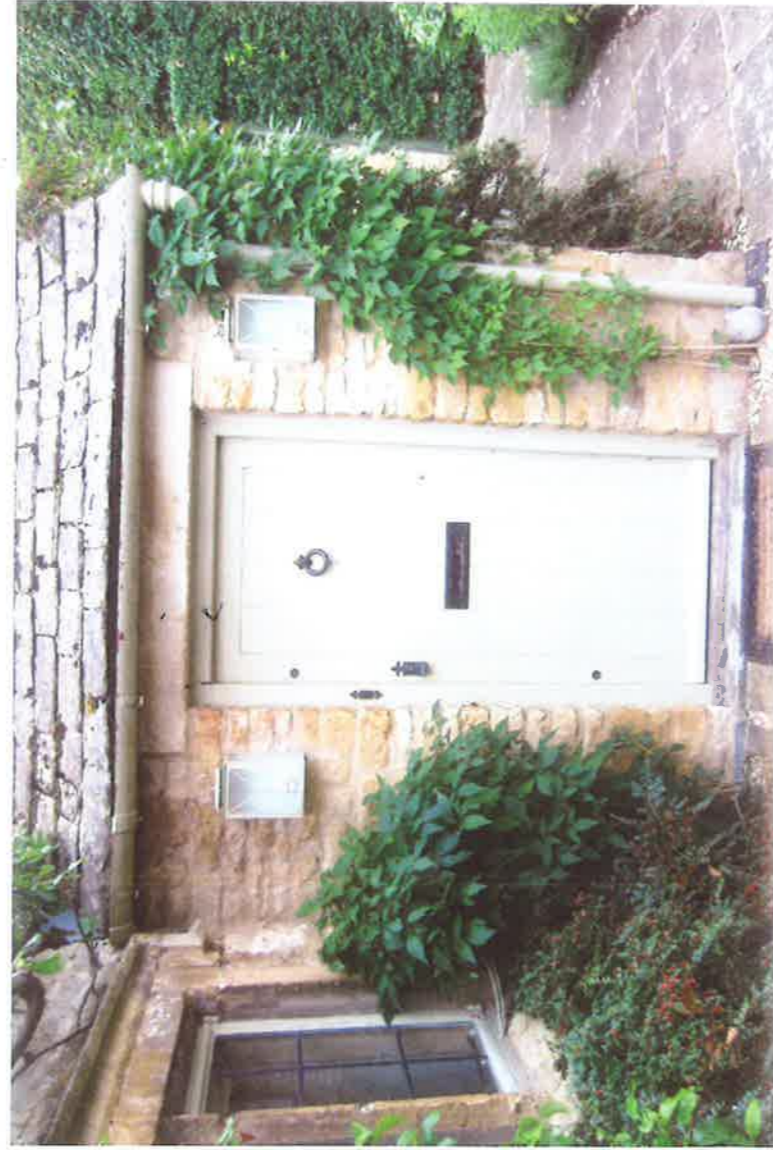
Photograph 14

**Detail** - North wall to existing front entrance porch.

**Proposal** - The existing front entrance door and frame will be replaced with a fully divided glazed window comprising a metal frame unit set in an oak natural finish sub-frame to match the glazing to the link structure.

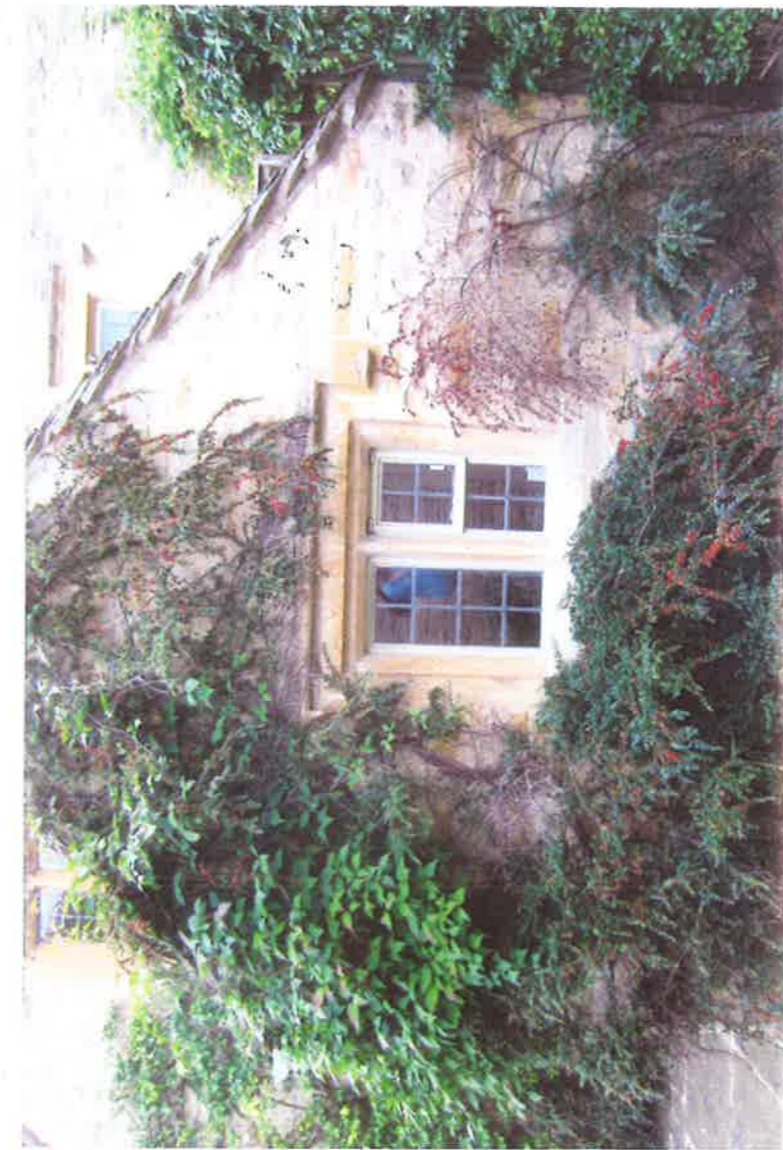
Photograph 15

**Location** - West external wall to front entrance lobby and cloakroom

**Detail** - The window comprises metal frame divided units set in natural stone mullion and stone set surround with projecting label mould cornice over. The external wall comprising natural limestone random rubble brought to course with stone quoins at opening reveals.

**Proposal** - This wall will become the internal wall between garden room and cloakroom/lobby with new door opening formed thereto. The stonework will be retained in its current form with the current windows infilled all modified as shown on the drawings. A window will be formed to the stone wall forming the south cloakroom flank wall with divided metal window set to stone set surround to match existing.

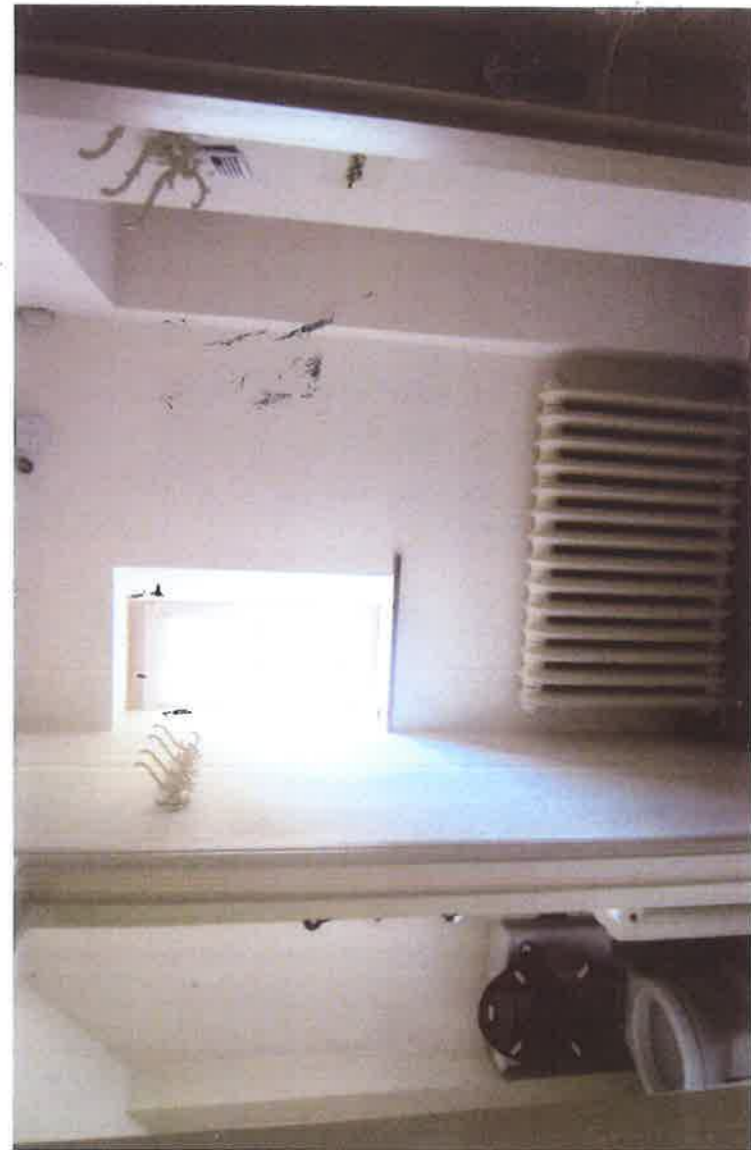
Photograph 16

**Detail** - Ground floor entrance, the door lobby and cloakroom with external west wall and existing window shown.

The photo shows a studwork plastered separation wall to the cloakroom with the west wall formed in natural stone with plaster finish to the inside.

**Proposal** - The wall shown inclusive of a radiator will be modified to form an opening through into the garden room with natural stone quoins forming the reveal to the opening with the plaster finish being retained into the original lobby area.
