Purpose of issue	
Project : Church House, Wood Street ENS	
Drawing Title: Photographic Survey	
Drawing No: 2964/ H /P2	
Revision:	
Scale:	Date: June 2021
UPCHURCH ASSOCIATES	C/O 58 The Drive, High Barnet, Herts EN5 4JQ
www.upchurch-architects.com

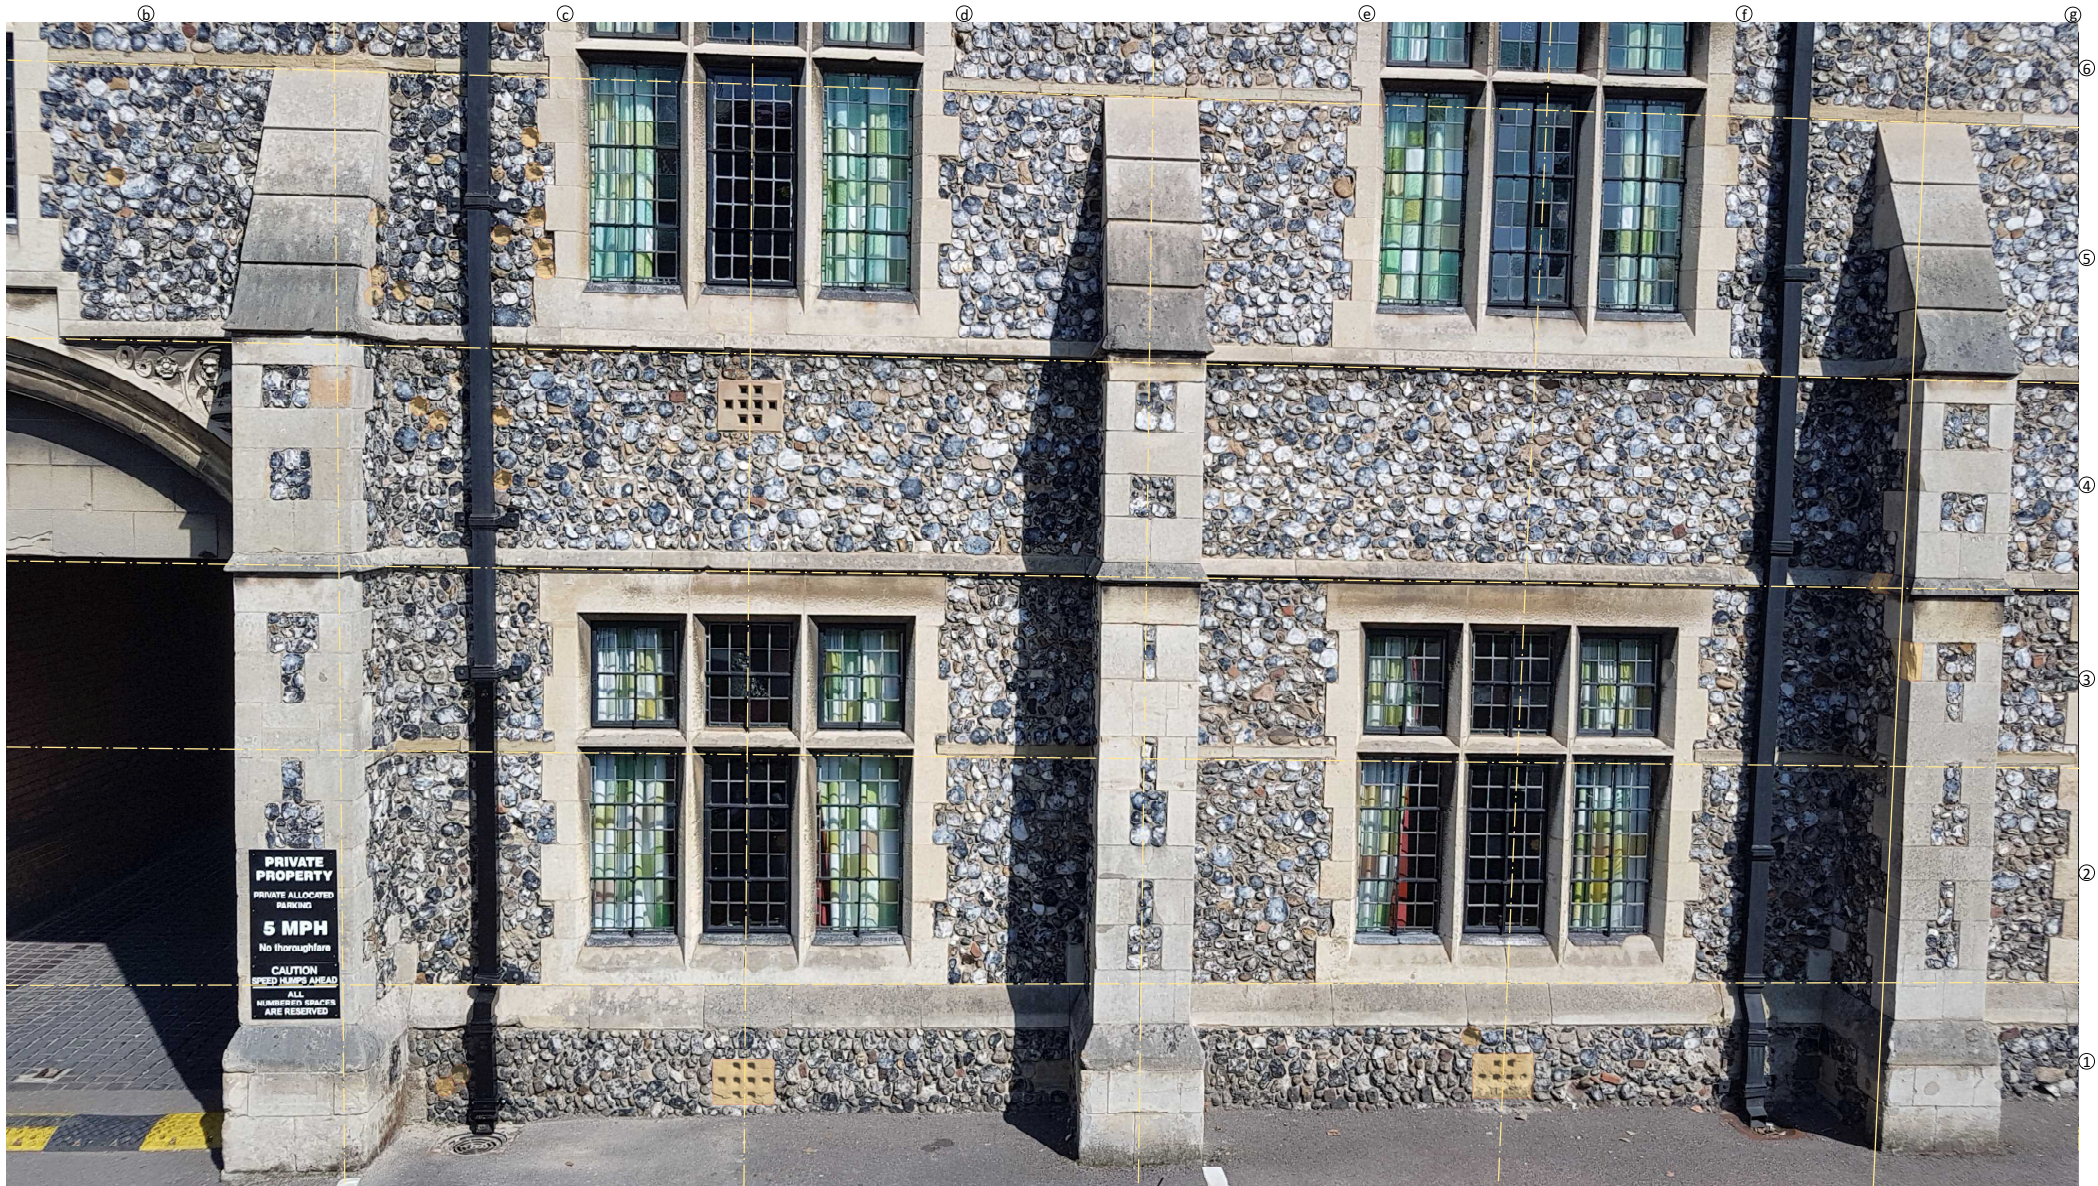
One missing stone noted 5b

All Sectors: Investigate for loose sections of face-work

Cavities high-lighted. Note that surrounding stones are likely to be loosened and that gaps opening up behind stones will need filling

worn surface to stone vent

Sector e3 new bath-stone indent to quoin block full height of block on side face proposed with new section of stringcourse above
