Bat Survey Report

Monks Hall, Syleham

March 2022

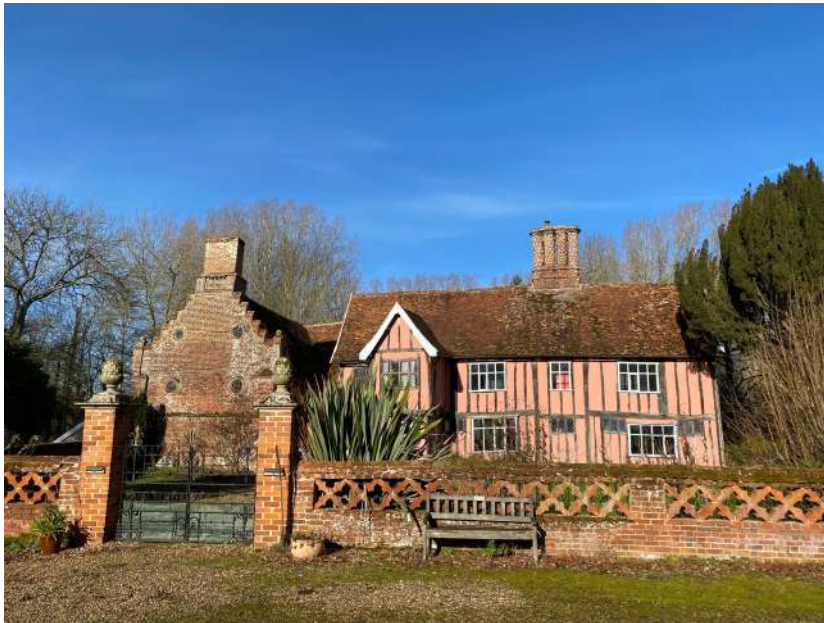
Photo 1 – Southern elevation of Monks Hall

3.1.8 Monks Hall is a 15th Century Grade II Listed Manor House with adjacent outbuildings (see Photo 1). The two-storey L-shaped building is timber-framed with plaster and lathe with exposed studding at the front (south side). The two-storey porch on the south side of the building has bargeboards at gable, with exposed timbers behind creating an internal soffit. The pitched roof is mainly plain tiled with ornate brick chimneys and overhanging eaves, there are gables at the east, west and north sides, and dormer windows on the north side of the building. There were gaps in roof tiles and at the base of the chimney, under the eaves and where exposed timbers had shrunk or been damaged in the past. Pipistrelle bat droppings were present on the first storey porch window and the wall next to the most easterly window on the southern elevation of the building. This indicated that bats had been roosting above or around these locations where there were gaps between timbers and under felt at the eaves. Internally, there was a loft running east to west that was approximately 3metres high to the

ridge, which was boarded, although there were gaps in the boarding where exposed insulation was visible. Inside the loft were less than ten pipistrelle droppings on the insulation and boarding. The 2022 hibernation visit did not find any pipistrelles roosting in gaps between timbers or under the eaves. This building was considered to be of high suitability for roosting bats as well as a confirmed bat roost.

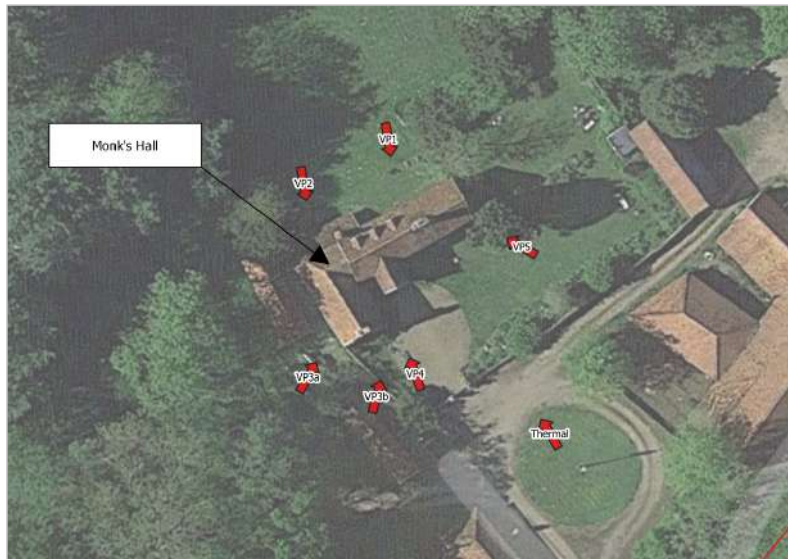
Figure 5 Surveyor and camera locations around Monks Hall

3.2.2 Observations were made from outside, from positions to the north, east, south, and west of the house providing vantage points of the building elevations considered to support bat roosts or where bats may access the buildings, are shown in Figure 5.

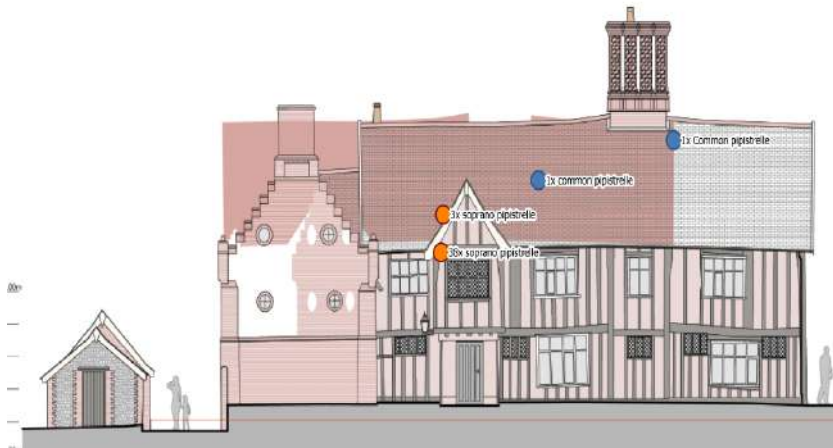
Figure 5 South Elevation - Roost locations identified on Survey 1 - 12.05.2021

- 3.4.4 In summary, two soprano and one common pipistrelle bats were recorded emerging from the north side of the building. One bat emerged from the upper area of the roof near the eastern gable, and two bats from the area of tiles to the west of the dormer windows near the western gable (Figure 6).
- 3.4.5 From the south side of the building, 38 soprano pipistrelle bats were recorded emerging from a horizontal cavity or slot in the front porch adjacent to the gable fascia board and three from the western horizontal bar of the porch gable. Two common pipistrelle bats were recorded emerging from the south side of the building, one from a roof tile near the chimney stack, and the second one from a roof tile between the chimney stack and porch (Figure 5).

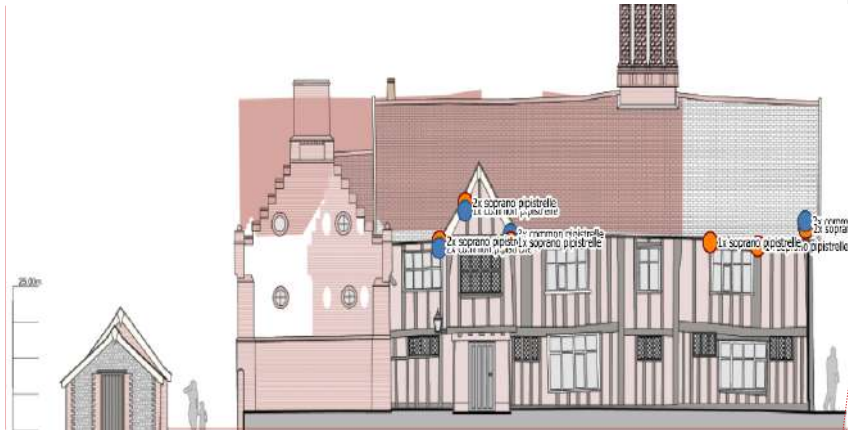
Figure 7 South Elevation - Roost locations identified on Survey 2 09.06.2021

3.4.12 On the south elevation of the house, 12 pipistrelle bats were observed emerging from roosts associated with the front porch, recorded emerging from different locations to those emerging on the May survey. A further six pipistrelle bats were observed emerging from roosting areas around the roof and eaves near the eastern gable (Figure 7).

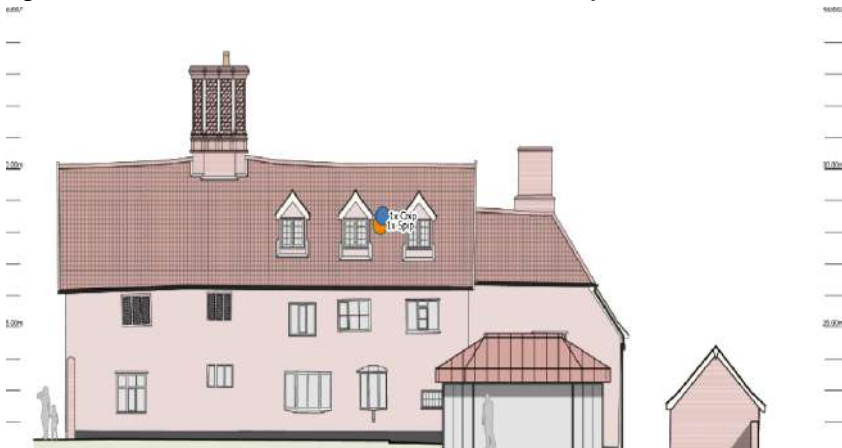
Figure 8 North Elevation - Roost locations identified on Survey 2 - 09.06.2021

3.4.11 In summary, on the north side of the house, two bats were observed emerging from roosts associated with roof tiles to the west of the central dormer window (Figure 8 and Photo 2)).

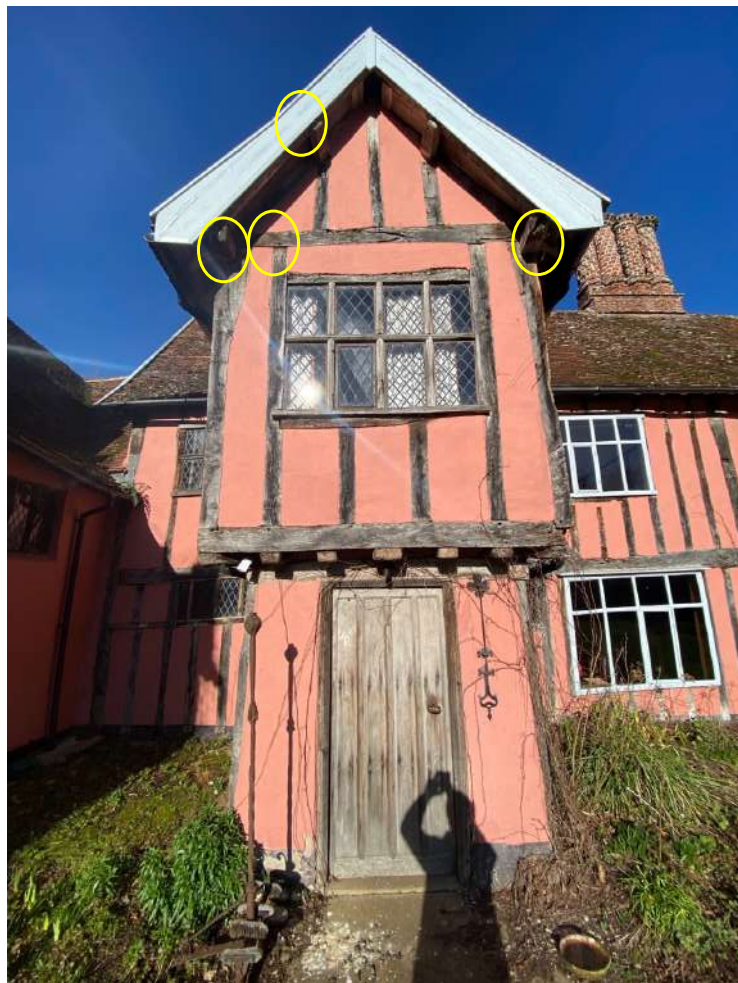
3.4.20 On the south elevation of the house, 16 pipistrelle bats including a single nathusius pipistrelle (Figure 11) were observed emerging from roosts associated with the front porch (see Photos 3 and 4) and recorded emerging from the same and different locations to those emerging on the June survey. One pipistrelle bat was observed emerging from a roost around the apex of

Photo 3 – Features above the porch where bats were observed emerging from.

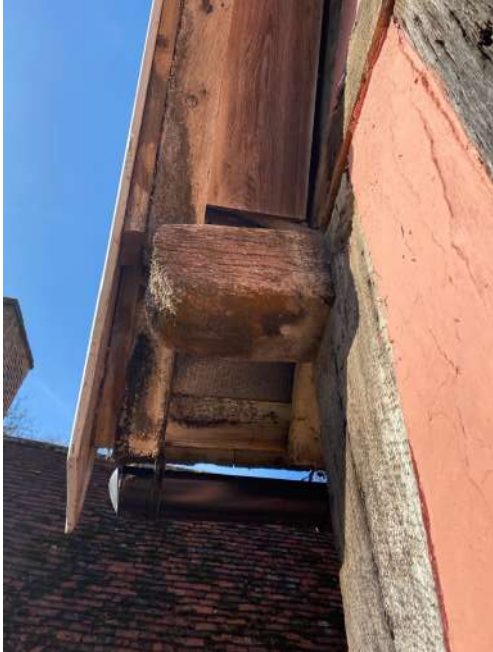
Photo 4 – Gap between timbers in the porch with bat droppings on the plaster.

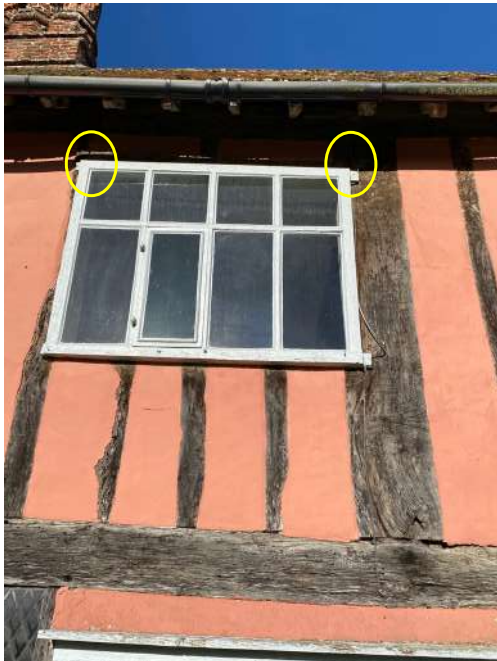
3.4.21 The soprano pipistrelles that had previously roosted above the porch in May 2021 moved to underneath the eaves at the top easternmost window (Figure 9, Photos 5 & 6), with approximately double the numbers from May meaning it is highly likely that the bats moved to this location either to give birth or to wean their pups. Smaller numbers of common pipistrelles were present in the building, with 8 emerging at the western gable, which may indicate a small maternity roost at this location. Individual pipistrelles were also present throughout this side of the building due to the number of available roosting locations. A single nathusius pipistrelle was recorded roosting in the western roof area. In total, 84 bats emerged from seven different locations.

Photo 5 – Roosting features above easternmost window of southern elevation

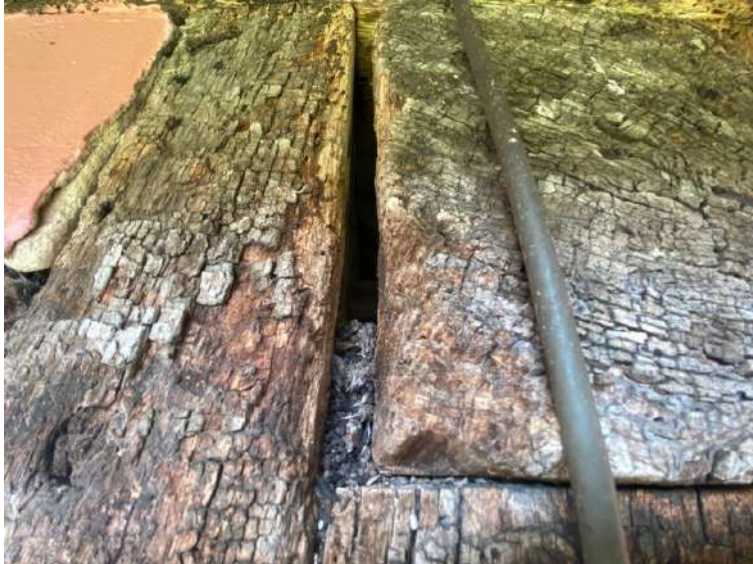
Photo 6 – Gap above easternmost window of southern elevation showing bat droppings

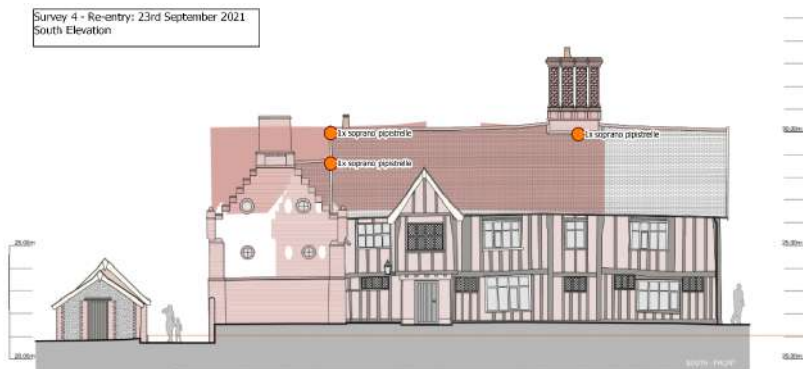
Figure 12 South Elevation - Roost locations identified on Survey 4 23.09.2021

3.4.28 On the south elevation of the house, 3 individual soprano pipistrelle bats returned to 3 separate roosting locations below missing tiles in the roof (Figure 12).

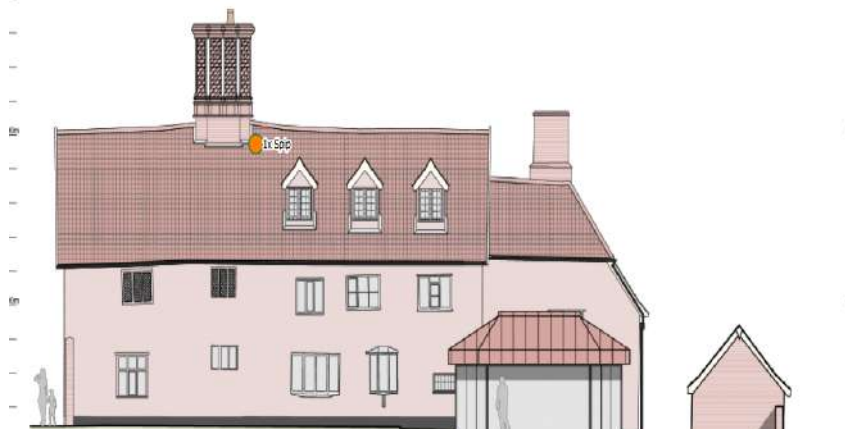
Figure 13 North Elevation - Roost locations identified on Survey 4 23.09.2021

3.4.27 In summary, on the north side of the house a single soprano pipistrelle was observed returning to a roosting location at the base of the chimney stack (Figure 13).

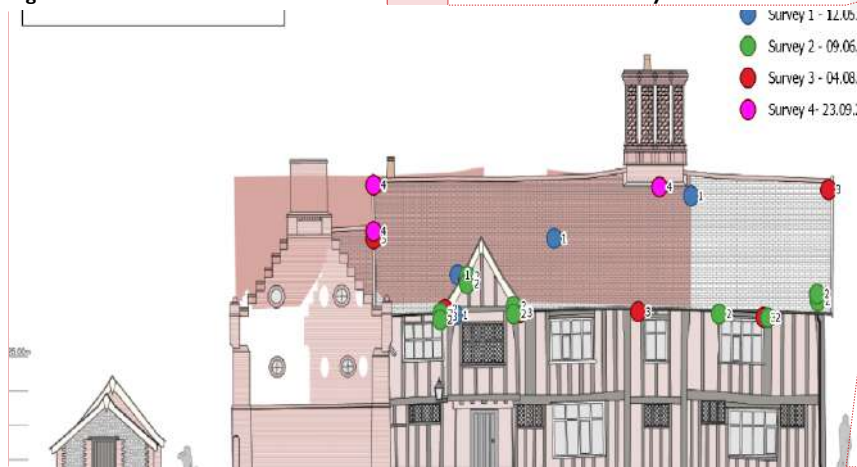
Figure 14 South Elevation – locations of roosts recorded on all surveys

3.5.1 There were eighteen roosting locations for three pipistrelle species at Monks Hall, three on the northern elevation and fifteen on the southern elevation – see paragraph 4.2.1 for the definition of a roost. Bat emergence and pre-dawn return locations are shown in Figures 6 - 12 above, with the combined locations in all four surveys being summarised in Figure 14 and 15 below.

4.3.1 For the Manor House, which has been identified as having roosting bats present, works to undertake disturbance or modification to, or damage or destruction of bat roosts will be carried out under a European Protected Species Licence (EPSL) from Natural England. Before the development commences, a standalone pole mounted bat box (Photo 7) will be erected in the grounds of Monks Hall, plus bat boxes placed on trees. These are designed to mitigate for the damage, modification, or destruction of bat roosts during works.

4.3.2 The disturbance or modification to, or damage or destruction of bat roosts will be supervised by a licensed bat worker. Features that may support bat roosts will be stripped by hand (soft demolition), features will be checked using torches and/or endoscopes, bats will be

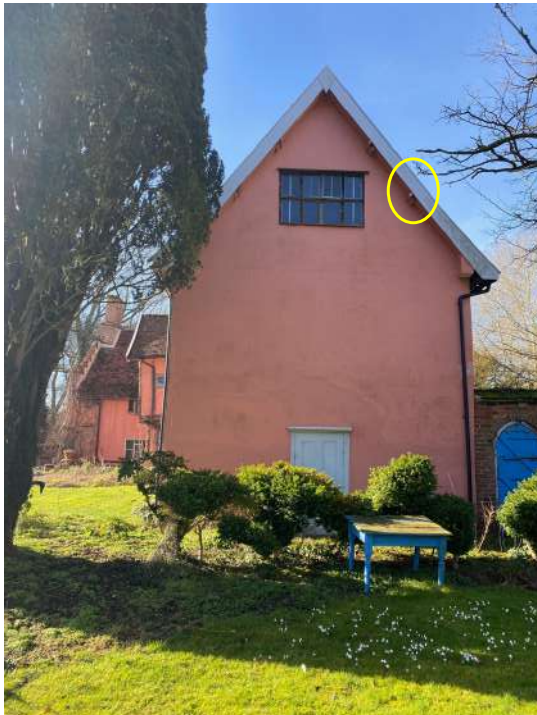
3.4.15 A great tit was observed nesting in a gap at the eastern gable.

Photo 7 – Great tit nesting location at eastern gable on 09.06.2021

A great tit was observed nesting in a gap at the eastern gable during the bat activity surveys. As a precautionary measure, before works begin, a qualified ecologist will check any gaps in the Manor House will be checked for nesting birds.

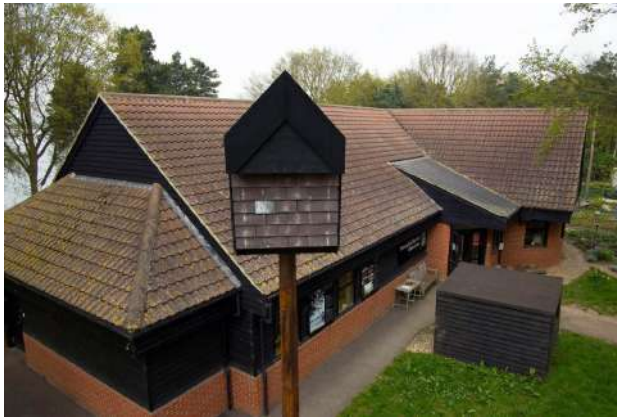
Photo 7 – an example of a pole mounted bat box that is used as a soprano pipistrelle maternity roost

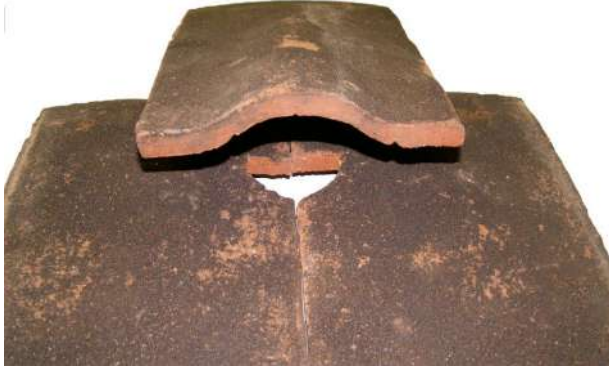
Photo 8 – an example of a bat access roof tile

- 4.3.5 Current proposals are to construct a single storey extension to the rear of the house, restoration and re-roofing of the main roof area, replacing clay pan tile with traditional clay 'flat tiles' and to repair structural timbers as required. Where roof tiles are being replaced bat access tiles can be used to create roosting spaces for one or two bats, these tiles are made to order to match the materials of the new roof tiles (Photo 8) <https://www.nhbs.com/bat-access-tile-set?bkfno=187127> .

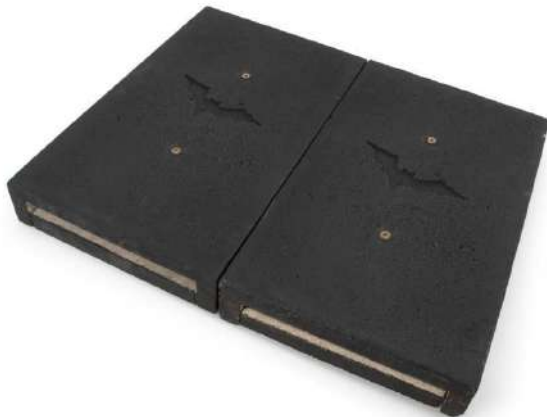
Photo 9 – Woodstone interconnecting bat box

- 4.3.6 Depending on the requirements for repairing the structural timbers, it may be possible to keep or modify the locations of the soprano pipistrelle pre-maternity roost above the porch and maternity roost above the easternmost window on the southern elevation. For the small common pipistrelle maternity at the gable of the western elevation, it is not known if a new or modified roost can be incorporated into the building due to listed building planning considerations. If it is not possible to keep any of the maternity or pre-maternity locations, then woodstone interconnecting bat boxes (Photo 9) <https://www.wildcare.co.uk/10667-interconnecting-bat-box.html> can be put in alternative structures.
