STABLES AT WIELD MANOR

Proposed Alterations

HERITAGE STATEMENT including Design and Access Statement

July 2021

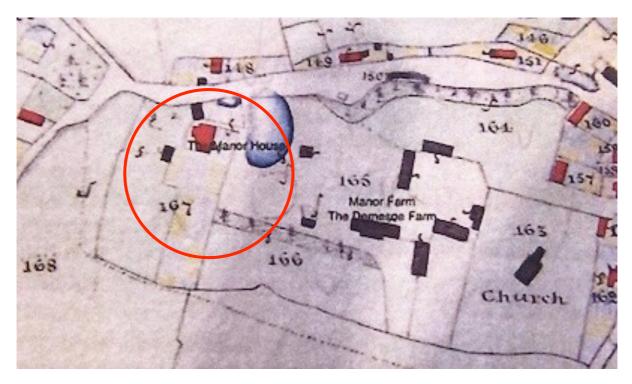
EXTRACT FROM THE TITHE MAP OF 1839

Ownership records show that the Stables Building was constructed between 1839 and 1870. While not shown on the Tithe Map of 1839, it does appear on the first edition of the OS County Series, Sheet 34. In 1839 the property was in the ownership of the Rodney family to whom it had devolved in 1760. By that time they had fallen into financial difficulties, being forced by order of the High Court of Chancery in 1852 to sell it together with many other holdings in the area. It is most likely that the new owner, Thomas Earle, in whose possession it remained until his death in 1889, had the stables constructed.

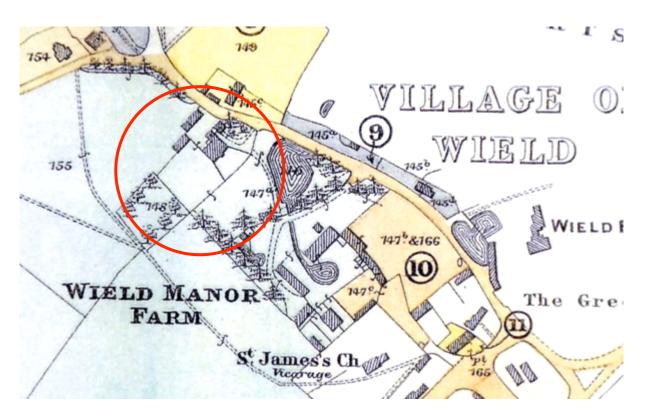
EXTRACT FROM THE ORDNANCE SURVEY COUNTY SERIES, 1ST ED c.1870

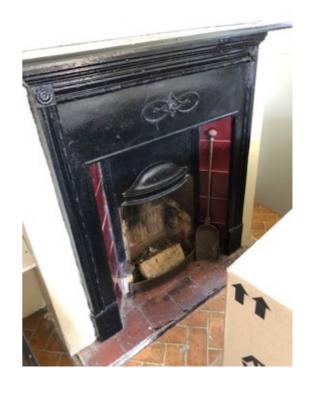
8 Early C20 cast iron fire grate and surround in the former tack room.

The **Fitness Room** would remain substantially as at present, albeit with the floor in the old Tack Room raised to the main level, and the opening between the two spaces enlarged. The fire grate is to be removed and the fire opening modified so as to cater for the raised floor level and to be visible from both sides. The major change would be to form openings in the wall either side of the chimney breast so as to link this area visually to the former stabling, now referred to as the Games Room. There would be sliding-folding doors to the new openings.

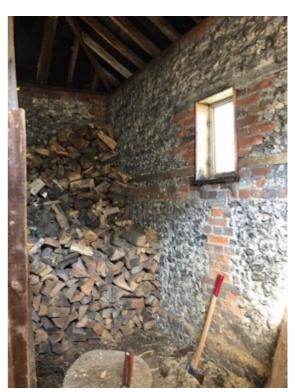
10 Log Store at north end of the building., showing crude nature of wall finish and exposed roof structure.

The old **Log Store** is to provide ancillary facilities, as a utility area. The floor level is to be raised approximately 300mm and a Limecrete slab provided on hardcore, with a limestone tiled finish. The external walls would be provided with a lime plaster finish as the very roughly finished masonry is not suitable for an internal finish. As for the Games Room, skim coated insulation board would be fixed to the underside of the rafters. Space for a WC and shower would be partitioned off.
