Cat and Fiddle, Clyst St Mary Updated Ecological Appraisal (Bats & Birds)

Report No: 17/3247.03
Date: September 2021
Client: St Austell Brewery

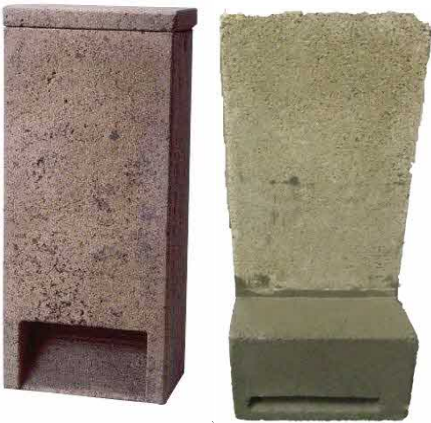
<p>General Purpose Wooden & Woodcrete Bat Boxes e.g. Schwegler Bat Boxes 2F & 2FN for trees</p> <p>Woodcrete boxes e.g. Schwegler are more durable and provide more stable temperatures</p> <p>Position: Upon external walls or mature trees with a southerly aspect, at approximately 3m or higher from ground level.</p> <p>http://www.wildcareshop.com/product/nest-boxes-artificial-habitats/bat-boxes.html</p> <p>http://www.nhbs.com/bat_boxes_eqcat_421.html</p>
 	<p>Bat boxes for external walls</p> <p>e.g. Schwegler 1FQ Bat Box (pictured)</p> <p>Position: On external walls with a southerly aspect, beneath eaves or approximately 3m or higher from ground level. Front panel can be painted to match building.</p>
 	<p>e.g. Beaumaris Woodstone Bat Box (pictured)</p>

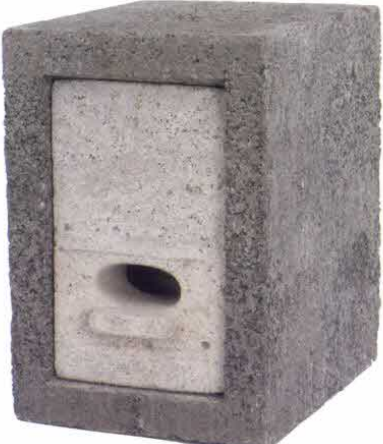
<p>Integrated bat boxes</p> <p>e.g. Schwegler 2FR Bat Tube (pictured left) or Build-in WoodStone Bat Box (pictures right)</p> <p>Position: Within or on external walls with a southerly aspect, beneath eaves or approximately 3m or higher from ground level.</p> <p>Additional information: Can be painted or rendered. No maintenance required. The top can be removed to allow access to cavity walls, or optional holes in the sides mean that several units can be installed together to form a larger roost.</p>

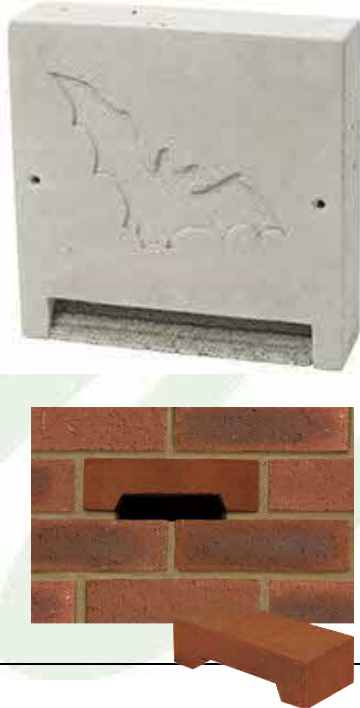
<p>Schwegler N27 Bat Box (pictured)</p> <p>Position: Within external walls with a southerly aspect, beneath eaves or approximately 3m or higher from ground level.</p>

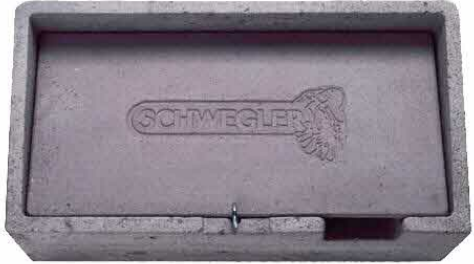
<p>General Purpose Wooden & Woodcrete Bird Boxes e.g. Greenalyte range (pictured), Schwegler Bird Boxes 1B & 2H for trees, and Schwegler 1MR Avianex for buildings.</p> <p>Woodcrete boxes e.g. Schwegler are more durable and provide more stable temperatures</p> <p>A range of entrance hole sizes will cater for different species e.g. 26mm: Blue Tit, Coal Tit, possibly Wren. 32mm: Great Tit, Nuthatch, Pied Flycatcher. 45mm: Starling Open Fronted: Robin, Wren, Pied Wagtail.</p> <p>Position: External walls or mature trees with a northerly aspect, approximately 2m or higher from ground level, with nearby tree or hedge cover.</p> <p>http://www.wildcareshop.com/product/nest-boxes-artificial-habitats/bird-boxes.html</p> <p>http://www.nhbs.com/bird_boxes_eqcat_426.html</p>
 	<p>Sparrows e.g. NHBS FSC sparrow terrace (pictured)</p> <p>Position: At a height of at least 2m upon external wall, facing east. Several boxes can be installed approximately 1.5m apart</p>

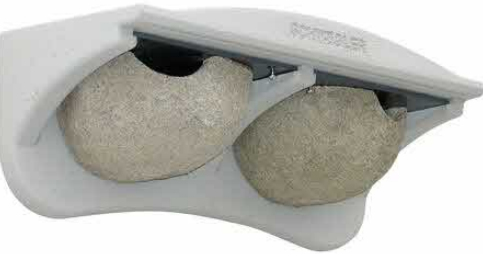
<p>Swifts e.g. Schwegler Swift No. 16 Swift Box (pictured), No. 18 Schwegler Swift Box (for eaves), Ibstock swift bricks, WoodStone Built-in Swift Boxes and Bricks.</p> <p>Position: At a height of 5m or above. Within external walls with a northerly aspect or beneath eaves and out of direct sunlight. Away from windows, obstructions and creepers. Provide several boxes.</p> <p>Note: Swift calls can be played in May to help swifts locate the nest site http://www.swift-conservation.org/Nestboxes&Attraction.htm</p>

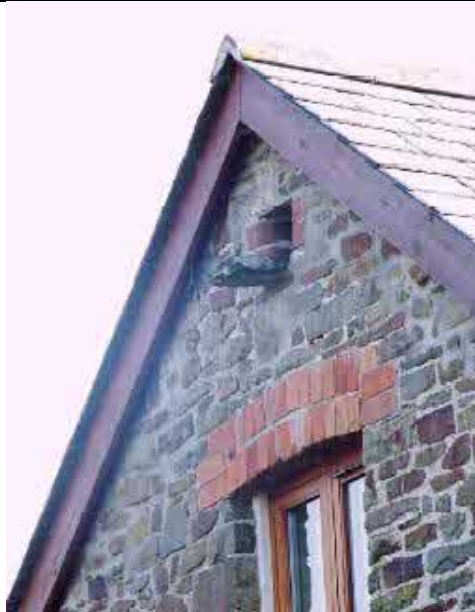
Barn Owl nest boxes

Barn Owl Trust design has been developed to reduce juvenile mortality.

Positioning: Over 3m in height, facing towards open countryside (more than 1km from a motorway or dual carriageway).

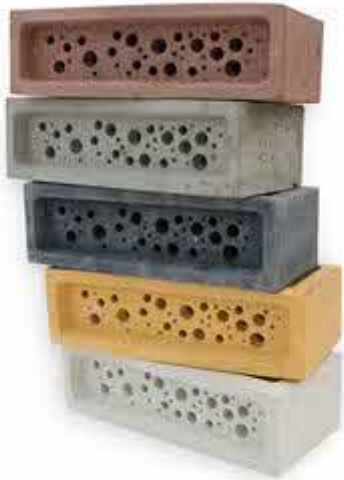
Bee Brick

e.g. Green&BlueBuild range (pictured)

Specification: Each concrete brick is 215mm x 105mm x 65mm.

Position: The bee brick has been created to be used either as an integral part of a building, used within landscaping, or to be positioned as a free standing bee nest in the garden. It offers the dual function of being a construction material that also promotes biodiversity. The bee brick should be positioned in a warm sunny spot, preferably a south facing wall, with no vegetation in front of the holes. They should be positioned at least 1m from the ground with no upward limit.

Function: Each Bee brick contains cavities for solitary bees to lay their eggs. Each cavity is moulded part way into the brick ensuring bees cannot enter the building. Bees lay their eggs inside the holes and seal the entrance with mud or chewed up vegetation. The offspring emerge the following Spring and begin the cycle again.
