THE STABLES, GUNBY HALL.

BAT SURVEY.

Ref No: 190457/Rev 1.

Date: 2nd August 2020.

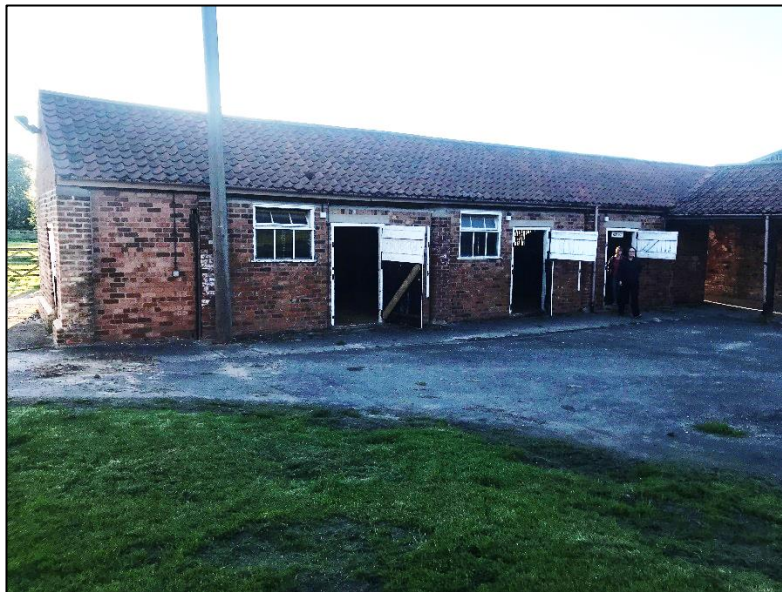
3.3.1. The stables are a single-storey brick building with solid brick walls and a pan tiles roof as shown in the photograph below this view shows the eastern side of the southern leg of the T shape. This arm of the building contains two stables and a corner workshop to the right.

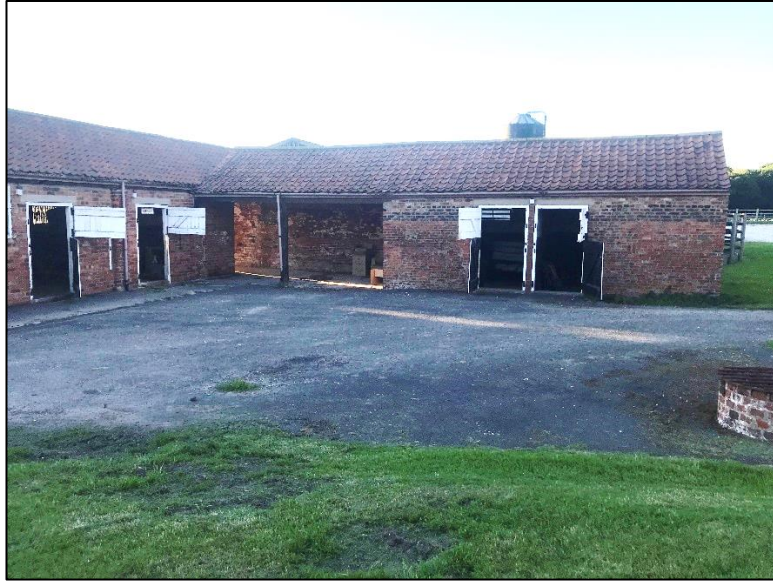
3.3.2. The eastern arm of the building also contains two stables with an open section in the corner that connect to a passageway to the west of the building.

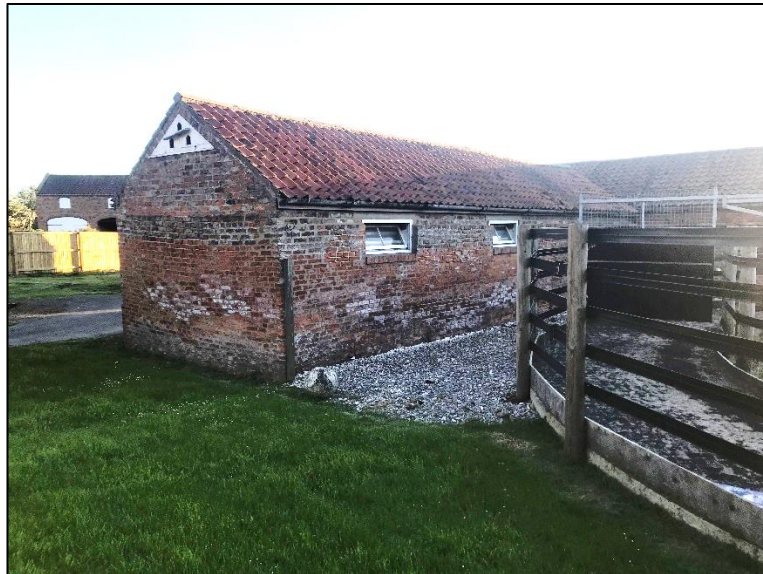
3.3.3. Between the eastern arm and the northern arm there is a horse exercise circle with access over ballast behind.

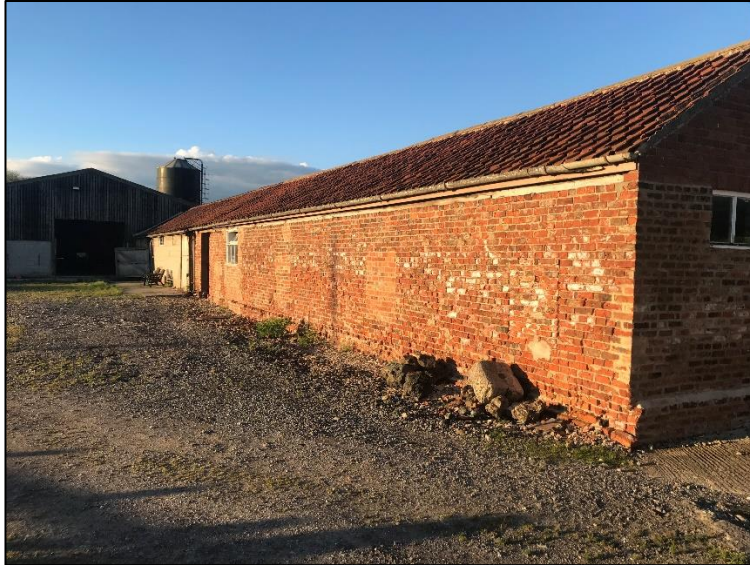
3.3.4. At the back of the buildings there is the access gate from the open area in the middle of the block and then a further stable area at the northern end accessible from the western side of the building. This section has been closed off with a concrete block wall.

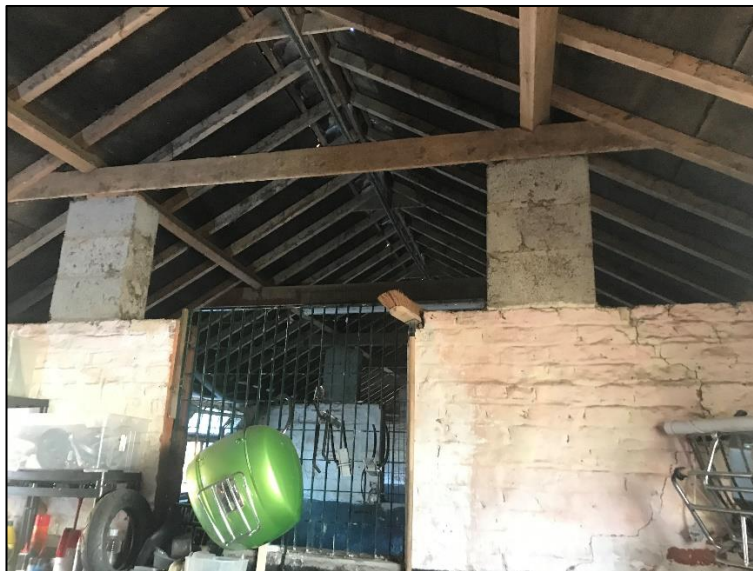
3.3.6. Internally, many of the walls only extend to head height with open access above, that would enable bats to fly between stables.

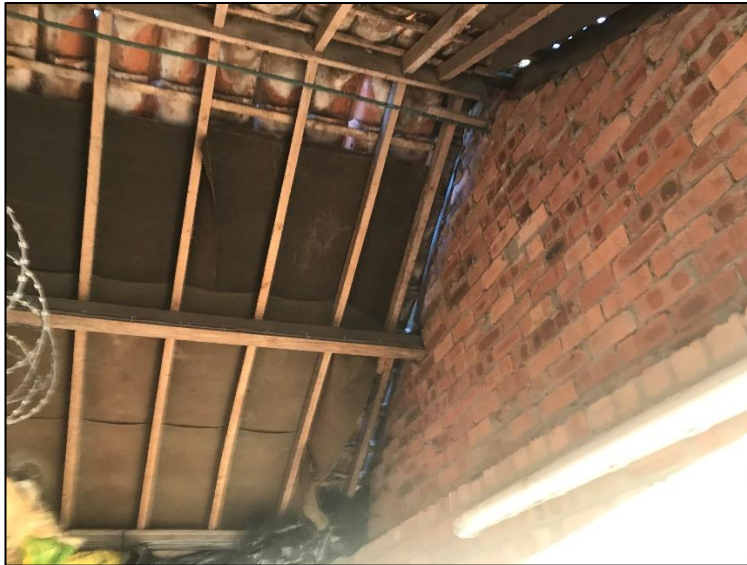
3.3.7. The pan tiles roof has numerous gaps between the tiles. The underside of the tiles is lined with bitumastic felt although this finishes short of the ridge in all cases, as shown below

3.3.12. The building overall was assessed to have a LOW potential for roosting bats limited to gaps between the pan tiles and the felt lining.

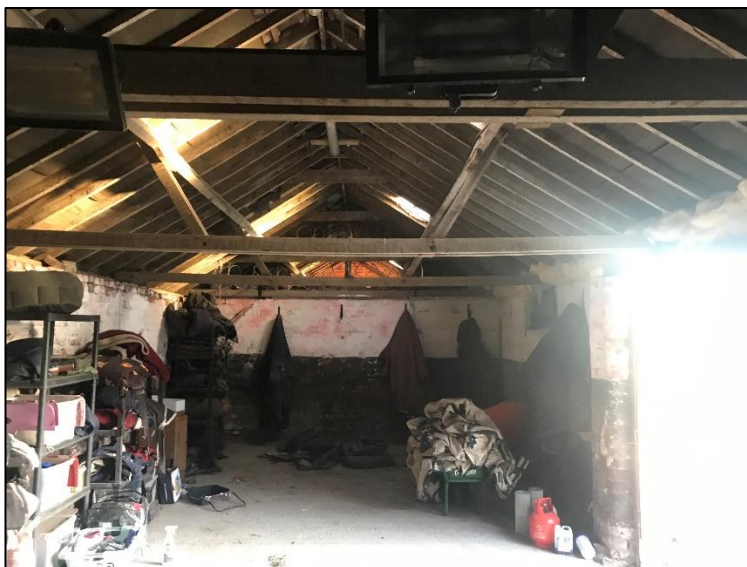
3.3.8. The photograph below looks south along the back section of the building, from the stables and this again shows access for flight lines over the walls.

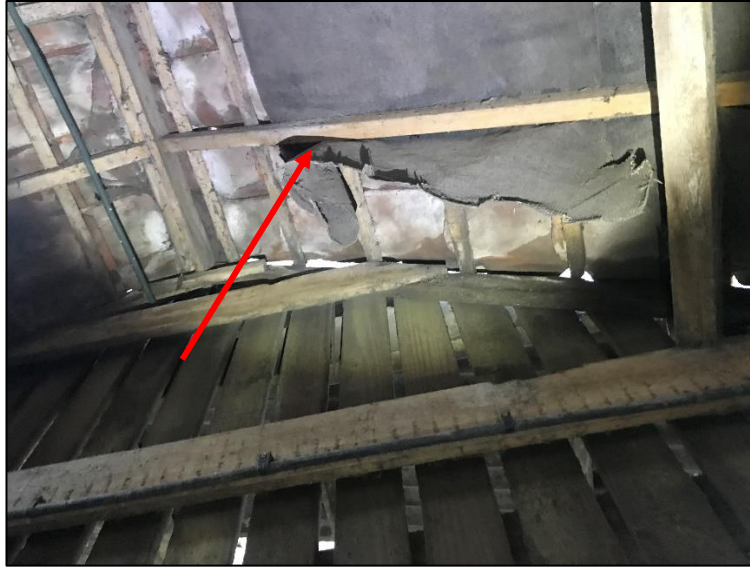
3.3.9. At the far northern end of the building the stables adjoin a larger open barn and between there is a slatted timber wall as shown in the photograph below. At this point, the felt roof lining is in a poor state of repair with a section hanging. Behind this, a small bat was found in the location marked by the red arrow, with a small number of bat droppings on the floor underneath.

4.1. The existing stables on the site was assessed to have a low potential for roosting bats during the daytime survey in line with the bat Conservation Trust Good Practice Guidelines. However, a small number of bat droppings were found and one bat was seen sheltering behind a hanging piece of roof felt liner.

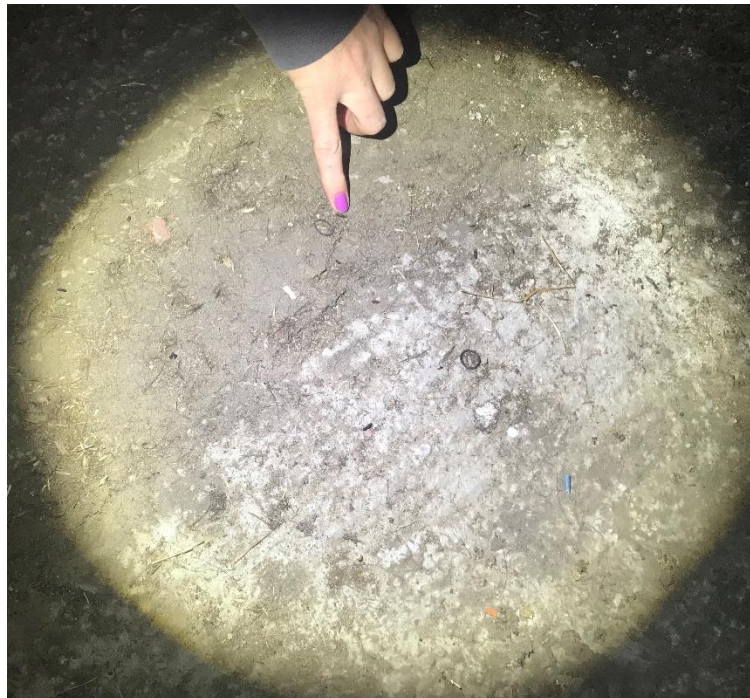
3.3.10. Further droppings were found on the concrete floor of the workshop area, as shown below.

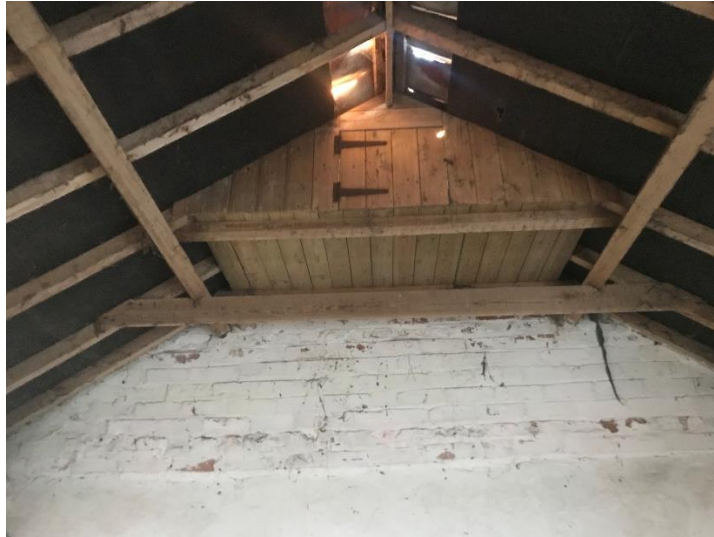
3.3.11. In the stable at the northern end of the northern arm there is a bird loft access leading into the boxed off area shown below. There was no evidence of use of this by birds, but swallows were nesting in the buildings.

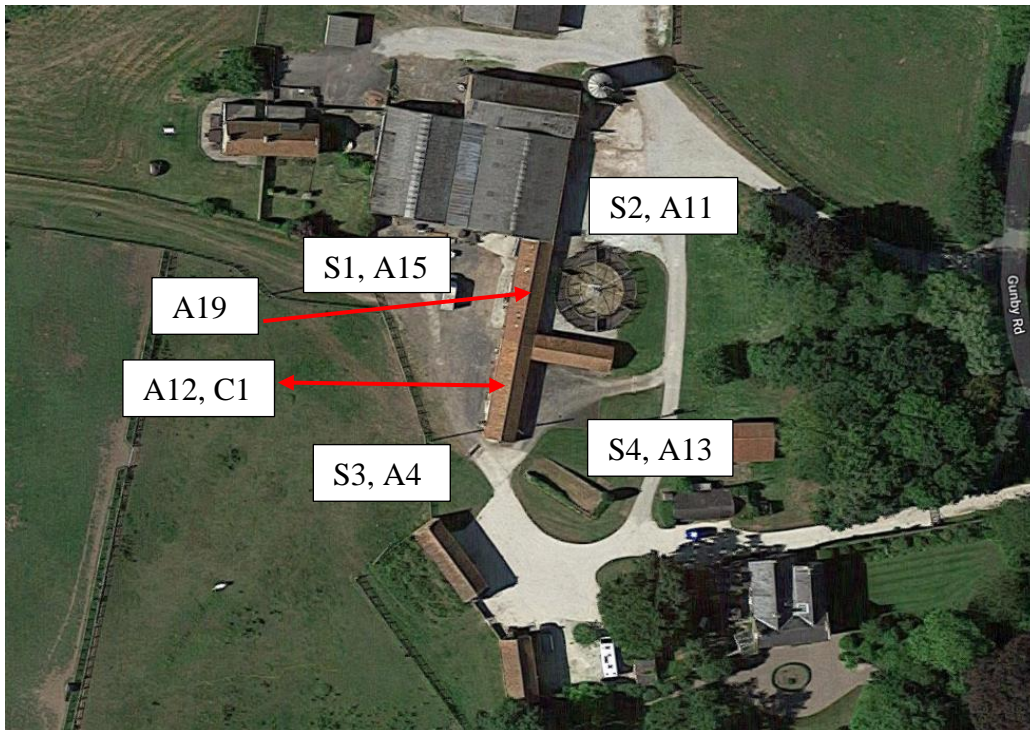
record bat activity for subsequent computer analysis using Anabook software. Two Anabat recorders were placed inside the building along with one camera with an infra-red light source and night sight (C).

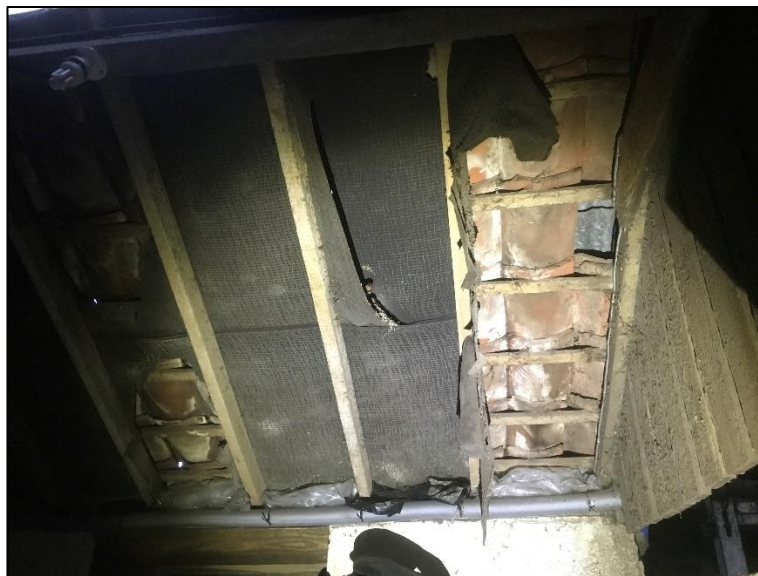
3.5.1. A repeat daytime survey showed that nothing has changed with the buildings. All remain as previously report from the 2019 survey. Where the Common Pipistrelle was originally found in 2019, there is a swallow's nest in 2020.

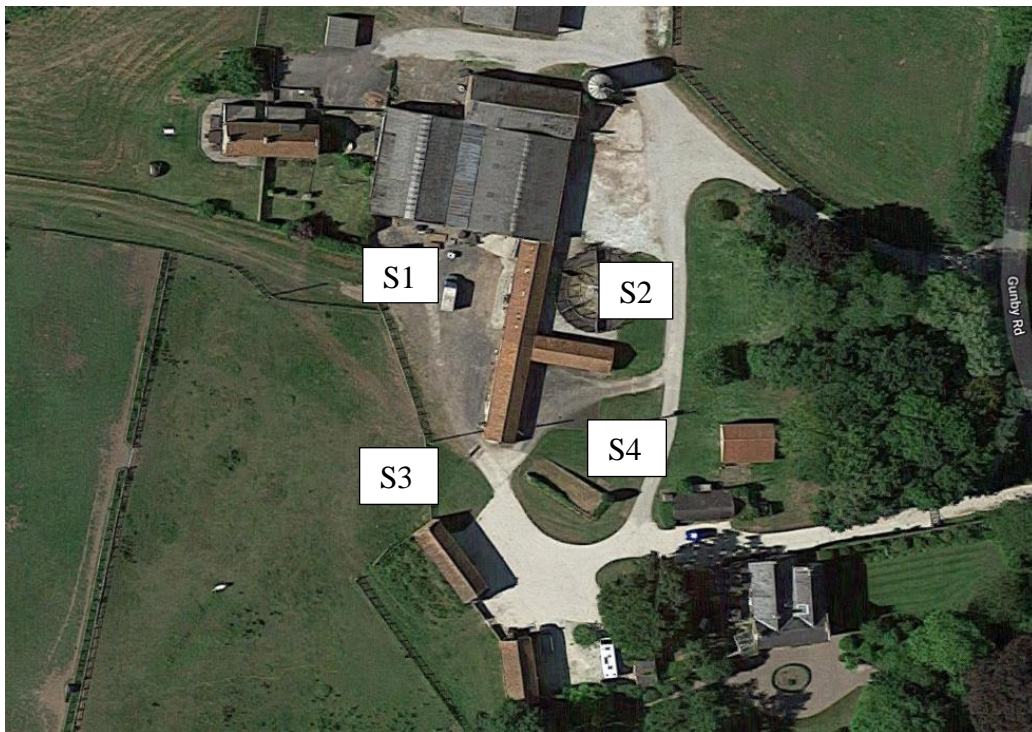
3.6.3. The four surveyors were positioned so that they could see all aspects of the stables to be surveyed. The position of each surveyor (S) was as shown on the aerial photograph below. Each surveyor was equipped with a Batbox Duet detector and a two-way radio for communication and a static Anabat recorder was placed close by to record bat activity for subsequent computer analysis using Analook software.

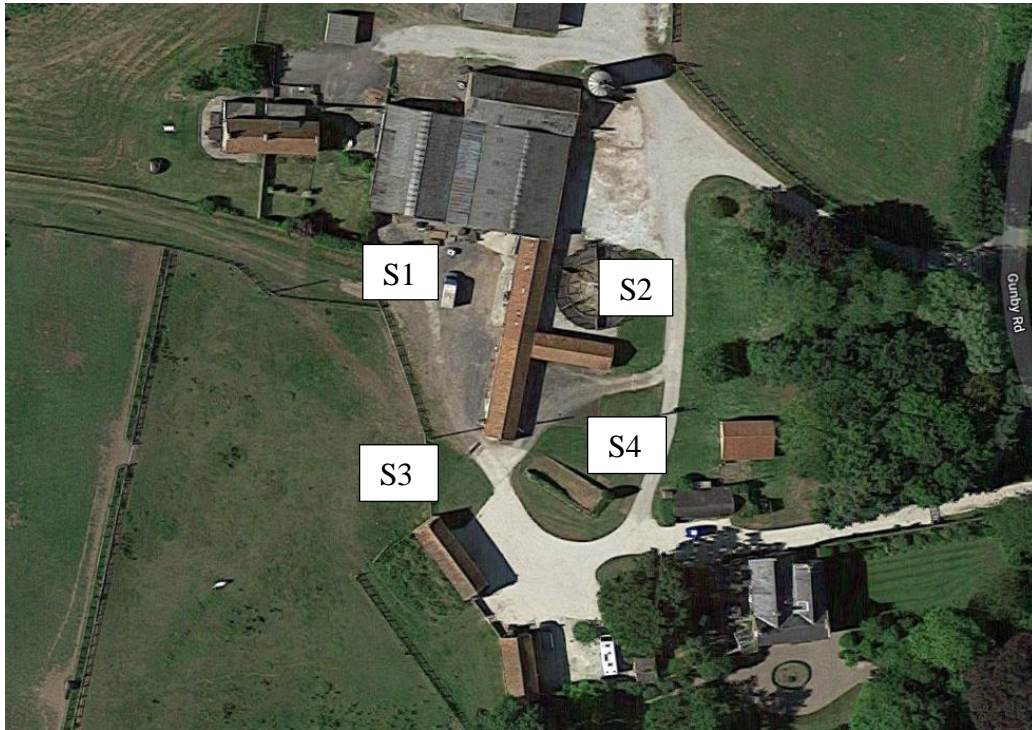
two-way radio for communication and a static Anabat recorder was placed close by to record bat activity for subsequent computer analysis using Anabook software.
