## **Holme House Aylmerton**

**Preliminary Ecological  
Appraisal including a  
Preliminary Roost  
Assessment**

Reference: 85-2101-GE-RW

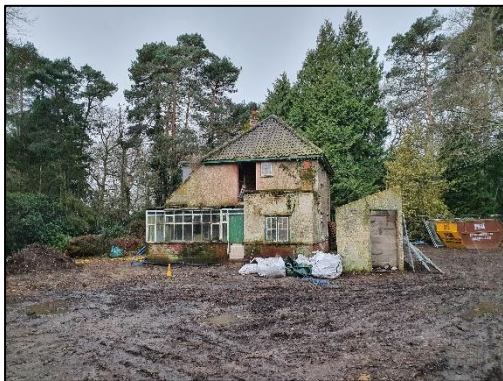
5.2.1 Much of the site had been cleared of vegetation as the house had been empty for a number of years and the grounds had been very overgrown (as per comms with owner). (Figure 1).

5.2.2 However, there were still mature trees around site boundaries and there were signs of new tree planting across the site, to the west of the house.

*Figure 1: Cleared ground around the house, with mature trees to eastern boundary.*

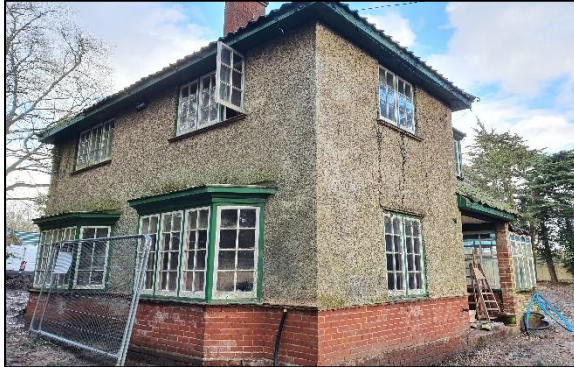
5.3.2 The house detached and two-storeys with rendered walls, a brick base and a pantile roof. (Figures 1 and 2).

Figure 1: Holme House – eastern and southern aspects.

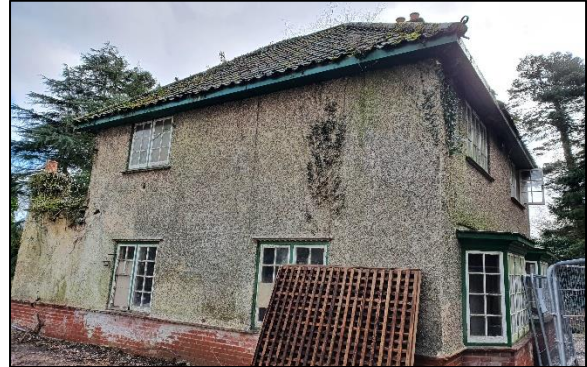
Figure 2: Holme House – northern and eastern aspects.

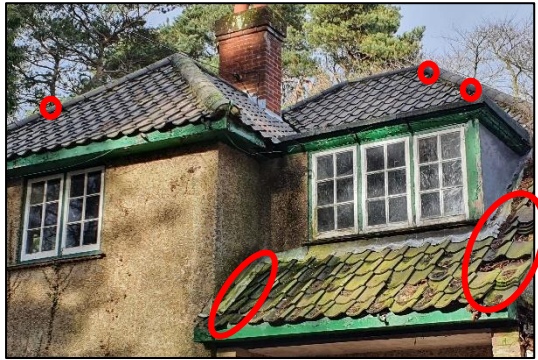
5.3.3 The majority of the ridge was well sealed but there were gaps on the eastern and southern aspects (Figure 3).

5.3.4 There were raised tiles throughout, although much of the central roof areas were well sealed. The roof above the porch was in worst condition which also had some lifting of the flashing on the left-hand side (see Figure 3).

Figure 3: Southern aspect – gaps circled.

- Two bat access tiles to be installed onto the southern aspect of the roof. Something similar to the [Bat Access Tile Kit](#) would be suitable. Alternatively, two access points can be created within the ridgeline by using a spacer to create gap 20mm x 50mm in size in the mortar under the tiles.
- Two bird boxes to be placed on trees around the boundaries. The [Woodstone nest box](#) and [blackbird nest box](#) would be suitable options.

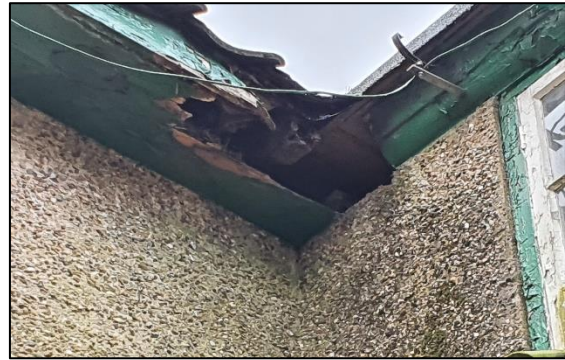
5.3.7 The soffit was well sealed to the wall, but there was one gap where the soffit had rotted on the southern aspect (Figure 4).

Figure 4: Gap in otherwise well-sealed soffit

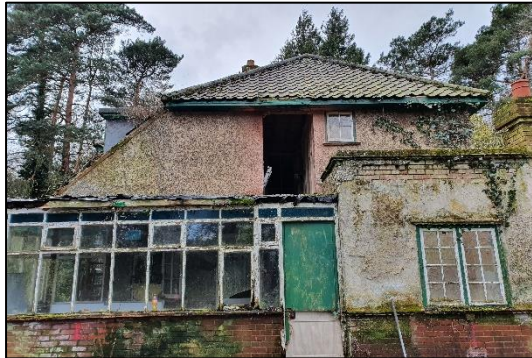
5.3.10 On the western aspect there was a flat roof extension and on the second floor an opening onto the second floor (Figure 5).

Figure 5: Western aspect.

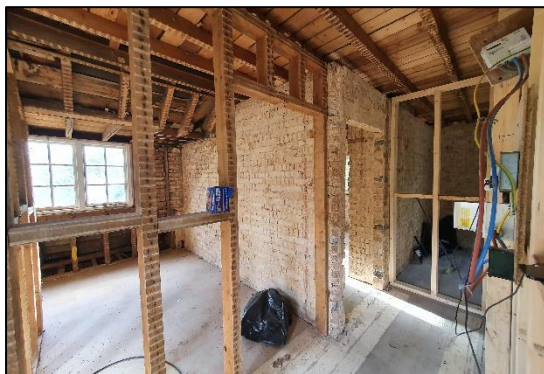
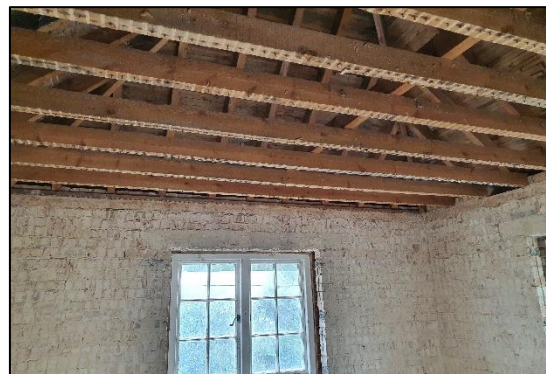
5.3.11 Internally the house had been stripped back and the ceiling removed from the second floor making the rooms open to the roof space (Figures 6 and 7) and at the time of the survey there was a high level of disturbance from human activity.

5.3.14 The lack of ceilings meant that the roof structure was exposed to a lot of daylight from the windows on the second floor.

Figure 6: Holme House – internal view

Figure 7: Holme House – internal view.

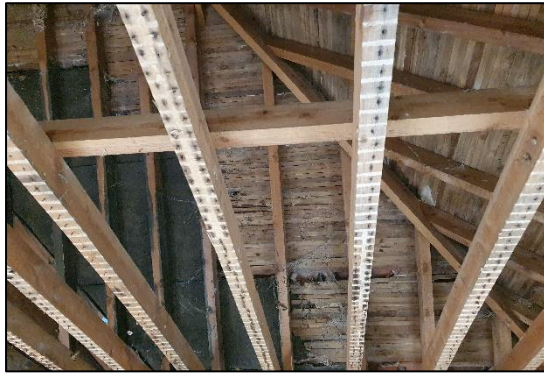
5.3.12 The roof structure was partially lined with wood lathe and partially to felt, both were intact (Figure 8).

5.3.13 The beams were all narrow and machine cut with no cracks or gaps.

Figure 8: Roof linings.
