Manor Farm, Harpham

Preliminary Bat Roost Assessment, December 2021.

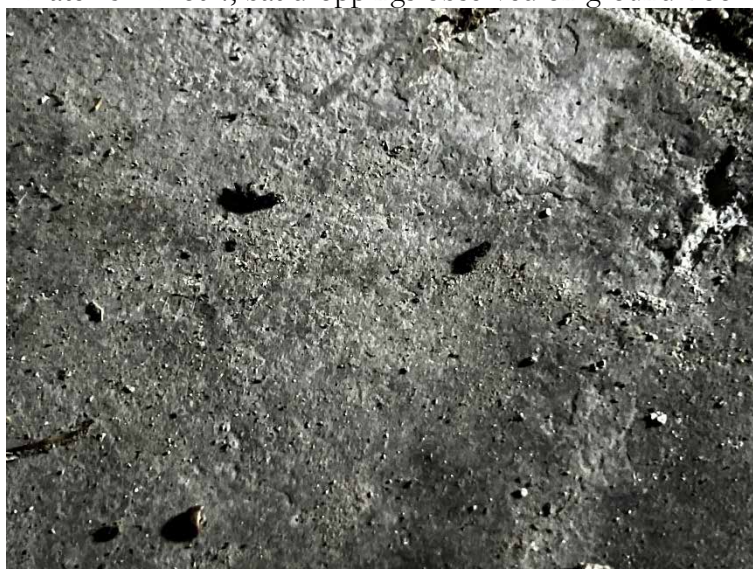
- Six bat droppings were observed on the ground floor of the building. The location of the bat droppings suggests a light sampling bat/a roost located above the ridge or internal wall plate.
- The building has been assessed as having a HIGH SUITABILITY to support bats in numerous locations.

Plate 15 – Plot 4, bat droppings observed on ground floor

6.7.2 In order to prevent any potential impacts occurring to bats present, it is recommended further activity surveys are undertaken. This will provide further information on bats at the site and should target all elevations of plots 1 - 5.

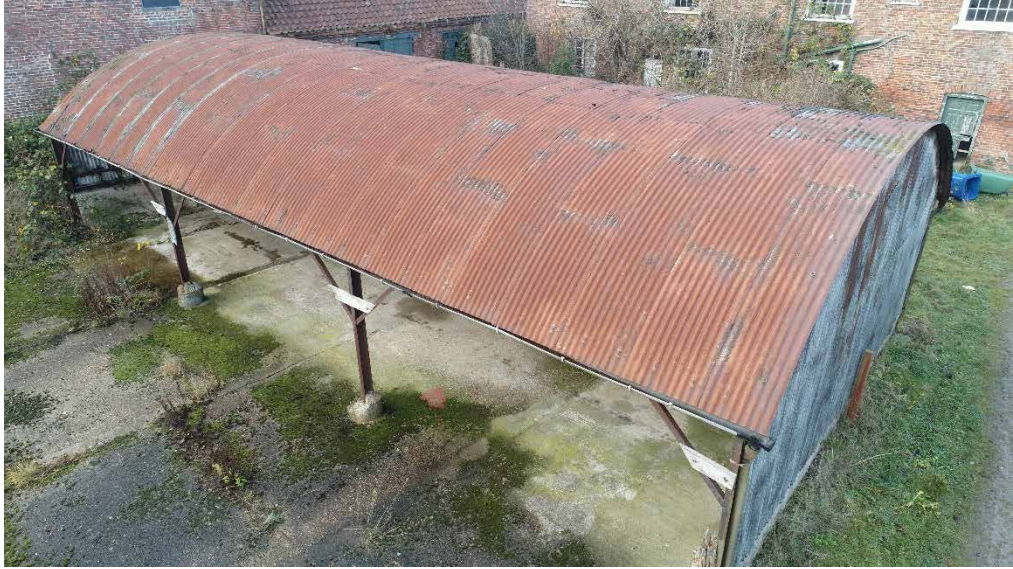
Plate 19 – Nissen hut

<p><i>Nissen Hut</i></p> <p>There were no signs of roosting bats or bat activity, and the building has no features to support roosting bats. Consequently, the building has a NEGLIGIBLE SUITABILITY to support bats (see 5.3 plates 19 and 20).</p>	15.5	7.6	4.1
		<p><i>Farm house</i></p> <p>There were no signs of roosting bats or bat activity, and the building has few features to support roosting bats. Consequently, the building has a LOW SUITABILITY to support bats (see 5.3 plates 21 - 23).</p>	17.9	8.7	3.3
17/12/21	Hibernation	No hibernating bats were observed during the endoscope inspection.

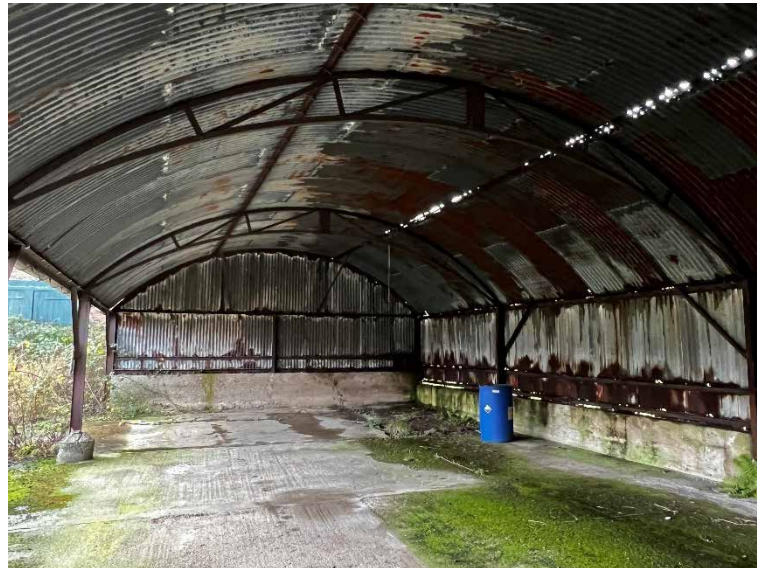
Plate 20 – Nissen hut internal roof structure.
