**Farmhouse at Dutton Park Farm,  
Lodge Lane,  
Dutton,  
Warrington.**

**Bat Scoping Survey Report**

**Report number:** DPFF/2021

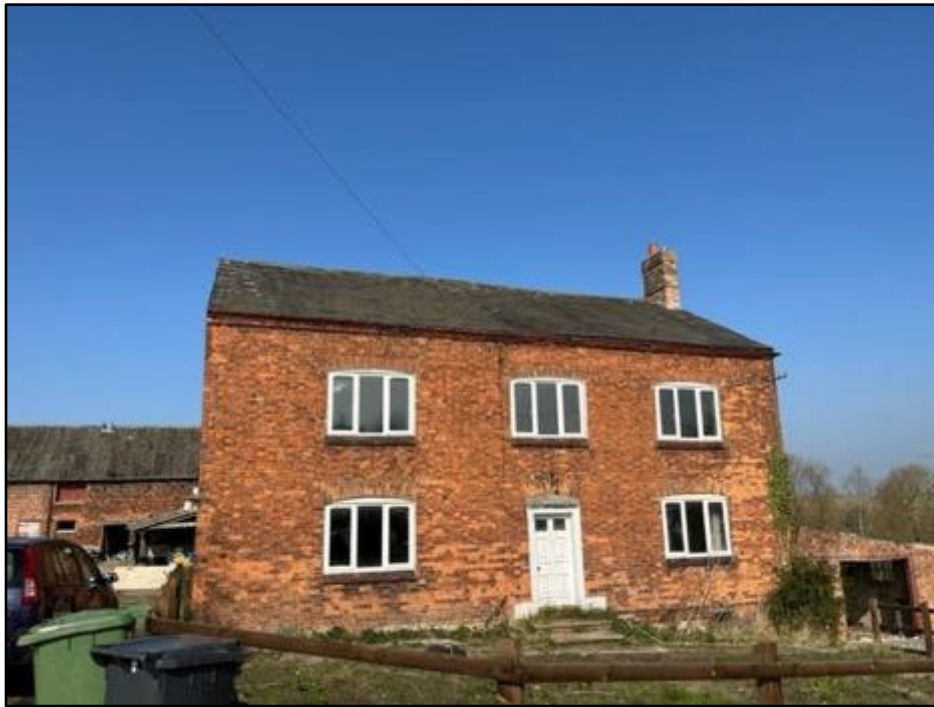
**Fig 2:** A front view of the subject farmhouse. The roof can be seen in fair condition with several entry points along the apex.

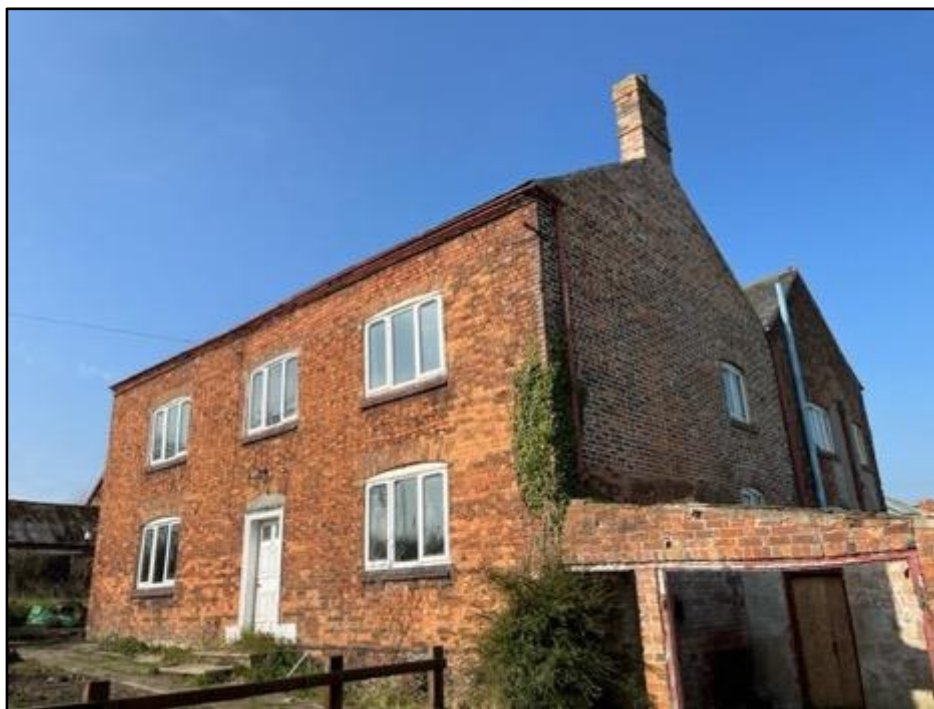
**Fig 3:** The northern gable of the building is in good condition.

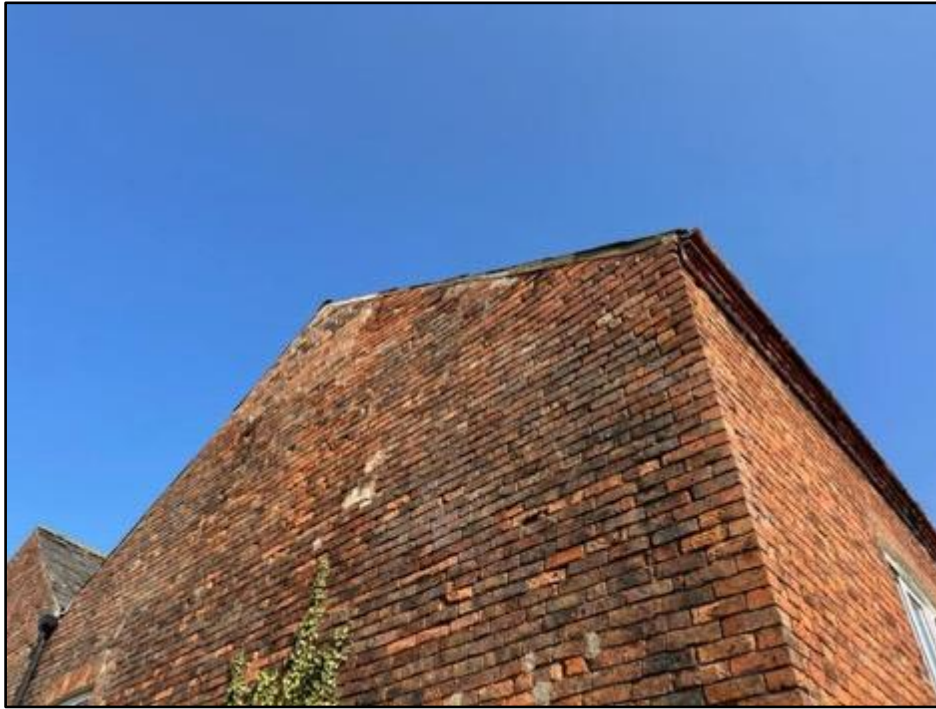
**Fig 4:** The southern gable is more conditioned than the northern face. The brick soffit of the building is damaged in parts.

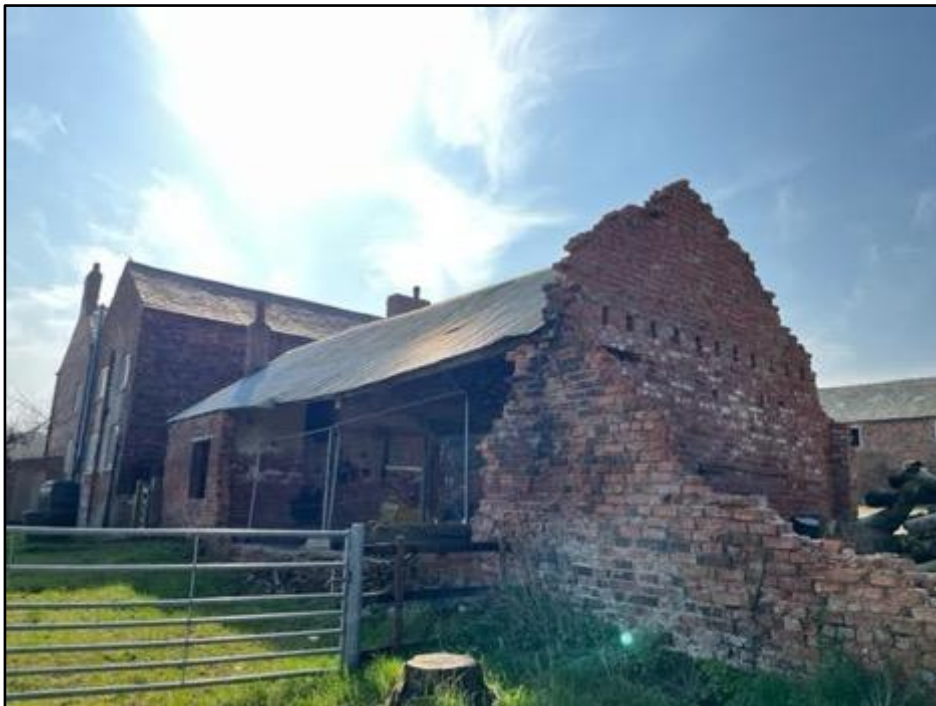
**Fig 5:** View of the adjacent outbuilding on site. The building is in decrepit condition throughout, although no active/ancient bird nests or signs of previous bat usage was found.

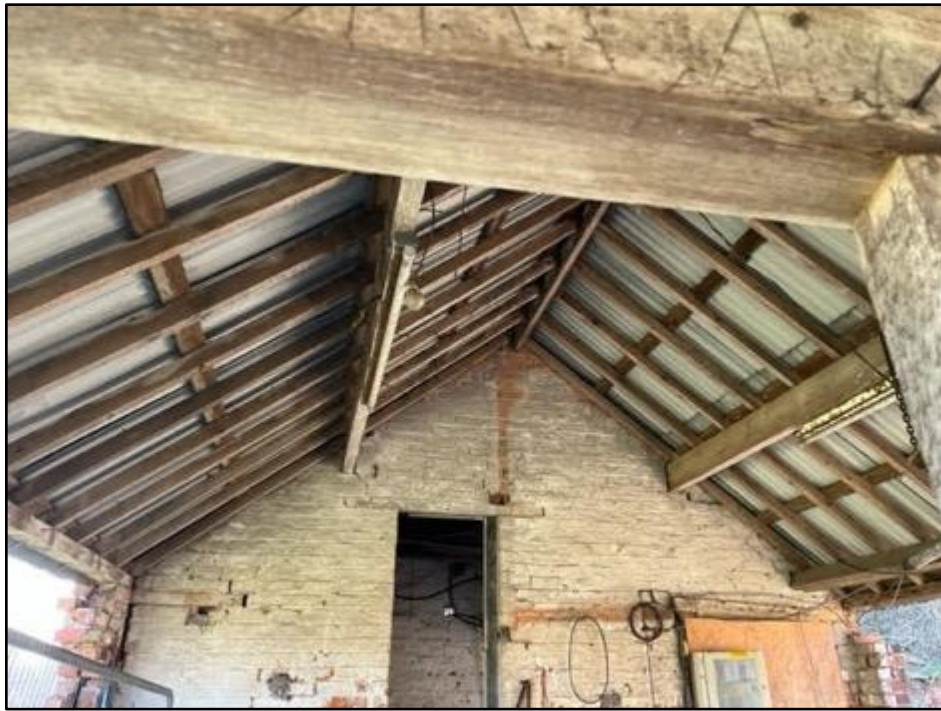
Fig 6: An internal view of the outbuilding.

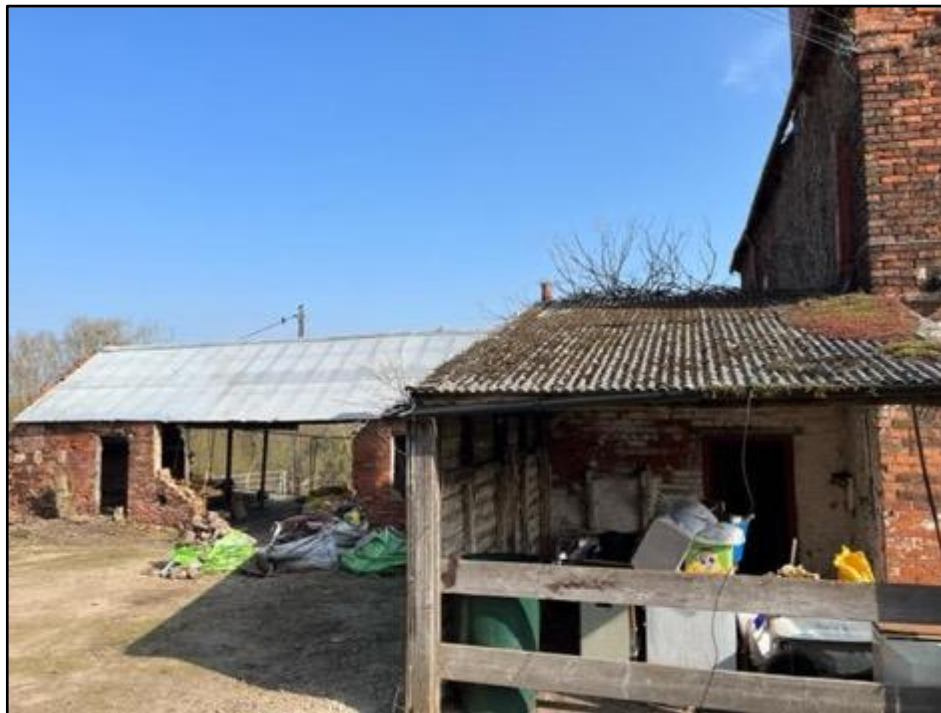
Fig 7: A single-storey extension on the western side of the building. Both this extension and the outbuilding feature a tin roof atop; this roof type is unsuitable for bird species and bats.

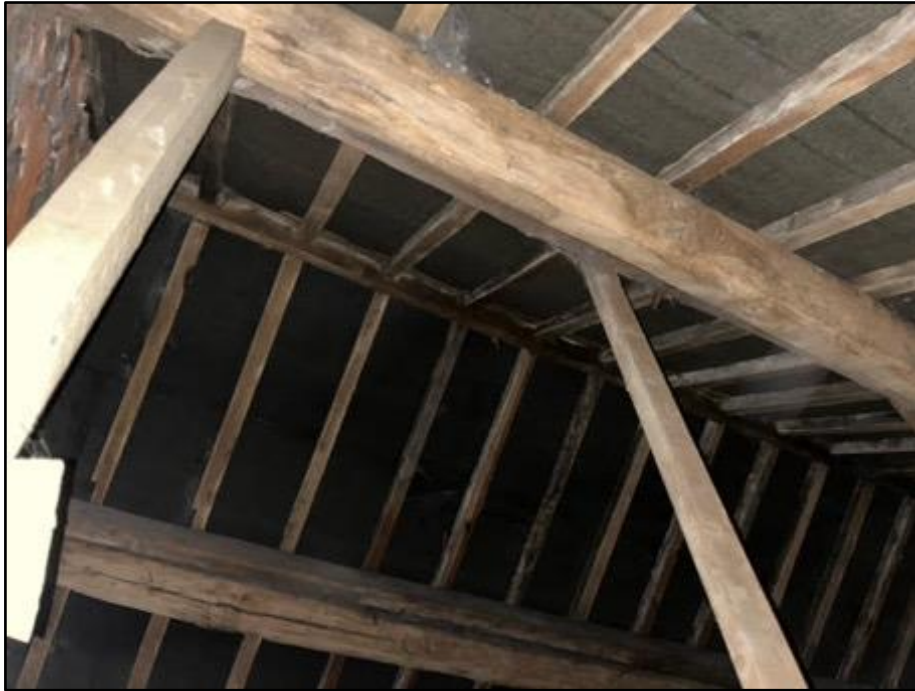
**Fig 8:** The internal roof space of the building. A felt lining beneath the slate tiles is in fair condition.

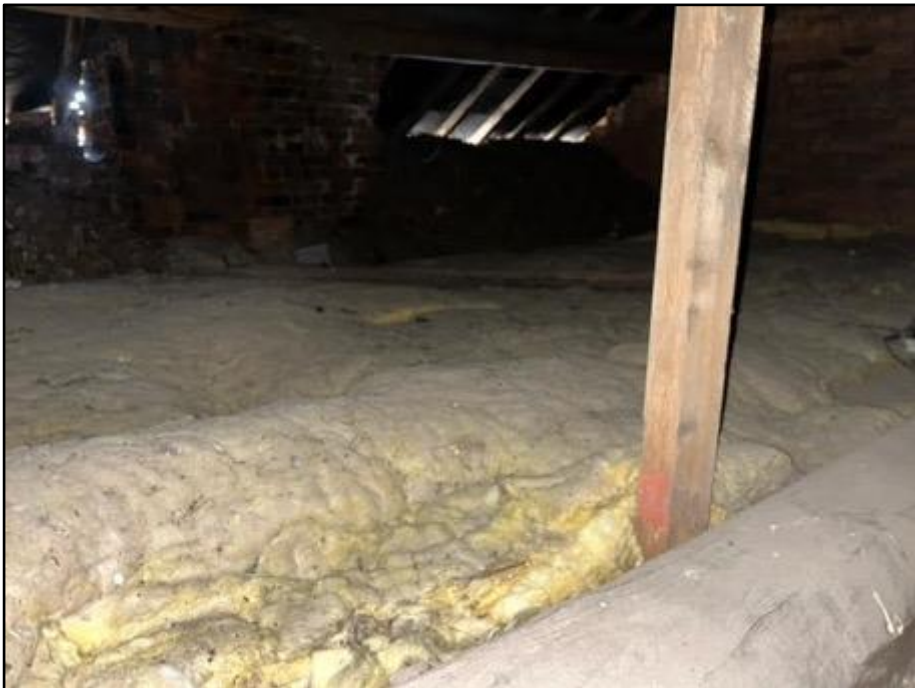
**Fig 9:** The extent of the roof space. House sparrows and jackdaw nests were identified within the roof space.

- 5.1 The results of the bat scoping survey indicate that the farmhouse building offers high bat potential; the roof space is ideal, and several openings make bat entry feasible. Previous bat activity surveys undertaken on the adjacent barns found that over 6 differing species of bat were recorded.
- 5.2 Bat mitigation measures have been embedded into current proposal plans in the previous bat activity report for the farm complex, **these mitigation proposals extend to the replacement farmhouse.**
- 5.3 Several ancient bird nests were found among the purlins and rafters in the roof space.
- 5.4 Therefore, it is recommended that **a further 3 bat activity surveys be undertaken** to determine the presence of roosting bats within the subject farmhouse building.

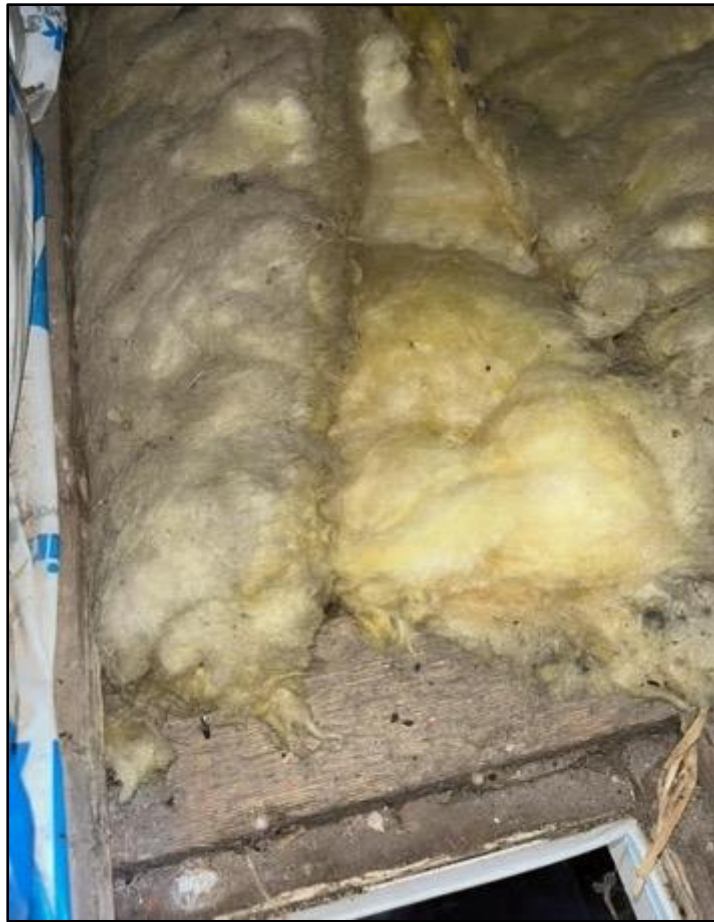
Fig 10: Bat droppings found within the roof space.

- 4.1.1 The farmhouse building offers **high bat potential**, due to the suitability of the roof space and the entry points found throughout; this coupled with the knowledge that bats are present on site (information found from previous surveys) and the finding of droppings within the roof space.
- 4.1.2 The buildings are located on a hard standing yard within a rural area with open fields and hedgerows. The area offers ideal foraging habitat, and previous bat activity surveys have identified the adjacent barns usage as well as nearby hedgerows and woodland areas.
- 4.1.3 Bat droppings and feeding remains were clearly identified within the building (figure 10 and 11), as well as several jackdaw and house sparrow nests.

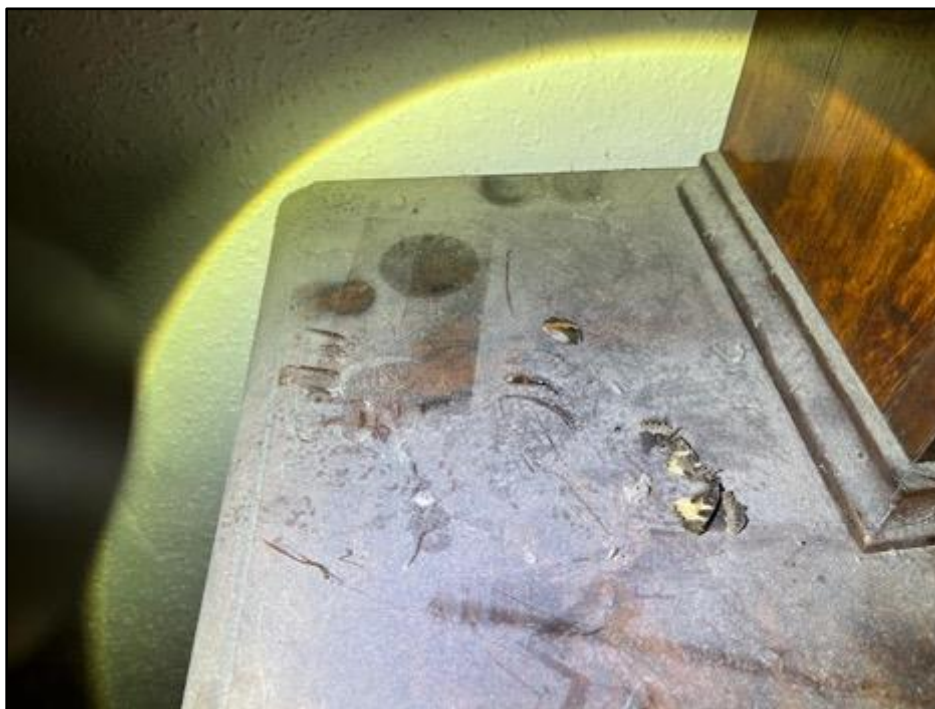
Fig 11: Feeding remains found on the second storey of the building.
