**PROPOSED RESIDENTIAL DEVELOPMENT  
ARTHURS LANE, HAMBLETON  
LANCASHIRE  
FOR  
WAINHOMES NW LIMITED**

**APRIL 2018**

**PHASE II GEO-ENVIRONMENTAL INVESTIGATION REPORT**

**18038/GEIR**

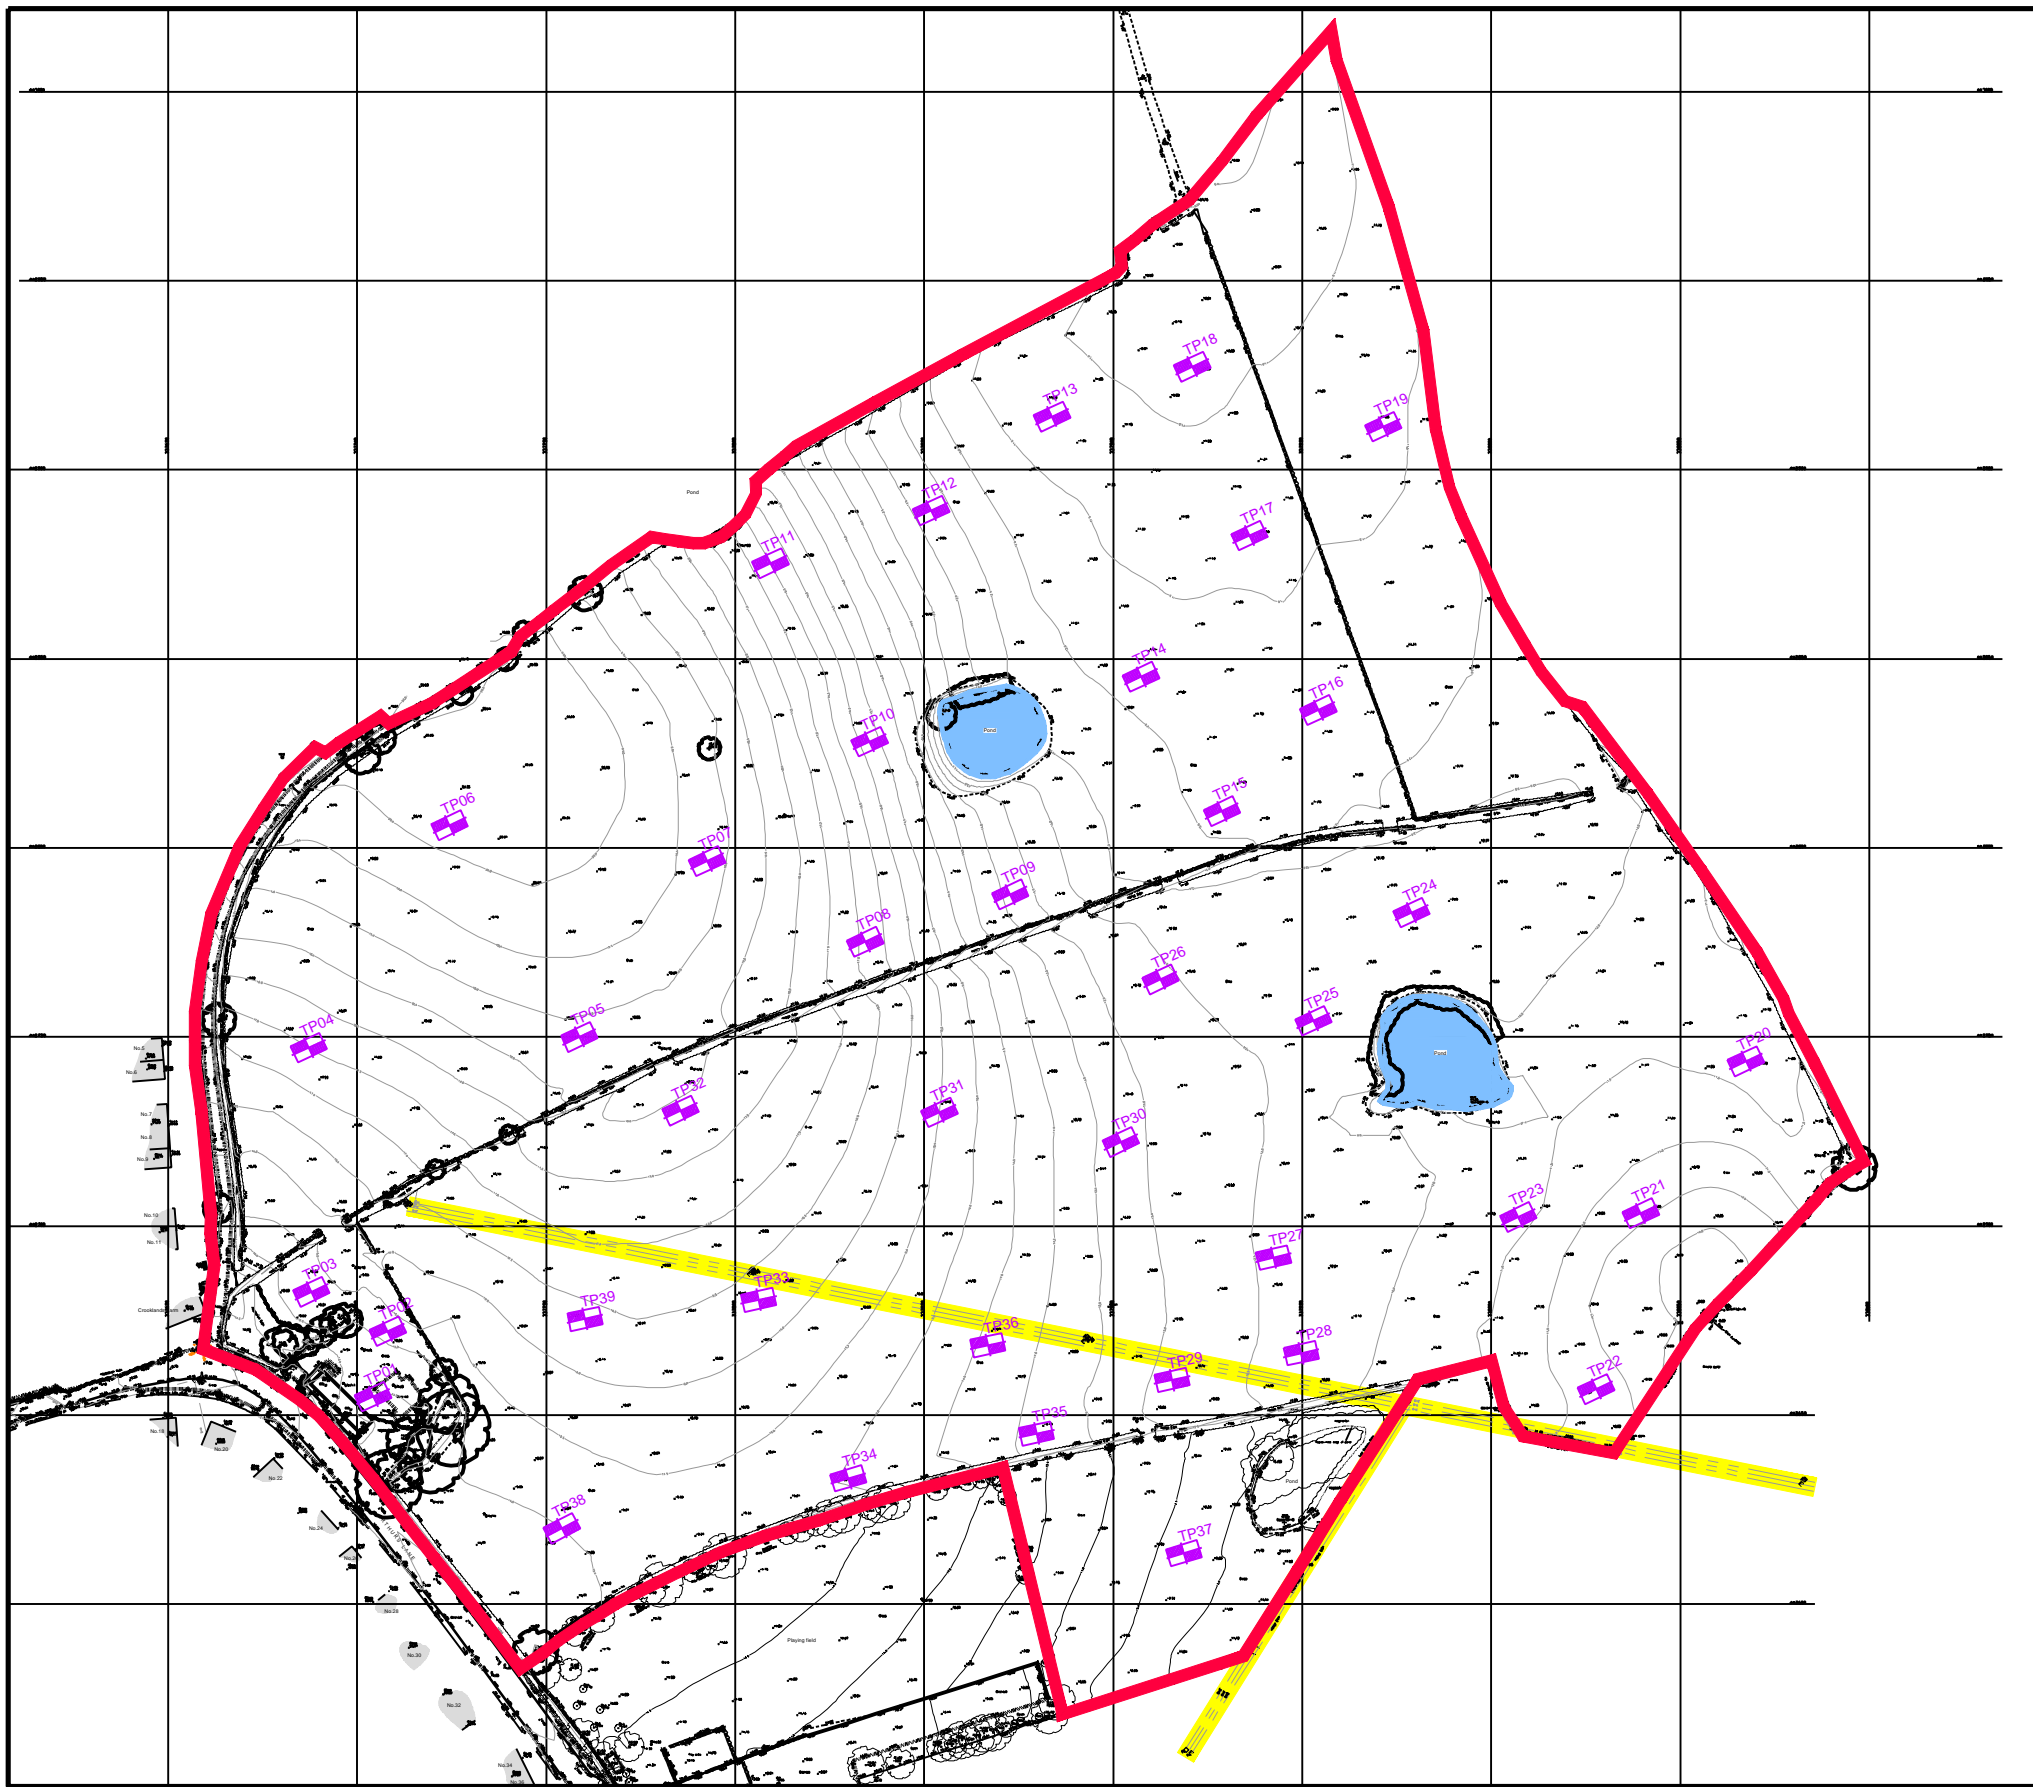
- Development boundary
- TP01  
Approximate Location of Trial Pits
- Overhead Power Lines
- Pond Areas

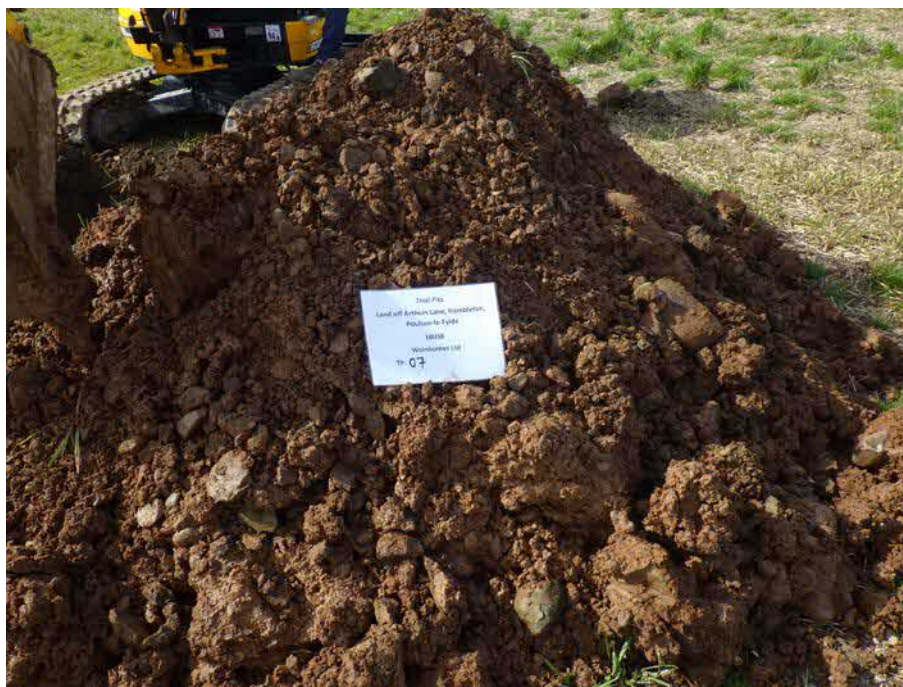
Photo 13 – Trial Pit 07

Groundwater	Groundwater ingress has been identified within positions TP07, TP14 and TP27 at depths between 1.5 – 2.4m bgl. These water strikes are considered to represent perched water within the natural strata. It should be noted that perched water in granular units may cause localised instability in excavations and the foundations. Instability was noted within position TP14 due to groundwater ingress and where excavations must stop if difficulties with groundwater are encountered and the foundations engineer must be consulted.
Environmental	Chemical testing has confirmed the topsoil material to be free of any potential contamination and it is suitable for re-use within a private residential garden environment. The made ground material is also suitable for retention.
Trees	The site contains numerous semi mature trees located around the site boundaries. The proposed development plan shows that existing trees will be retained. All trees within the site area and those lying outside the site but within influencing distance should be subject to an arboriculturist report. The clay soils within this site have a MEDIUM volume change potential as defined by the NHBC.

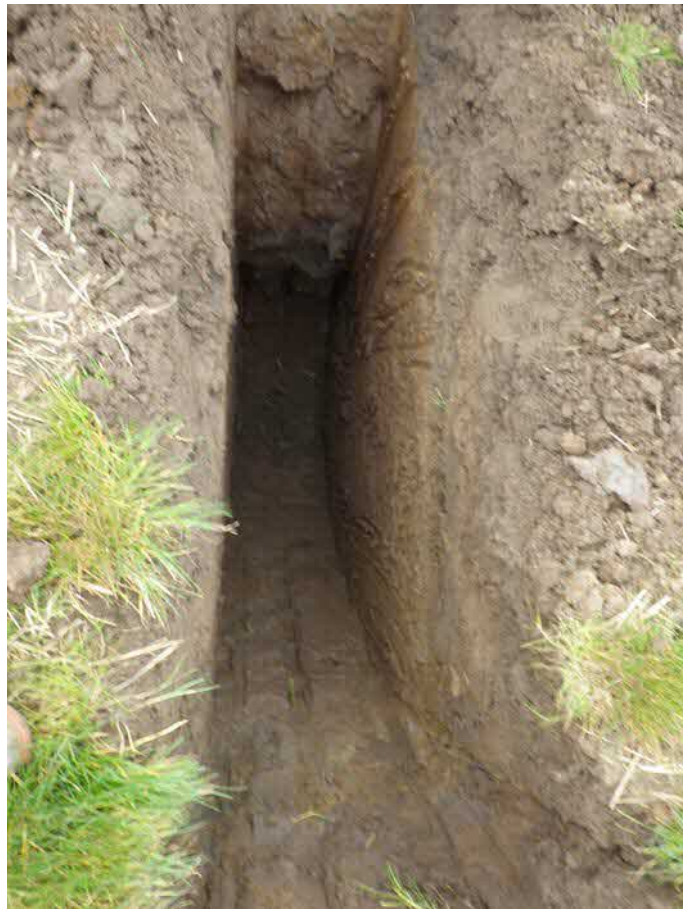
Photo 28 – Arising's from Trial Pit 14

- 5.5.2 *Within position TP14 collapse was noted at depths between 1.5 – 2.2m bgl and this is anticipated to be caused by perched ground water. Again where perched ground water is encountered and causes instability excavation should cease and advice should be sought from the foundations engineer and the building inspector.*

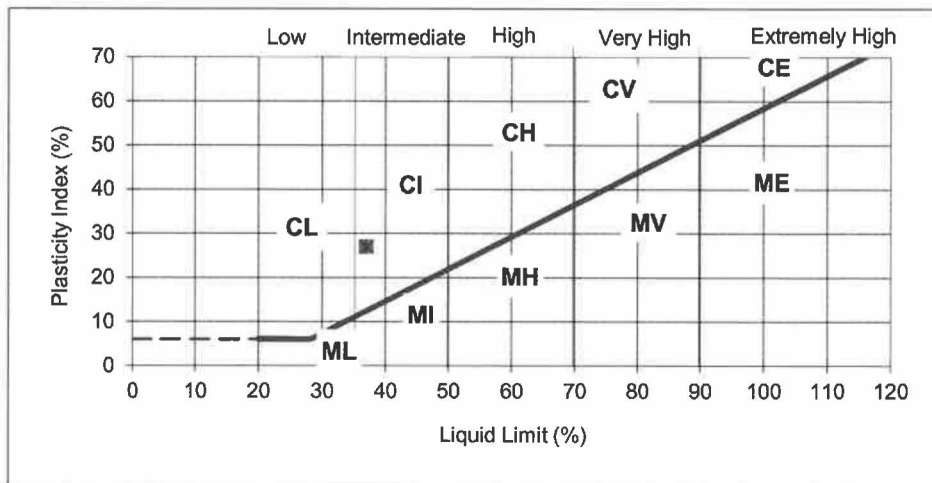
MATERIAL	Stiff brown silty very sandy CLAY with rare gravel
ADVISED SOURCE	Site Investigation Sample

Moisture Content (Natural) (%)	Liquid Limit (%)	Plastic Limit (%)	Plasticity Index (%)	Passing 425 micron (%)
9.5	37	10	27	51

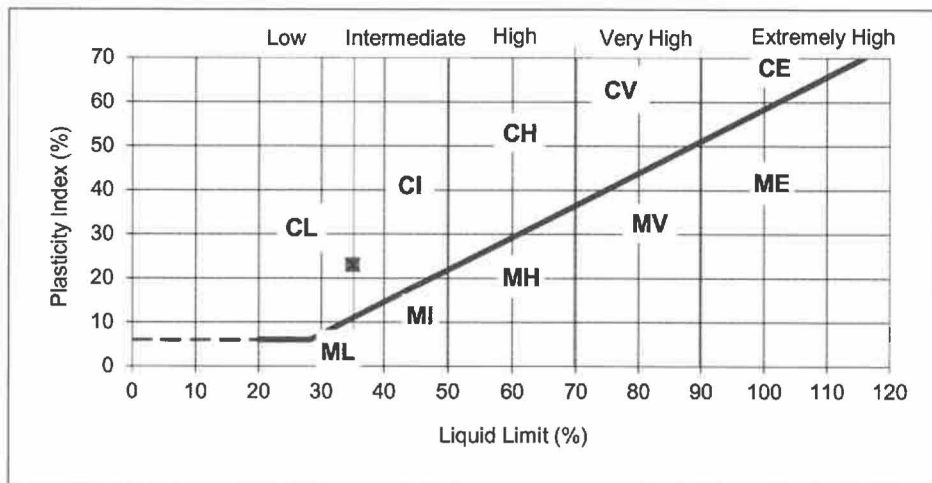
MATERIAL	Firm brown silty very sandy CLAY with rare gravel
ADVISED SOURCE	Site Investigation Sample

Moisture Content (Natural) (%)	Liquid Limit (%)	Plastic Limit (%)	Plasticity Index (%)	Passing 425 micron (%)
17	35	12	23	70

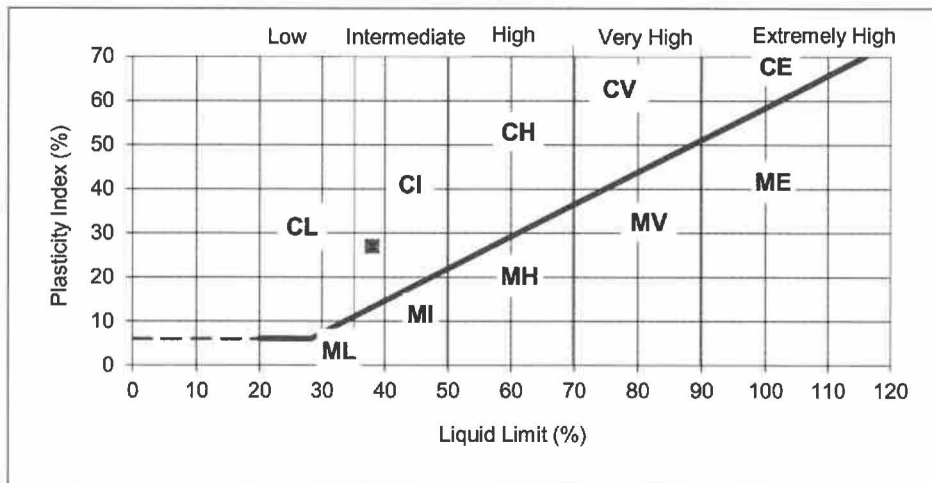
MATERIAL	Stiff brown silty very sandy CLAY with rare gravel
ADVISED SOURCE	Site Investigation Sample

Moisture Content (Natural) (%)	Liquid Limit (%)	Plastic Limit (%)	Plasticity Index (%)	Passing 425 micron (%)
13	38	11	27	68

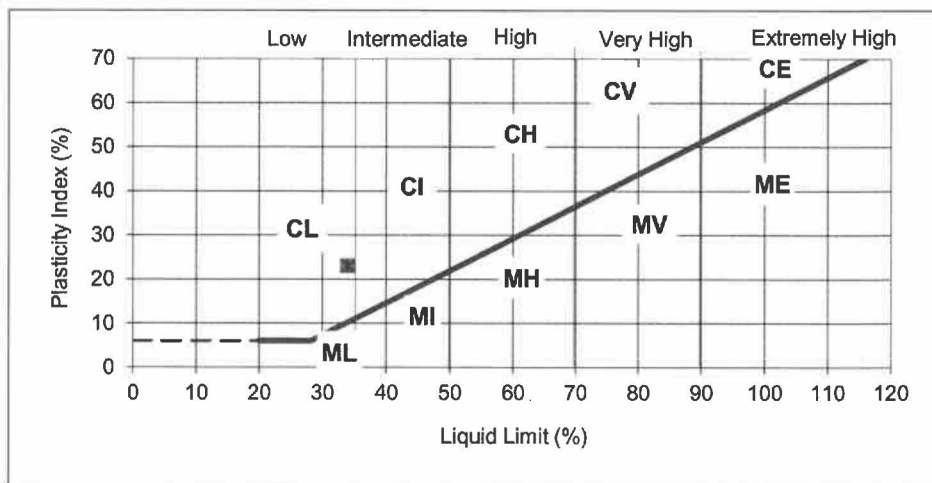
MATERIAL	Firm brown silty sandy CLAY with occasional gravel
ADVISED SOURCE	Site Investigation Sample

Moisture Content (Natural) (%)	Liquid Limit (%)	Plastic Limit (%)	Plasticity Index (%)	Passing 425 micron (%)
15	34	11	23	69

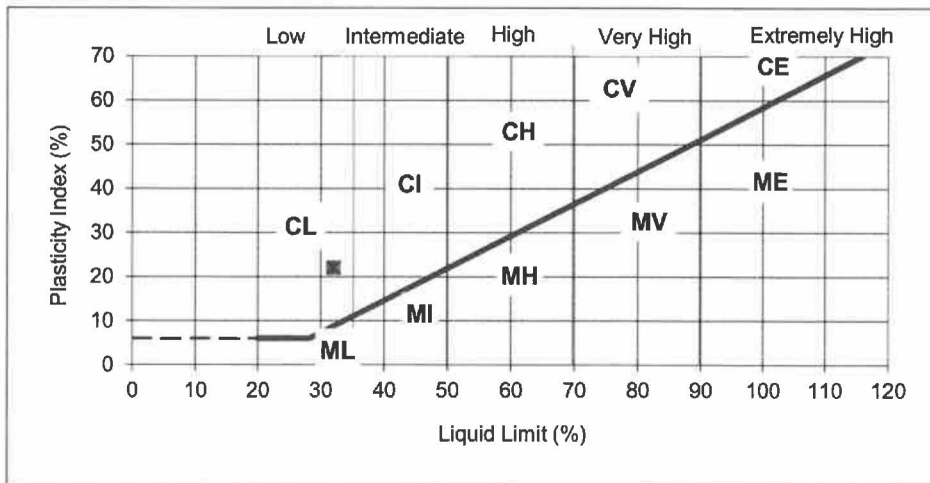
MATERIAL	Firm brown silty sandy CLAY with occasional gravel
ADVISED SOURCE	Site Investigation Sample

Moisture Content (Natural) (%)	Liquid Limit (%)	Plastic Limit (%)	Plasticity Index (%)	Passing 425 micron (%)
13	32	10	22	65

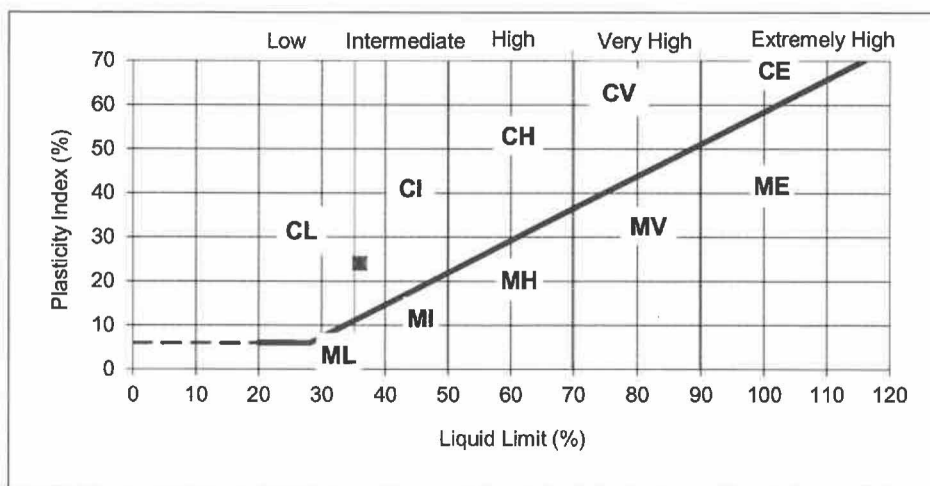
MATERIAL	Stiff brown silty sandy CLAY with occasional gravel
ADVISED SOURCE	Site Investigation Sample

Moisture Content (Natural) (%)	Liquid Limit (%)	Plastic Limit (%)	Plasticity Index (%)	Passing 425 micron (%)
13	36	12	24	71

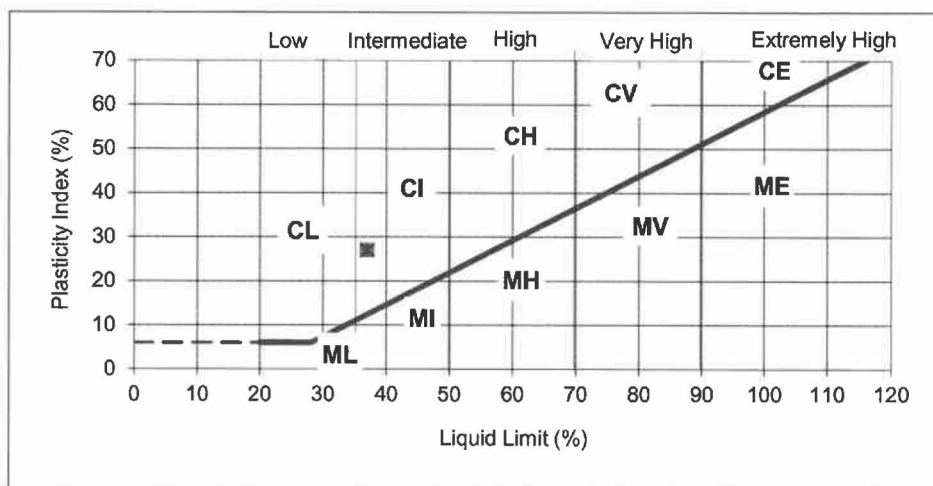
MATERIAL	Firm brown silty sandy CLAY with occasional gravel
ADVISED SOURCE	Site Investigation Sample

Moisture Content (Natural) (%)	Liquid Limit (%)	Plastic Limit (%)	Plasticity Index (%)	Passing 425 micron (%)
14	37	10	27	70

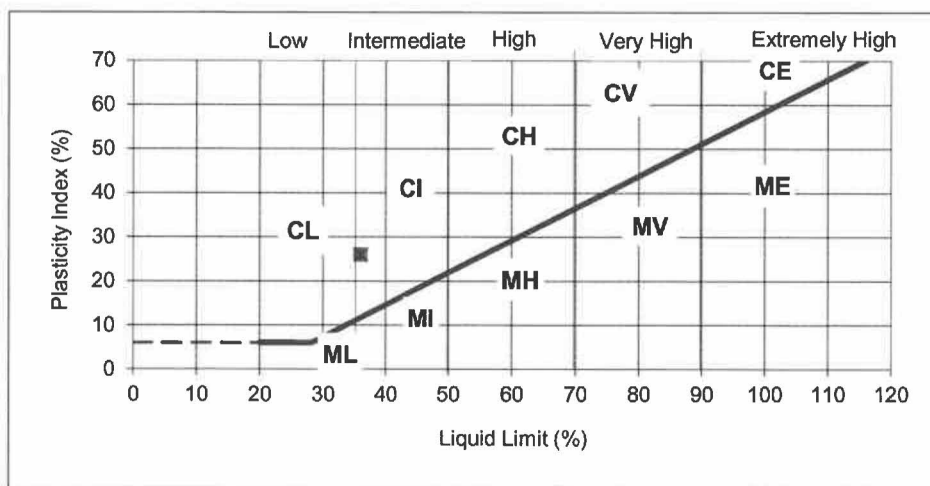
MATERIAL	Firm brown silty sandy CLAY with occasional gravel
ADVISED SOURCE	Site Investigation Sample

Moisture Content (Natural) (%)	Liquid Limit (%)	Plastic Limit (%)	Plasticity Index (%)	Passing 425 micron (%)
13	36	10	26	68

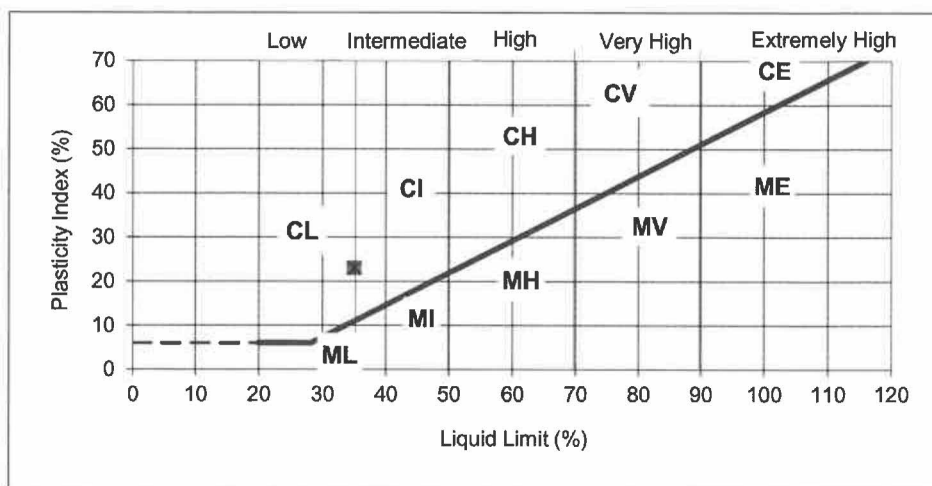
MATERIAL	Firm brown silty sandy CLAY with occasional gravel
ADVISED SOURCE	Site Investigation Sample

Moisture Content (Natural) (%)	Liquid Limit (%)	Plastic Limit (%)	Plasticity Index (%)	Passing 425 micron (%)
21	35	12	23	69

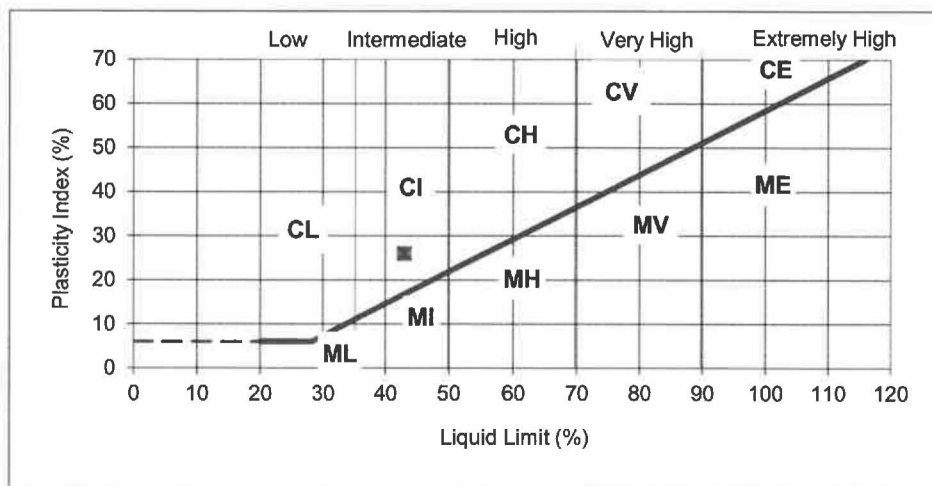
MATERIAL	Stiff brown grey mottled silty sandy CLAY with rare gravel
ADVISED SOURCE	Site Investigation Sample

Moisture Content (Natural) (%)	Liquid Limit (%)	Plastic Limit (%)	Plasticity Index (%)	Passing 425 micron (%)
24	43	17	26	87

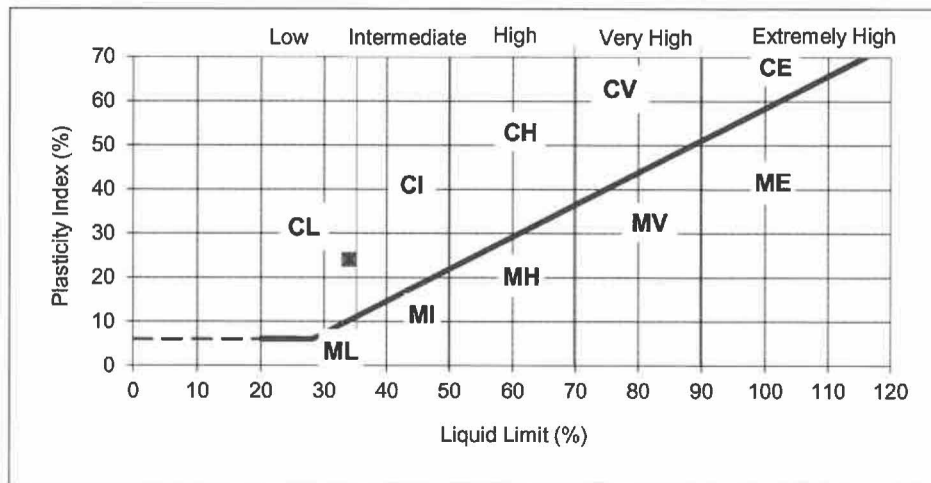
MATERIAL	Stiff brown silty sandy CLAY with rare gravel
ADVISED SOURCE	Site Investigation Sample

Moisture Content (Natural) (%)	Liquid Limit (%)	Plastic Limit (%)	Plasticity Index (%)	Passing 425 micron (%)
13	34	10	24	70

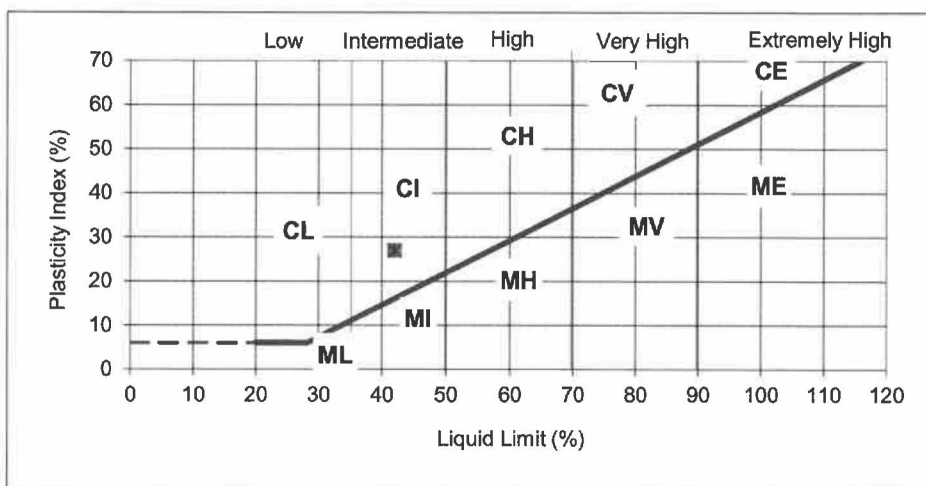
MATERIAL	Stiff brown grey mottled silty sandy CLAY with rare gravel
ADVISED SOURCE	Site Investigation Sample

Moisture Content (Natural) (%)	Liquid Limit (%)	Plastic Limit (%)	Plasticity Index (%)	Passing 425 micron (%)
22	42	15	27	90

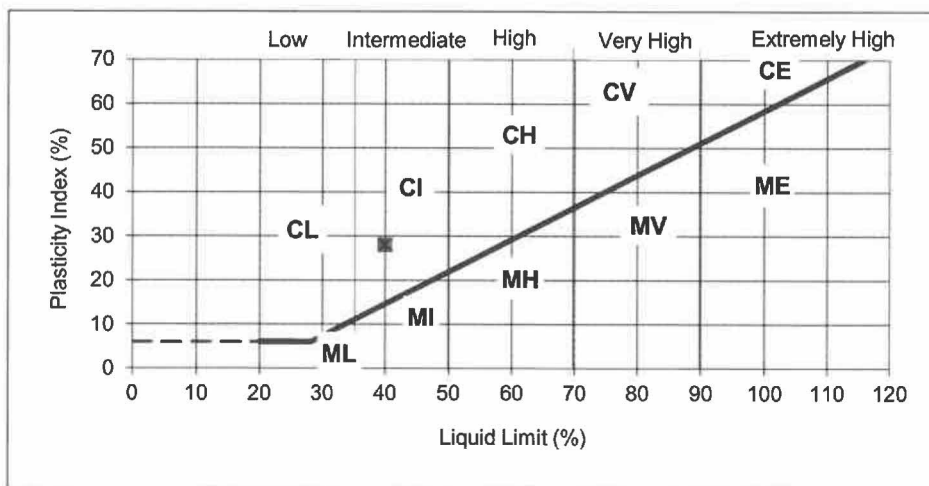
MATERIAL	Stiff brown silty very sandy CLAY with occasional gravel
ADVISED SOURCE	Site Investigation Sample

Moisture Content (Natural) (%)	Liquid Limit (%)	Plastic Limit (%)	Plasticity Index (%)	Passing 425 micron (%)
15	40	12	28	59

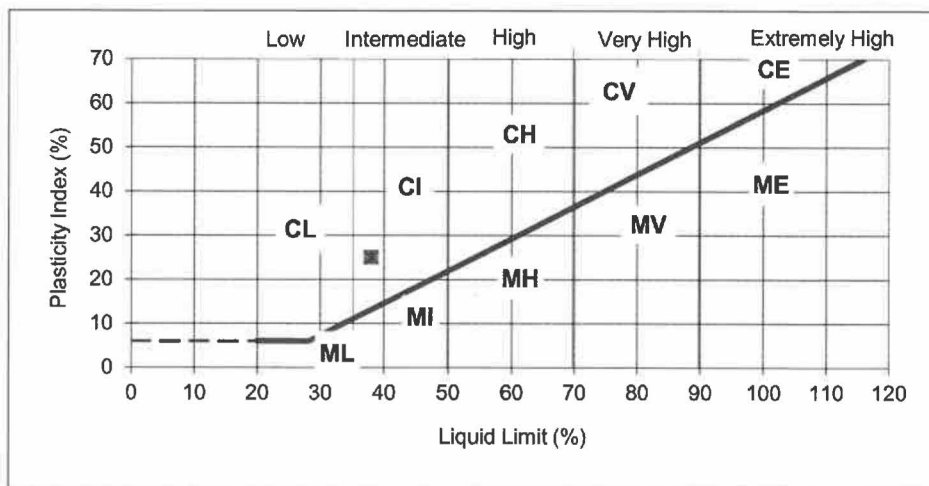
MATERIAL	Stiff orange green brown mottled silty very sandy CLAY with frequent gravel
ADVISED SOURCE	Site Investigation Sample

Moisture Content (Natural) (%)	Liquid Limit (%)	Plastic Limit (%)	Plasticity Index (%)	Passing 425 micron (%)
14	38	13	25	40

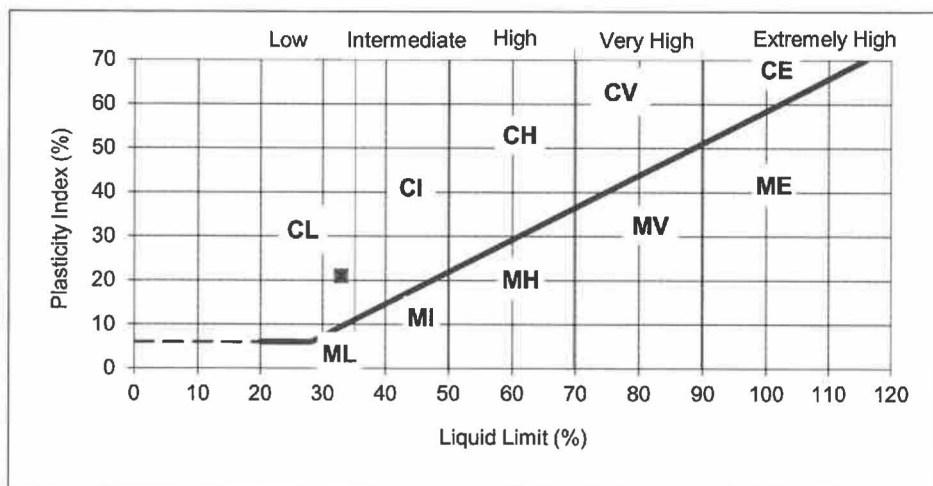
MATERIAL	Firm brown silty sandy CLAY with occasional gravel
ADVISED SOURCE	Site Investigation Sample

Moisture Content (Natural) (%)	Liquid Limit (%)	Plastic Limit (%)	Plasticity Index (%)	Passing 425 micron (%)
16	33	12	21	72

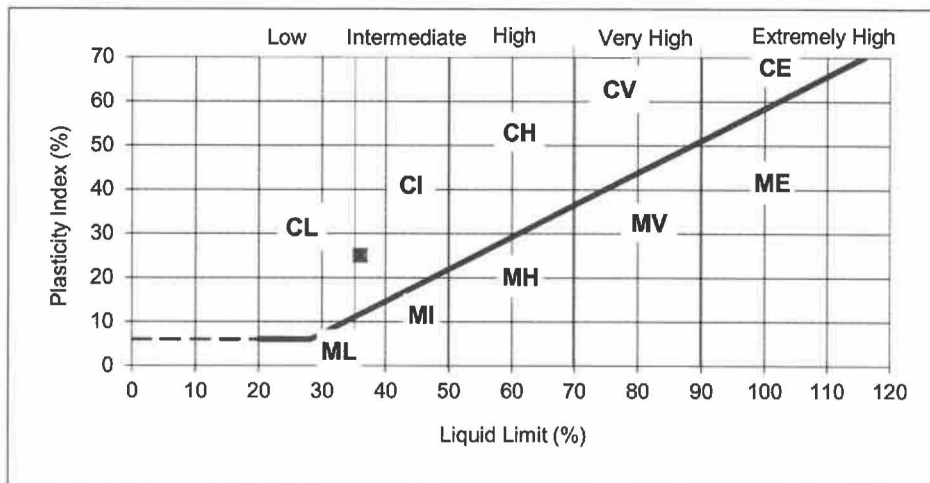
MATERIAL	Firm brown silty very sandy CLAY with rare gravel
ADVISED SOURCE	Site Investigation Sample

Moisture Content (Natural) (%)	Liquid Limit (%)	Plastic Limit (%)	Plasticity Index (%)	Passing 425 micron (%)
15	36	11	25	67
