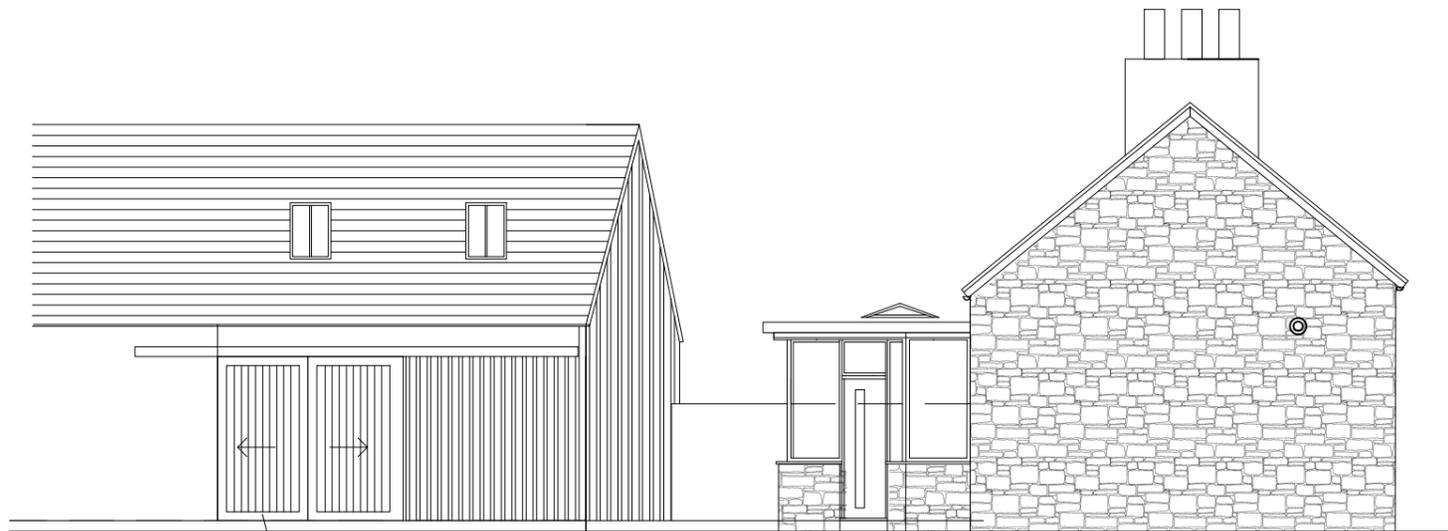
EAST ELEVATION

Existing barn doors removed and replaced with vertical timber cladding (stained black) and new sliding door with window behind- doors shown closed

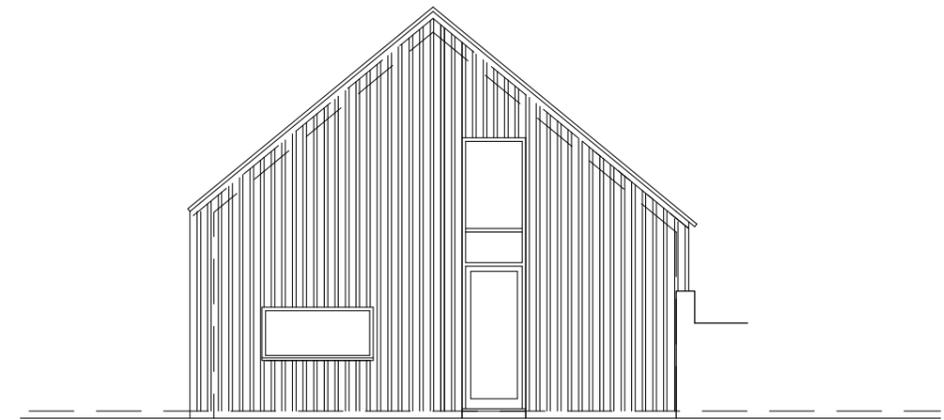
NORTH ELEVATION

Existing barn with vertical stained timber cladding to exterior -with new openings formed facing on to garden area.

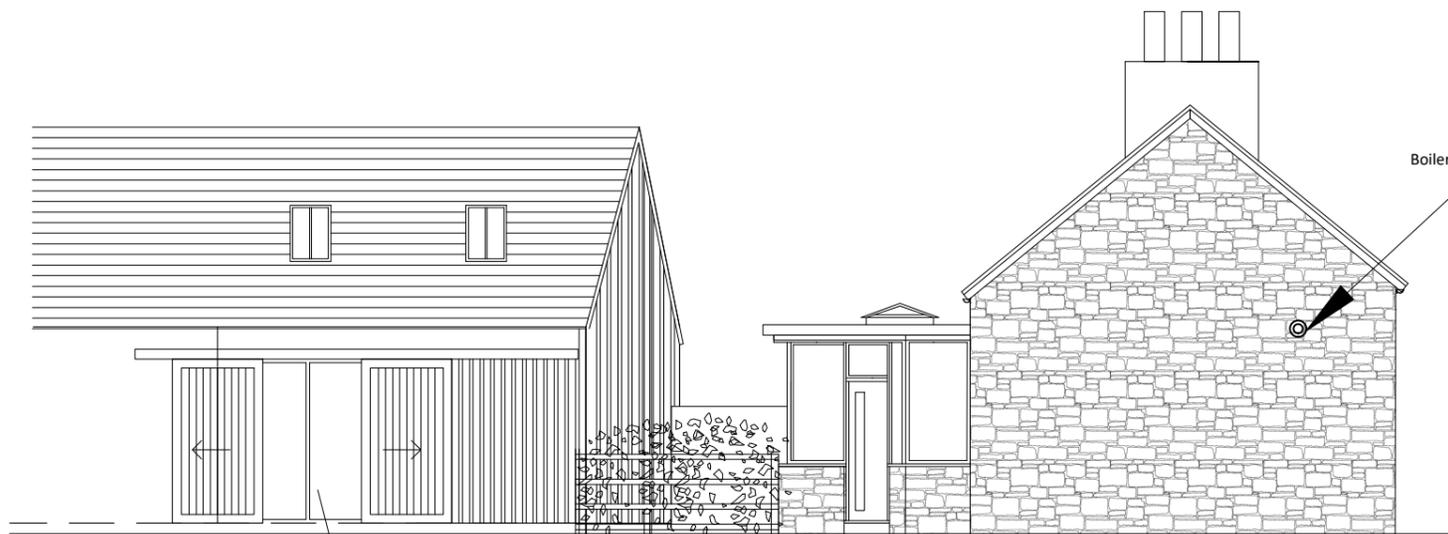
EAST ELEVATION

Existing barn doors removed and replaced with vertical timber cladding (stained black) and new sliding door with window behind.

New sun room with flat roof and overhang with low pitched rooflight above

New solid front door with vision panel

Boiler flue re-located

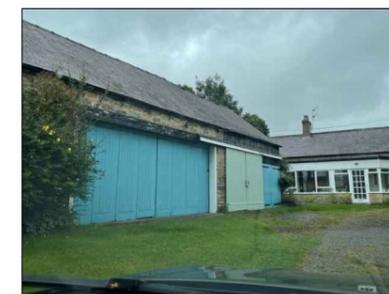
Barn as existing with hinged and sliding doors

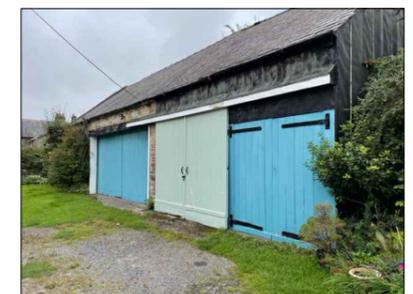
Barn as existing with hinged and sliding doors

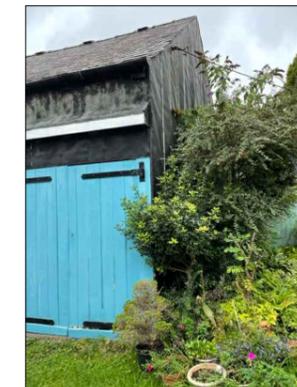
Barn as existing with hinged and sliding doors
