Preliminary Risk Assessment & Geo-Environmental Assessment

Torgate Lane, Bassingham

Presented to: **Lindum Group**

Delta-Simons Project No: 12-0310.03

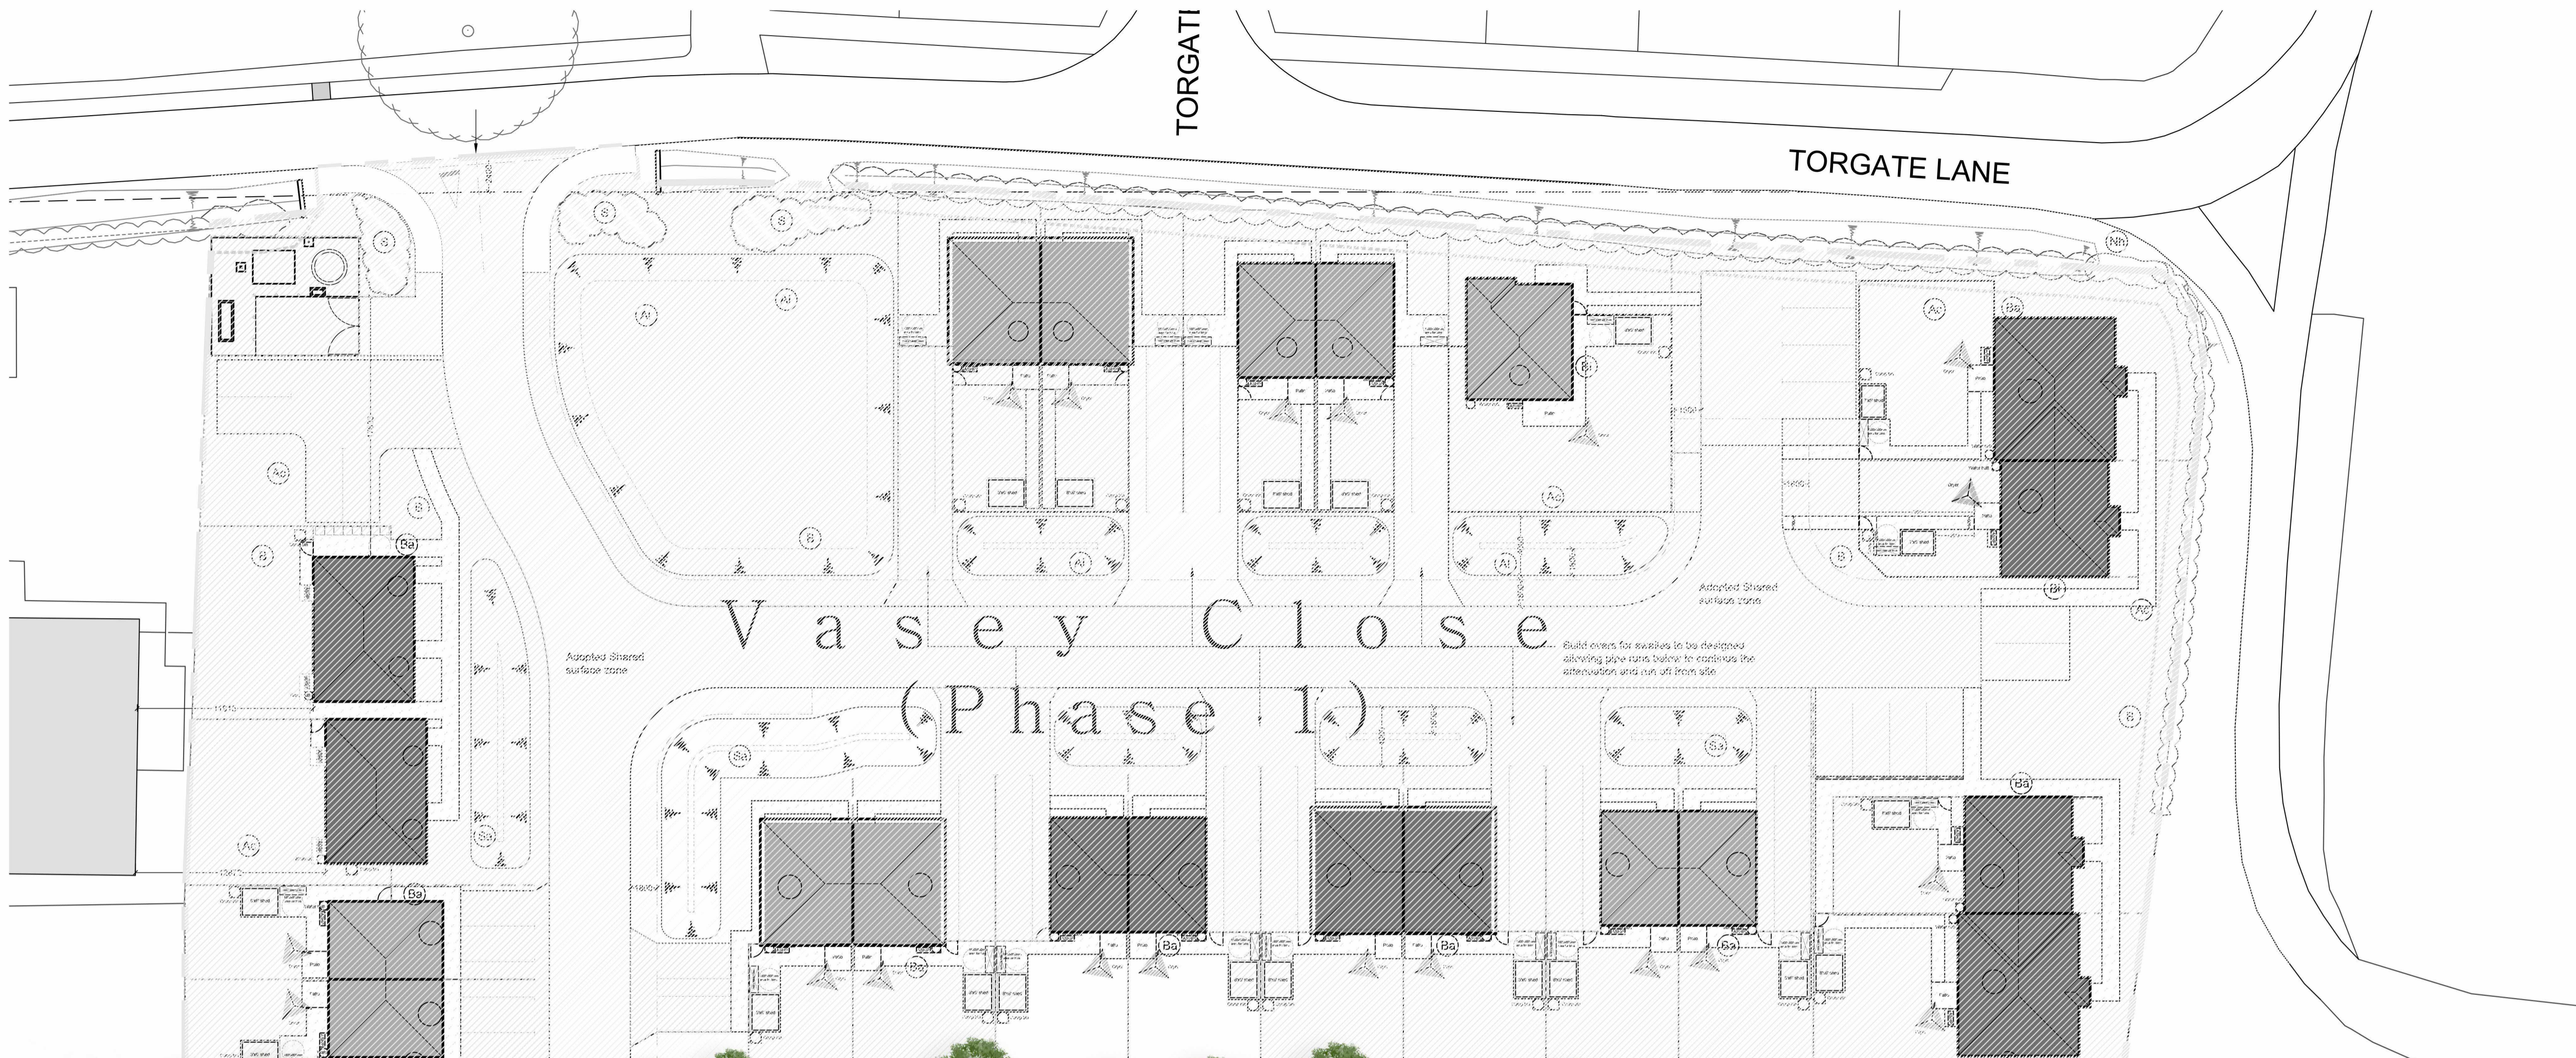
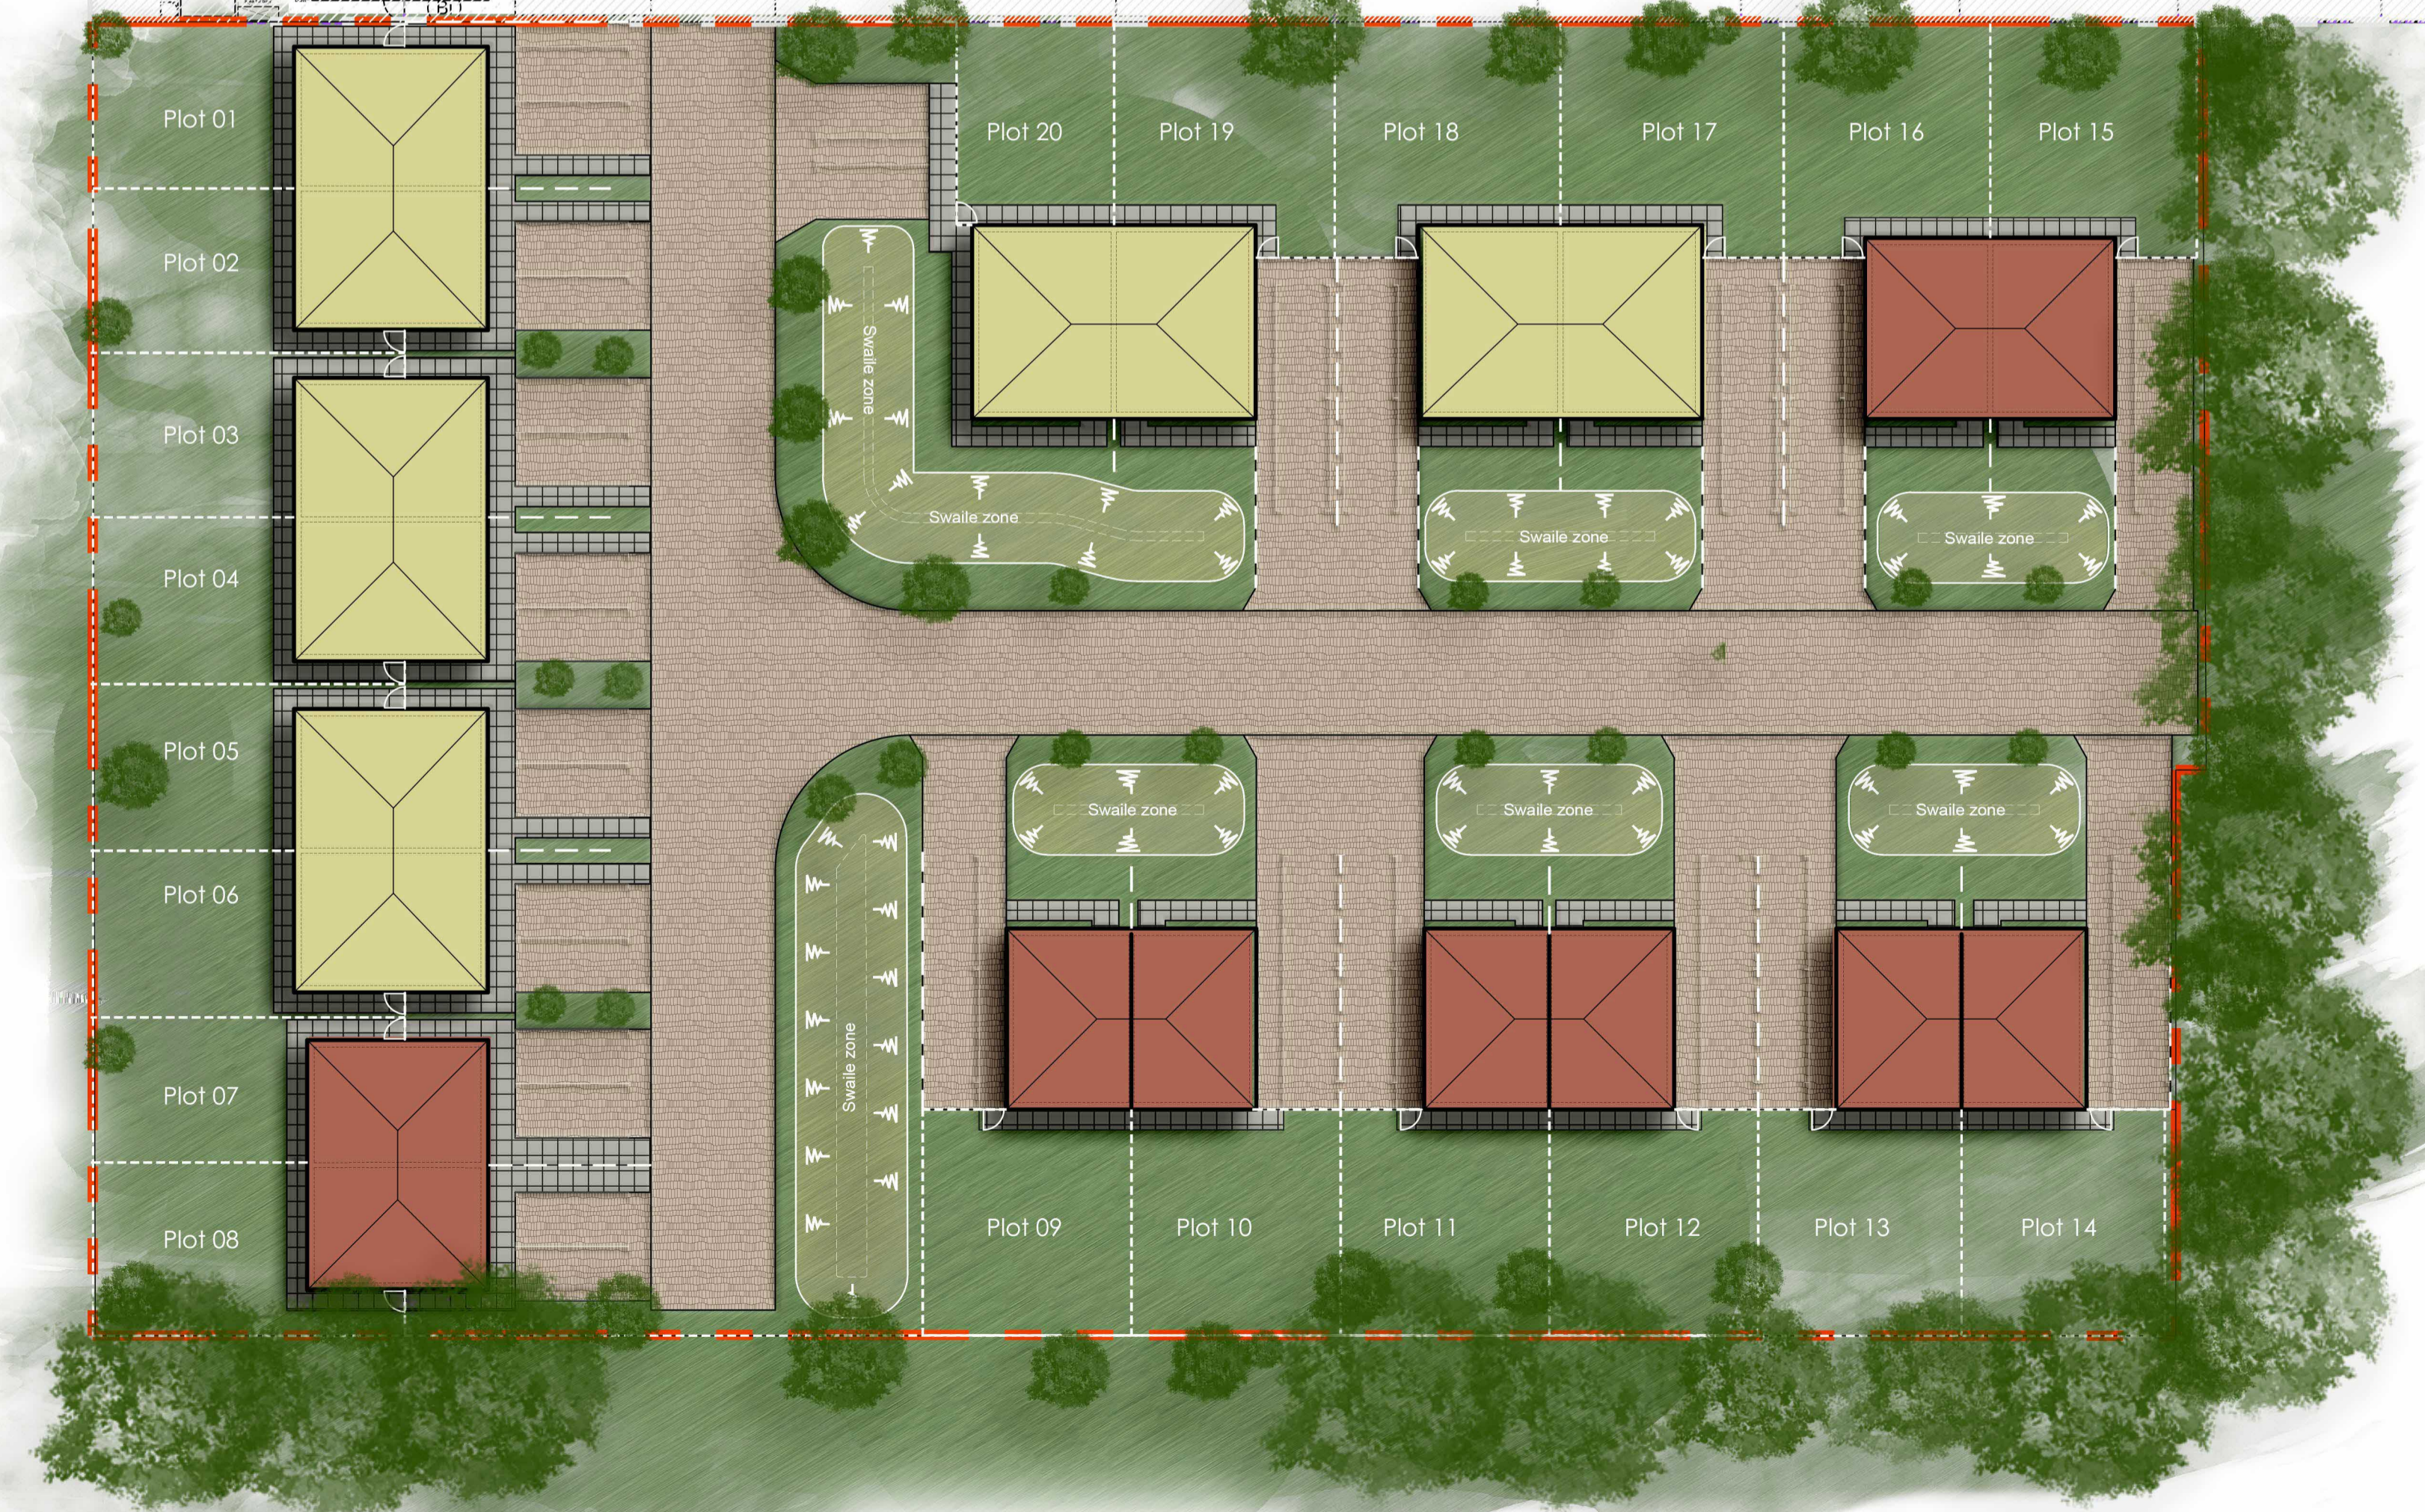
Rev	Description	Date
A	Unit GIA increased as per client instruction. Number of units increased to 20 from 16	12.02.18

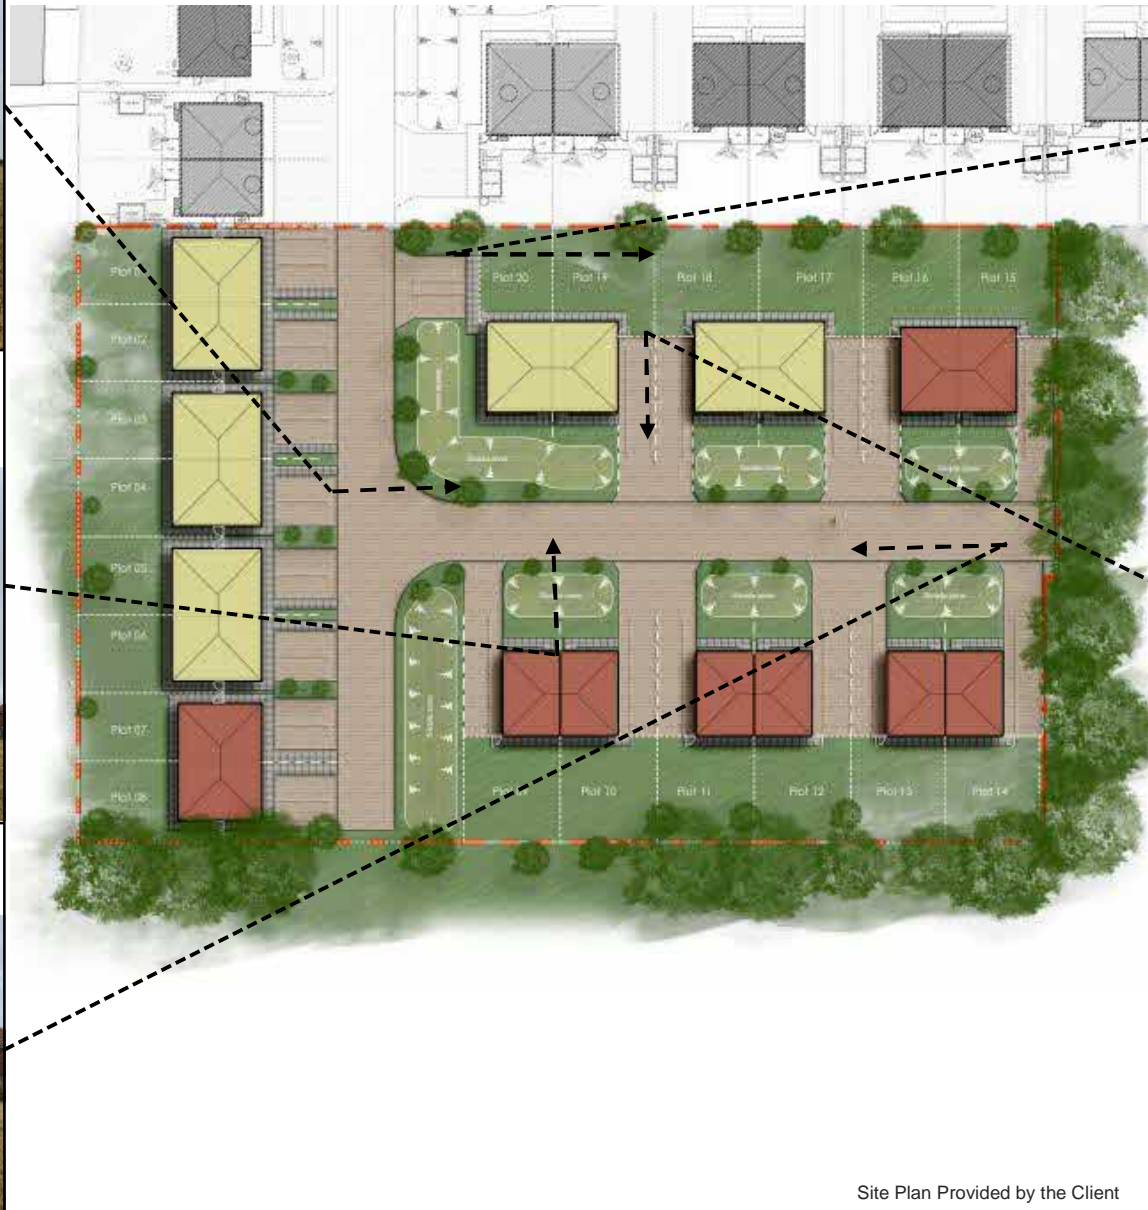
Figure 2 – Relevant Features Plan

COMMENTS: There is uncertainty as unrecorded land use may have occurred and caused contamination that has not been identified by the observations.
