Contaminated Land Phase One Desk Study for Proposed Residential Dwelling at, Land adjacent 58 Common Edge Road, Blackpool, FY4 5AU.

July 2019

Martin Environmental Solutions has been commissioned, to carry out a phase one contaminated land desk study report in relation to a proposed residential development on land at 58 Common Edge Road, Blackpool, FY4 5AU.

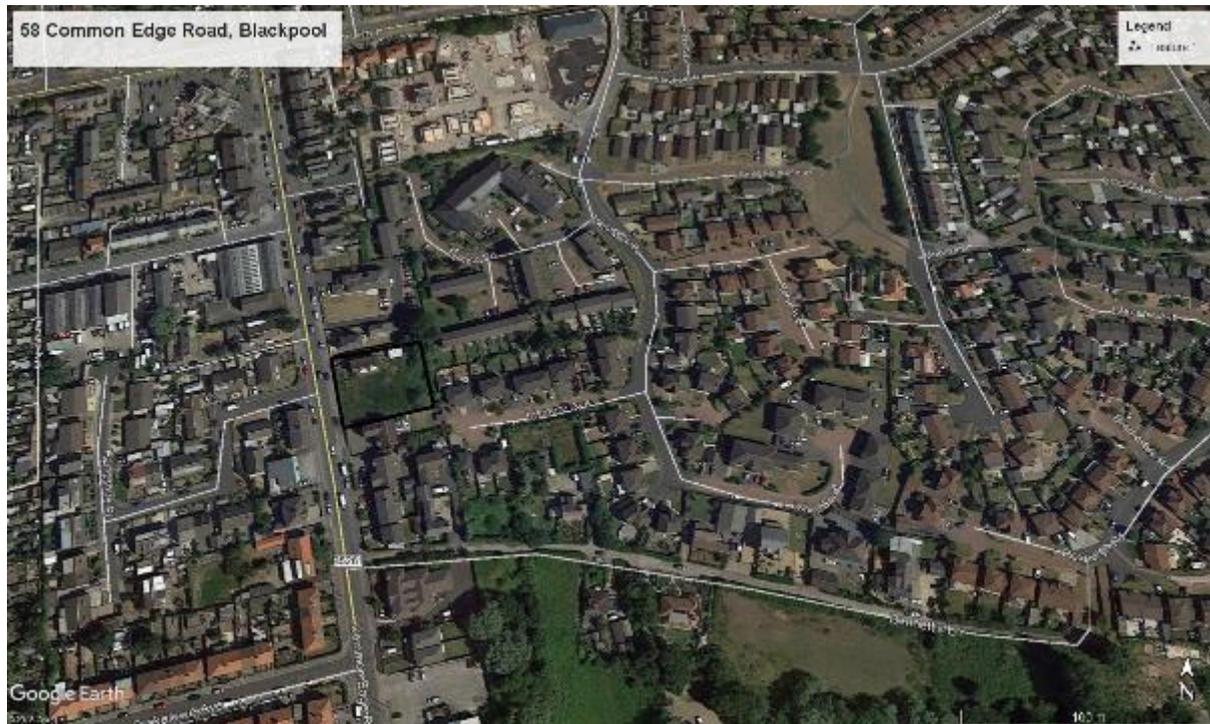
Figure 1 - Aerial Photograph

The site currently consists of the property 58 Common Edge Road to the north of the larger site, with a garage and outbuildings to the rear. The remainder of the site which is to be developed is currently overgrown, approx. square and covers an area of approx. 0.17ha.

Common Edge Road runs to the west of the site and residential properties surround the site to the north, east and south.

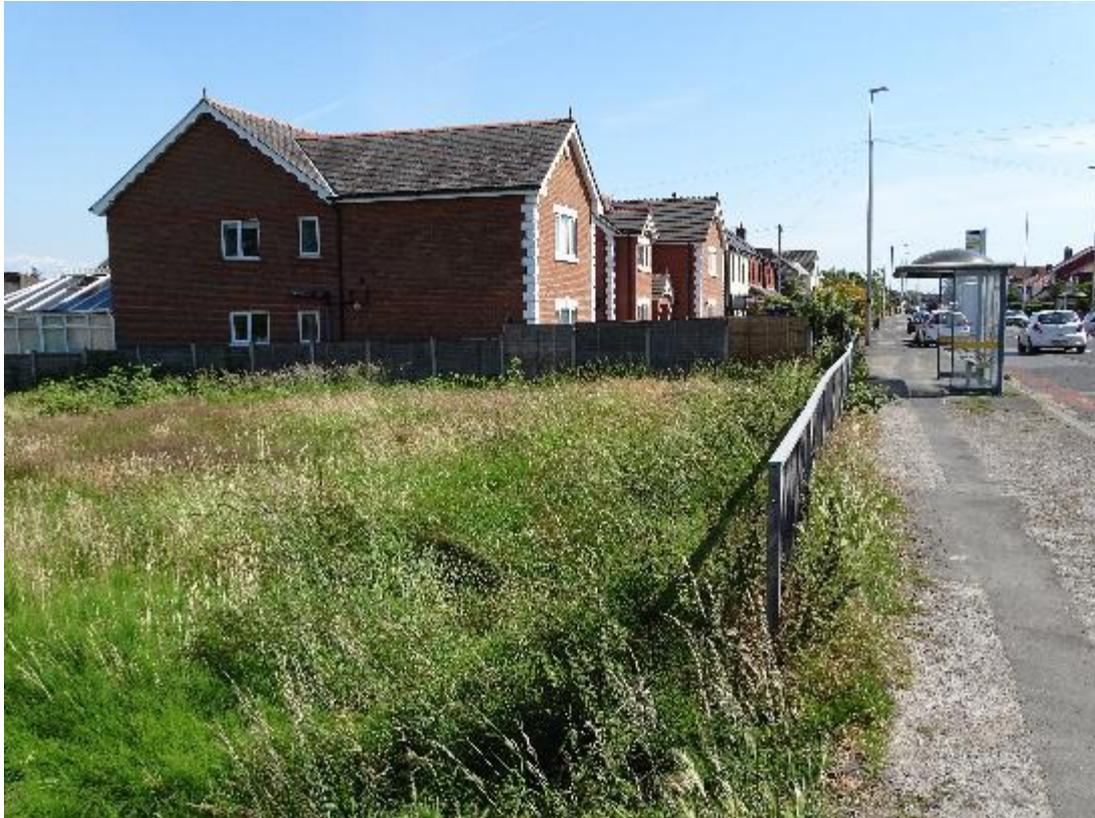
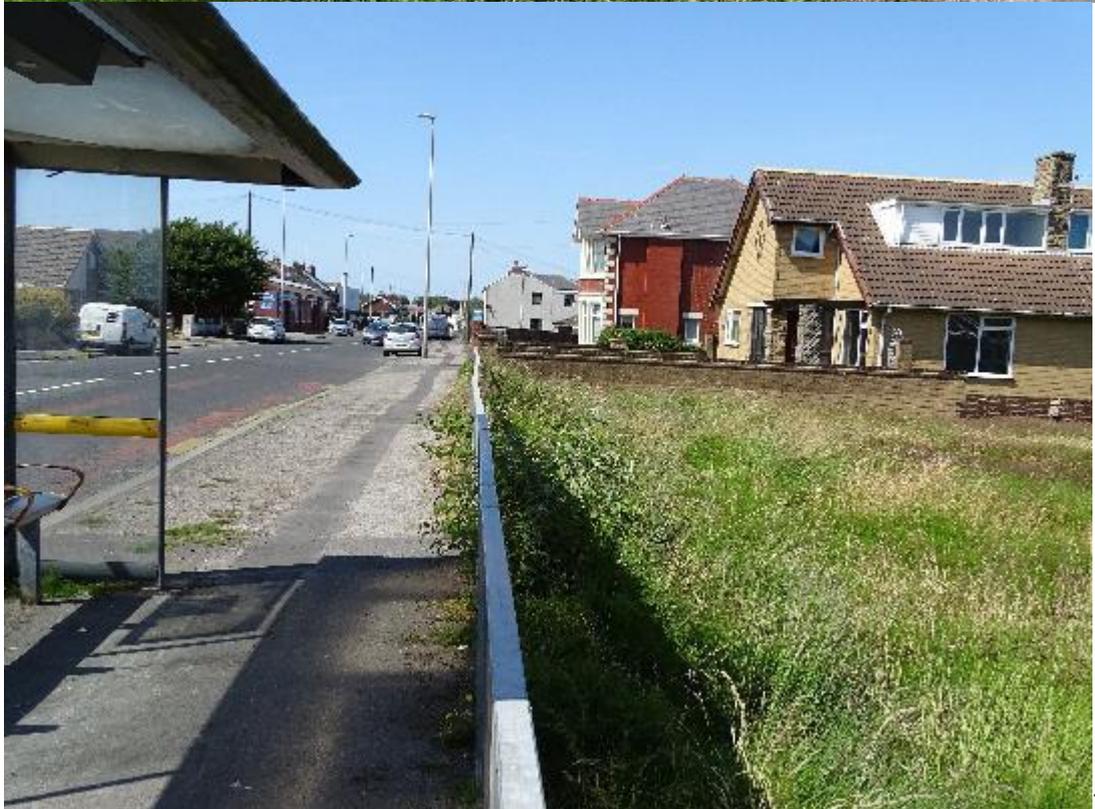
The western Boundary

The site is accessed from Common Edge Road, and sits at a lower level than the road. It continues to drop towards the rear of the site and the properties behind.

The remainder of the site was overgrown with no signs of any other deposits, contamination dead or distressed vegetation identified.

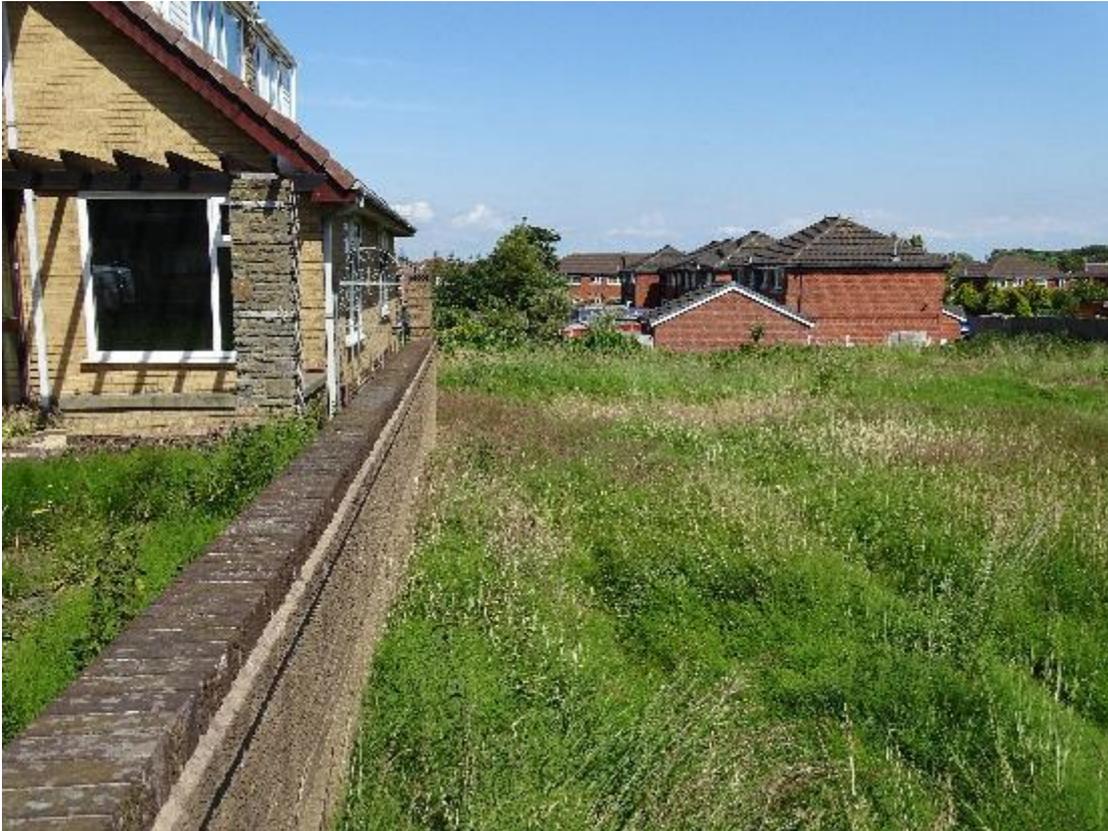
The existing house is located along the northern boundary of the site with a domestic garage and garden sheds to the rear all in a dilapidated state.

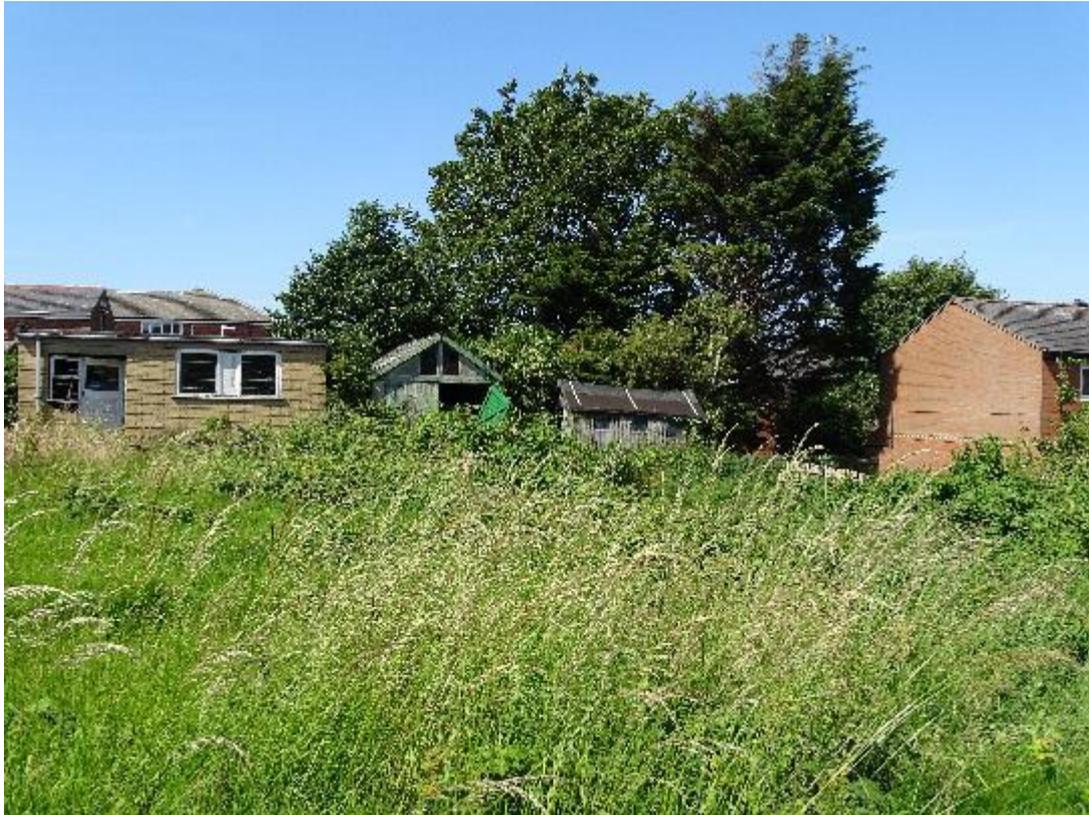
The out buildings behind the house

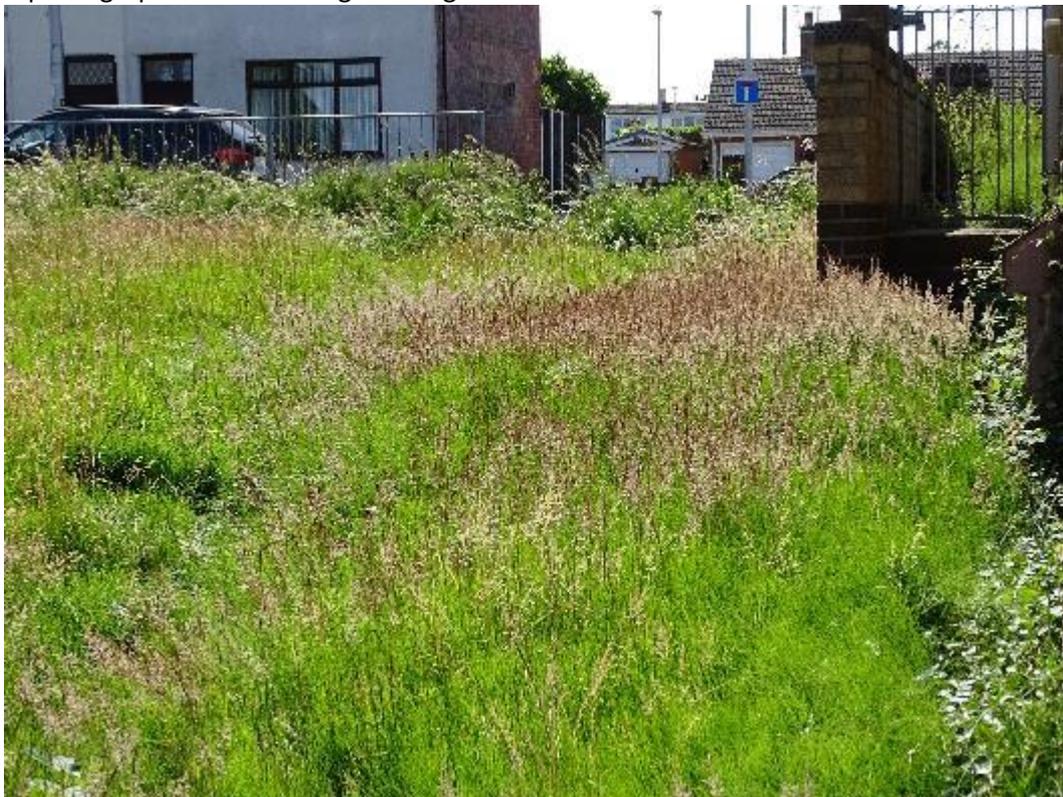
A photograph demonstrating the height difference between the road and the site.
