A CONTAMINATION ASSESSMENT FOR A PROPOSED COMMERCIAL DEVELOPMENT AT:

**HORNBEAM BUSINESS PARK PHASE 4, HORNBEAM ROAD,  
NORTH WALSHAM, NORFOLK, NR28 0FQ**

CLIENT:	Birchwood Building Limited
REFERENCE:	JAH/21.008/CA/Phase4
DATE:	11 January 2022

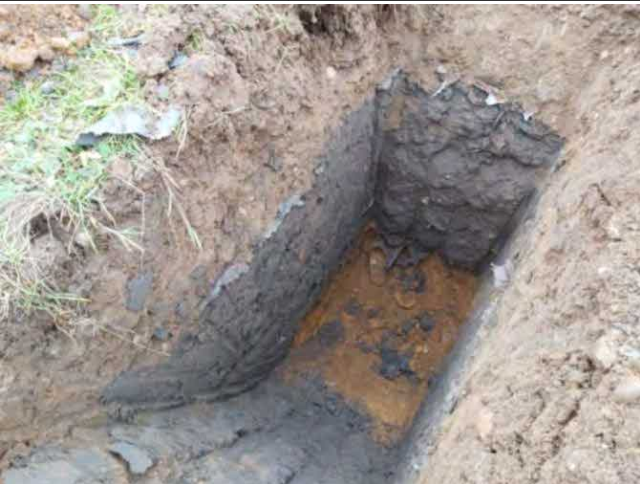
0.80 0.80	D2 ES2			40.87	0.50	MADE GROUND (Grey clayey slightly gravelly fine to medium sand. Gravel is subangular to subrounded fine to coarse flint, brick and clinker. Slight organic odour)

(1.00)		
1.60	D3			39.87	1.50	Orange brown very gravelly fine to coarse SAND. Gravel is angular to subrounded fine to coarse flint. With occasional flint cobbles	
			14/12/2022:DRY	39.57	1.80	Complete at 1.80m

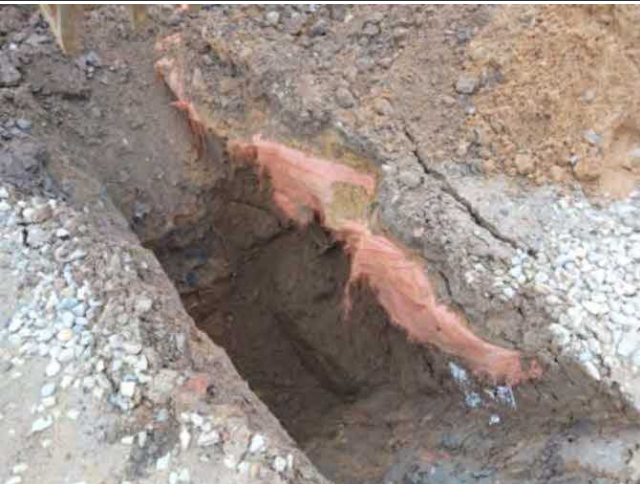
1.00 1.00	D2 ES3			40.06	(1.00) 1.60	MADE GROUND (Brown mottled orange brown and grey slightly silty gravelly fine to coarse sand. Gravel is angular to subrounded fine to coarse flint and brick)

1.80 1.80	D3 ES4		14/12/2022:DRY	39.76	(0.30) 1.90	Orange brown slightly silty gravelly fine to coarse SAND. Gravel is subangular to subrounded fine to coarse flint	
						Complete at 1.90m

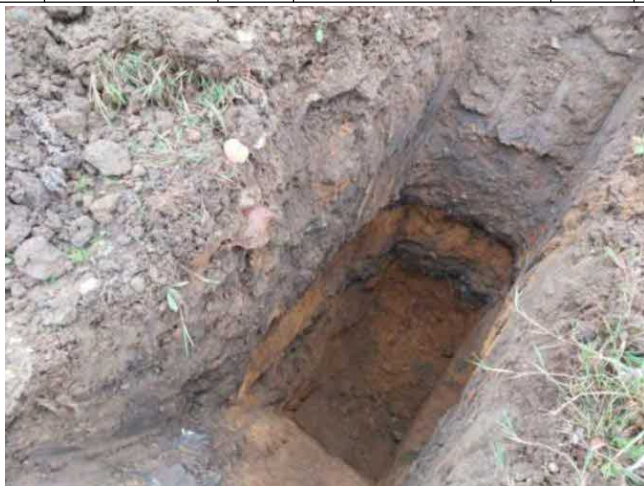
1.50 1.50	D3 ES3		ES3 = 1 jar		(0.55)		
				40.24	1.90	Orange brown silty slightly gravelly fine to coarse SAND. Gravel is subangular to subrounded fine to medium flint

(0.50)		
2.00	D4			39.74	2.40	Complete at 2.40m	
			14/12/2022: DRY

1. Location CAT scanned prior to excavation
2. No groundwater encountered
3. Trial pit remained open and sidewalls stable during excavation.
4. Trial pit backfilled with arisings upon completion.

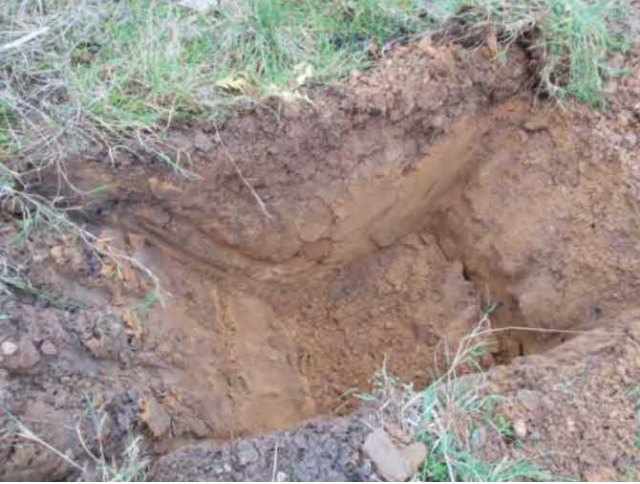
14/12/2022: DRY	41.08	1.00	Complete at 1.00m			
<div>

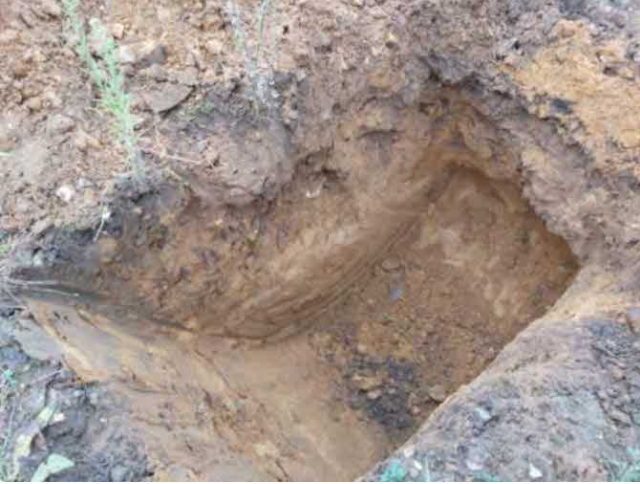
14/12/2022:DRY	41.23	1.10	Complete at 1.10m

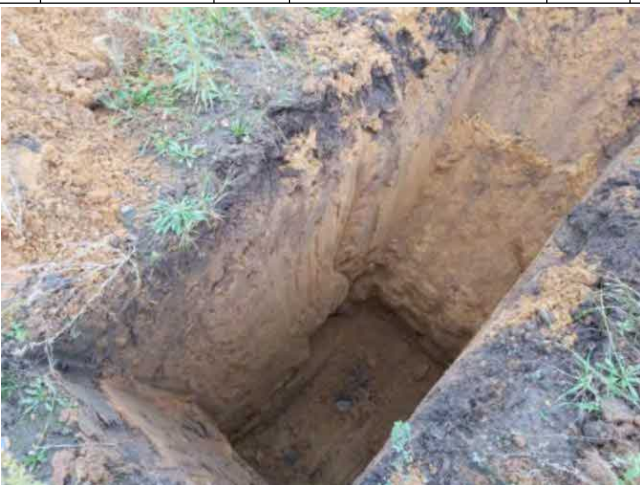
1.00 1.00	D2 ES2				41.53	0.80	Orange brown mottled yellow brown slightly silty slightly gravelly fine to coarse SAND. Gravel is subangular to subrounded fine to coarse flint. With rare flint cobbles

2.00 2.00	D3 ES3	(1.40)	...becoming gravelly and with occasional cobbles					
		40.13	2.20	Complete at 2.20m

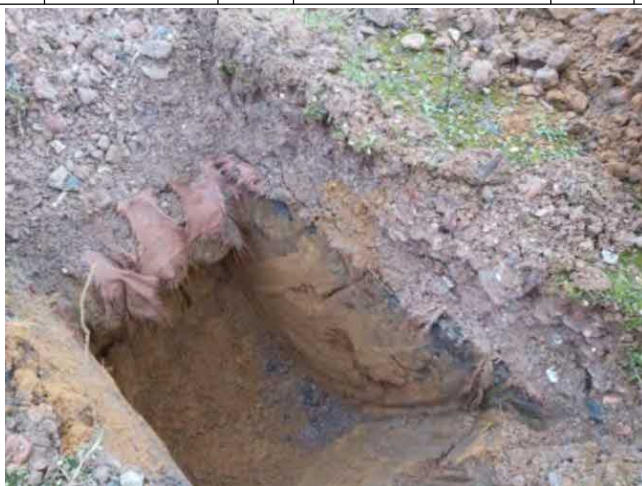
14/12/2022:DRY		40.89	1.30	Complete at 1.30m

1. Location CAT scanned prior to excavation
2. No groundwater encountered
3. Trial pit remained open and sidewalls stable during excavation.
4. Trial pit backfilled with arisings upon completion.
5. Samples A1 and A2 were confirmed, via laboratory analysis, to not be asbestos containing materials (ACM)
