Residential & amenity improvements to the main house

Heritage Statement
23rd March 2022

Wilderness House,
Wilderness Avenue. Sevenoaks
Kent, TN15 OEA

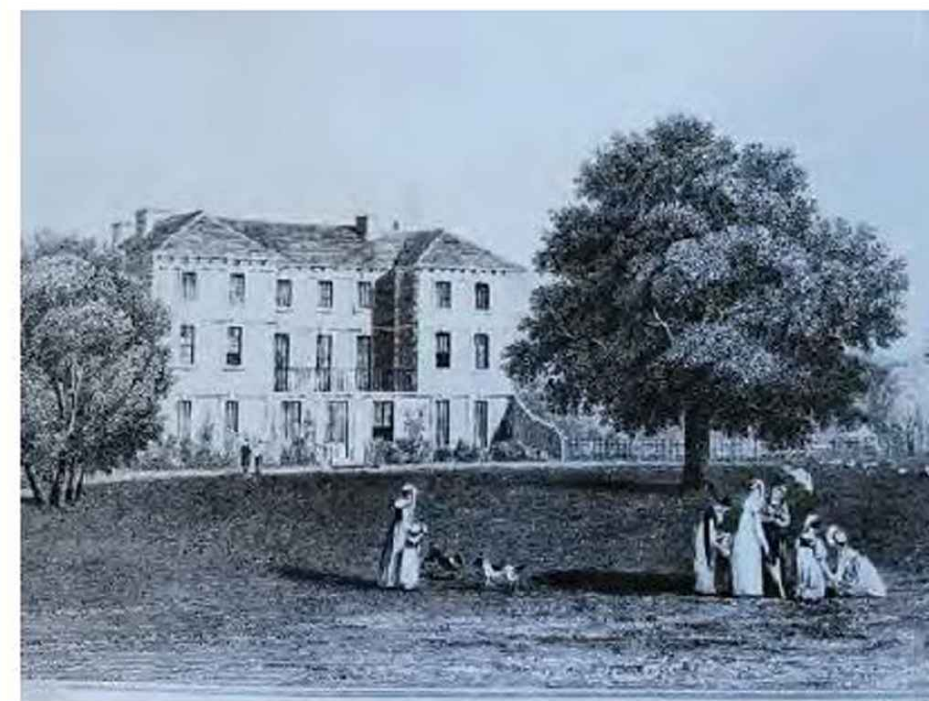
The house itself is shown by Neale to front directly onto an expansive front lawn with a screen wall extending from the south-east corner of the house disallowing access to the gardens to the south. The engraving suggests multi paned sash windows and a first floor balcony above the central doorway (Now lost to 19th and 20th century modifications). The image also shows differences in the roof layout to that in place in the present day. Subsequent to Neale's image, a parapet wall has been added hiding the base of the roof and the chimneys altered. These alterations are likely to date from the late 19th century.

Engraving of Wildernesse House by Neale, 1818

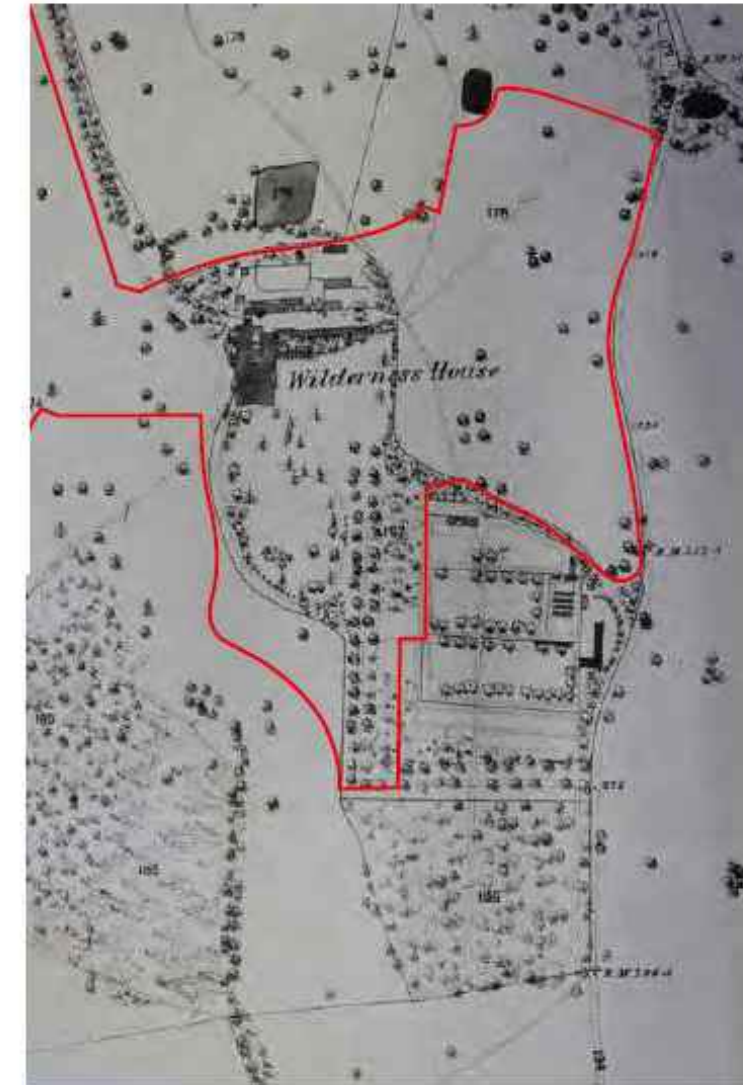
1866 - The second Marquis was succeeded by the third Marquis who leased the Wilderness Estate to a London Banker named Charles H Mills, later known as the first Baron Hillingdon. The 1869 Ordnance Survey map shows a detailed layout of the estate at this time. The main house appears to have been augmented to the east by a linear range of buildings with glass houses to the south. The layout of the estate grounds appears to generally correspond with that shown by Andrews et al at the end of the preceding century. South of the house, open wooded grounds are encircled by a woodland walk. The estate is approached via a main tree lined drive (Wilderness Avenue) from the north-west. The alignment of a second tree lined drive is shown to traverse the estate from the south. East of this the kitchen gardens are laid out and incorporate planting, pathways and greenhouses. Open parkland continues to flank the house to the east and west.

1st Edition Ordnance Survey map, 1869.

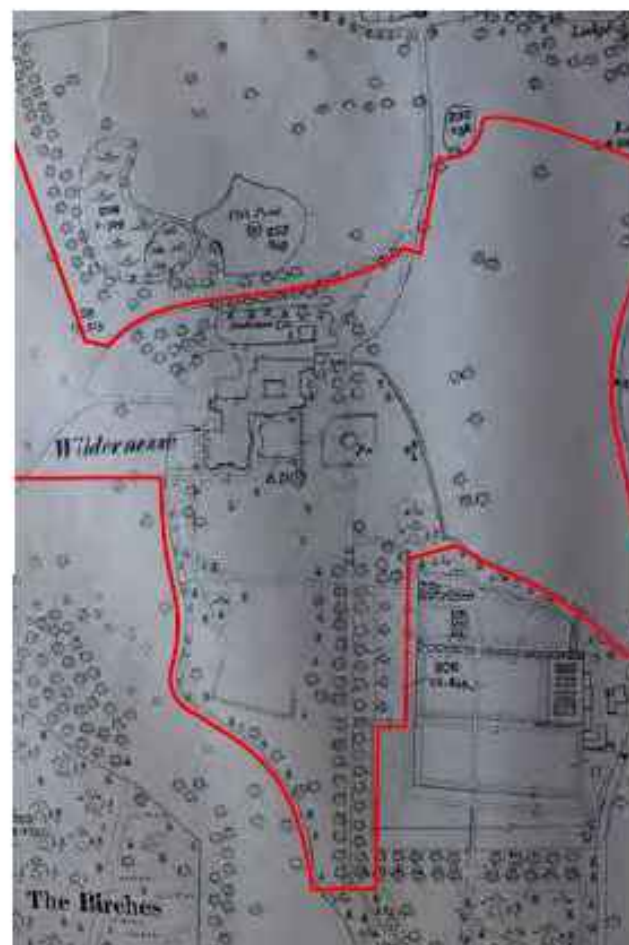
1909 - The development of the house and gardens are reflected on the Ordnance Survey map. The outline of a rectangular terrace is noted to the south of the main house. By this date a fountain and sun dial have been introduced into the formal gardens east of the house.

Ordnance Survey map, 1909

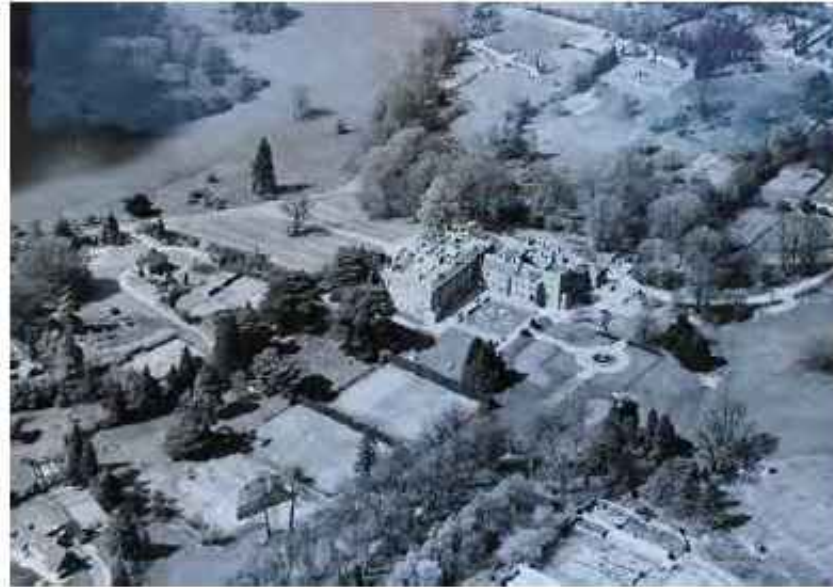
An aerial photo (predating 1961) shows the layout of the estate during the middle part of the 20th century, the tennis courts in particular dominant the former landscaped grounds

Aerial Photograph of the site (Mid-20th century)

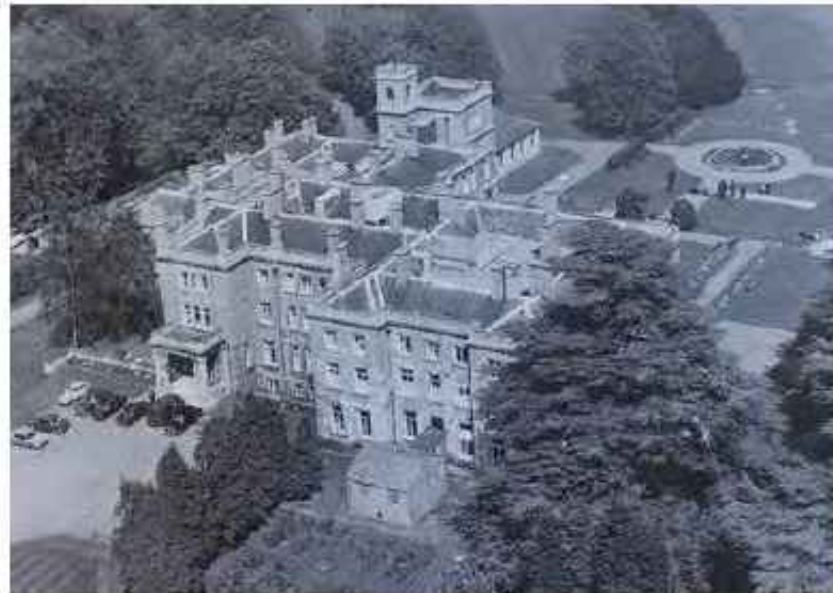
A second aerial photograph dating from 1960 shows a clear view of the main west elevation of the property at this date. Of note is the single storey extension to the former entrance to the 18th century house (east of the Rose Garden). The extension, since replaced by a more recent extension is unsympathetic to the historic form of the building but is obscured from view by the overgrown hedge defining the northern edge of the Rose Garden.

Aerial photograph showing the west elevation in 1960 showing extension against 18th century main entrance. This extension was replaced with another extension during the late 20th century (still extant)

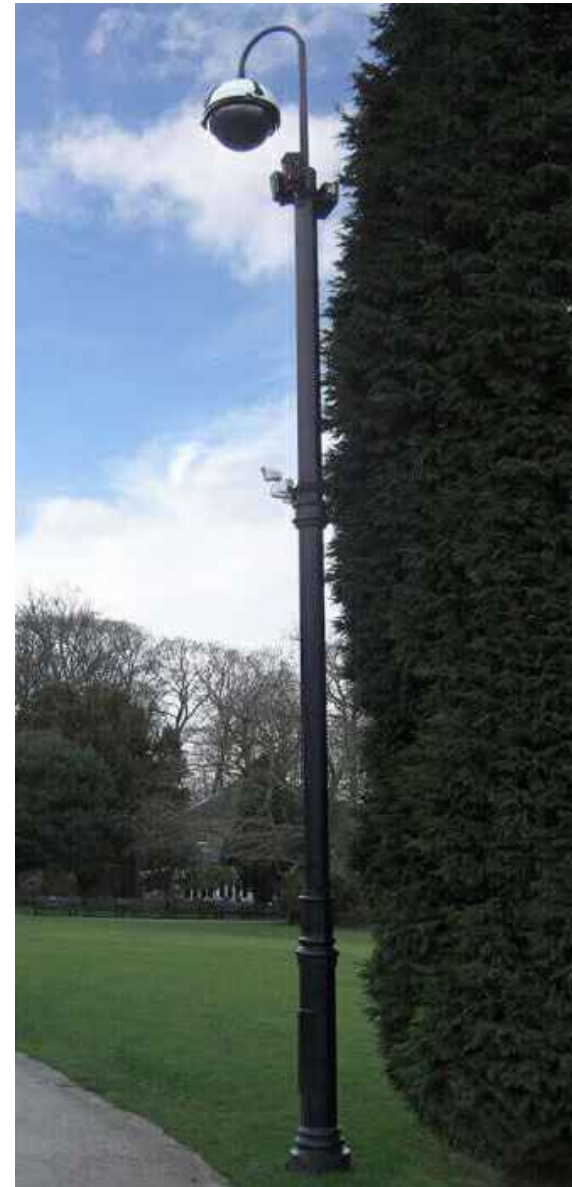
The level of change proposed is minor as a result of the insertion of 2 no CCTV post which will be sympathetic and in keeping with the style that is currently found on the site.

Proposed CCTV post style

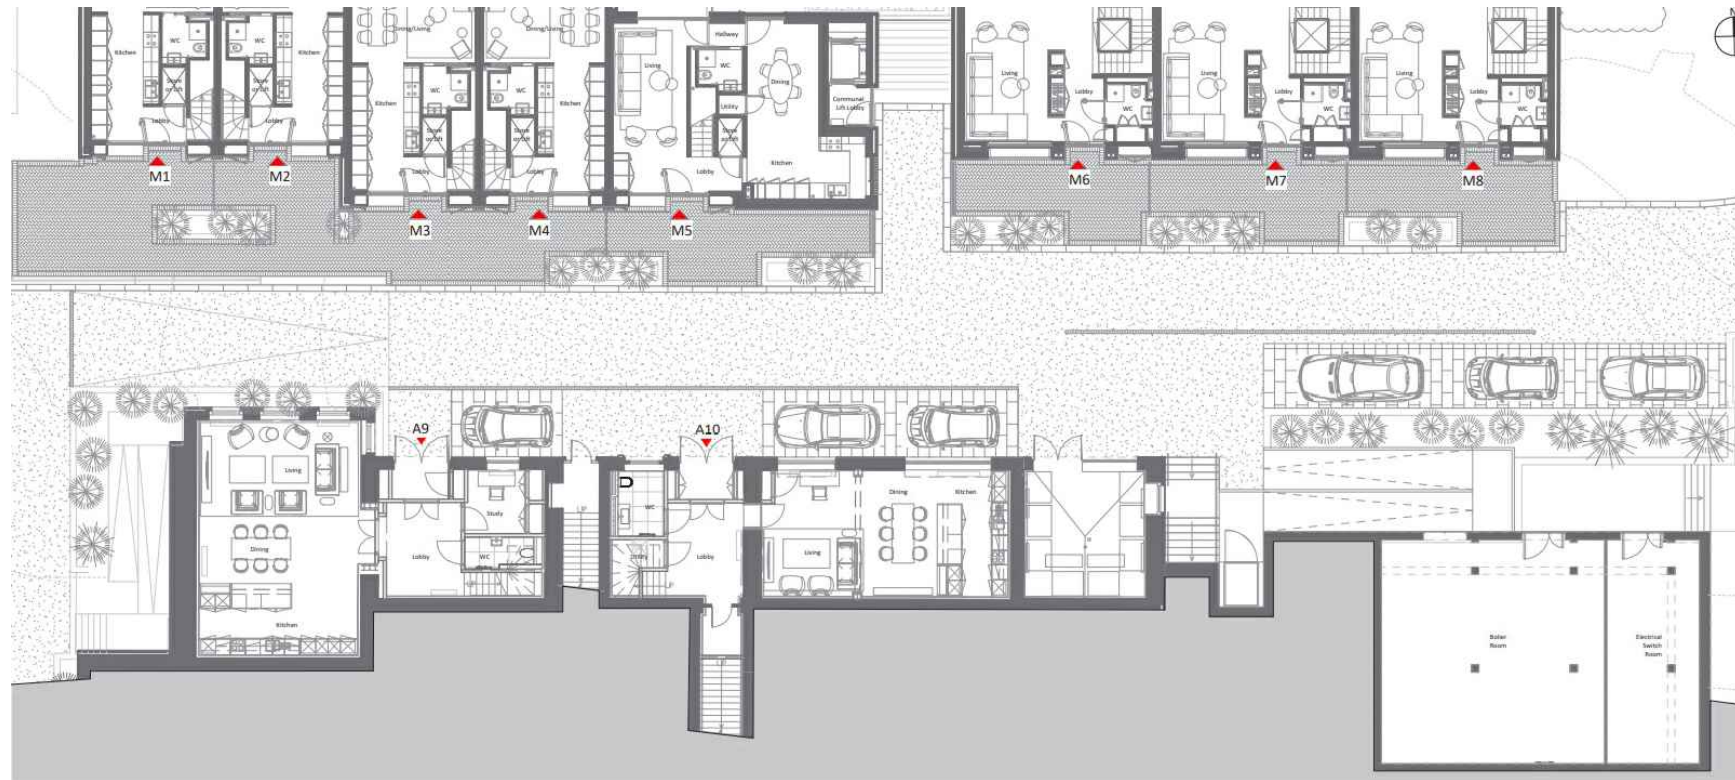
Existing landscape plan (NTS) showing apartment 9 & 10 entrances

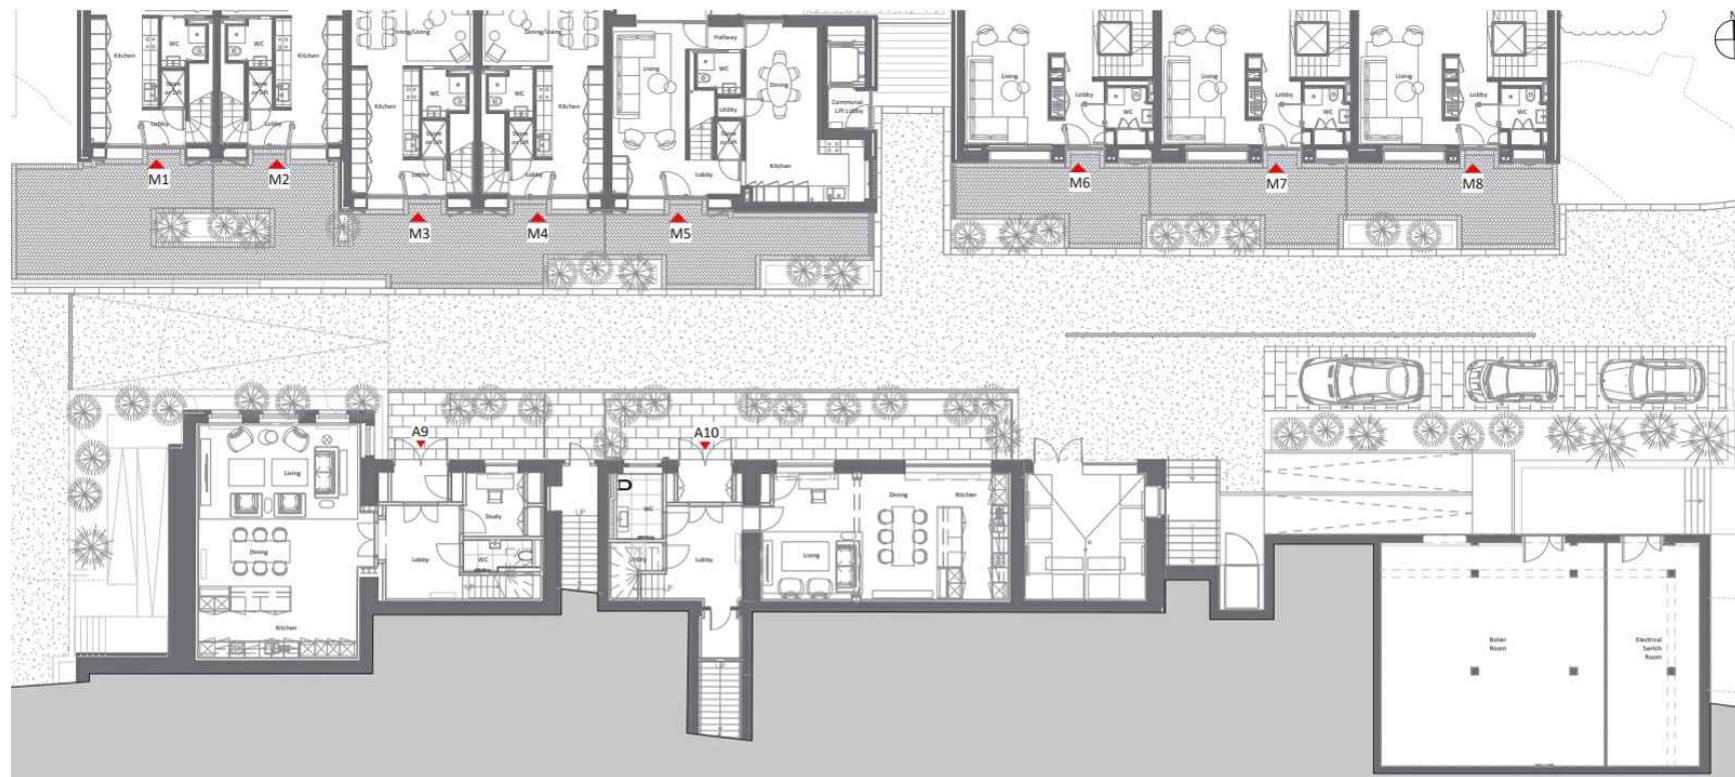
The proposal will have a minor level of change to historic form with the insertion of landscaped buffer zones to the front door entrances. The insertion of the low level planting will provide a better outlook and level of protection to the entrances. The proposed change is in keeping with treatment found in other areas of the site.

Proposed landscape plan (NTS) showing apartment 9 & 10 entrances

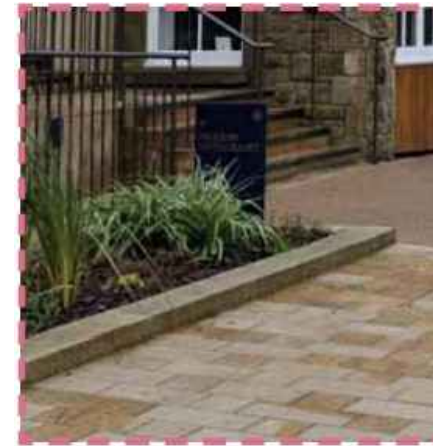
Removable planters defining edge of terrace. Height to match mews house planter heights and finish stained to match timber panels on facade

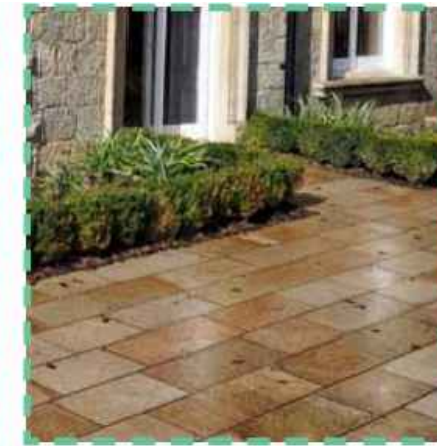
Terracing to apartment 13, 14, and 15 use rectangular pavers to define terrace areas. These will be used in a similar fashion to apartments 9 & 10.
