1557 :: Cradlebridge Farm

Planning Condition Discharge Information

09.05.2022

Surface Water Drainage System (condition 4)

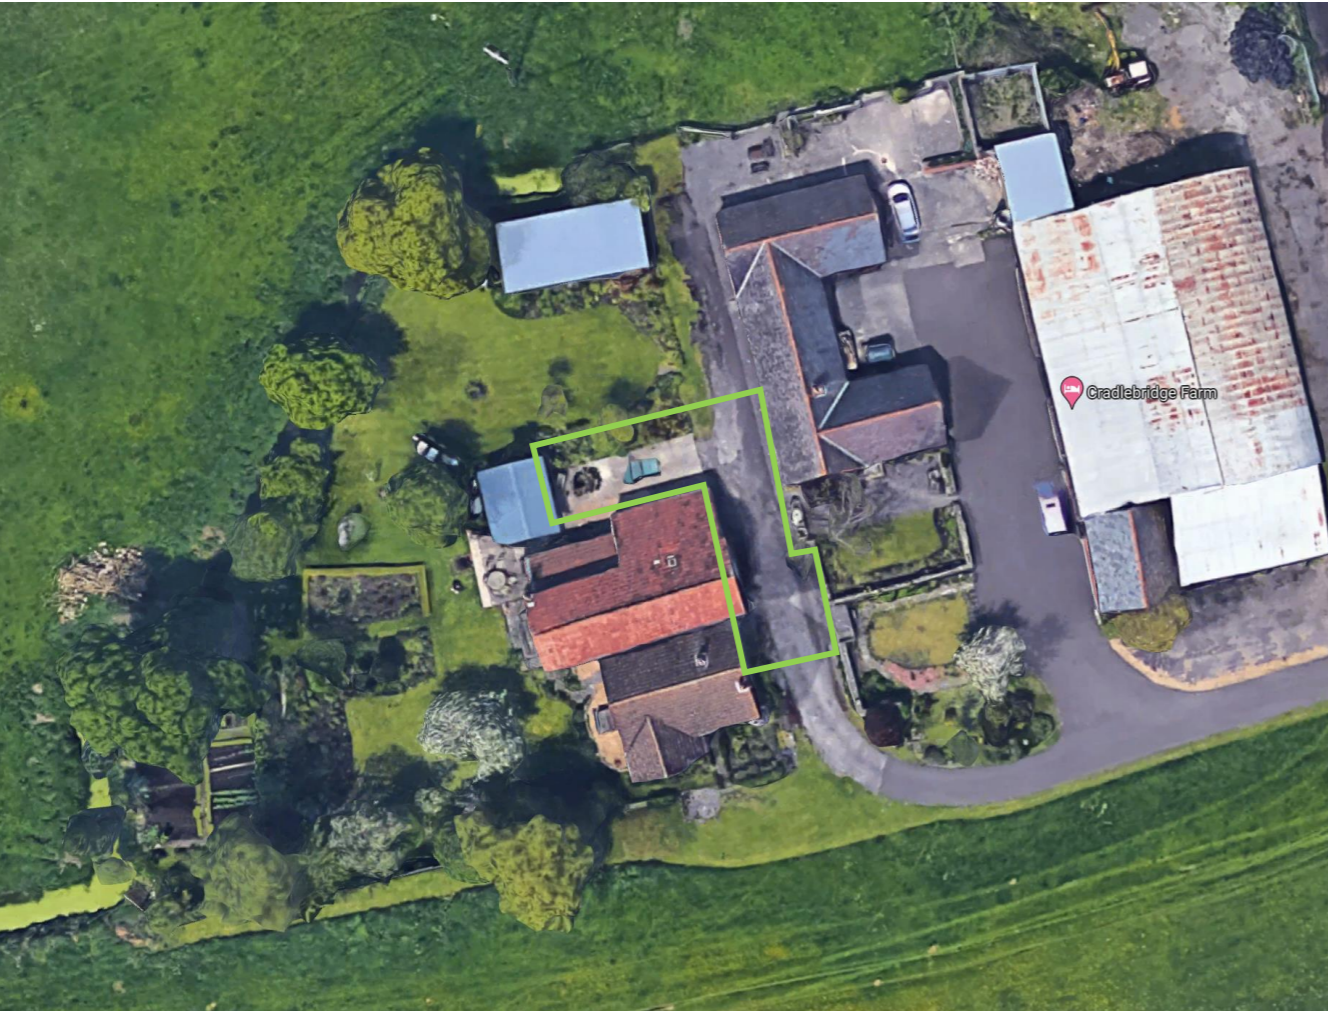
Aerial photograph demonstrating area of lawn (green outline) proposed to replace tarmac track and concrete hardstanding.

There is a large reduction in impermeable area as part of the proposals – hard standing tarmac track to the East and North of the dwelling is replaced with lawn.

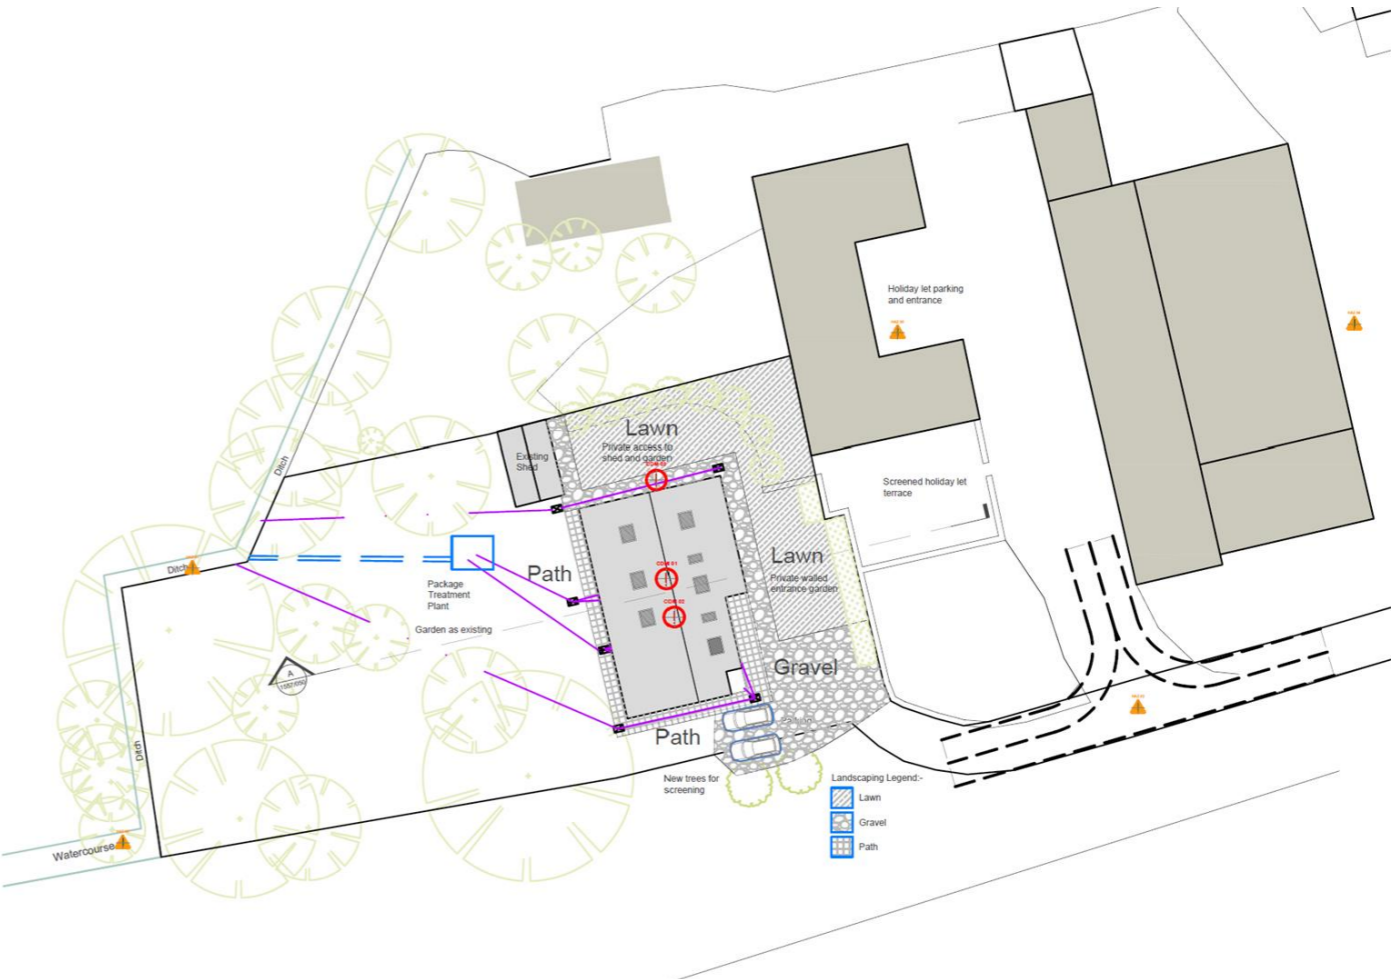
Drawing 1557/100 demonstrating landscape proposals and surface water drainage

In relation to planning condition 4 – surface Water Drainage System, we confirm that surface water collected from the roof of the proposed dwelling will be

- i) Harvested in water butts for domestic irrigation purposes
- ii) Overflow will be directed into the watercourse adjacent to the site.

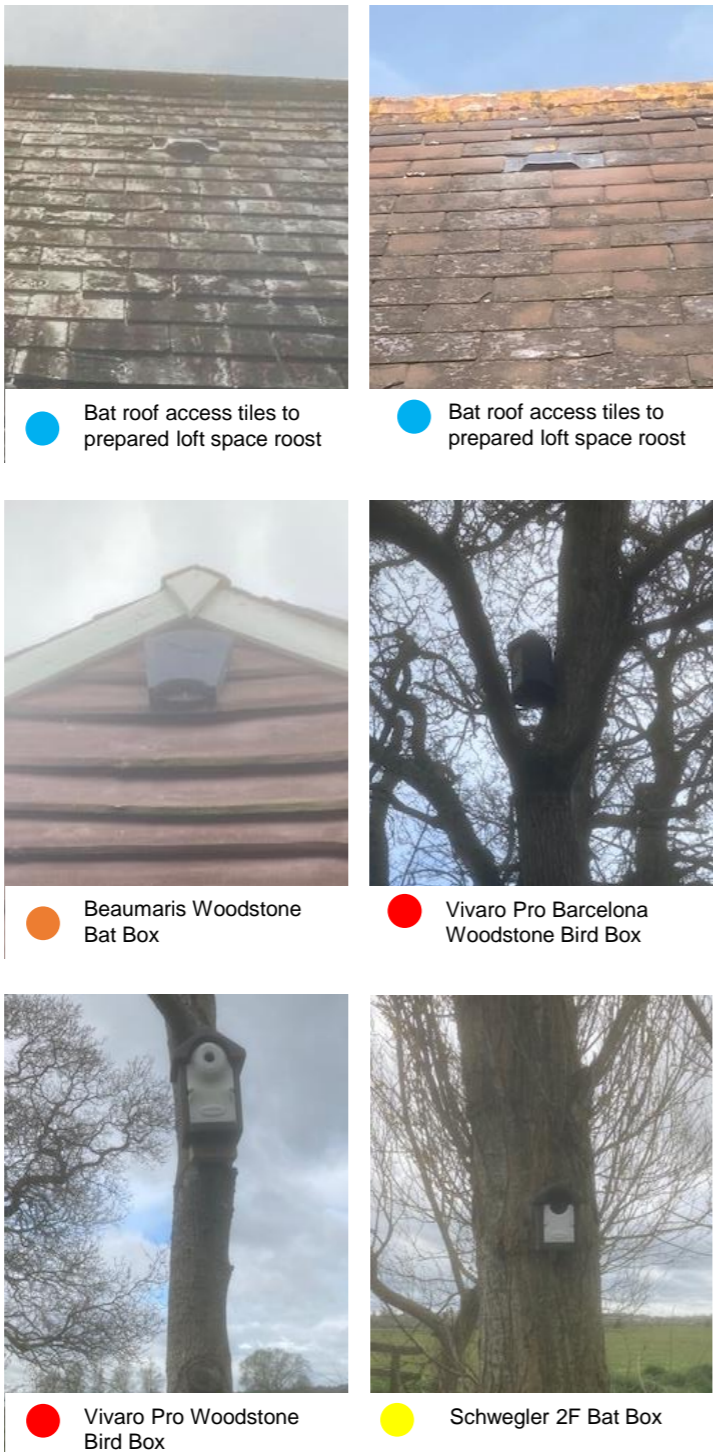
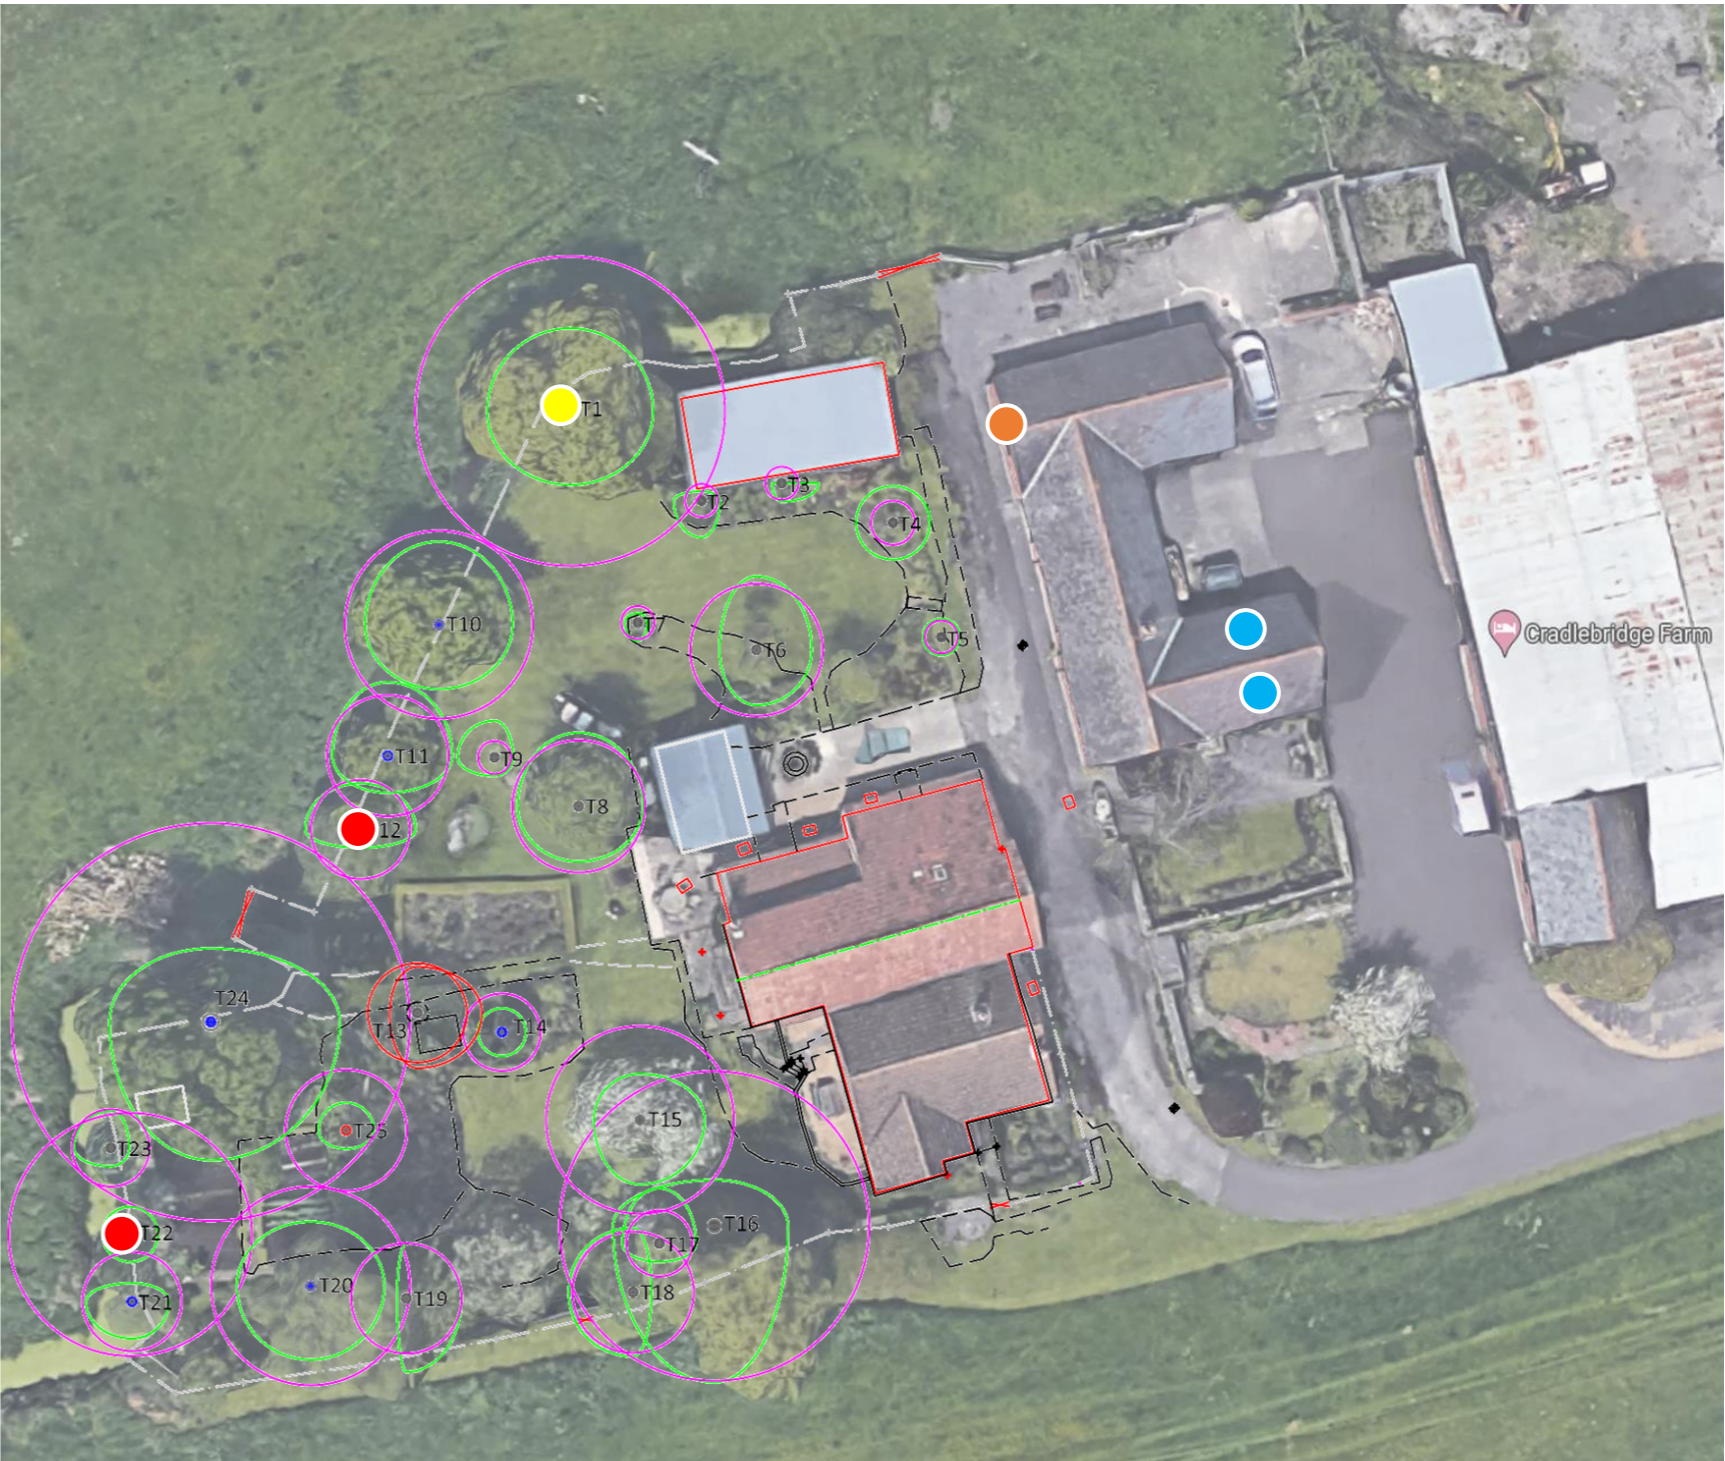
Referring to the images and plan opposite, we confirm that bat roof access tiles have been installed to provide entry into the loft space constructed in accordance with the ecological requirements set out in the original planning application.

A Beaumaris Woodstone Bat Box has been installed on the gable end of the holiday let cottage adjacent to the site, and Vivaro Pro Woodstone bird boxes and a Schwegler 2F bat box have been installed on the surrounding trees (trees T12 & 22 for the bird boxes and tree T1 for the bat box).

Installed photographs are included opposite.
