Client:	Project:
W. J. & M. Mash Limited	Bovingdon Airfield WW2 Control Tower
	Bovingdon Airfield
	Chesham Rd, Bovingdon
	Hemel Hempstead, HP3 0NP

Job Number:	Drawing No:	Title:
2114	P_2000	Elevations As Existing & Original

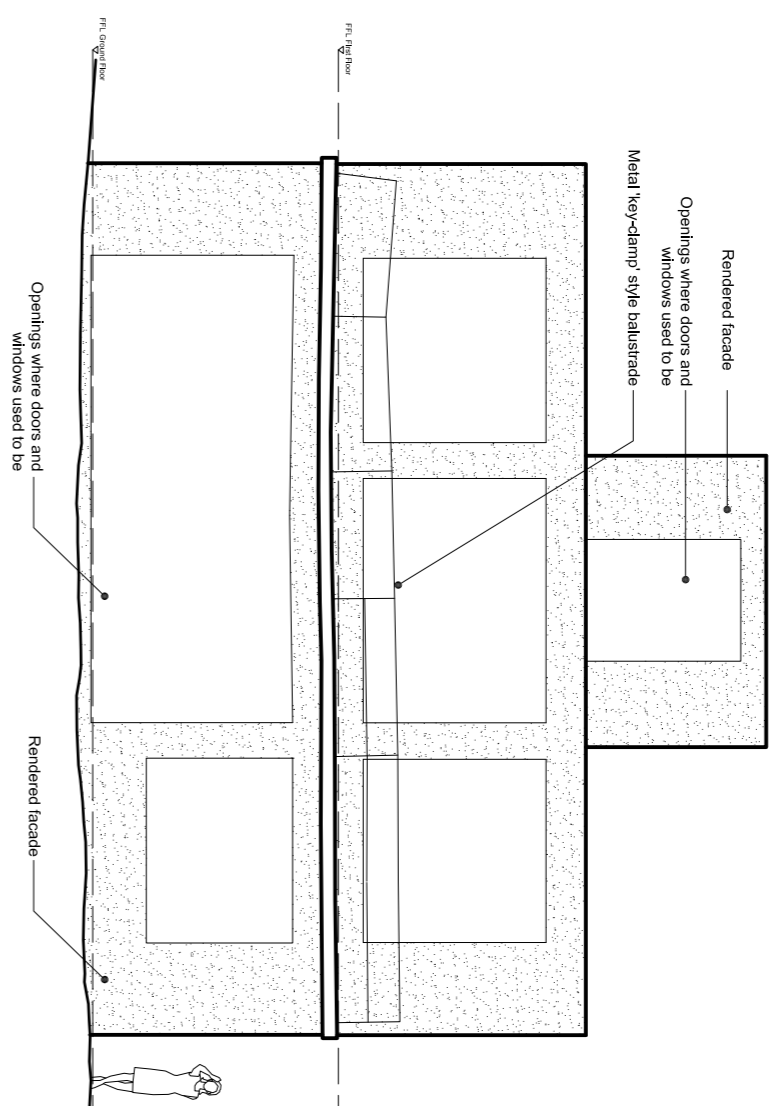
01 Front Elevation As Existing

Note: The existing building is derelict and is in an extremely poor state of repair - no doors or windows exist with the exception of a few odd broken frames. The building has been severely damaged by water ingress and possibly fire in the past and much of it is unsafe to enter

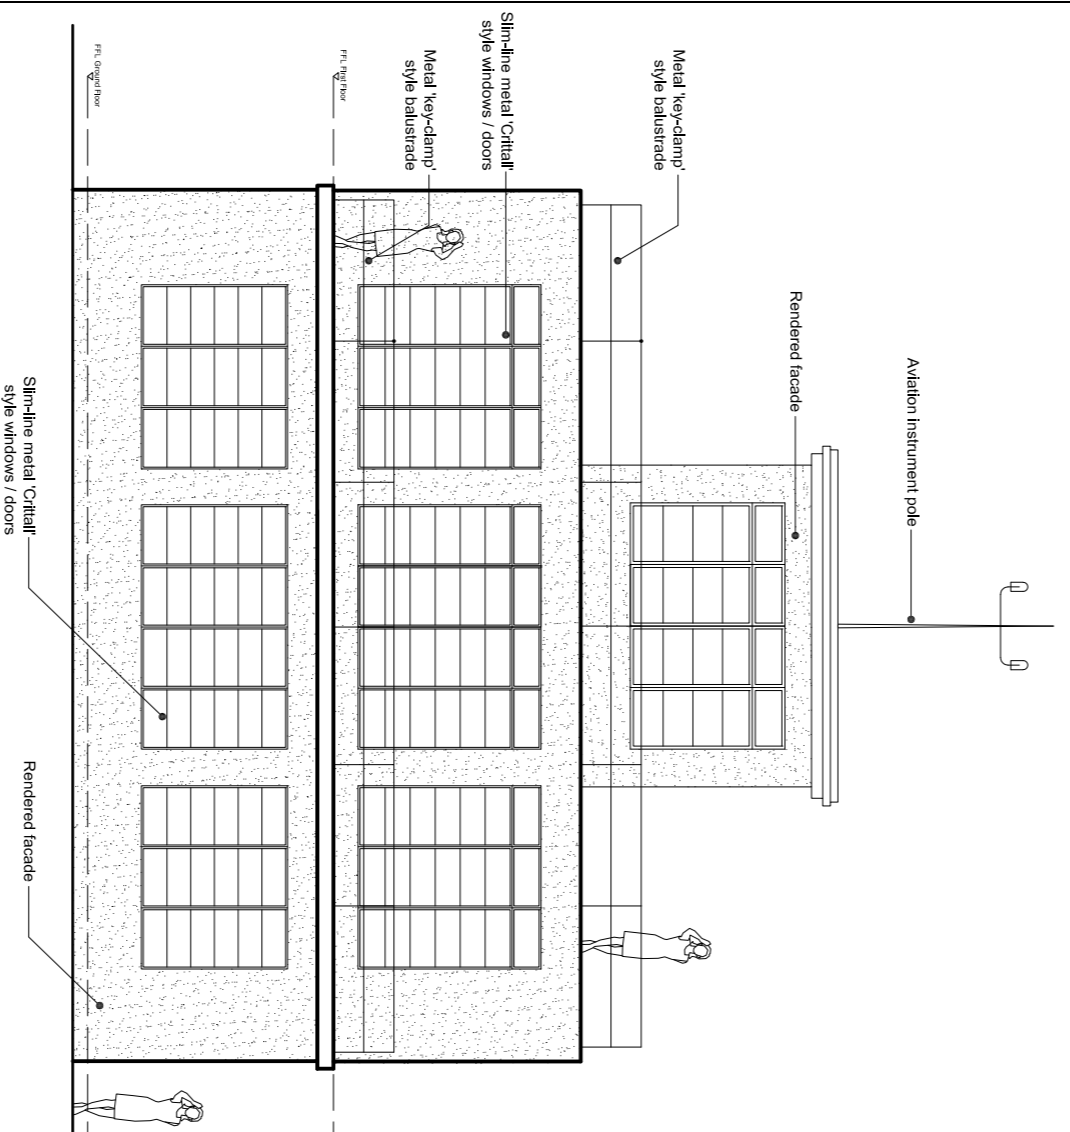
05 Front Elevation As Original (assumed)

Note: All doors and windows have been drawn in assumed locations following site analysis and from reviewing old photographs. Complete original internal layout unknown
