EXTENDED PHASE 1 HABITAT SURVEY & DAYTIME BAT SURVEY

4A KINDER DRIVE, MARPLE, STOCKPORT,
CHESHIRE

MARCH 2022

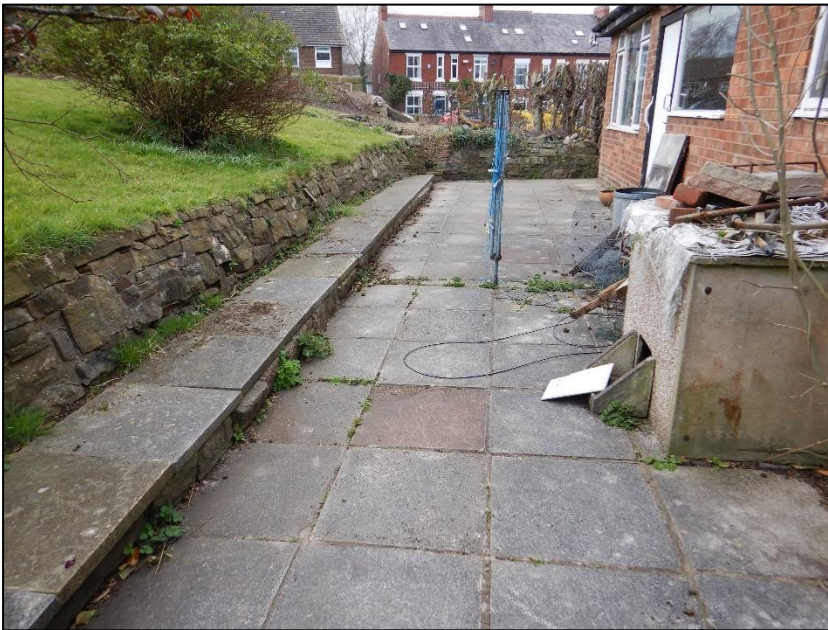
- 3.2 Bare ground surrounds the dwelling, in the form of patios, paths and a parking area (see Photograph 1). This is mainly laid to flags with areas of hardstanding. A small area of bare ground occurs on the rear lawn where shrubs have been removed.

Photograph 1 showing the bare ground at the rear of the property

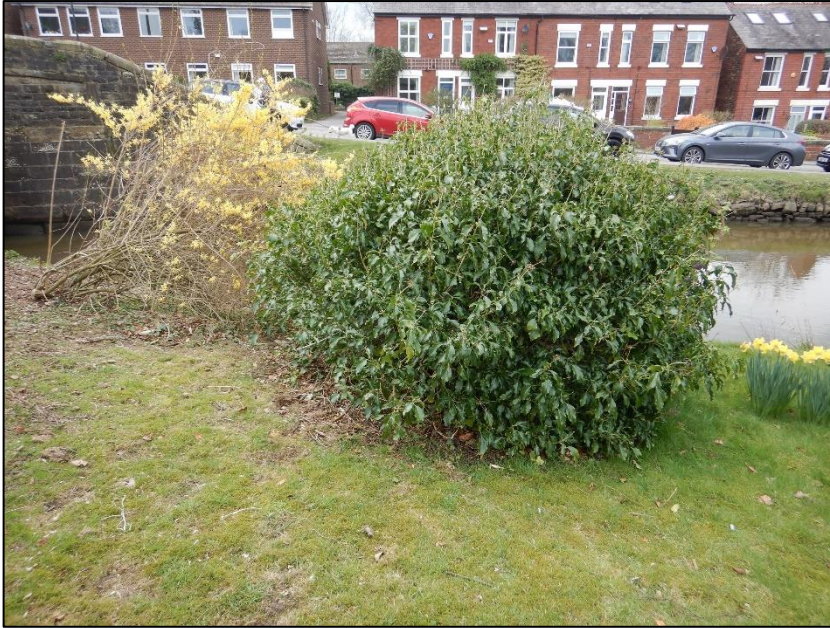
- 3.3 Small shrub beds exist on site, as well as individual shrubs (see Photograph 2). Varieties include Camelia, roses, heathers, conifers, Pieris and bulbs.

Photograph 2 showing some of the shrubs

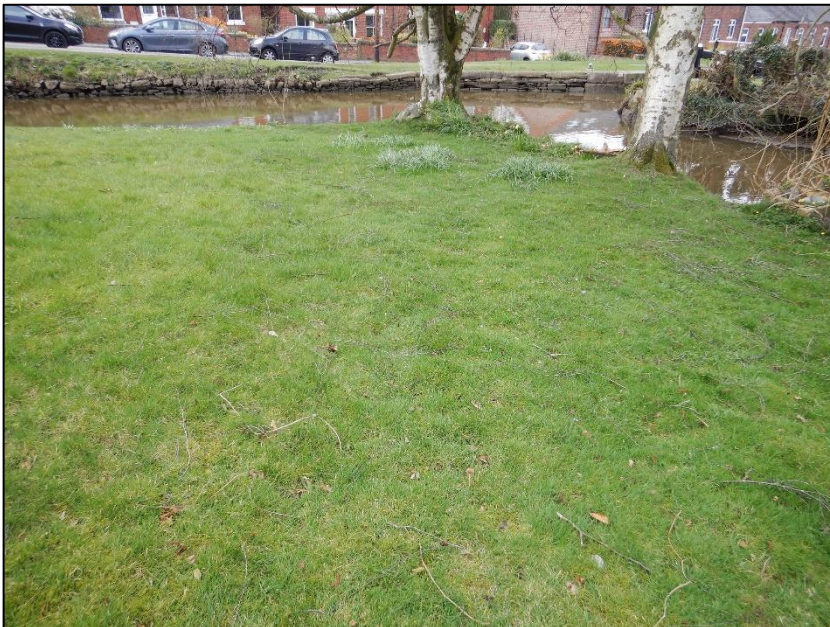
- 3.4 Lawns exist on site, to the front, side and rear of the dwelling (see Photographs 3 and 4). These are mapped as amenity grassland and are species-poor and regularly mown. Species include Perennial Rye-grass *Lolium perenne*, Annual Meadow-grass *Poa annua*, Selfheal *Prunella vulgaris*, Creeping Buttercup *Ranunculus repens* and Dandelion *Taraxacum officinale* agg.

Photograph 3 showing amenity grassland at the front of the site

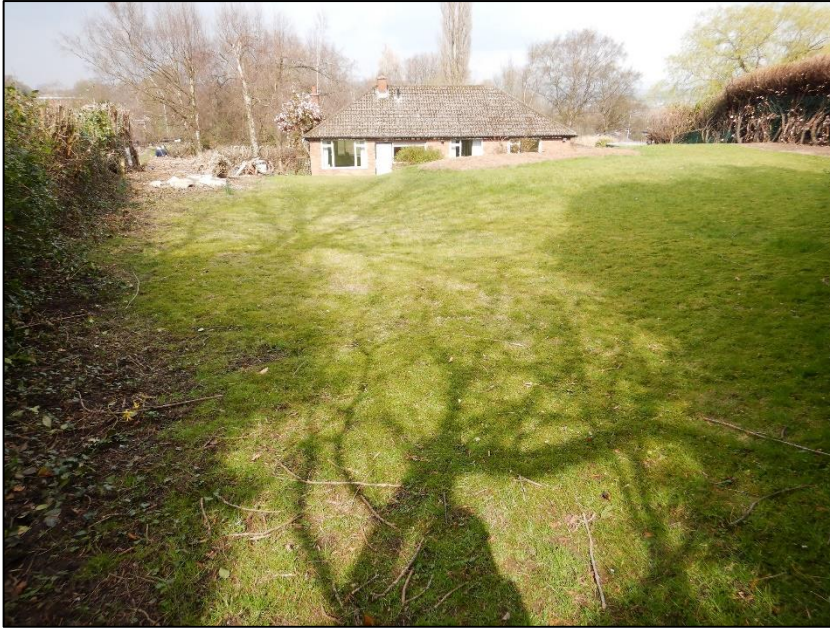
Photograph 4 showing amenity grassland at the rear of the site

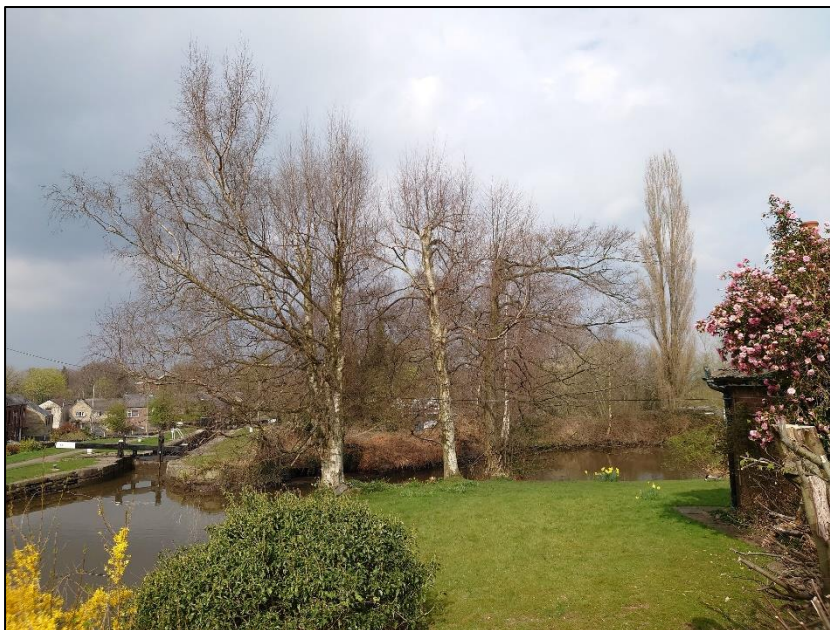
- 3.6 A small number of mature trees exist on the boundaries of the site; three at the front and one at the rear (see Photograph 5). The tree species are Silver Birch *Betula pendula* and Pedunculate Oak *Quercus robur*. Scattered garden shrubs also occur on site and on the boundaries.

Photograph 5 showing the mature trees at the front of the site

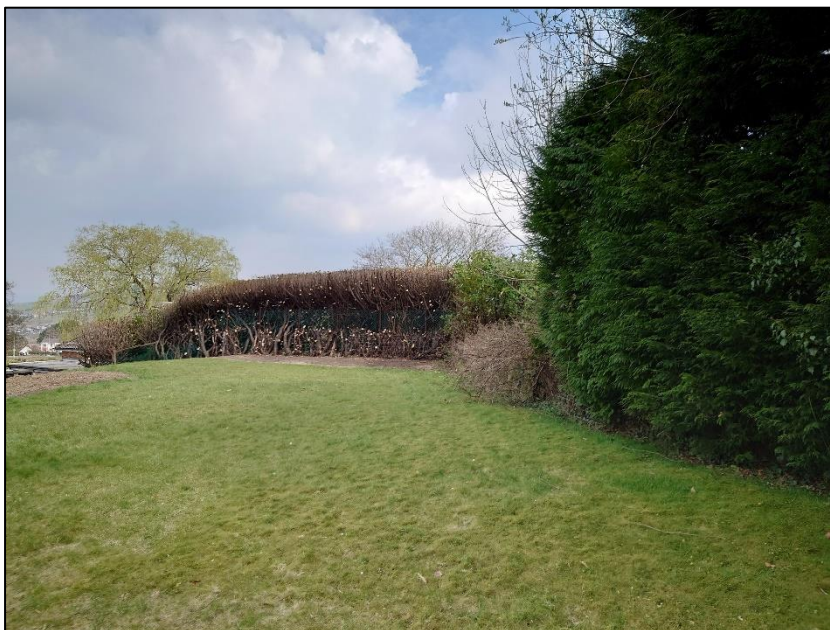
- 3.7 Species-poor intact hedgerows exist on parts of the eastern, western and southern site boundaries (see Photograph 6). The eastern hedgerow comprises Cherry Laurel *Prunus laurocerasus* and this has recently been cut. The southern hedgerow comprises mature Leylandii. The western hedgerow includes Holly *Ilex aquifolium*, Hawthorn *Crataegus monogyna* and Beech *Fagus sylvatica* and this has also been recently cut (see Photograph 7).

Photograph 6 showing the eastern and part of the southern hedgerows

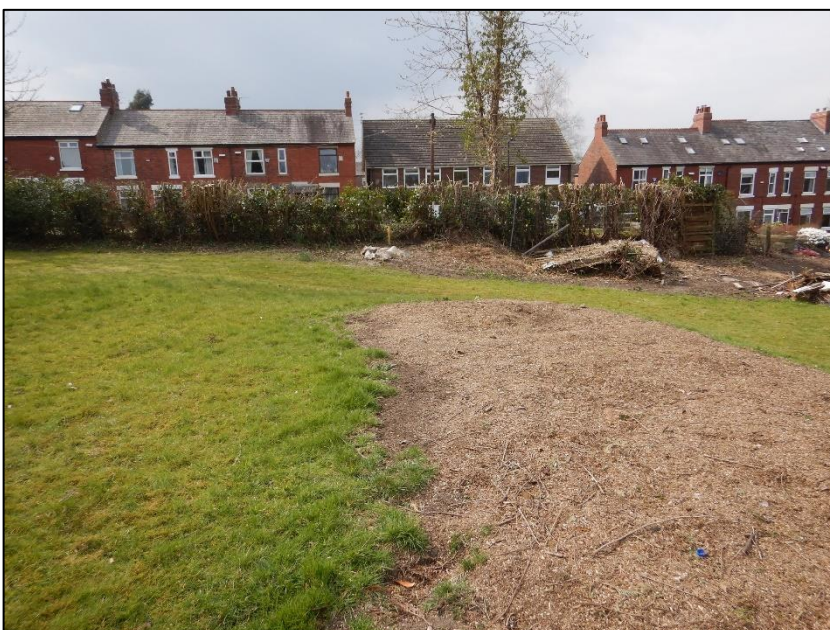
Photograph 7 showing the western boundary hedgerow

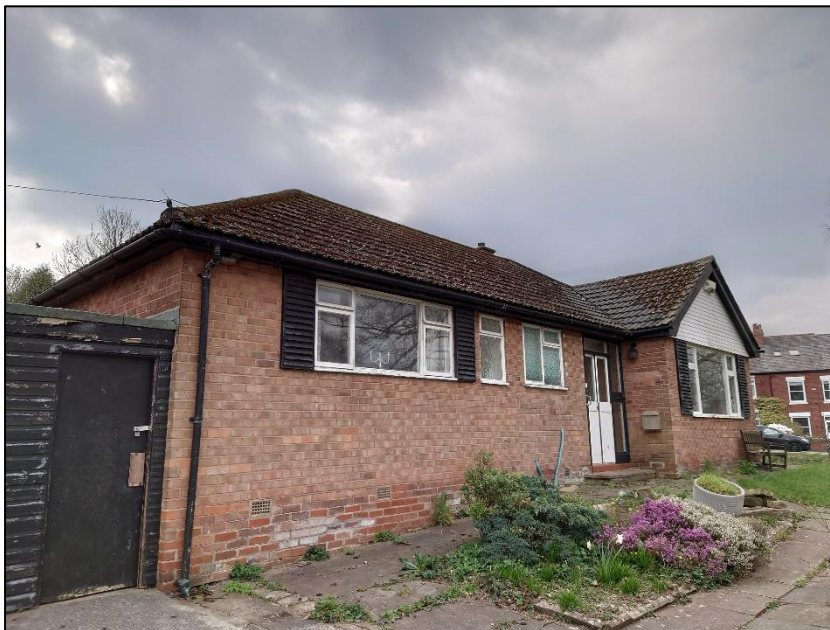
- 3.12 The bungalow is of relatively modern brick construction, with a pitched composite tile roof. The brickwork is in good condition, with no missing bricks or mortar (see Photographs 8 and 9). The windows are all intact. The frames are wooden and are weather but do not support suitable bat roosting cavities.

Photograph 8 showing the front of the dwelling

- 4.5 No evidence of bat activity was found at the dwelling on site. The building is in good material condition, with no suitable bat entry or exit points found. The loft void is well-sealed. Given the findings of the survey, the dwelling is considered to offer negligible bat roosting suitability. The trees do not support bat roosting features and these are to be retained. The trees offer negligible bat roosting suitability. The trees and hedgerows, coupled with the adjacent waterway, offer suitable bat foraging habitat. These features are to be retained and protected through a Construction Environmental Management Plan (CEMP) which will include a sensitive lighting scheme. No further bat survey work is required.

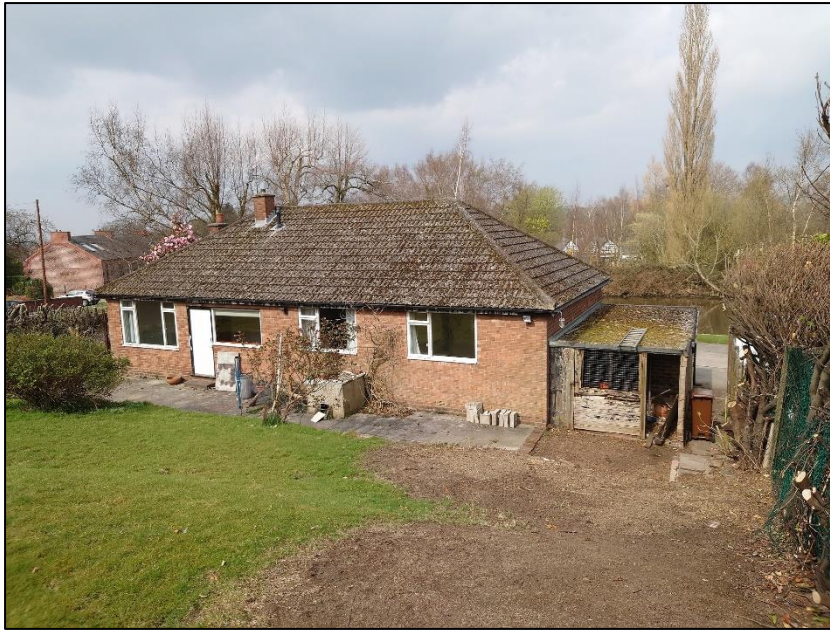
Photograph 9 showing the rear of the dwelling

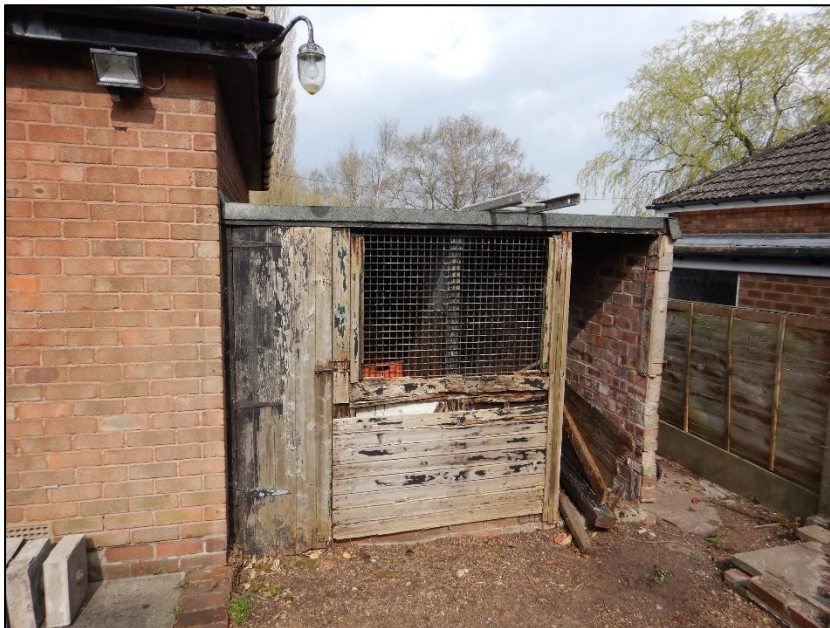
- 3.13 The attached storage structure is also constructed of brick, with wooden panels in places (see Photograph 10). The brickwork is intact but the panels are weathered. The structure is open to the rear, with parts covered in chicken wire.

Photograph 10 showing the store

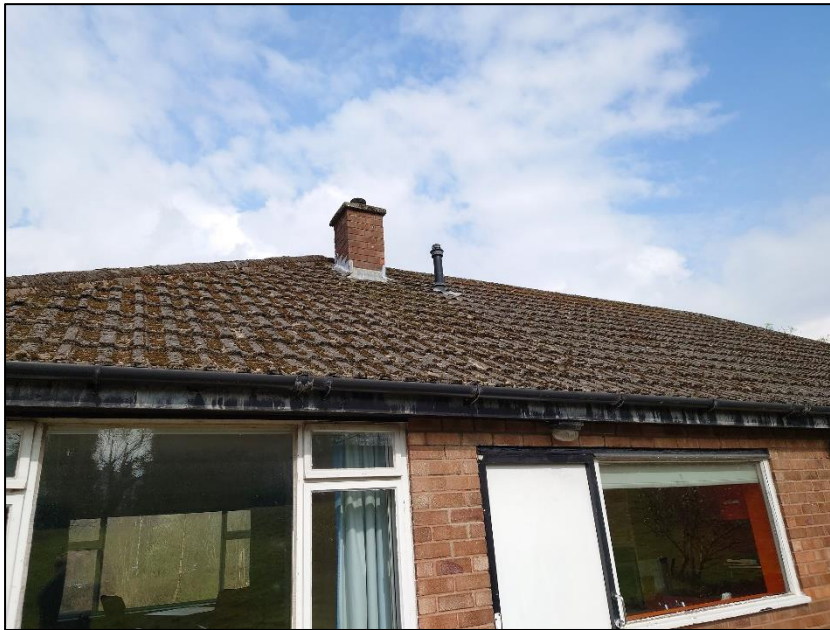
- 3.14 The main bungalow has a pitched, tiled roof (see Photograph 11). The tiles are all place, with no slipped tiles. The ridge tiles are intact and in good condition. Where the chimney exists, the brickwork is intact and the lead flashing at the base is flush to the brickwork and tiles. A ventilation pipe is also well-sealed at the base. The storage structure has a flat bitumen felt roof which is intact. The overhang is flush. A small corner is missing but this does not present a suitable bat roosting cavity.

Photograph 11 showing the roof of the bungalow

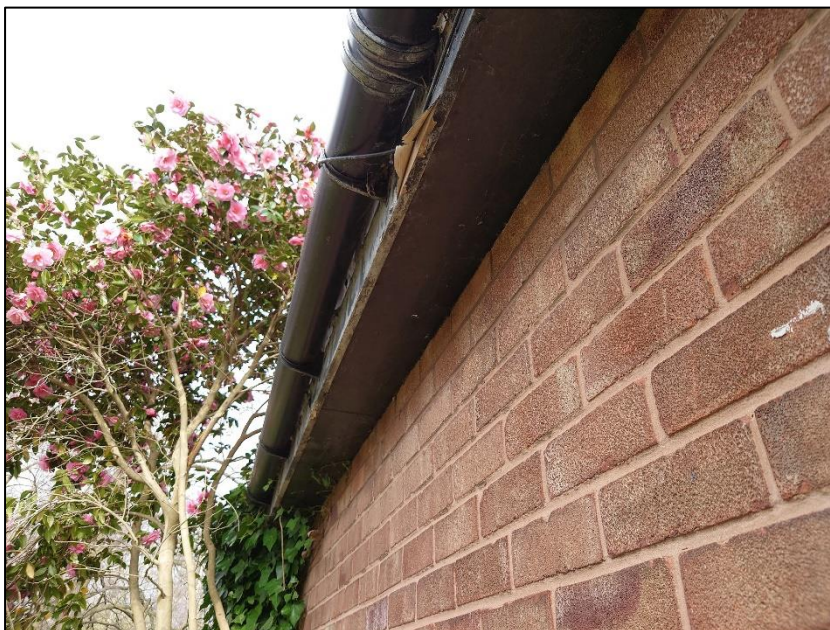
- 3.15 The building supports wooden bargeboards and soffits (see Photograph 12). Some of these are weathered but any peeling does not lead to suitable gaps or cavities for bats. The soffits are all flush to the brickwork.

Photograph 12 showing the soffits and bargeboards

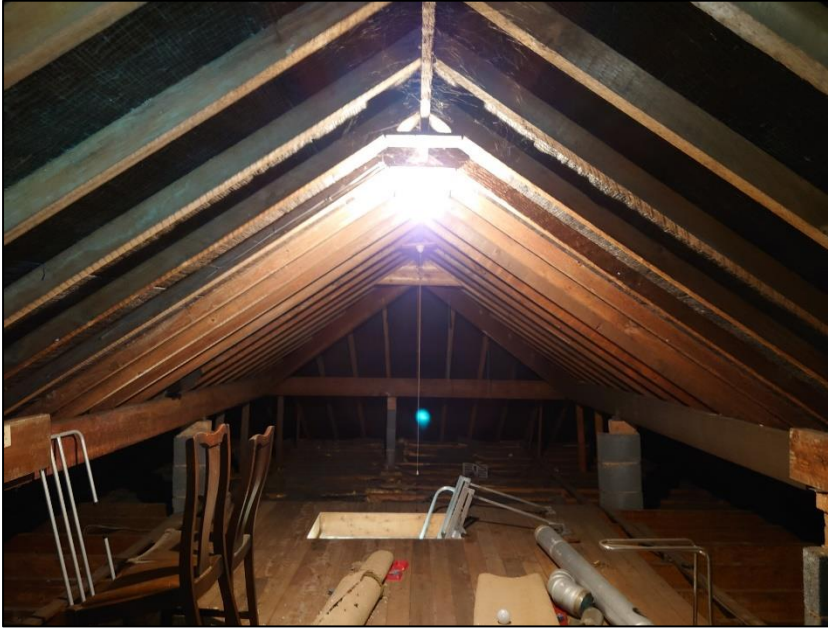
- 3.17 One large loft space is present. The main loft space is well-sealed (see Photographs 13 and 14). No daylight is visible within the loft space. The wooden beams are modern and intact, with no gaps or cavities for bats to exploit. The roof lining is all intact, with no tears. The void is lit with a single bulb and has been used for storage. Parts of the floor are boarded and other parts are part-insulated. The beams and lining are heavily cobwebbed and cobwebs occur from roof to floor. No evidence of bat activity was found within the bungalow. Rodent droppings are present.

Photograph 13 showing the roof void

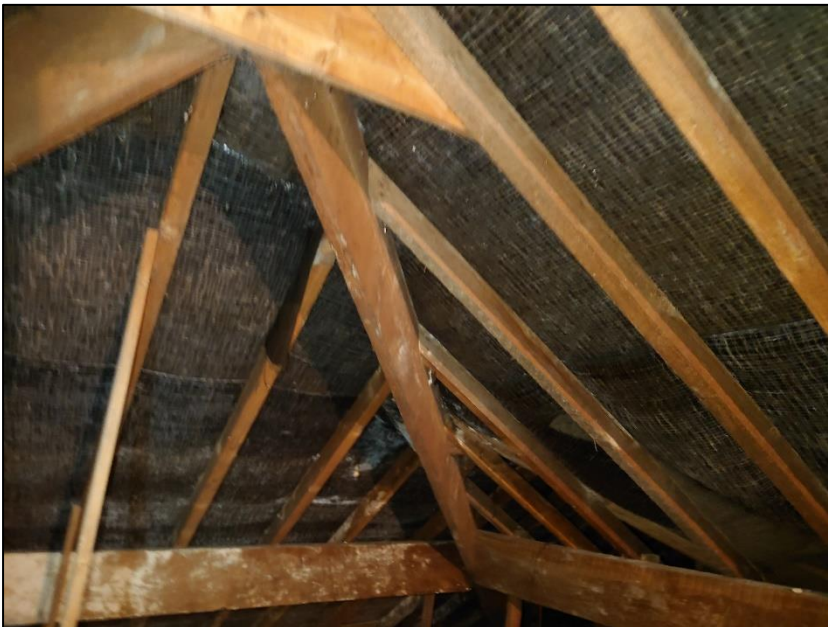
Photograph 14 showing the roof lining and timbers

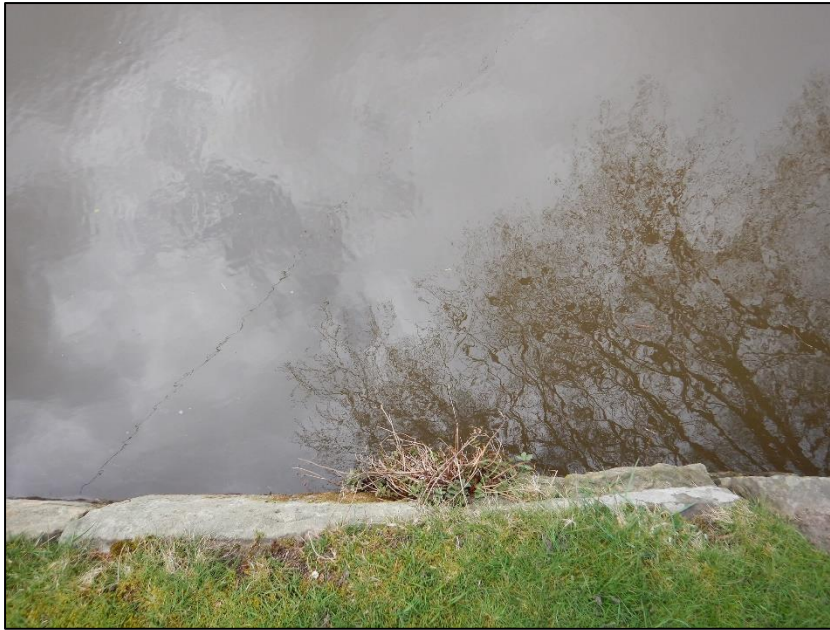
Photograph 15 showing the

- 3.21 Water Vole *Arvicola terrestris* is fully protected under The Wildlife and Countryside Act 1981 (as amended). Otter *Lutra lutra* is a European Protected Species under the Conservation (Natural Habitats etc.) Regulations 1994. This is implemented in the UK through the Conservation of Habitats and Species (Amendment) (EU Exit) Regulations 2019. Otter is also protected under the Wildlife and Countryside Act 1981 (as amended).
- 3.22 No suitable Otter or Water Vole habitat exists on site. The banks of the Peak Forest Canal were searched and assessed for these two species. The banks are shallow stone walls (see Photograph 15), with small pockets of mud at the basin edges. No aquatic vegetation is present and the canal itself is deep. The edges of the basins are fairly shallow with a deep centre. No burrows, holts, footprints or feeding remains were found at the canal edges.

- 4.7 No evidence of Water Vole or Otter was found at the edge of the canal and associated basins. The canal banks where they adjoin the site are not considered to be suitable for Water Vole and Otter. No feeding remains were found. No construction will take place adjacent to the canal and the banks will be protected through a CEMP. No further Water Vole or Otter surveys or mitigation are required.

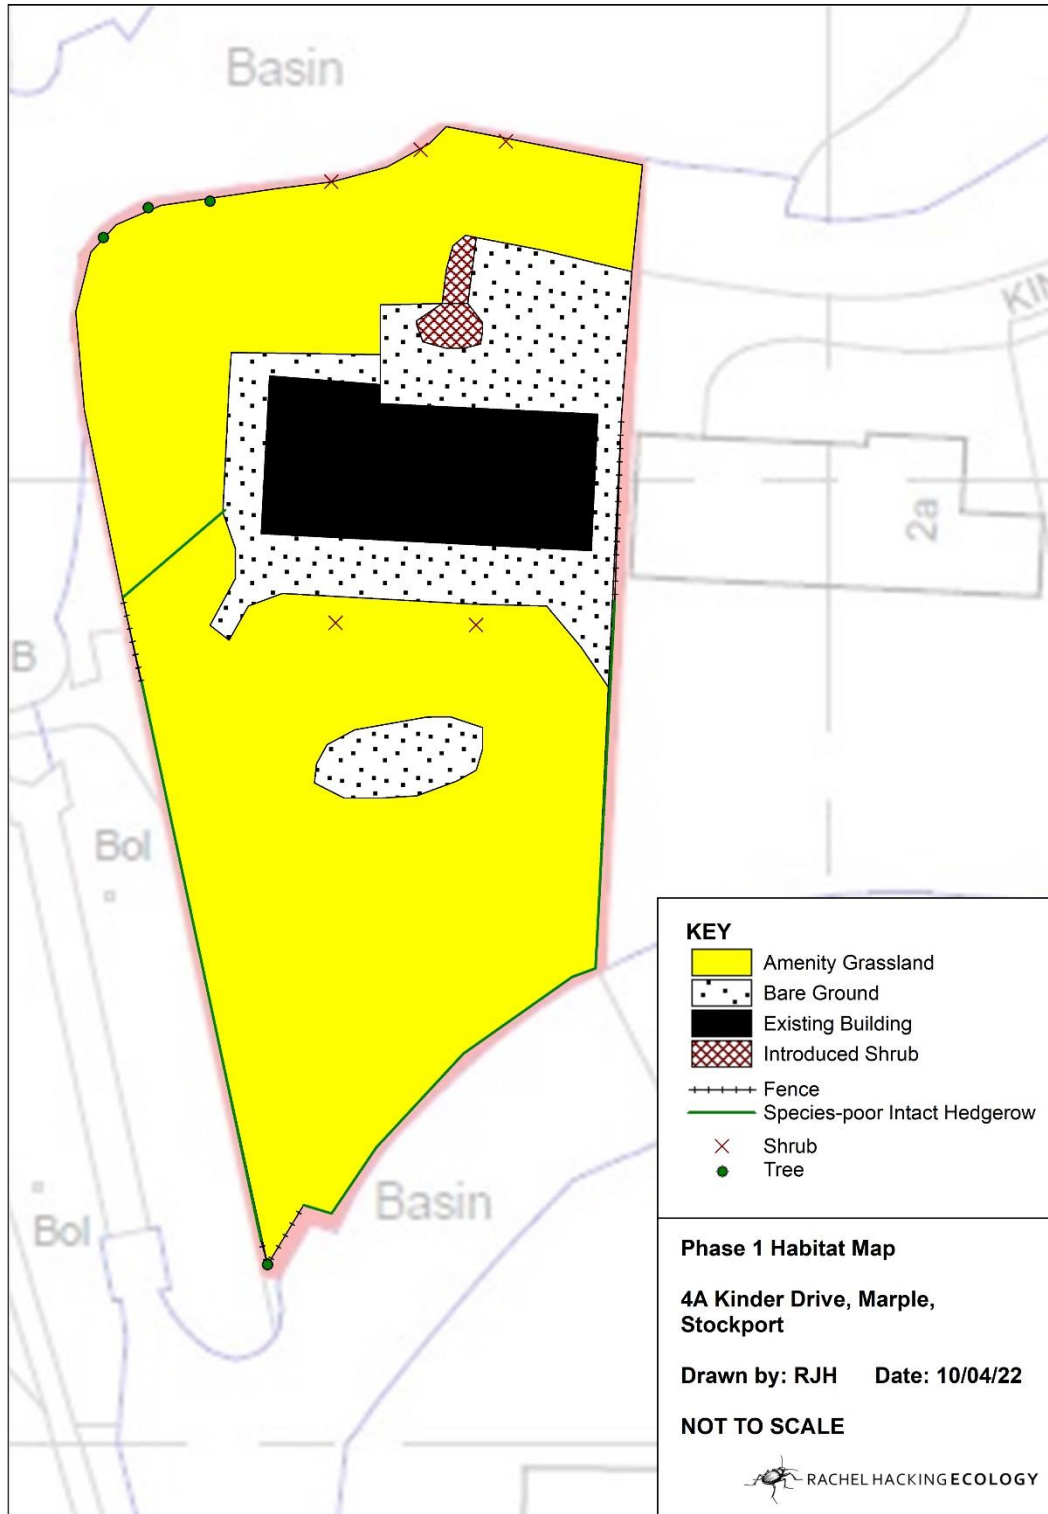
APPENDIX A – PHASE 1 HABITAT MAP

- 3.1 The Phase 1 Habitat Map can be found at the back of the report. The habitats on the proposed development site are described below.
