EDWARD STREET HOSPITAL, EDWARD STREET, WEST BROMWICH, WEST  
MIDLANDS, B70 8NL

## Detailed Unexploded Ordnance (UXO) Risk Assessment

| Project Name | Edward Street Hospital, West Bromwich |

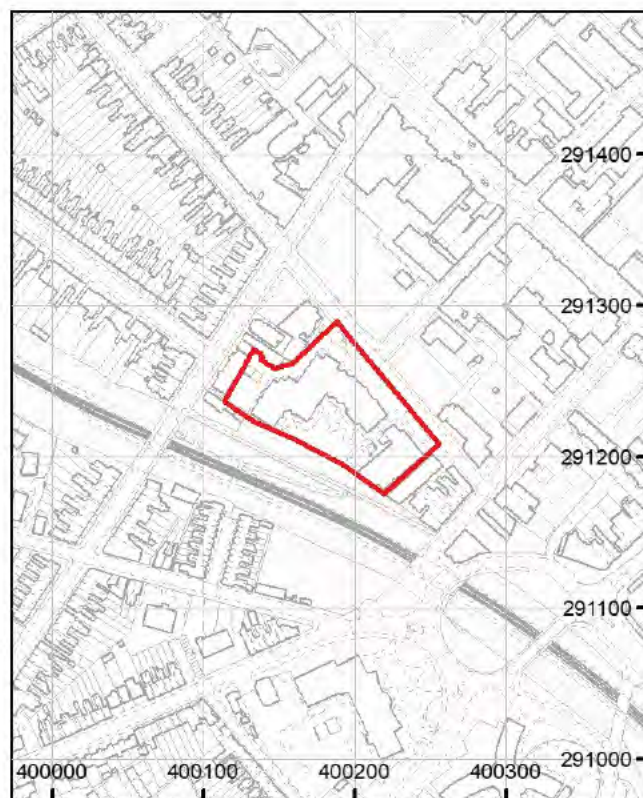
# Enquiry boundary

Approximate position of enquiry boundary shown

We can confirm that the location is  
**on the coalfield**

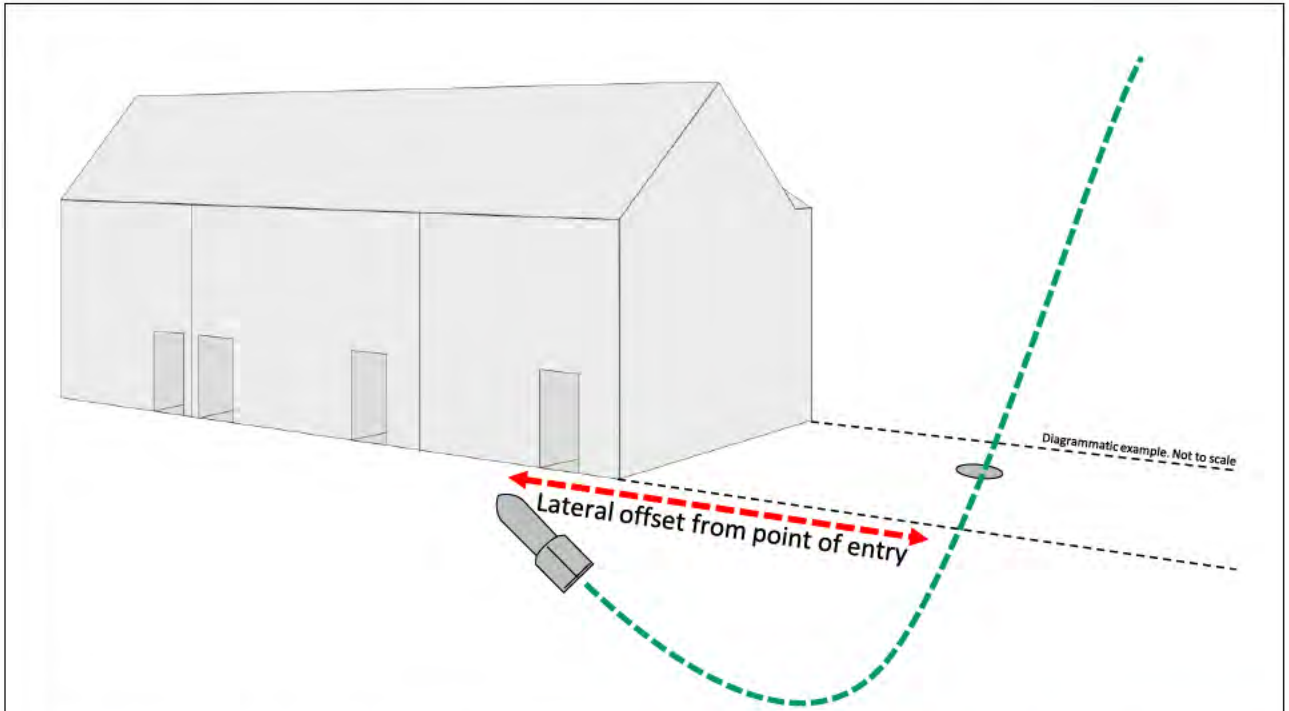
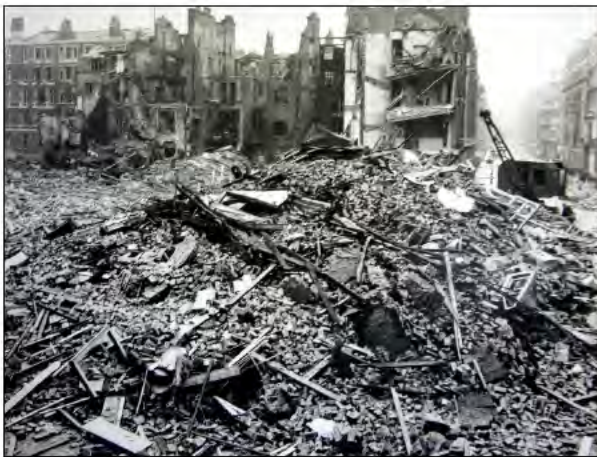
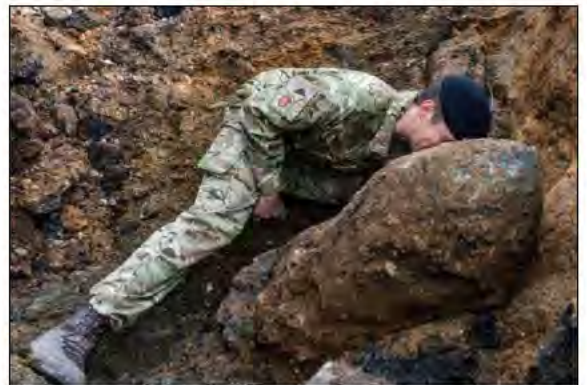
**Top:** J-curve Effect - Due to angle of entry, unexploded bombs would often end their trajectory at a lateral offset from point of entry, often ending up beneath adjacent extant structures/sites. The photograph above shows 250kg bomb found in Bermondsey pointing upwards, demonstrating 'J-curve'

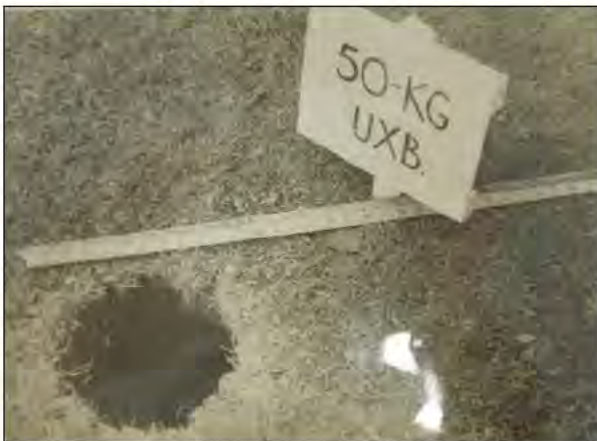
One of the most common scenarios for UXO going unnoticed was when a UXB fell into a 'bomb site' (such as the area shown **Top Left**), the entry hole of the bomb obscured by any debris and rubble present. Note that the entry hole of a 50kg UXB could be as little as 20cm in diameter (**Left**).

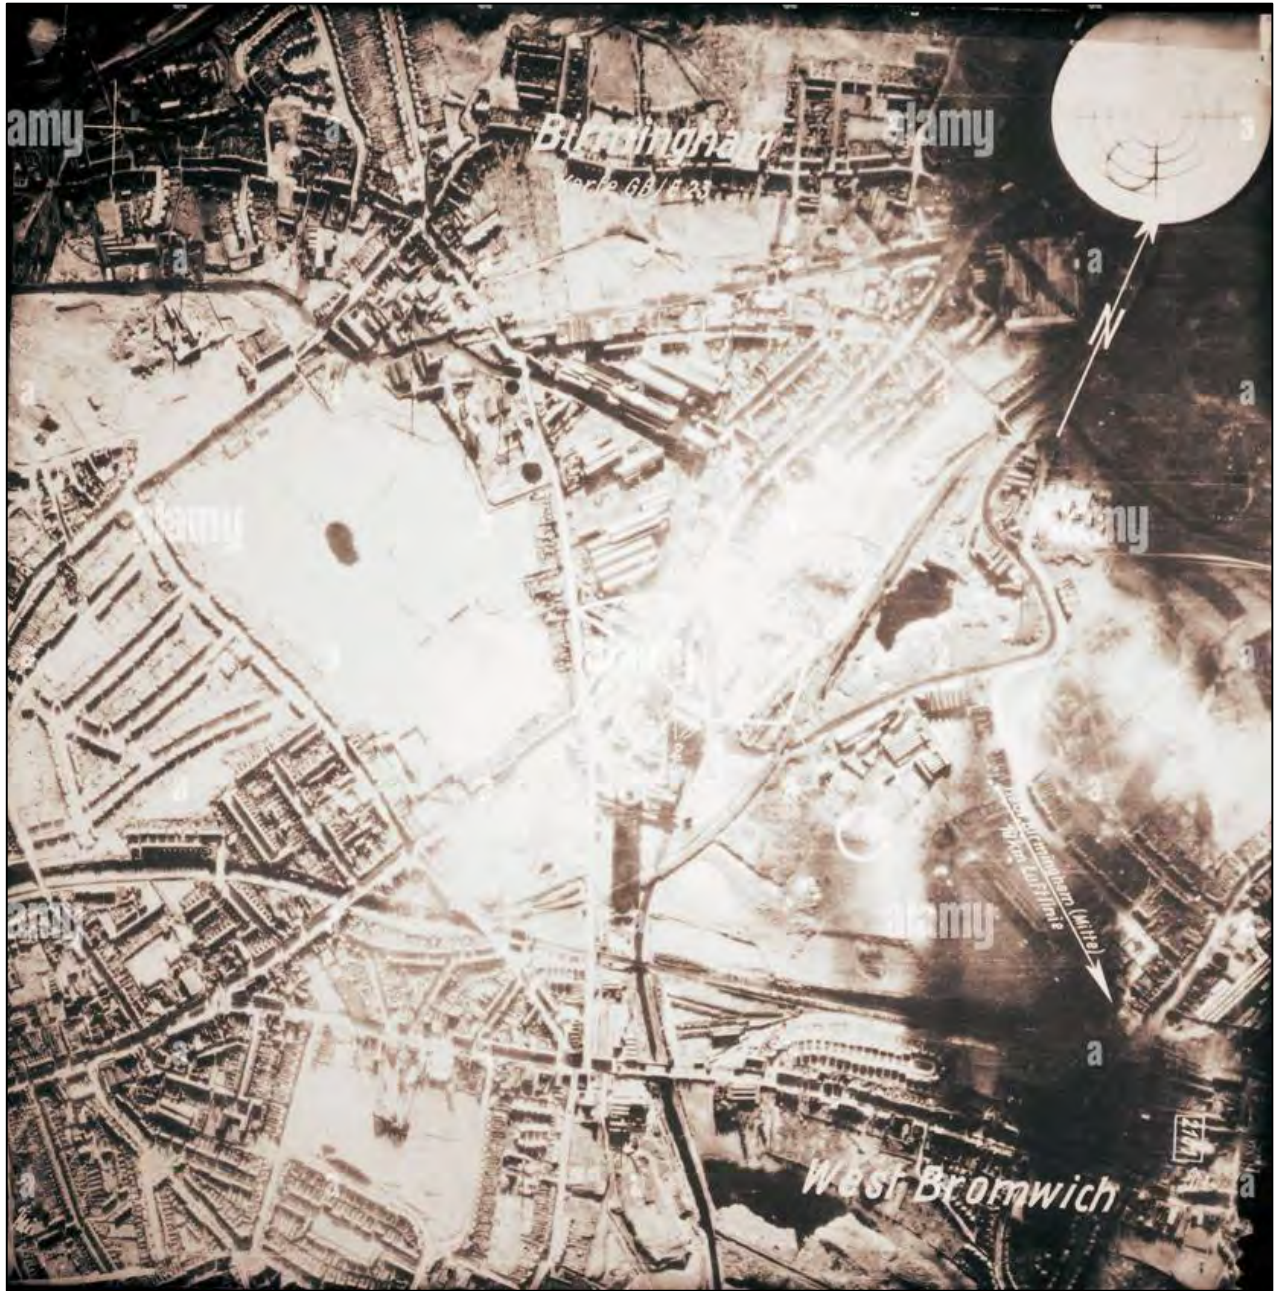
Above: The Swan Lane Gas Works, identified as a target within this image, was located approximately 1km north-west of the site

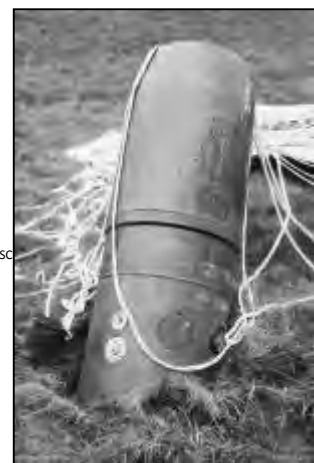
## SC 1000kg

| Bomb Weight | 996-1061kg (1,058-1,146lb) |
| Use | SC type bombs are General Purpose Bombs used primarily for general demolition work. Constructed of parallel walls with comparatively heavy noses. They are usually of three piece welded construction |

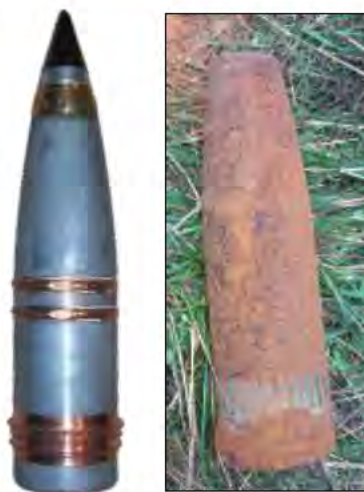
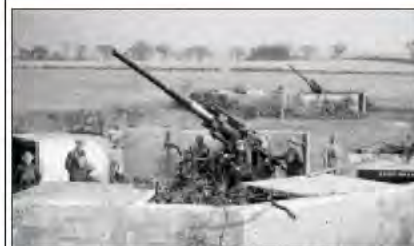
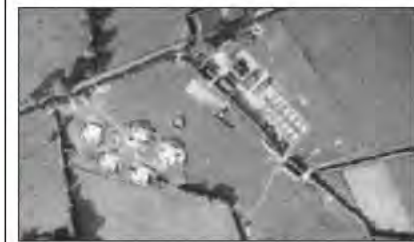
| Use | High Explosive Anti-Aircraft projectile. 4.5in projectiles were also used in this role. |
| Ceiling | 30,000ft to 59,000ft |

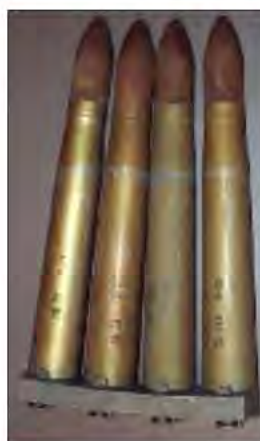
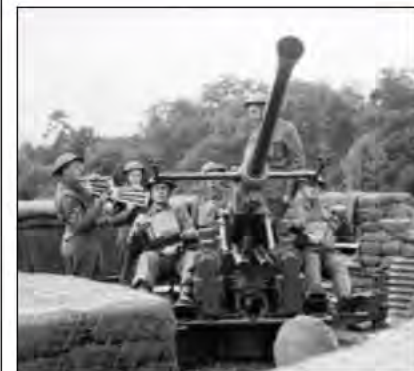
## 40mm Bofors Projectile

| Projectile Weight | 1.96lb (0.86kg) |
| Projectile Dimensions | 40mm x 310mm (1.6in x 12.2in) |
| Ceiling | 23,000ft (7000m) |

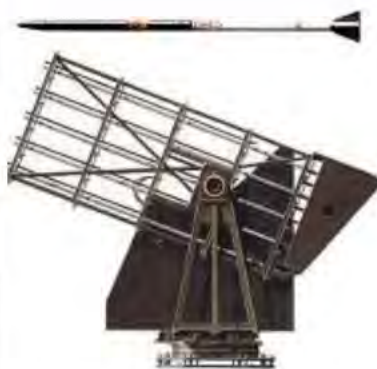
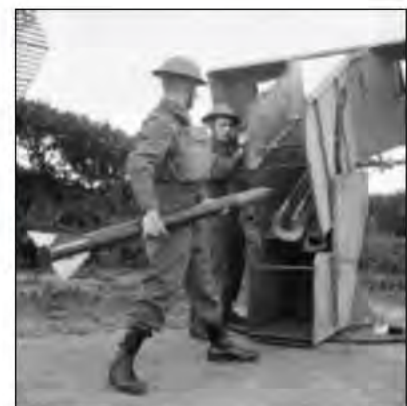
## Unrotated Projectile (UP) – Z Battery

| Projectile Weight | 84lb (24.5kg) |
| Dimensions | 1930mm x 82.6mm (76 x 3.25in) |
| Use | As a short range rocket-firing anti-aircraft weapon developed for the Royal Navy. It was used extensively by British ships during the early days of World War II. The UP was also used in ground-based single and 128-round launchers known as Z Batteries. |

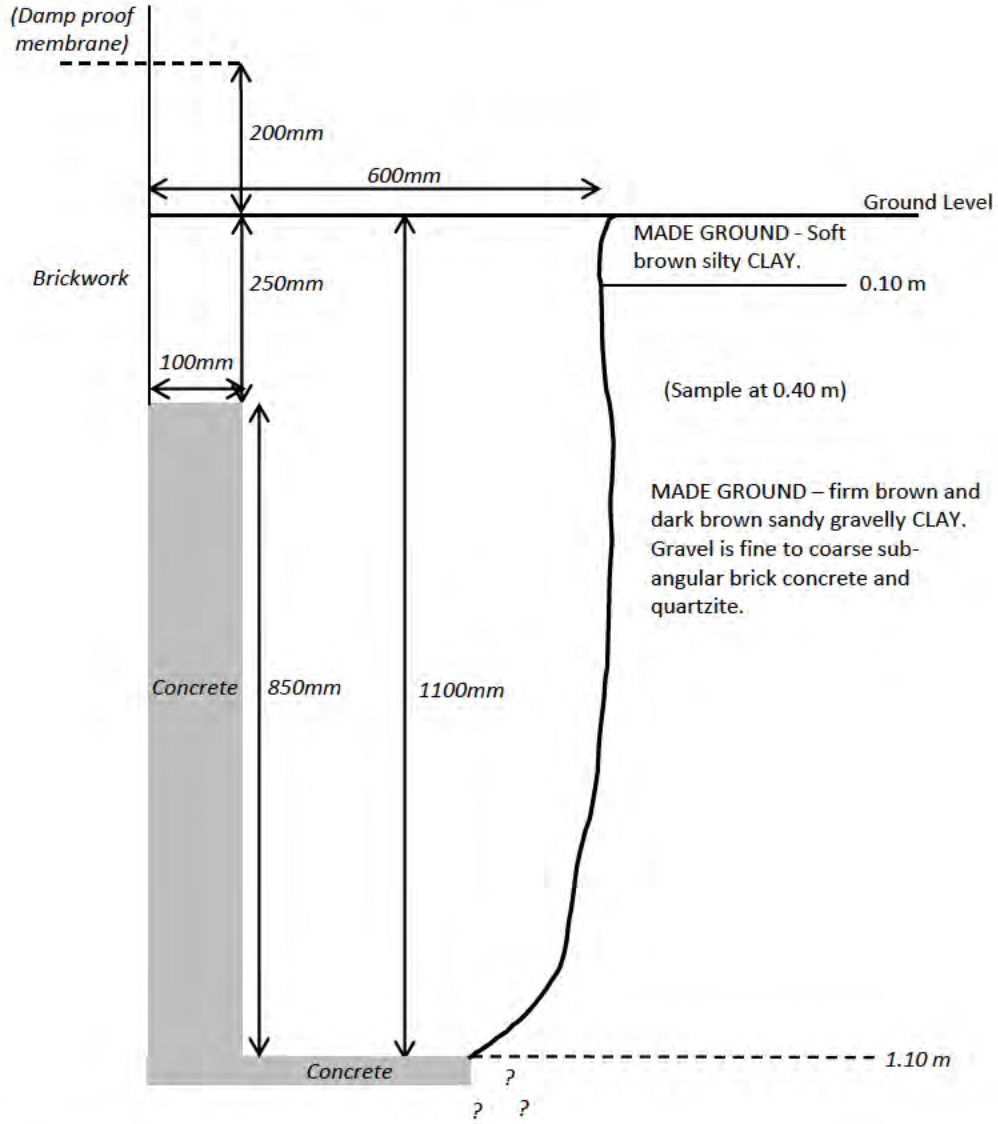
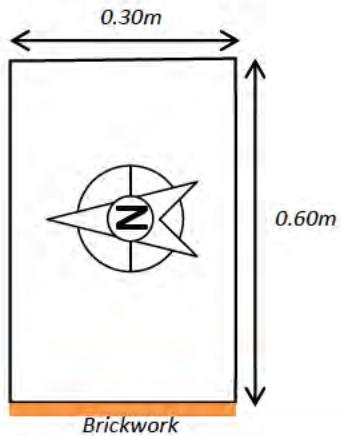
| <b>TITLE:</b><br>FOUNDATION PIT DRAWING (TP01) | <b>CLIENT:</b><br>VINCI | <b>DRAWN/CHECKED:</b><br>EB | GEG House<br>17 Graham Road, Malvern, WR14 2HR<br>Tel. 01684 212526<br>admin@g-eg.co.uk<br>www.g-eg.co.uk |

Method: Hand Excavated

## PLAN VIEW

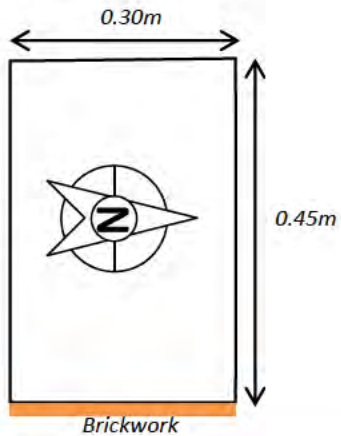
| <b>TITLE:</b><br>FOUNDATION PIT DRAWING (TP02) | <b>CLIENT:</b><br>VINCI | <b>DRAWN/CHECKED:</b><br>EB | GEG House<br>17 Graham Road, Malvern, WR14 2HR<br>Tel. 01684 212526<br>admin@g-eg.co.uk<br>www.g-eg.co.uk |

Method: Hand Excavated

## PLAN VIEW

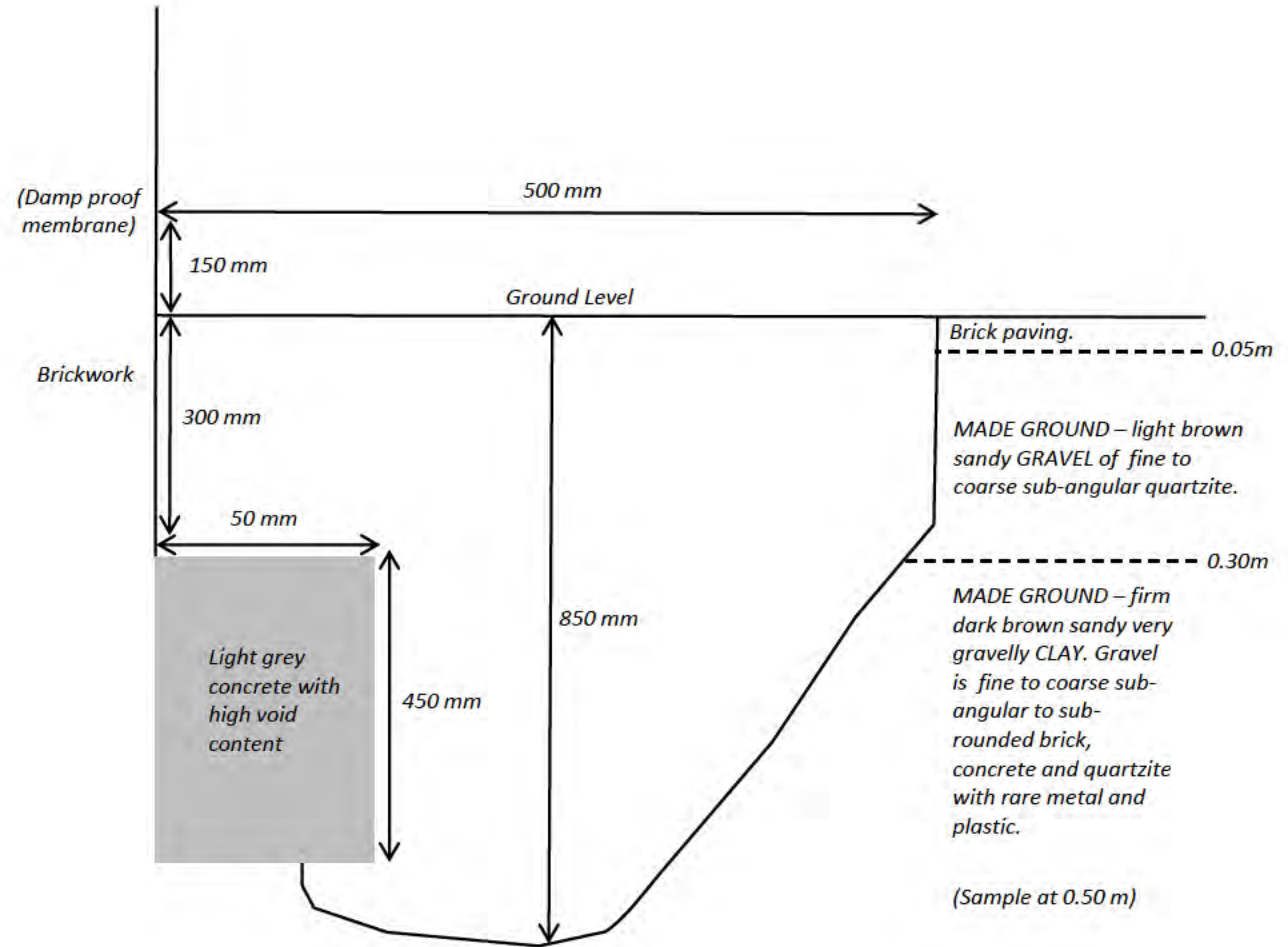
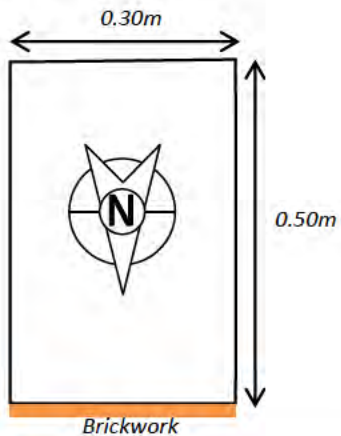
| <b>TITLE:</b><br>FOUNDATION PIT DRAWING (TP03) | <b>CLIENT:</b><br>VINCI | <b>DRAWN/CHECKED:</b><br>EB | GEG House<br>17 Graham Road, Malvern, WR14 2HR<br>Tel. 01684 212526<br>admin@g-eg.co.uk<br>www.g-eg.co.uk |

Method: Hand Excavated

## PLAN VIEW

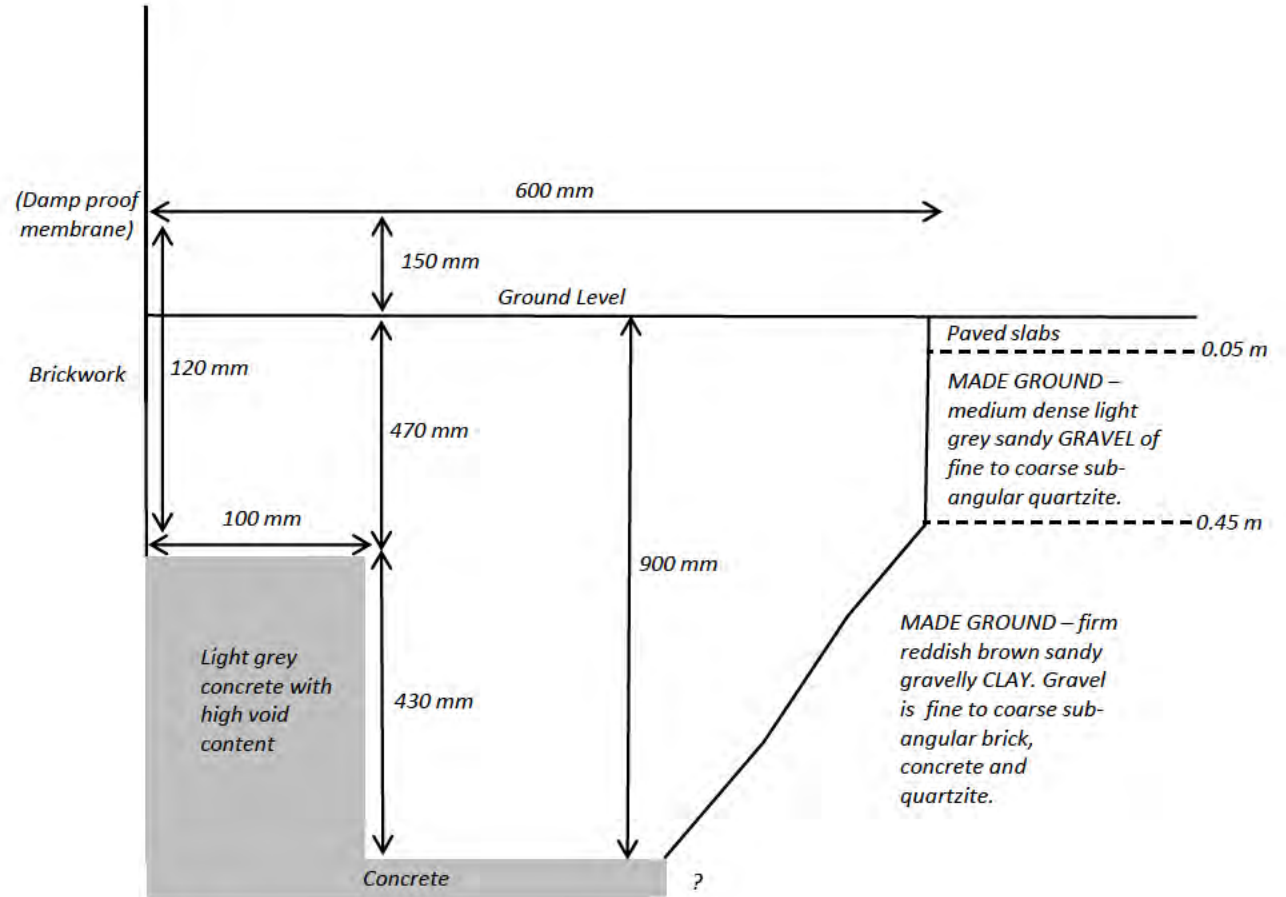
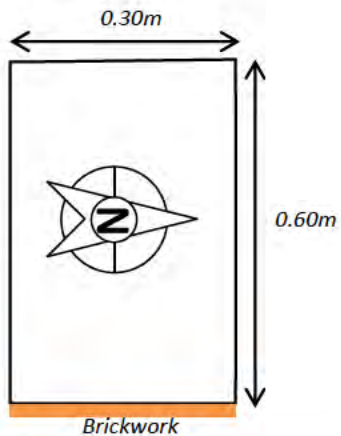
| <b>TITLE:</b><br>FOUNDATION PIT DRAWING (TP05) | <b>CLIENT:</b><br>VINCI | <b>DRAWN/CHECKED:</b><br>EB | GEG House<br>17 Graham Road, Malvern, WR14 2HR<br>Tel. 01684 212526<br>admin@g-eg.co.uk<br>www.g-eg.co.uk |

Method: Hand Excavated

## PLAN VIEW

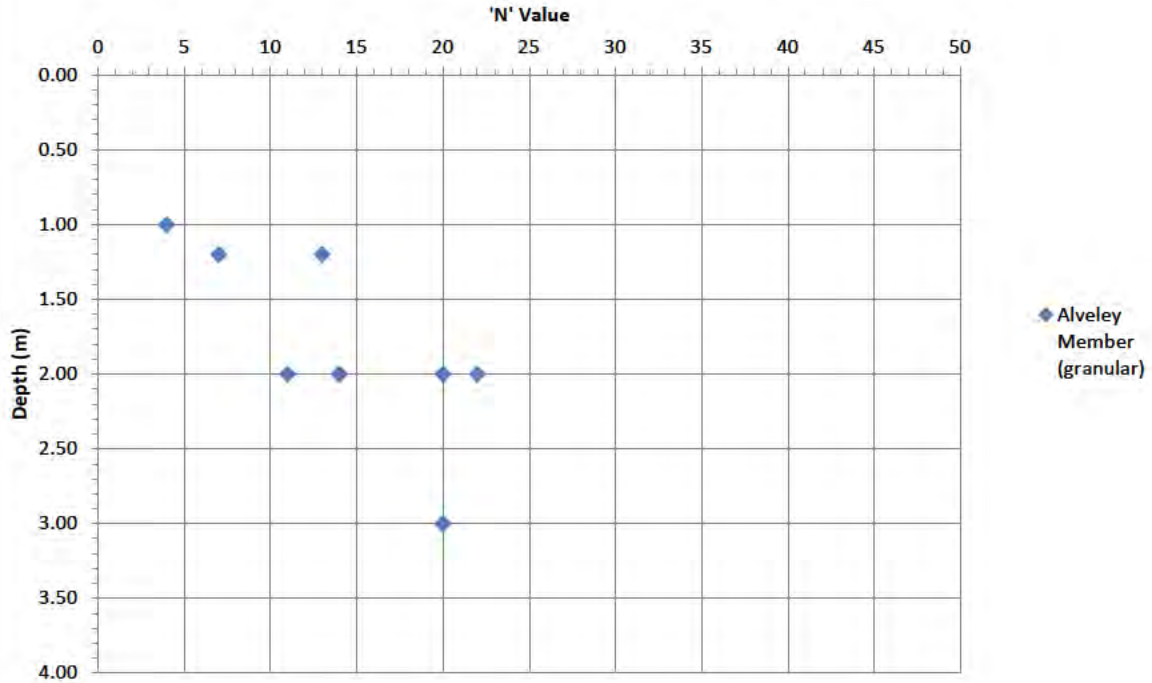
Graph 1. SPT 'N' Value vs Depth

Standard Penetration Tests (SPT) 'N' Values
