**Bat & Owl Survey
of
Pear Tree Farm Barn
Ashfield-cum-Thorpe**

**Hollins Architects
4a Market Hill
Framlingham
Suffolk
IP13 9BA**

**John Dobson B.Sc
Essex Mammal Surveys**

December 2016

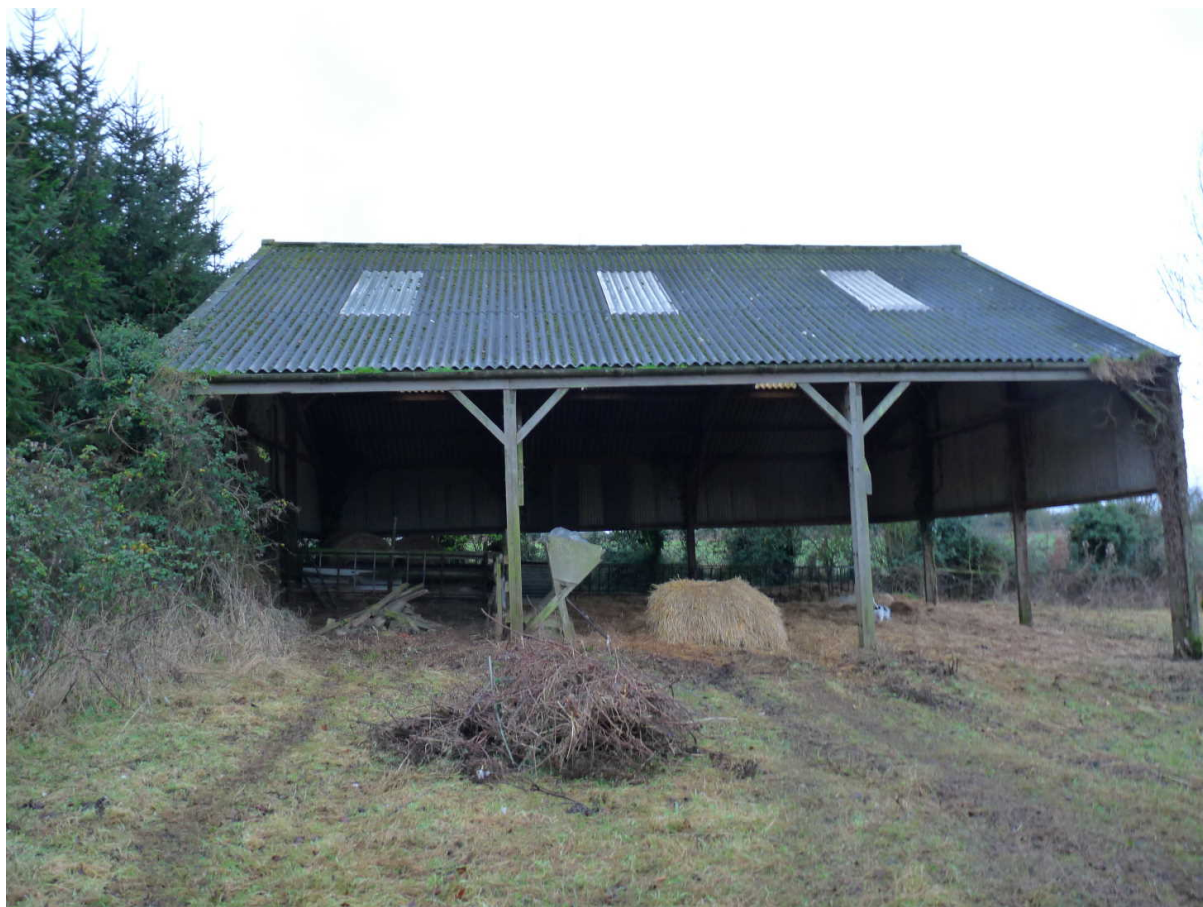
Photo 1: The north-eastern elevation. The other three sides have corrugated asbestos cladding to c. 2m above the ground

The survey building is an open-sided barn with a corrugated asbestos roof and cladding to three sides. The barn is aligned NW-SE and has a sawn timber frame. The interior receives daylight illumination due to its design and also six via transparent panels in the roof. In such conditions, bats seek out dark areas or crevices in which to roost, and the lack of such features, together with the draughty interior, made the building unsuitable as a roosting place for bats. The barn is currently in use as a shelter for sheep that graze the paddocks to the north.

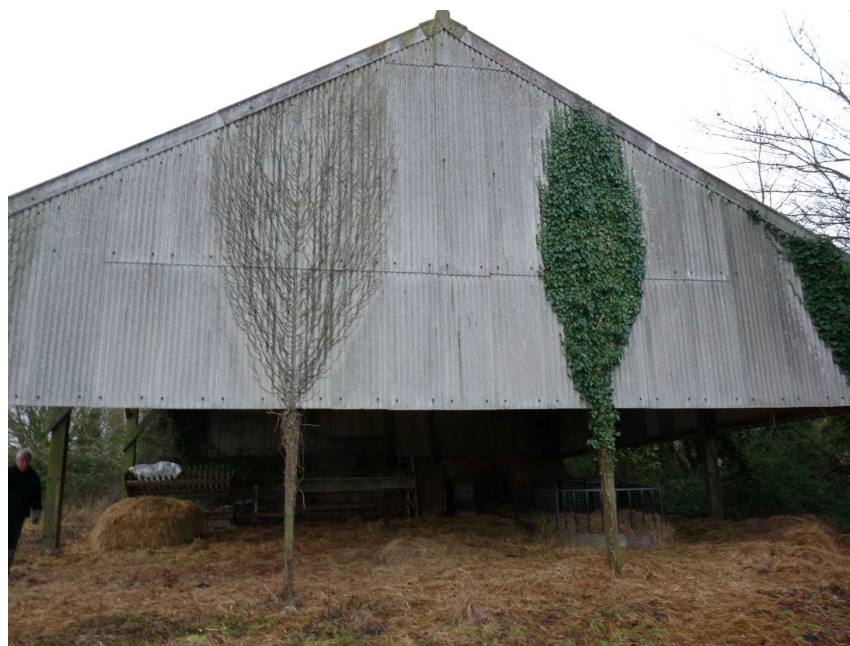
Photo 2: North-western elevation

The survey building is an open-sided barn with a corrugated asbestos roof and cladding to three sides. The barn is aligned NW-SE and has a sawn timber frame. The interior receives

daylight illumination due to its design and also six via transparent panels in the roof. In such conditions, bats seek out dark areas or crevices in which to roost, and the lack of such features, together with the draughty interior, made the building unsuitable as a roosting place for bats. The barn is currently in use as a shelter for sheep that graze the paddocks to the north.

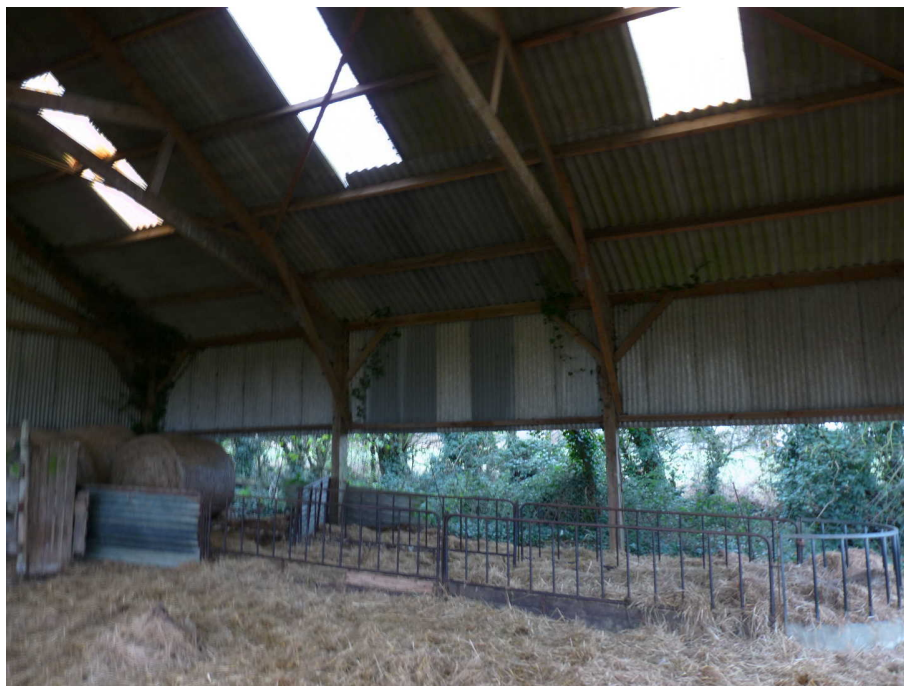
Photo 3: Looking south-west within the barn. Note transparent roof panels, sawn timber beams and ivy growing within the building

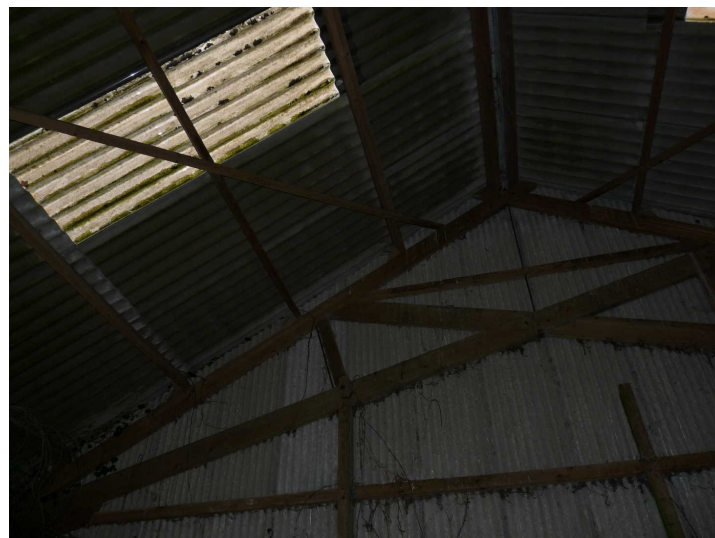
Photo 7: Showing sawn timber beams that lack crevices for bats

No evidence of the presence of bats was found at this site.
