**Preliminary Bat Roost Assessment and Bird  
Survey for,  
Mr. and Mrs. A. Bond.  
Buildings at,  
Fern Bank,  
Common Side,  
Gentleshaw,  
LICHFIELD,  
WS15 4NG.**

**Map Ref SK 0541 1130  
22<sup>nd</sup> December 2020.**

**S. Christopher Smith MRICS MSc CEnv.  
The Hayloft,  
Farm Lane,  
Grendon,  
ATHERSTONE,  
Warwickshire.  
CV9 3DR  
01827 713324**

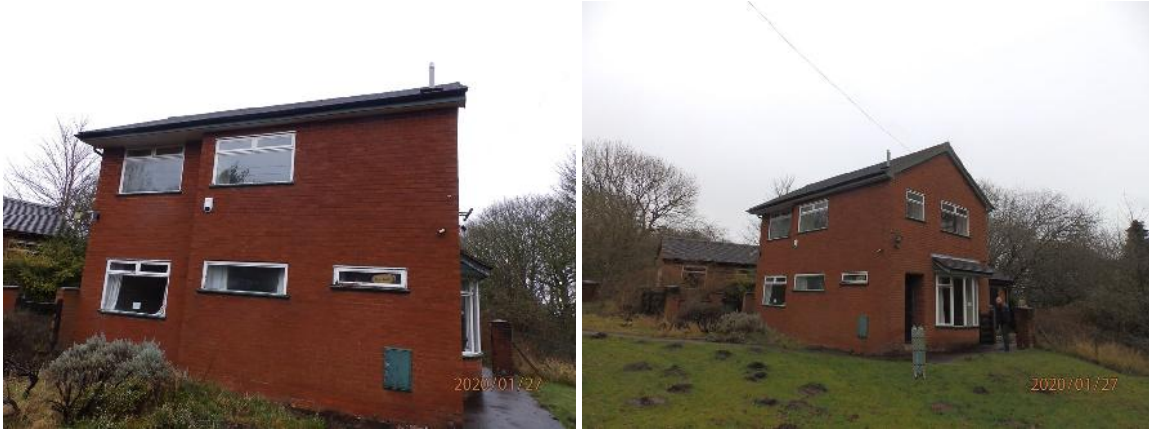
The buildings to be surveyed consisted of a two storey dwelling with cavity brick walls. The dwelling has a pitched roof with plain tiles and a bitumous underfelt. There is a single storey rear pitched roof area with plain tiles and a bitumous underfelt

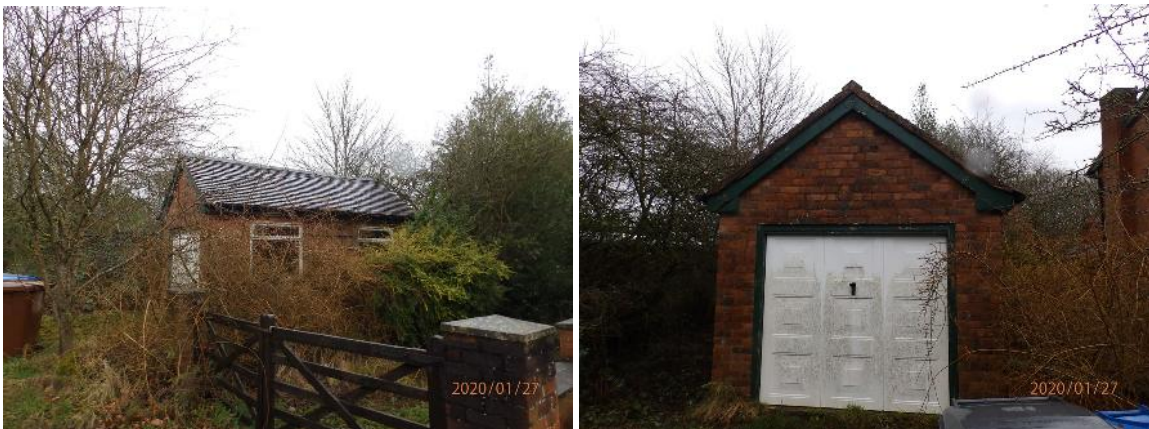
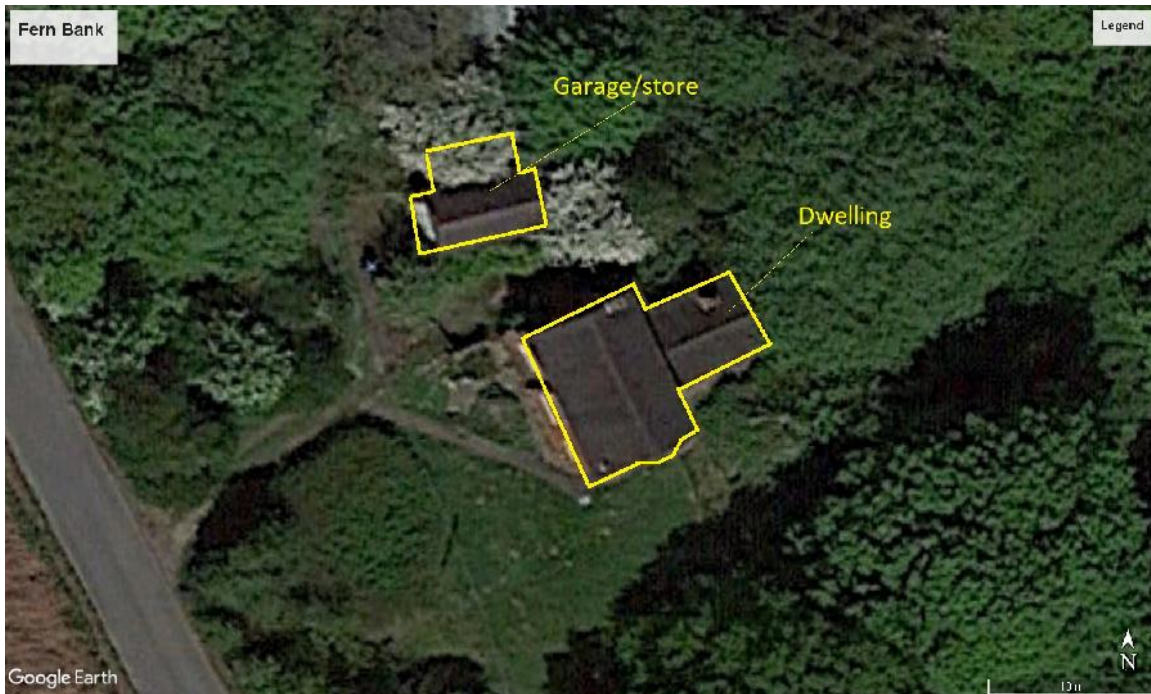
There is a garage and store building to the north of the dwelling.

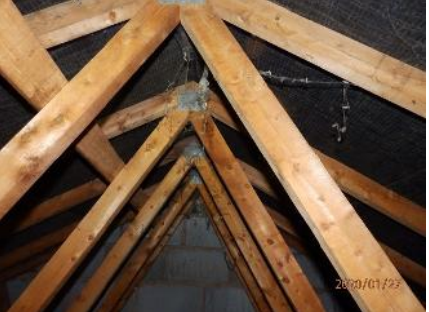
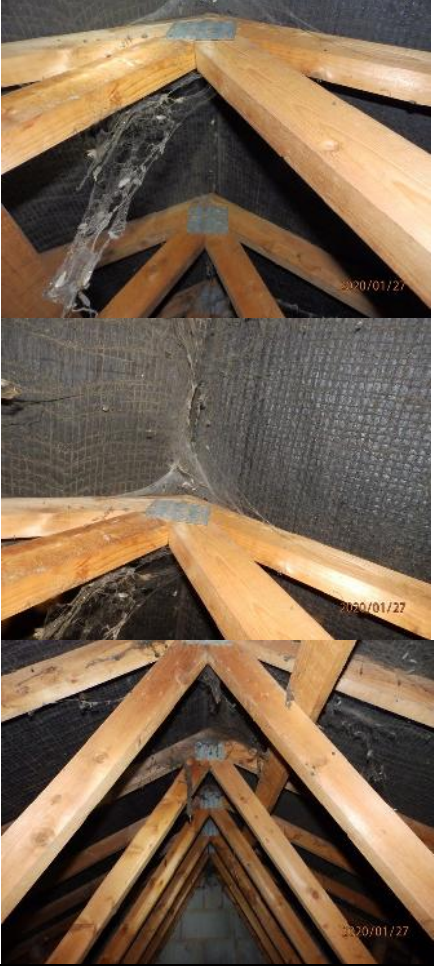
Feature.	Evidence of bats.	Likelihood of bats roosting.	Photograph.
Behind ridge board or against roof timbers.	None.	None. There is no access to the roof space for bats and the ridge board is covered with cobwebs showing no use by bats.

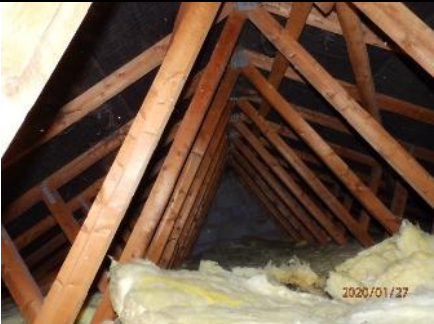
<b>Feature.</b>	<b>Evidence of bats.</b>	<b>Likelihood of bats roosting.</b>	<b>Photograph.</b>
In splits in timber rafters.	None.	None. Machine cut modern trussed rafter timbers.

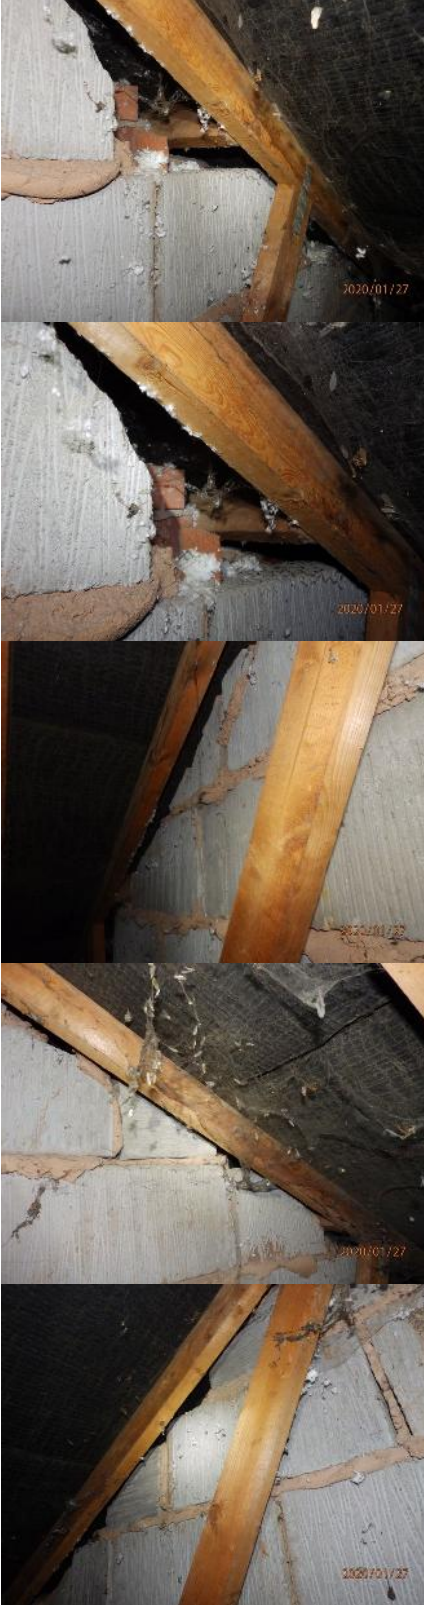
<p>Between the top of the blockwork and the underside of the bitumous underfelt.</p>	<p>None.</p>	<p>None. There is a gap internally but there is no access from the gables externally to this area.</p>

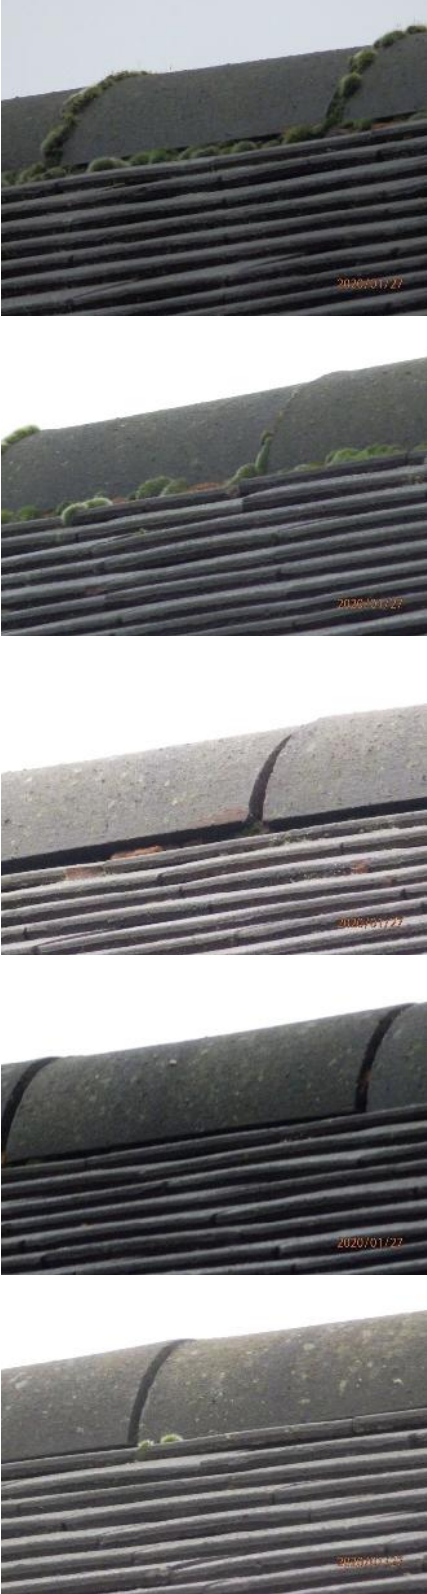
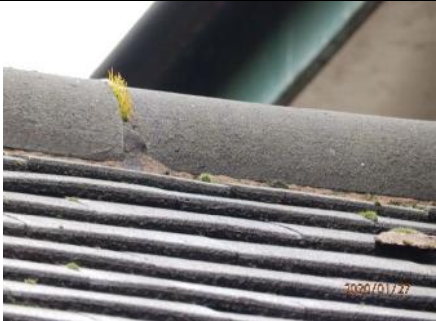
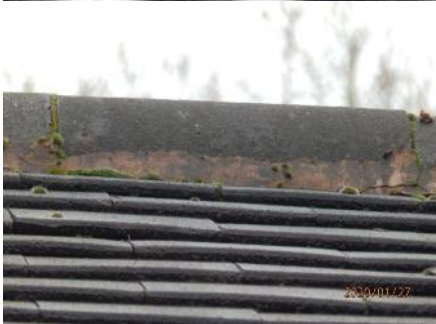
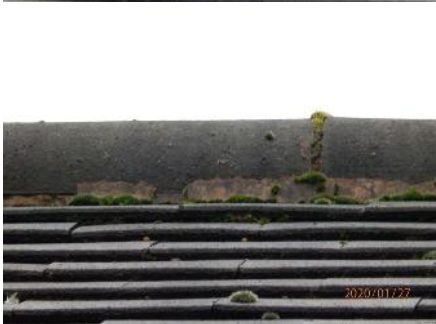
Feature.	Evidence of bats.	Likelihood of bats roosting.	Photograph.
Under ridge tiles.	None.	None. There is no access to the underside of the ridge tiles for bats.

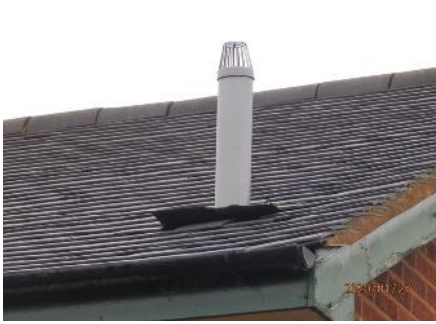
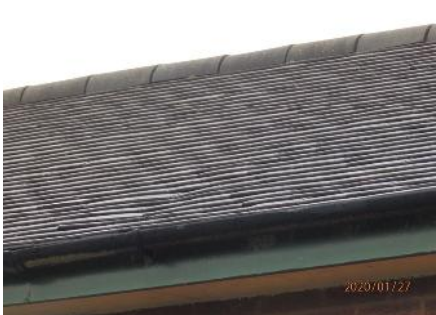
<b>Feature.</b>	<b>Evidence of bats.</b>	<b>Likelihood of bats roosting.</b>	<b>Photograph.</b>
Under loose or missing roof tiles.	None.	None. The plain tiles have no access points for bats. There is one broken tile on the single storey area but the nibs are in place blocking any access for bats.

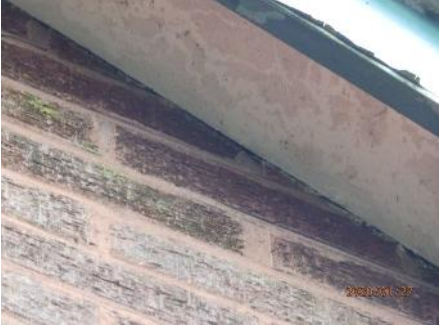
<b>Feature.</b>	<b>Evidence of bats.</b>	<b>Likelihood of bats roosting.</b>	<b>Photograph.</b>
In eaves.	None.	None. Timber soffits, barge board and fascia boards with no access for bats.

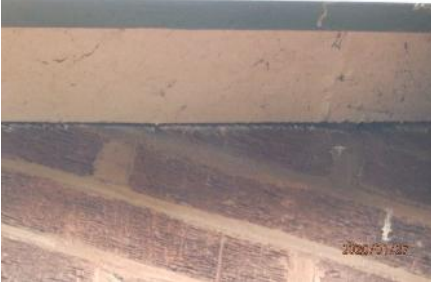
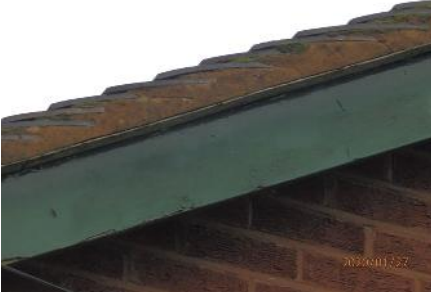
<b>Feature.</b>	<b>Evidence of bats.</b>	<b>Likelihood of bats roosting.</b>	<b>Photograph.</b>
In verge.	None.	Possible. There is access for bats to the verge on the northern gable where the verge adjoins the chimney and on the southern gable under the ridge tile.

There is a roosting opportunity for bats to the verge and underside of the ridge tiles on the southern gable.

There is access to the verge where the verge meets the chimney on the northern gable.

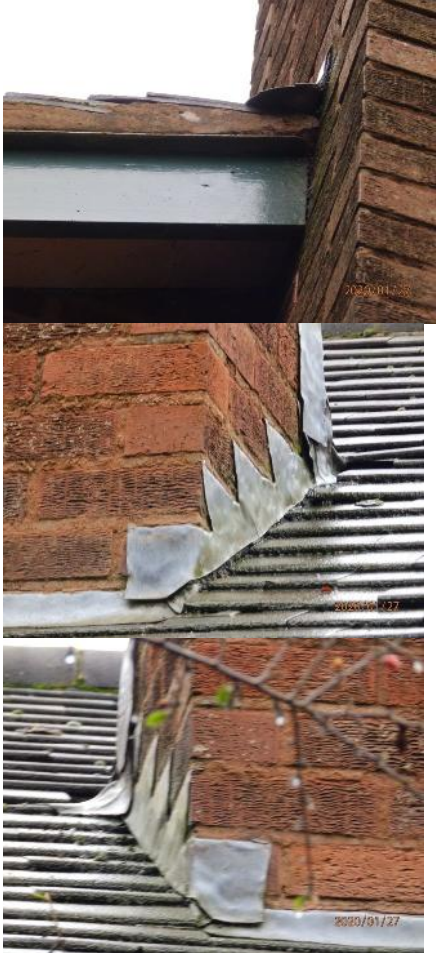
<b>Feature.</b>	<b>Evidence of bats.</b>	<b>Likelihood of bats roosting.</b>	<b>Photograph.</b>
Under lead flashings on chimneys.	None.	Possible. There is access for bats where the lead flashing adjoins the verge on the northern gable. There is no access under other lead flashings including the lead flashing around the soil and vent pipe which has partially lifted.

<p>The top photograph shows a close-up of a wooden eave with a dark, recessed area. The middle photograph shows a brick wall with a corrugated metal roof, with a white plastic sheet partially covering the roof. The bottom photograph shows a similar scene with a brick wall and corrugated metal roof, with a white plastic sheet covering the roof and some greenery visible in the background.</p>
<b>Feature.</b>	<b>Evidence of bats.</b>	<b>Likelyhood of bats roosting.</b>	<b>Photograph.</b>

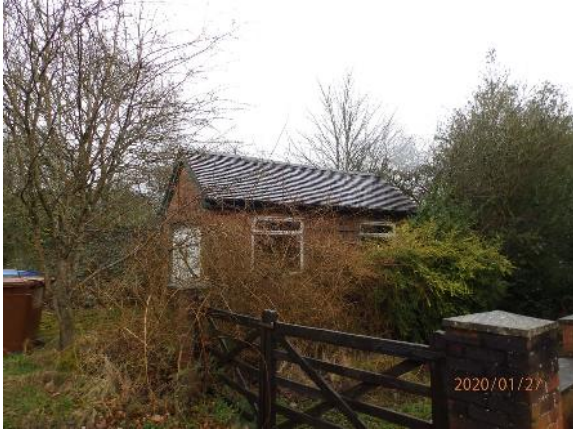
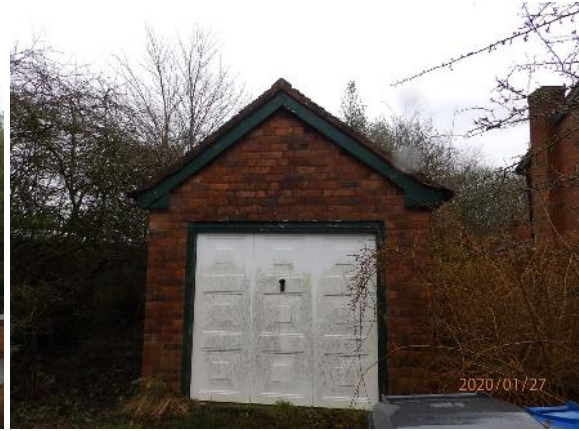
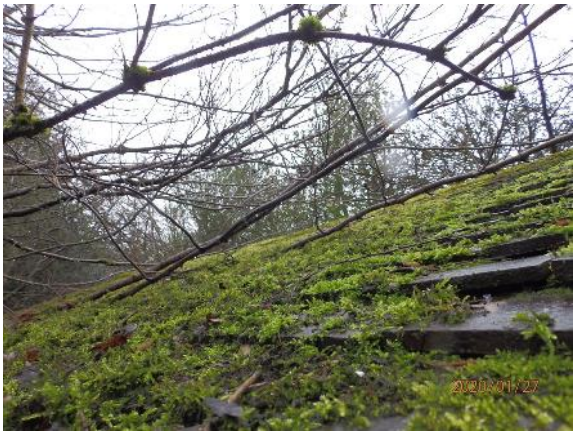
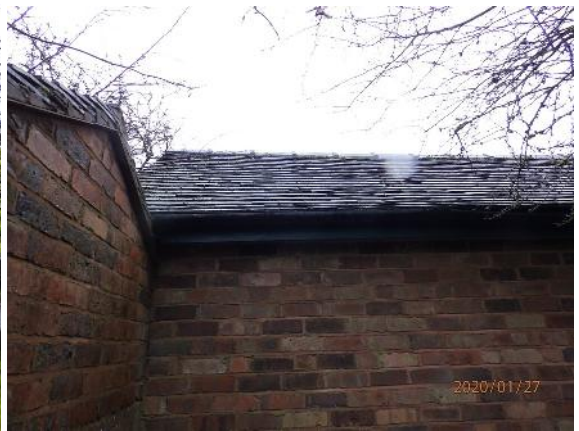
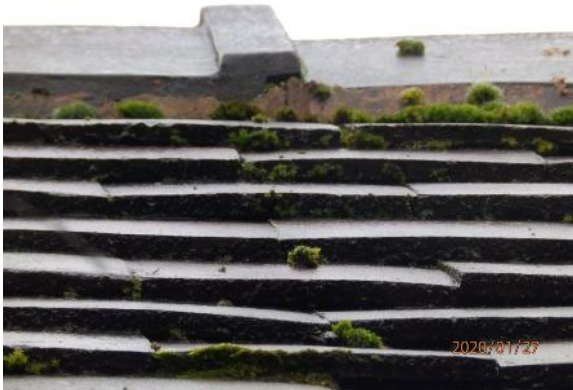
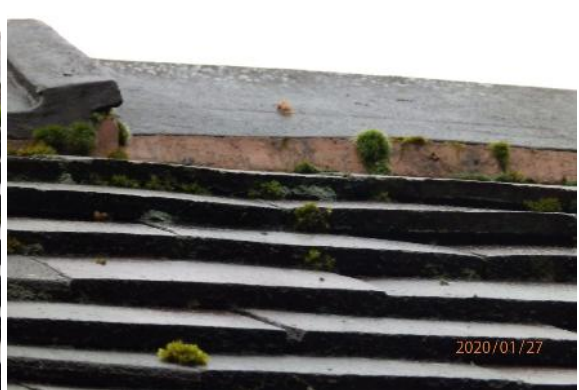
This is a solid brick store with a cavity brick garage adjoining.

There are plain tiles on the roof with a bitumous underfelt. There is no access under the plain tiles or the ridge tiles.

The only place of shelter is in the open store where it is possible for bats to roost against the rafters but this is thought to be unlikely due to the light and open nature of the building.

The building offers only very poor places of shelter for bats.

The garage/store only offers a very poor place of shelter for bats and its re-use or demolition will not affect a place of shelter for bats.

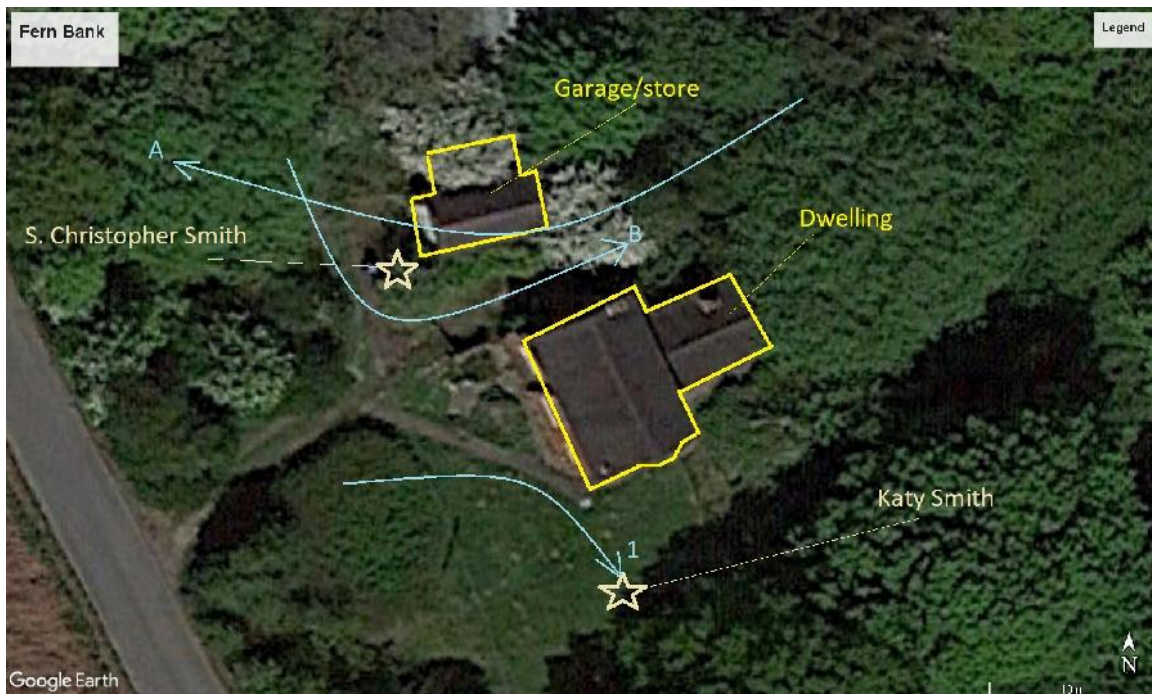
Analysis of the recordings from the bat detectors have confirmed the presence of Common Pipistrelle bats and Soprano pipistrelle bats.

The bats were commuting across the site with no forage calls recorded. The sonogram shows the typical 'hockey stick' shape for all pipistrelle echolocation calls, an initial frequency modulated downwards sweeping call followed by the constant frequency peak frequency area. The peak frequency can be seen to be around 45kHz on the peak frequency graph, confirming that the bat was a Common Pipistrelle.

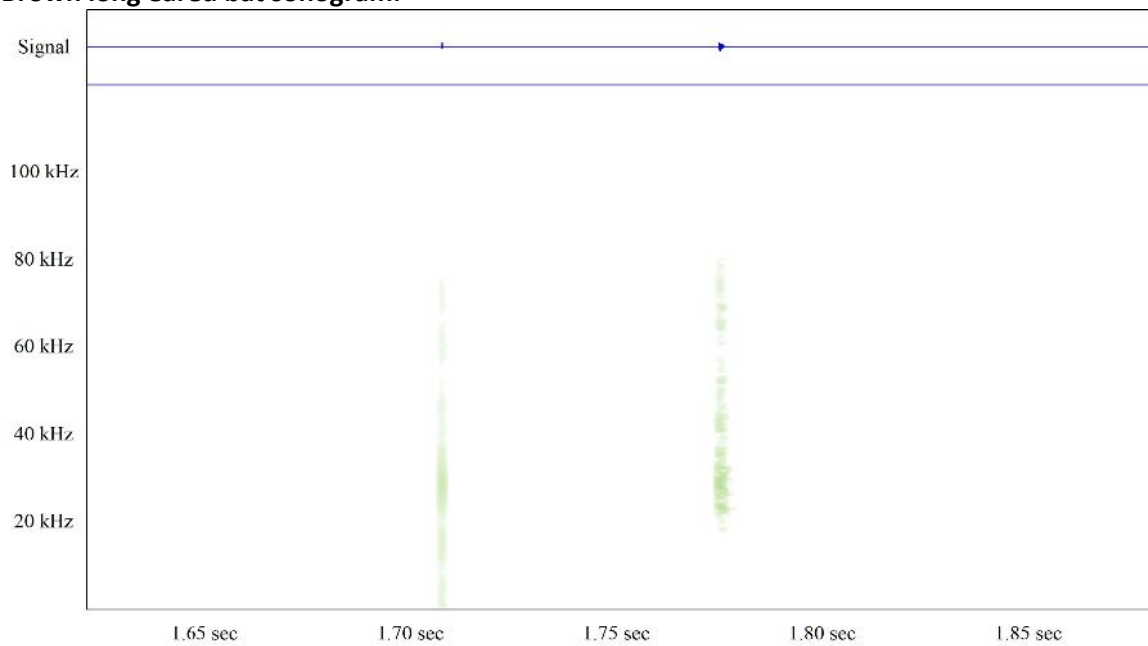
### Brown long eared bat sonogram.

The presence of Brown long eared bats was confirmed by the bats being seen in flight, the presence of 7 bats in the roof space of Building A when the bat consultant visited the site on the 8<sup>th</sup> August 2017. The calls are very quiet and show a faint frequency modulated call with a split in the call making it appear as a staggered downwards line.

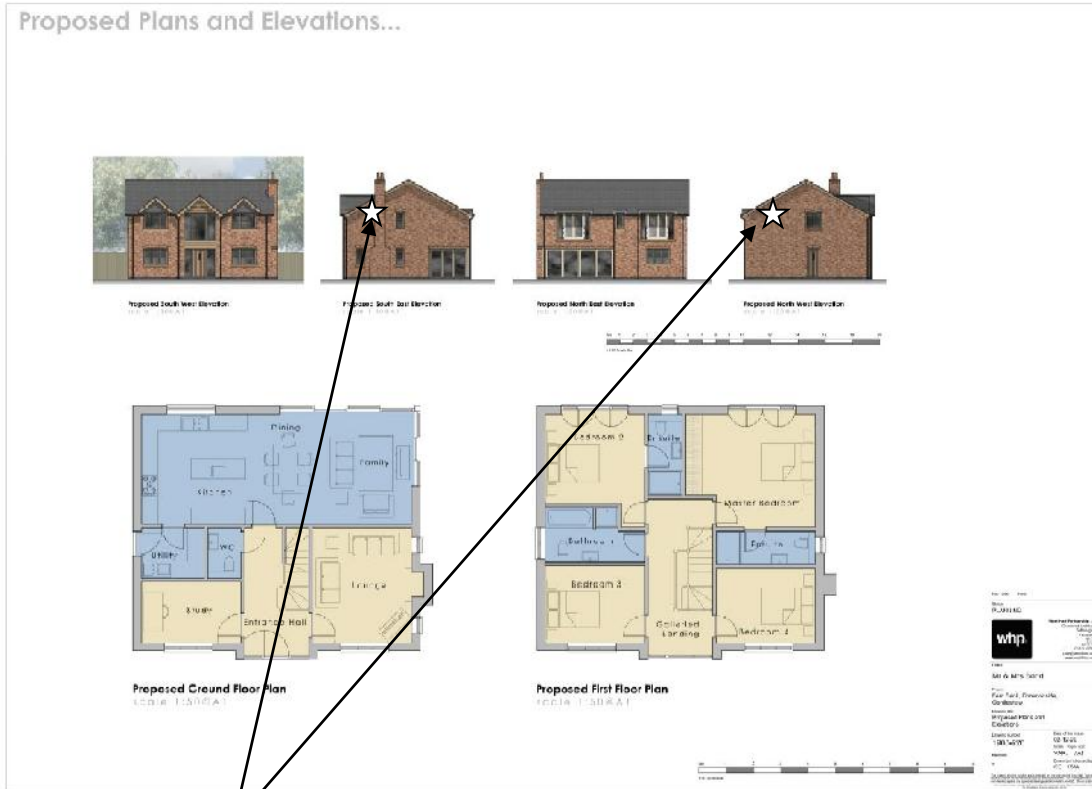
## Brick built bat boxes.

Enhancements for bat roosting can be created by installing two brick built bat boxes on the new dwelling.

A brick built bat box can be installed at the gables of two elevations on the new dwelling, should planning permission be granted. These are constructed from brick or concrete blocks and are built into the outer leaf of brickwork. They can have facing bricks or be rendered. They provide no access to the cavity wall.
