**Bat Survey Report for
253-255 London Road,
Headington, Oxford, OX3 9EH**

Cotswold Wildlife Surveys

11th February 2022

Report Number: 3903-CWS-01

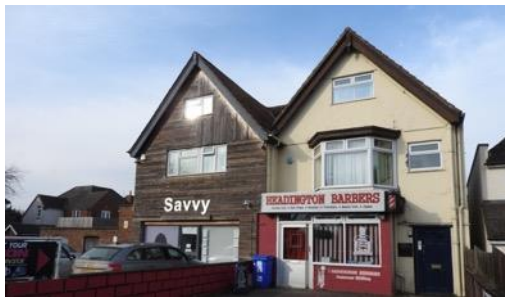
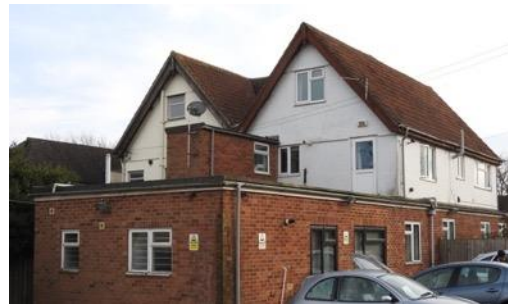
Figs. 1 & 2 Front and rear aspects of number 253-255

The survey site comprised a pair of semi-detached, pitched tile roofed houses, with flat roofed extensions to their rear (Figs. 1 and 2), and a detached, pitched tile roofed garage (Fig. 3).

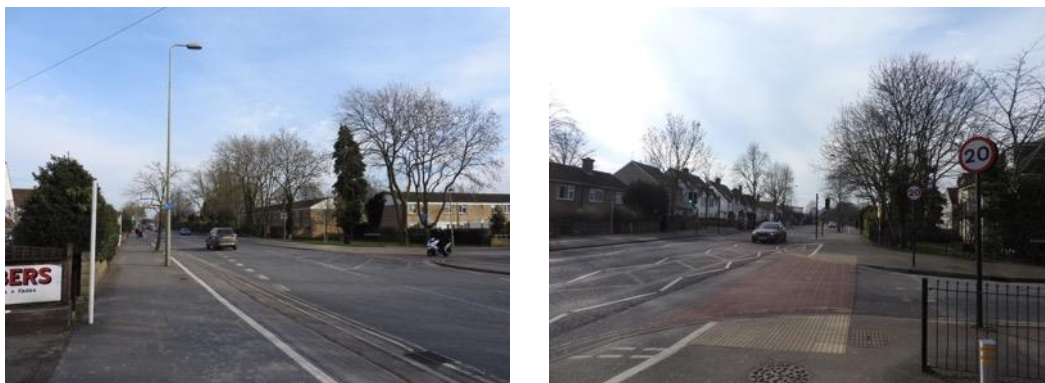
The site opened straight onto London Road with mature trees observed to the east and west (Figs. 4 and 5).

Figs. 4 & 5 Views to the front looking east (L) and west (R)

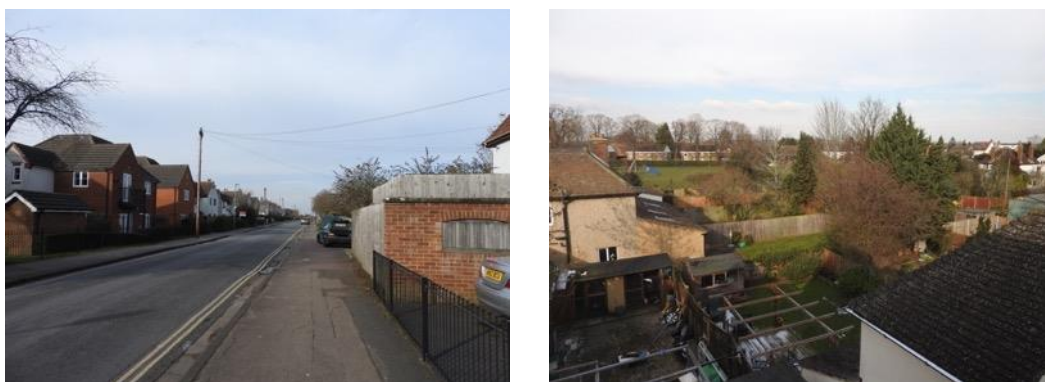
Mature trees were observed in the distance on Barton Road, and trees were observed in rear gardens to the northeast (Figs. 6 and 7).

Figs. 6 & 7 Barton Road looking northwest (L) and view looking northeast (R)

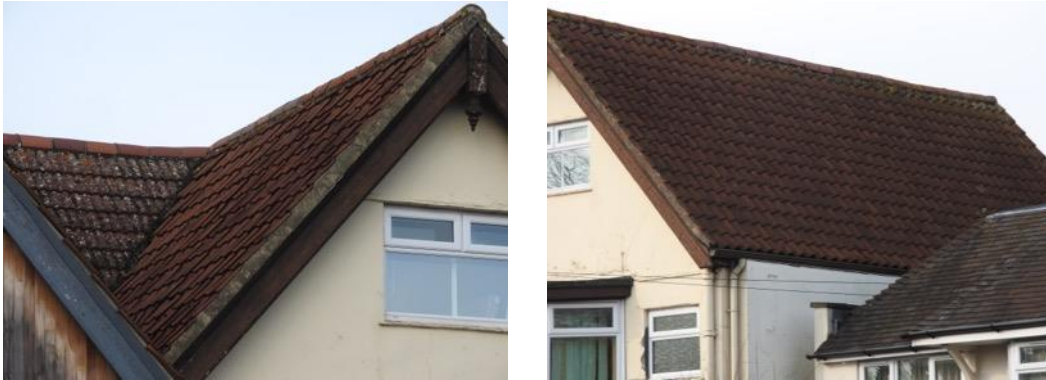
Figs. 8 &9 Ridges and roof tiles to the front and side

The ridges were intact and sealed, whilst all the roof tiles were tightly overlapping, with none raised, broken, dislodged or missing (Figs. 8 and 9).

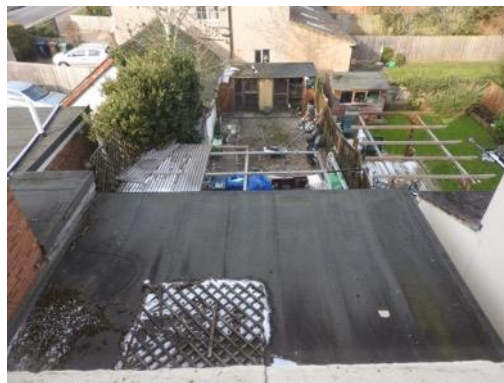
Fig. 10 Tarred felt flat roof to the rear

The flat roof to the rear was finished with tarred felt in good condition with no holes or tears (Fig. 10).

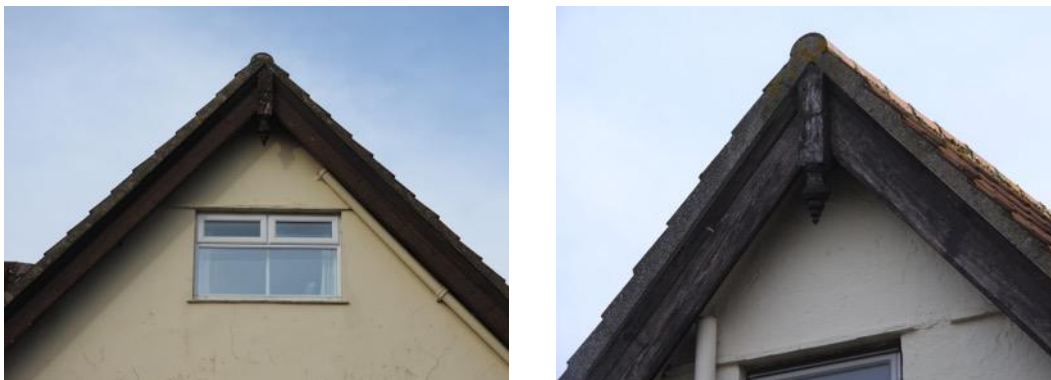
Figs. 11& 12 Sealed gables

The roof verges at the gables were sealed to the timber barge boards, with the roof tightly fitting against the gable wall plates (Figs. 11 and 12).

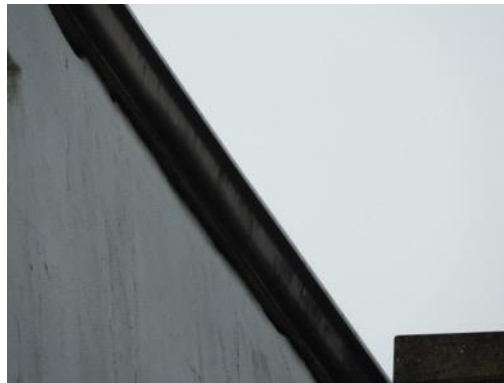
Fig. 13 Sealed eaves

The roof ends at eaves level were tightly fitting against timber fascia boards (Fig. 13).

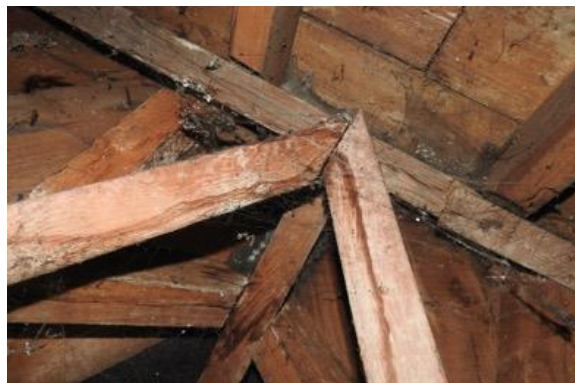
Fig. 14 Cobwebbed plumb cut

The ridge, gable ends, and plumb cut were all very heavily cobwebbed (Figs. 14-17).

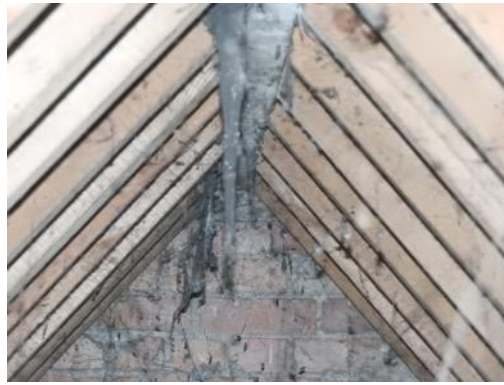
Fig. 17 Cobwebbed ridge and gable end of the perpendicular void

The roof was lined with timber sarking and there was no light penetration. Unsurprisingly no evidence of bat occupation was discovered inside number 255.

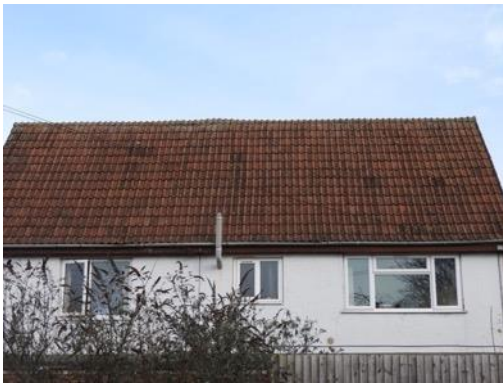
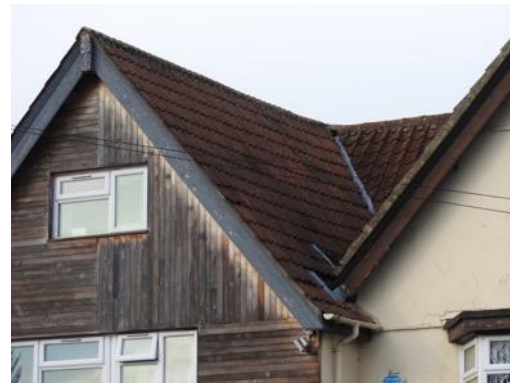
Figs. 18 &19 Ridges and roof tiles to the front and side

The ridges were again intact and sealed, whilst all the roof tiles were tightly overlapping with none raised, broken, dislodged or missing (Figs. 18 and 19).

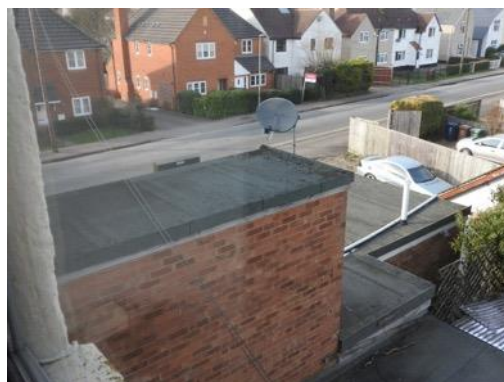
Fig. 20 Tarred felt flat roof to the rear

The flat roofs to the rear and side were finished with tarred felt in good condition with no holes or tears (Fig. 20).

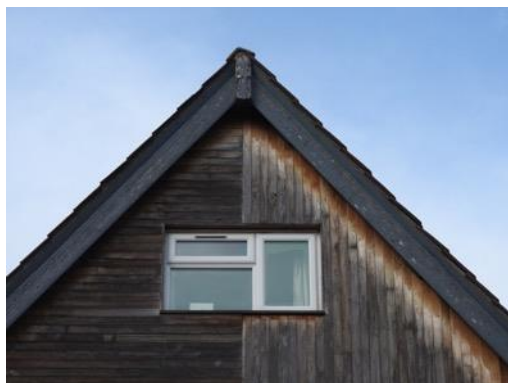
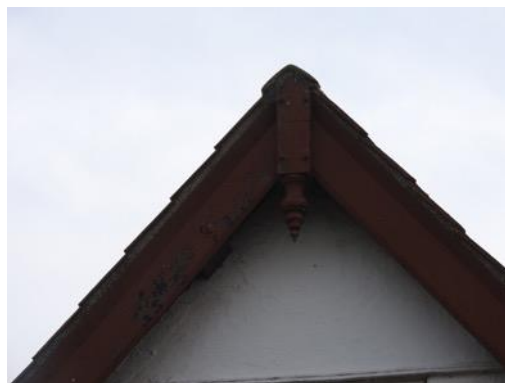
Figs. 21 & 22 Sealed gables

The roof verges were sealed to the timber barge boards with the roof tightly fitting against the gable wall plates (Figs. 21 and 22).

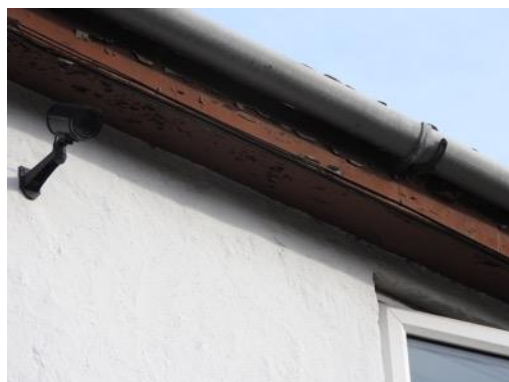
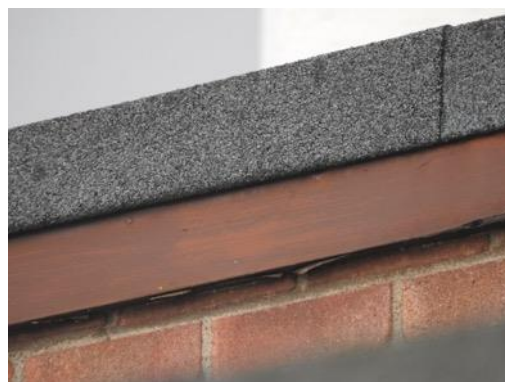
Figs. 23 & 24 Sealed eaves – house (L) and flat roofs (R)

The eaves were finished with boxed soffits tightly fitting against the walls (Fig. 23). The flat roofs were finished with the felt tightly fitting against fascia boards, these tight to the walls (Fig. 24).

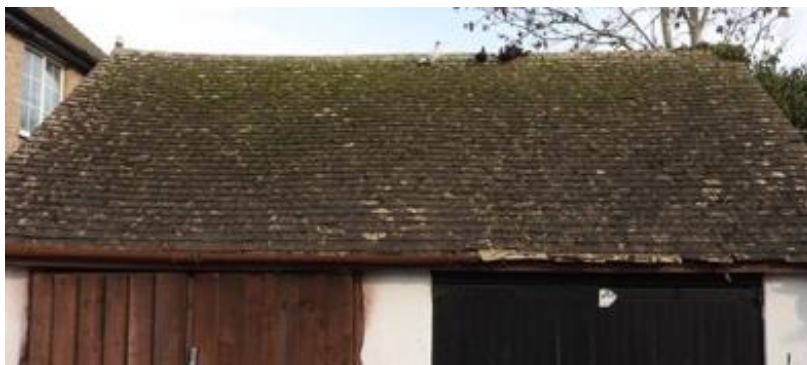
Fig. 25 Ridge and roof tiles on the west side

The ridge was intact and sealed, whilst the roof tiles on the west facing slope were tightly overlapping (Fig. 25).

The east facing roof slope was partially overgrown with Ivy *Hedera helix*, but again the tiles were tightly overlapping.

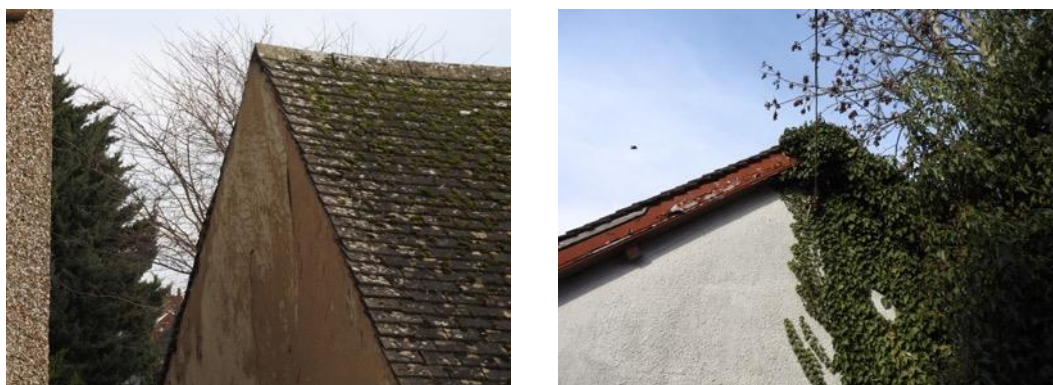
Figs. 26 & 27 Sealed gables north (L) and south (R)

The gables were finished with the roof verges cement sealed to the gable wall plate at the north end and barge board at the south (Figs. 26 and 27).

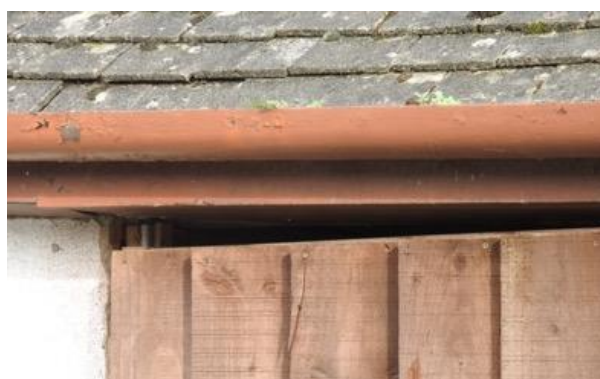
Fig. 28 Door with gaps

The clipped eaves were sealed, with the roof ends tightly fitting against the timber finished wall plates (Fig. 28).

The rendered walls were sound throughout, whilst the door frames were tightly fitting. However, there were gaps around the doors providing potential bat access to the interior (Ref. Fig. 28).

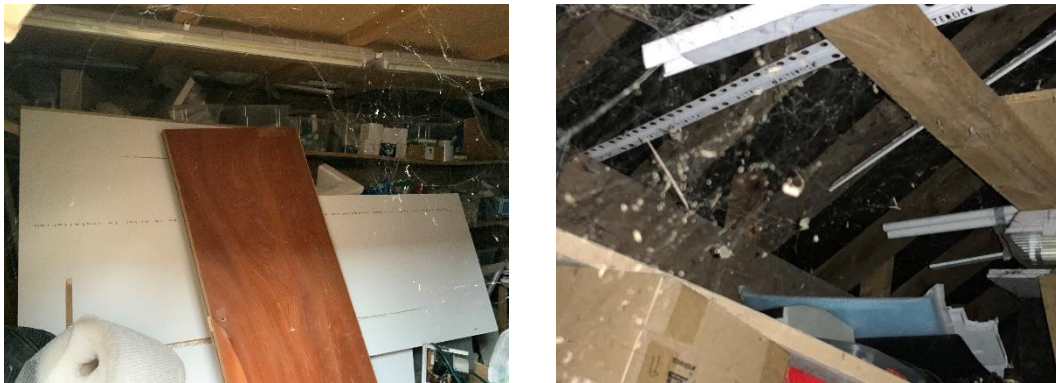
Figs. 29 & 30 Garage interior

Internally the garage was an open construction to the ridge line. The roof was lined with tarred felt, this intact and un-torn, with no light penetration. The whole void was heavily cobwebbed with no signs of bat use. (Figs. 29 and 30)
