PHASE 1: DESK TOP STUDY & COAL MINING RISK ASSESSMENT REPORT
THIRTEEN GROUP
PROPOSED RESIDENTIAL DEVELOPMENT
LAND AT AMBERLEY STREET & HARROGATE STREET
HENDON
SUNDERLAND
SR2 8ES

Project No: 20-794

Proposed Development Layout Plan

Site Photographic Record Sheet

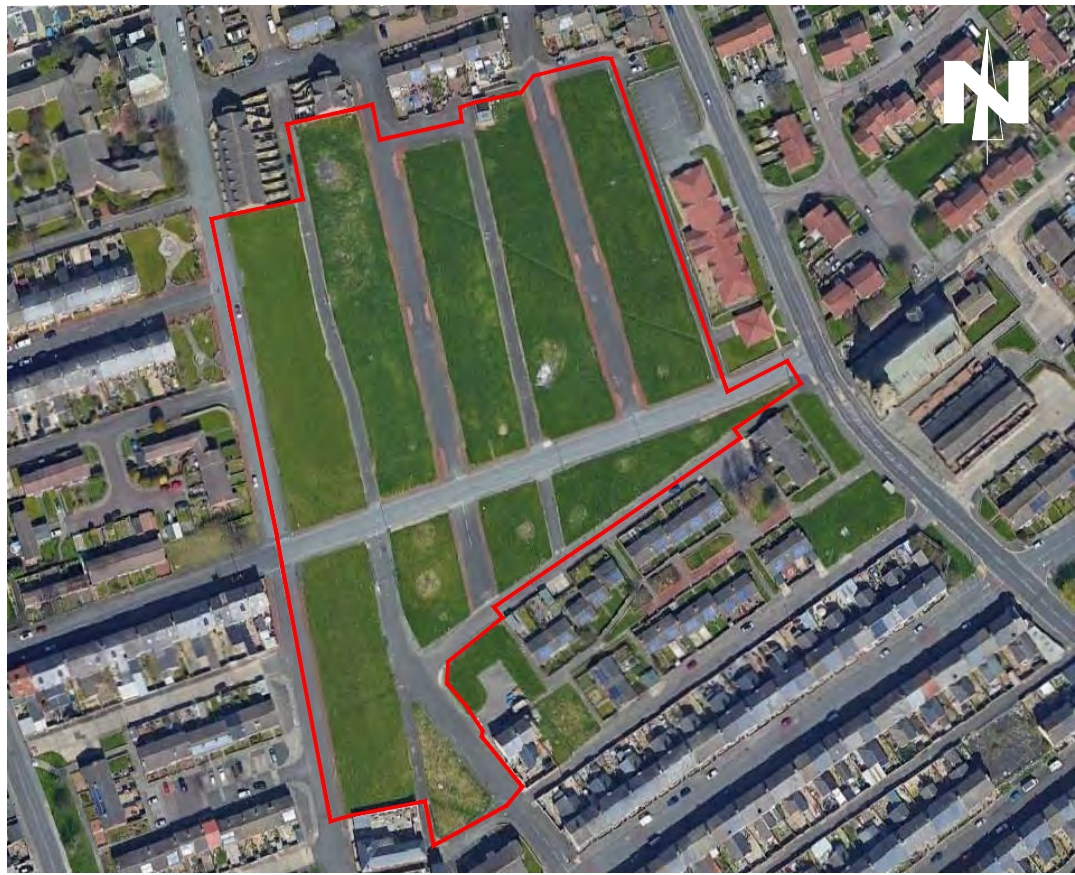
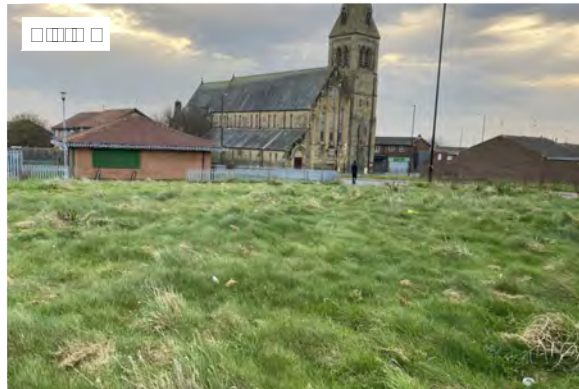
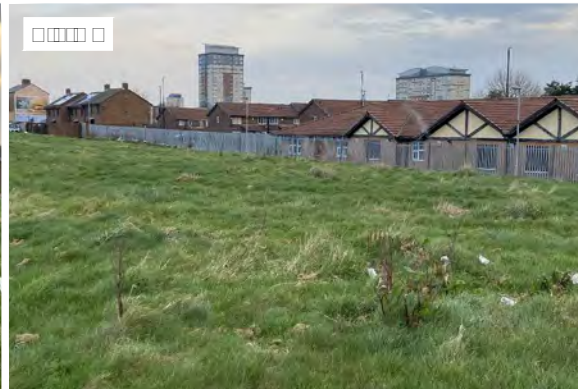
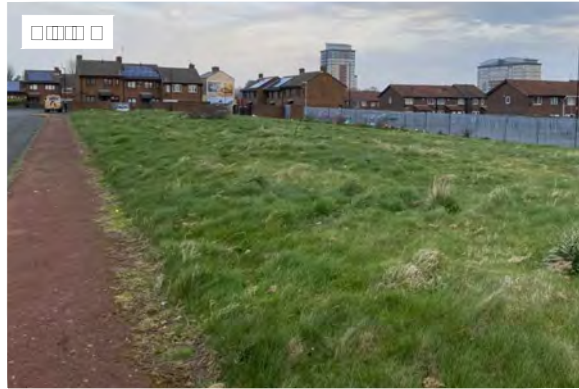
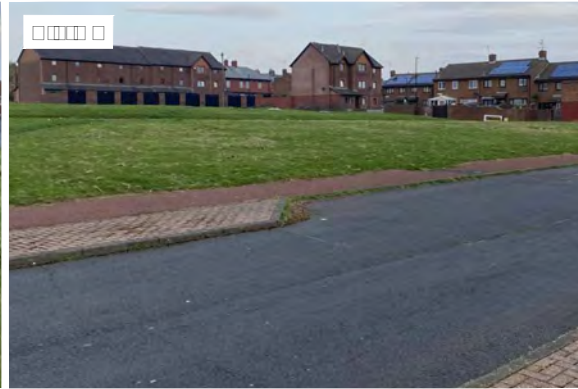
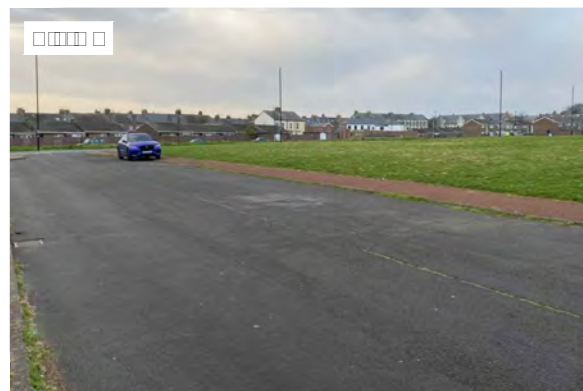
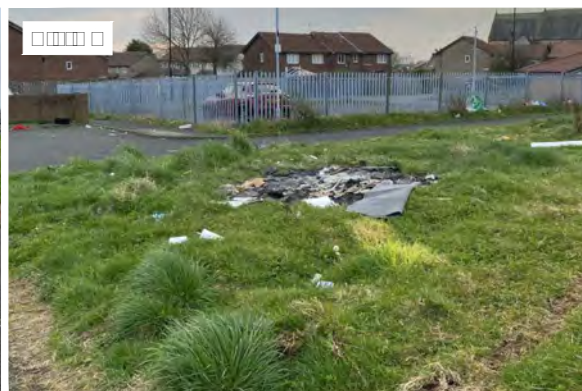
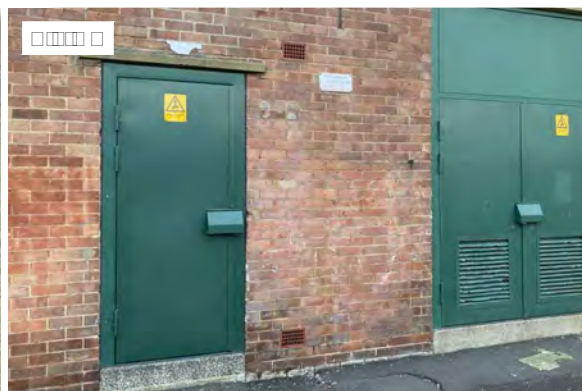
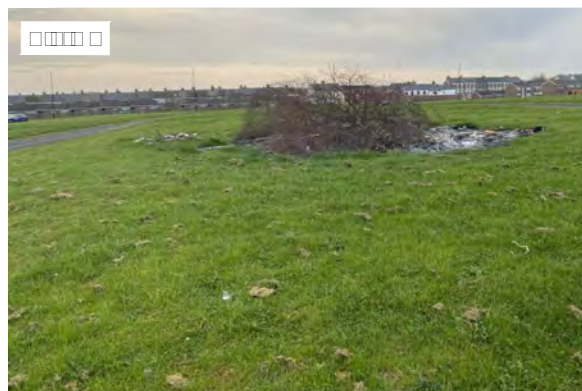
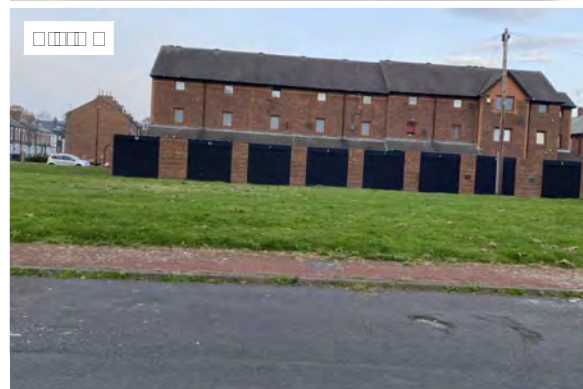
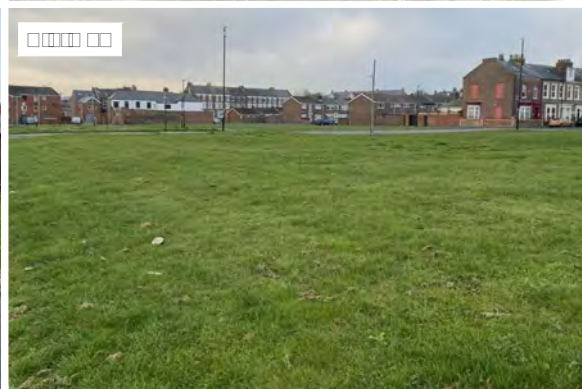
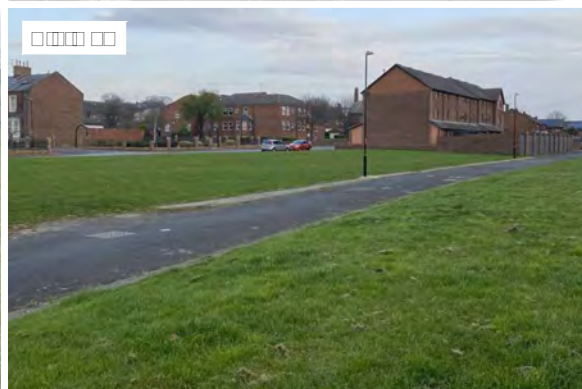
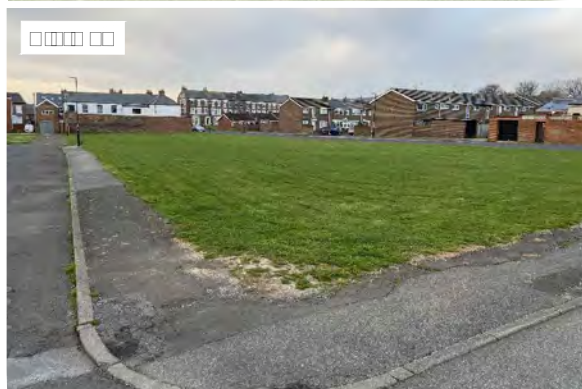
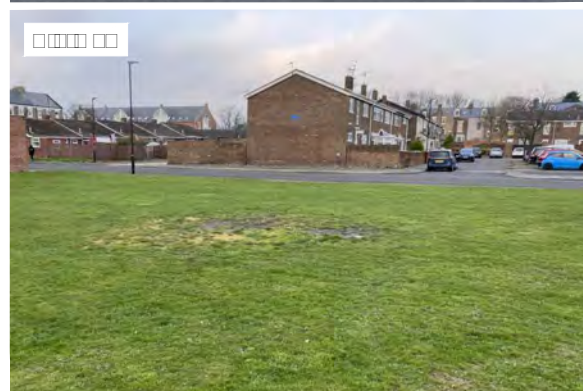
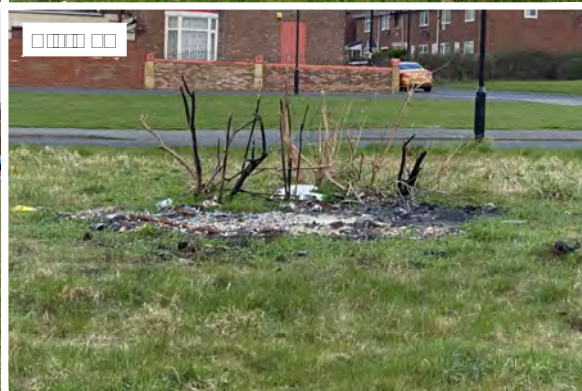
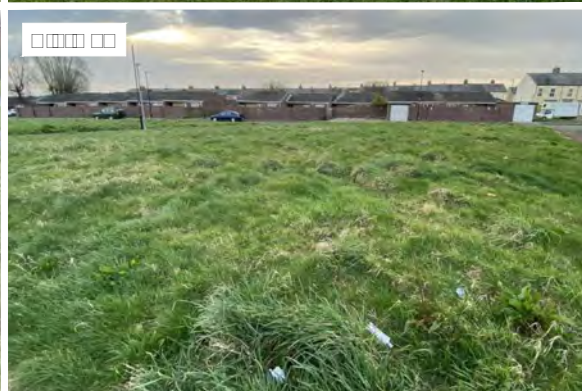
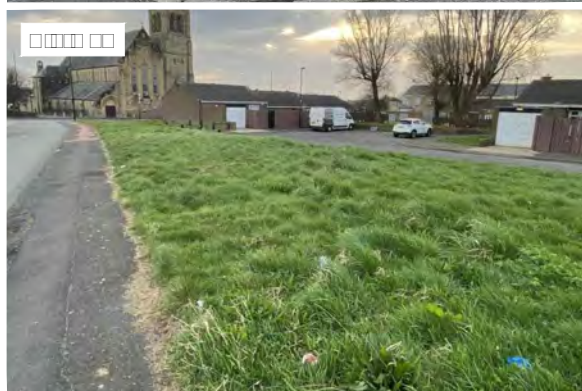
Additional Comments:	From, the site walkover carried out, several small areas where former fires have occurred were noted across the site.
