# Heritage Impact Assessment

## *Additional Information*

In Support of Application for Planning Permission for Proposed Works at  
Arbour Tree Farm, Warwick Road, Chadwick End, Solihull B93 0BE

January 2022

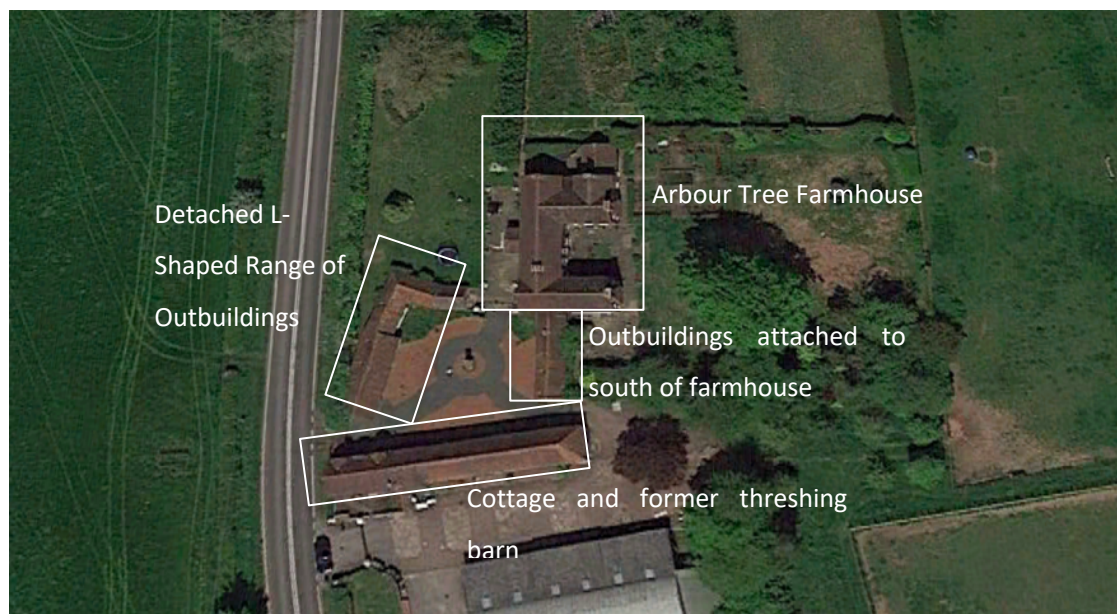
Figure 1 Extant buildings within the application site. Source: Google Earth.

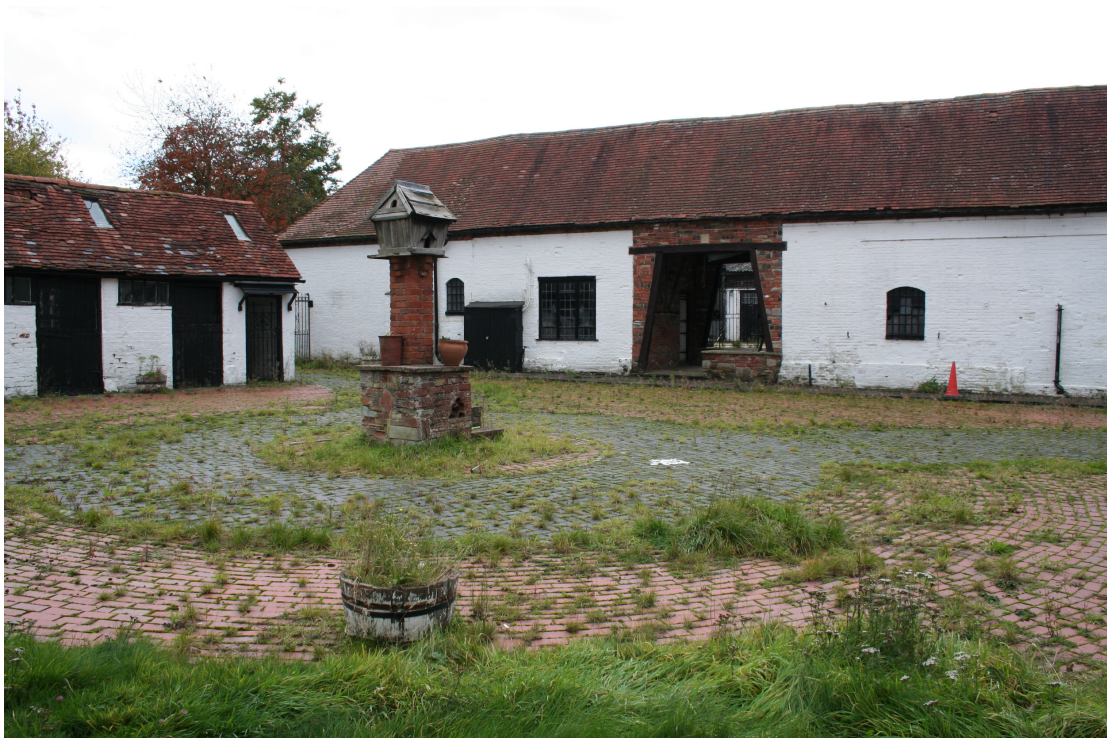
*Figure 2 Central courtyard at Arbour Tree Farm.*

- 3.12 The existing brick surfacing and dovecote may be relatively modern additions, but the use of this space in conjunction with the working barn and stables in an area animated with noise and activity would have been a defining feature of the farm. The yard is currently disused and is becoming overgrown.

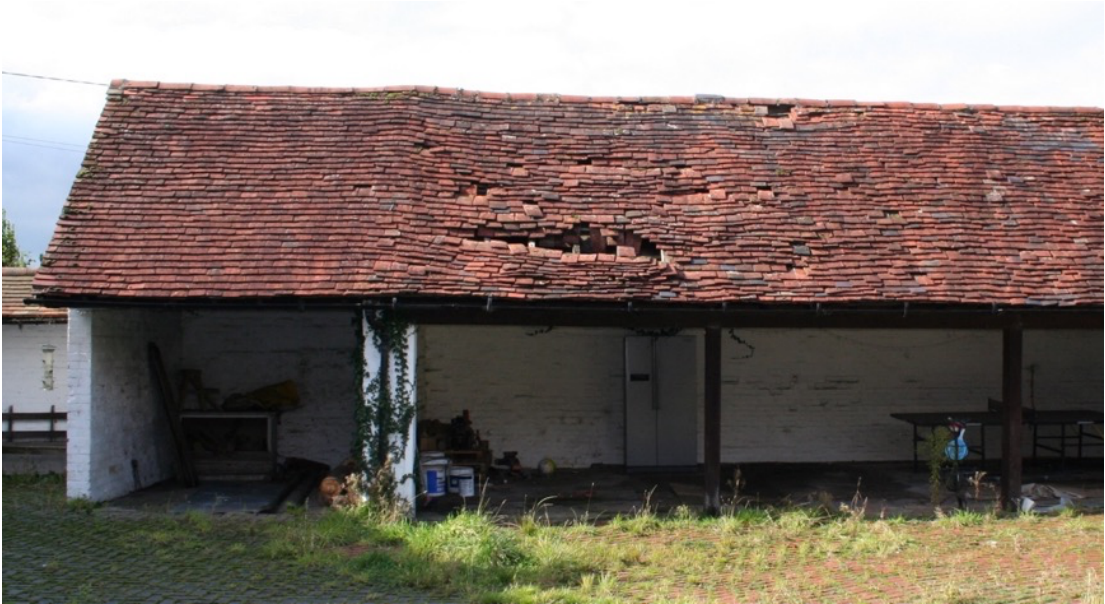
- 3.7 This range is not in beneficial use and is beginning to suffer from a lack of maintenance. Part of the building has been re-roofed using modern sawn timbers but elsewhere the stables seem to retain the original timber roofing structure.

- 4.8 The site is currently not fully occupied or in use and a number of outbuildings are vacant. As such they are no longer being maintained and are starting to fall into a state of disrepair.

*Figure 3 South end of the L-shaped range is in particularly urgent need of repair.*
