Bat & Protected Species Survey & Bat Emergence Survey: Club House

Axe Cliff Golf & Country Club
Seaton
Devon
EX12 4AB

Planning Reference:		Report Reference:	190824 B-1 rev00
Client/s:	Robert Loveridge		
Architect/Agent:	Woldon Architects Ltd.		
Survey Date/s:	2019: 21 st , 22 nd August & 10 th September 2021: 9 th December		
Report Date:	March 2021	OS Grid Ref:	SY 25737 90105
Report Author:	William Corbett BSc (Hons), MRes		
Approved By:	Andrew Charles BSc (Hons), MSc, MCIEEM		
Surveyor/s & Licence N°:	Luke Gibbons	Bats: 2015-15452-CLS-CLS (WML-A34 – Level 2) Barn Owl: CL29/00265 (WMLCL29)	
	William Corbett	Bats: 2022-10213-CL18-BAT (WML-A34 – Level 2)	
Additional Surveyor/s:	George Greenshields & Adrian Bayley

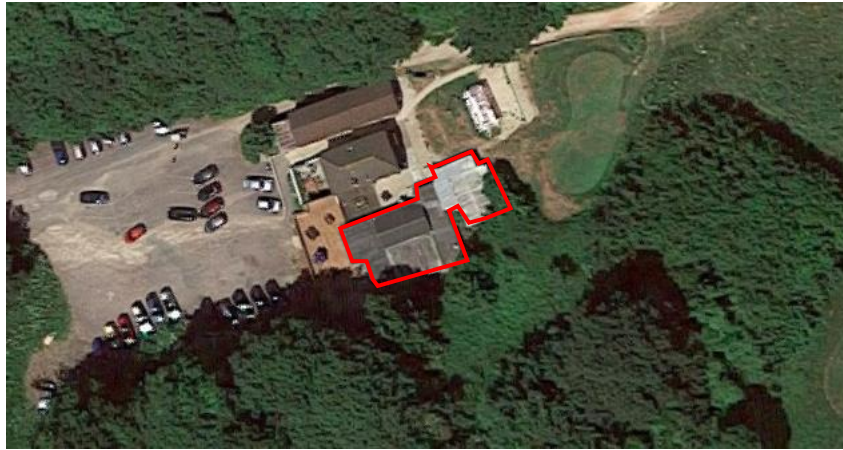
Figure 1. The Clubhouse at Axe Cliff Golf Course

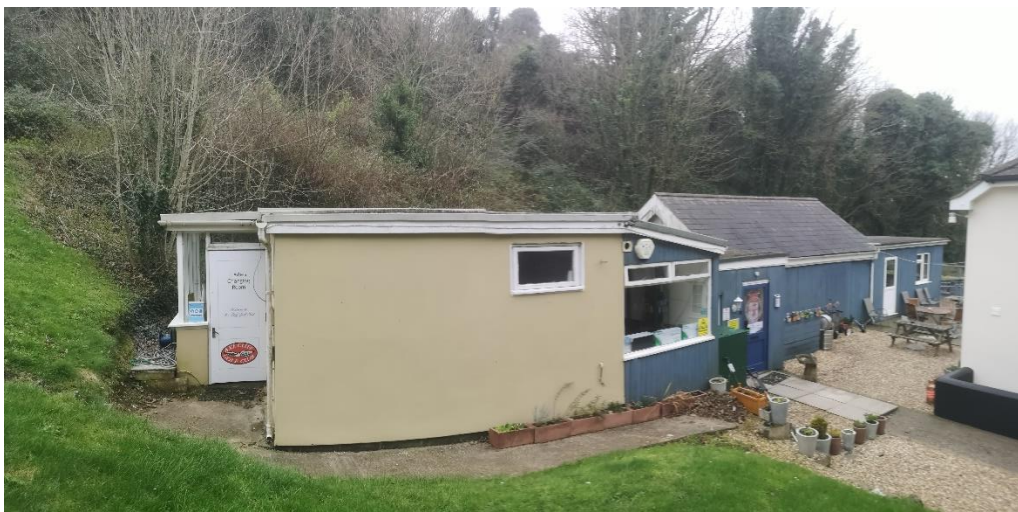
The Clubhouse is a single storey building with multiple pitches and flat roof sections (see Figure 2). The pitched roof of the Clubhouse includes a covering of fake slate and the flat roof sections include a bitumen roofing felt covering. The building is both externally rendered and clad with wooden weather boarding.

Figure 2. The northern elevations of the Clubhouse

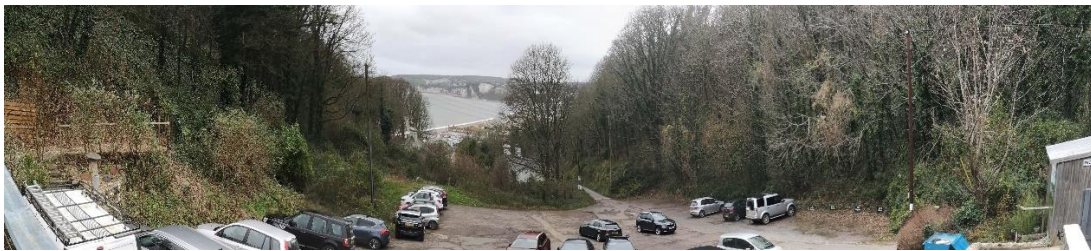
The car park comprises of in majority an extent of hardstanding (see Figure 3). Surrounding habitats to the car park included the edge of a woodland, amenity grassland, scrub and tall ruderal. The wooded species includes elder (*Sambucus nigra*), hazel (*Corylus avellana*), bramble (*Rubus fruticosus* agg.), Jasmine (*Jasminum* sp.), buddleia (*Buddleja* sp.), ash (*Fraxinus excelsior*) and sycamore (*Acer pseudoplatanus*). The ground flora species includes hedge bindweed (*Calystegia sepium*), ivy (*Hedera helix*), herb-Robert (*Geranium robertianum*), cleavers (*Galium*

Figure 3. The car park and surrounding habitat

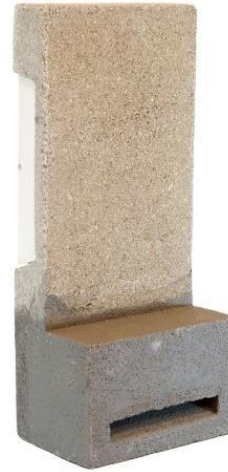
Segovia Build-In Woodstone Bat Box

Material: Woodcrete

Width: 210 mm

Height: 500 mm

Depth: 170 mm

Entrance Width: 160 mm

Entrance Height: 25 mm

Position: Built into external wall, below eaves or at a minimum height of 3 m with the entrance face at the front, remaining exposed and visible. The boxes have removable sides so that an extension box can be placed next to this box, to create a larger roosting space.

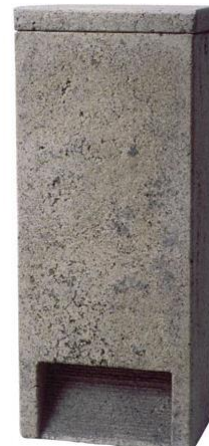
**Schwegler 1FR Bat Tube**

Material: Woodcrete (75% wood sawdust, concrete and clay mixture)

Width: 200 mm

Height: 475 mm

Depth: 125 mm

Entrance Width: 150 mm

Entrance Depth: 20 mm

Weight: 9.5 kg

Position: Within external walls in place of a standard block on a southerly aspect, beneath eaves or at a minimum height of 3 m

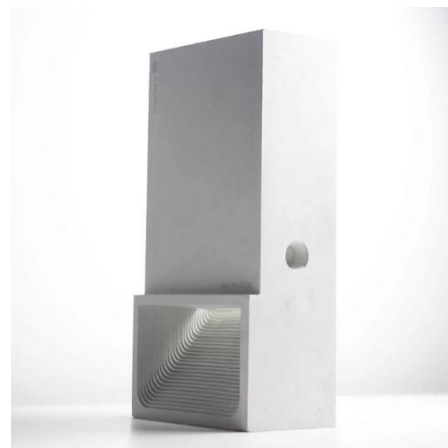
**Green & Blue Bat Block**

Material: Cast concrete (75% waste materials from Cornish China Clay Industry)

Width: 215 mm

Height 440 mm

Depth: 120 mm

Position: Within external walls in place of a standard block on a southerly aspect, beneath eaves or at a minimum height of 3 m

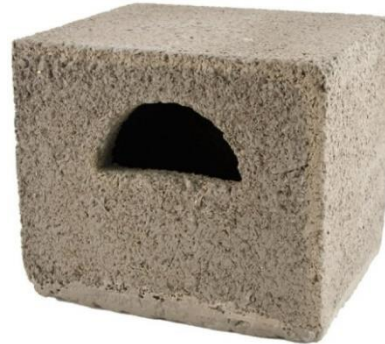
WoodStone Build in Open Nest Box

Suitable for: robins, wrens and blackbirds.
Material: Woodstone
Height: 180 mm
Width: 220 mm
Depth: 180 mm
Weight: 4.2kg

Position: Within external walls, at a minimum height of 2 m

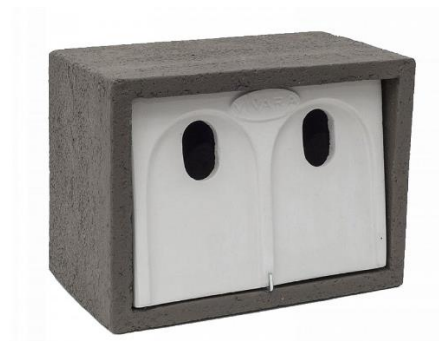
**Vivara Pro Estelle House Sparrow Terrace**

Suitable for: House sparrows and individual blue & great tits
Material: Woodstone

Height: 210 mm
Width: 290 mm
Depth: 160 mm
Weight: 7.5 kg

Position: Within external walls, at a minimum height of 2 m

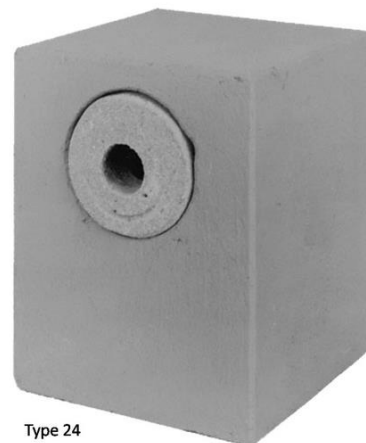
**Schwegler Brick Nest Box (Type 24)**

Suitable for: House sparrows, great tits, blue tits and nuthatches
Material: Woodcrete

Height: 235 mm
Width: 180 mm
Depth: 180 mm
Weight: 2.8 kg

Position: Within external walls, at a minimum height of 2 m

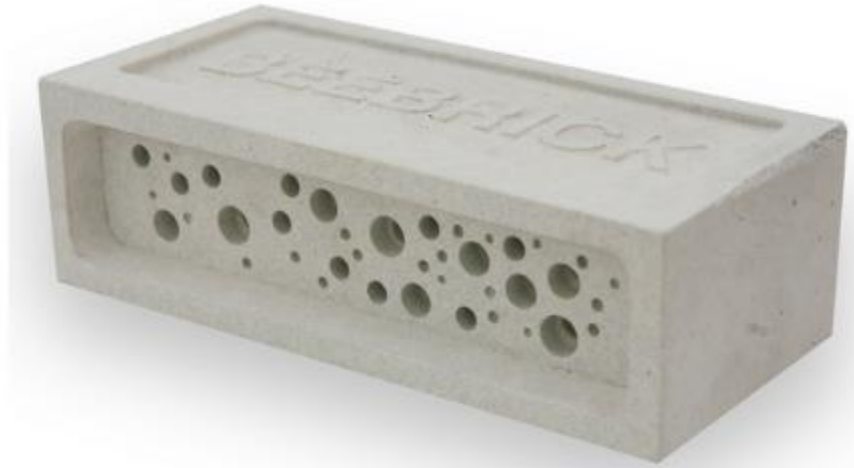
Each bee brick includes nesting compartments for solitary nesting bees, including for egg laying and hibernation.

Bee bricks to be positioned within southerly elevations, which includes part or full sun, between 1 m to 2 m above ground level, and ideally facing garden or boundary habitats.

Bee Brick - case in concrete: 215 mm x 105 mm x 65 mm
<http://greenandbluebuild.co.uk/product/bee-brick/>

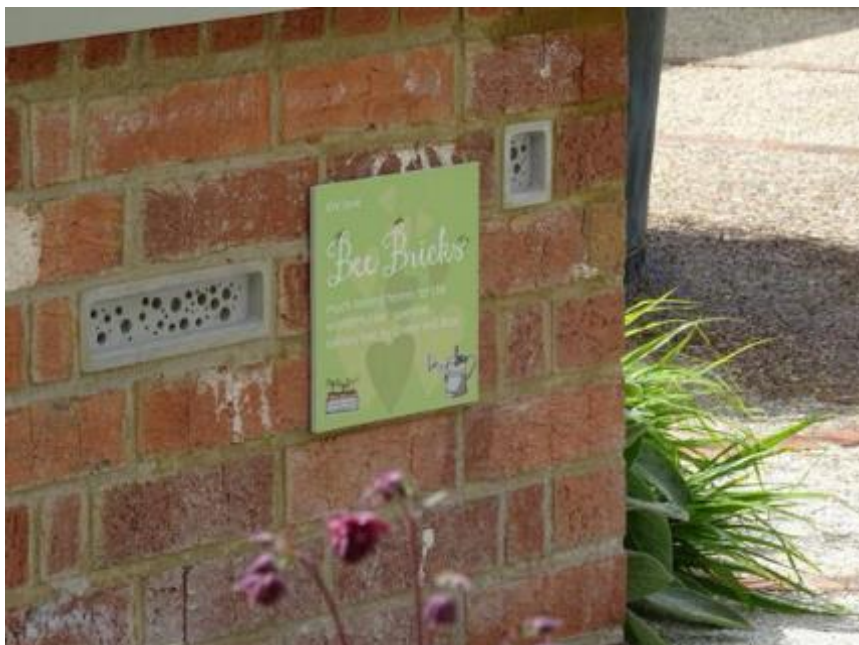
Bee brick & bee block incorporated into an external brick wall
