**Oak Farm House, Rougham,
Bury St Edmunds, IP30 9JU**

Application for Listed Building Consent
to alter the internal layout, install new external waste soil pipe and reopen inglenook
fireplace of the above property.

Design & Access Statement including Heritage

May 2022

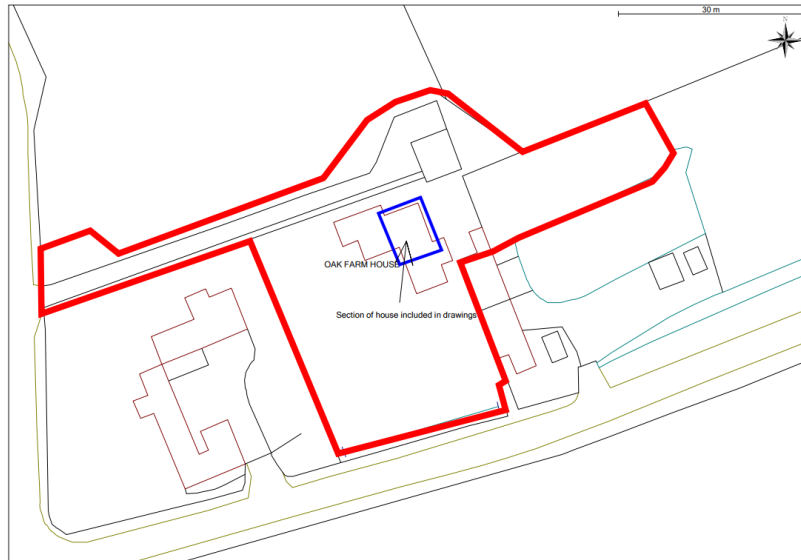
Plan I showing the section of the property used in the drawings.

- 3.1 Drawings I,2,3, and 5 show the existing and proposed layouts to part of the property as indicated by the plan of the property below.

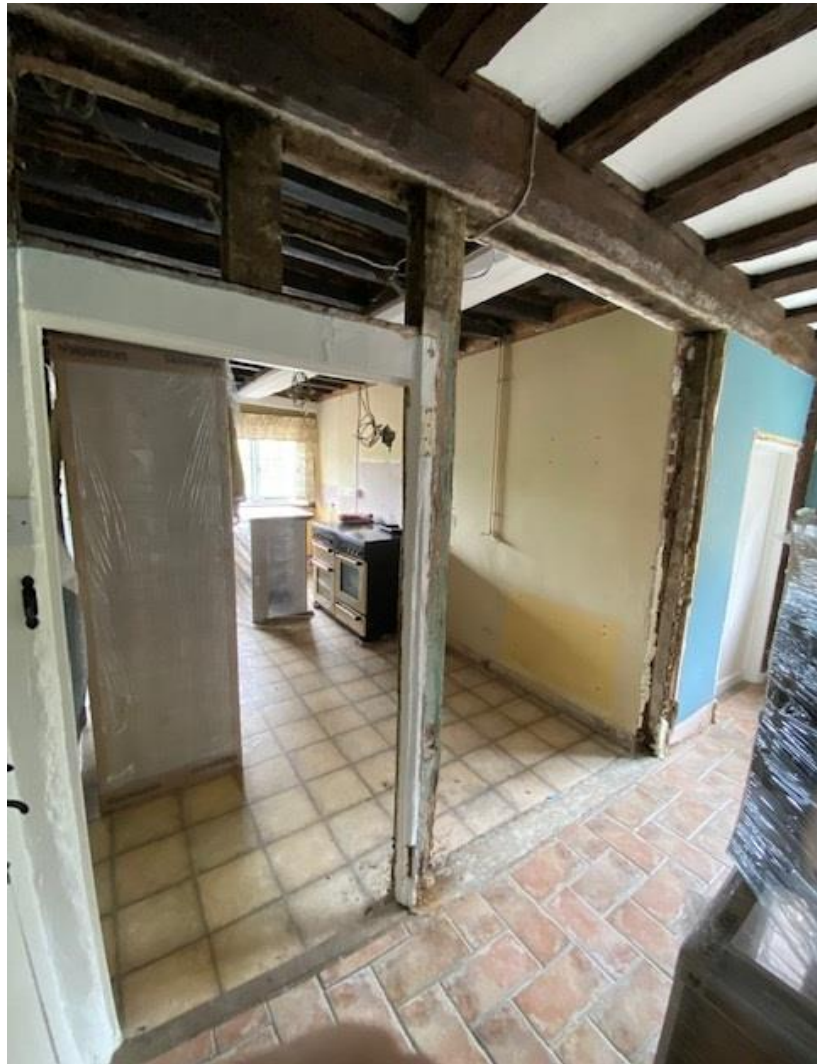
Picture 1. Wall A with the middle section removed which was softwood timber frame studding

- 4.1 A section of the existing ground floor layout to Oak Farm is shown in Drawing I. The two internal walls that are being proposed to be removed are labelled A and B on Drawing 2.
- 4.2 Both walls A and B are later additions to the property, which was once an open hall house.
- 4.3 Wall A is a timber framed stud wall, which has had a middle section replaced with modern softwood timber. The majority of Wall A was covered in plasterboard and a skim of plaster with the exception of a small area which was lathe and plaster shown on the right-hand side of picture I.

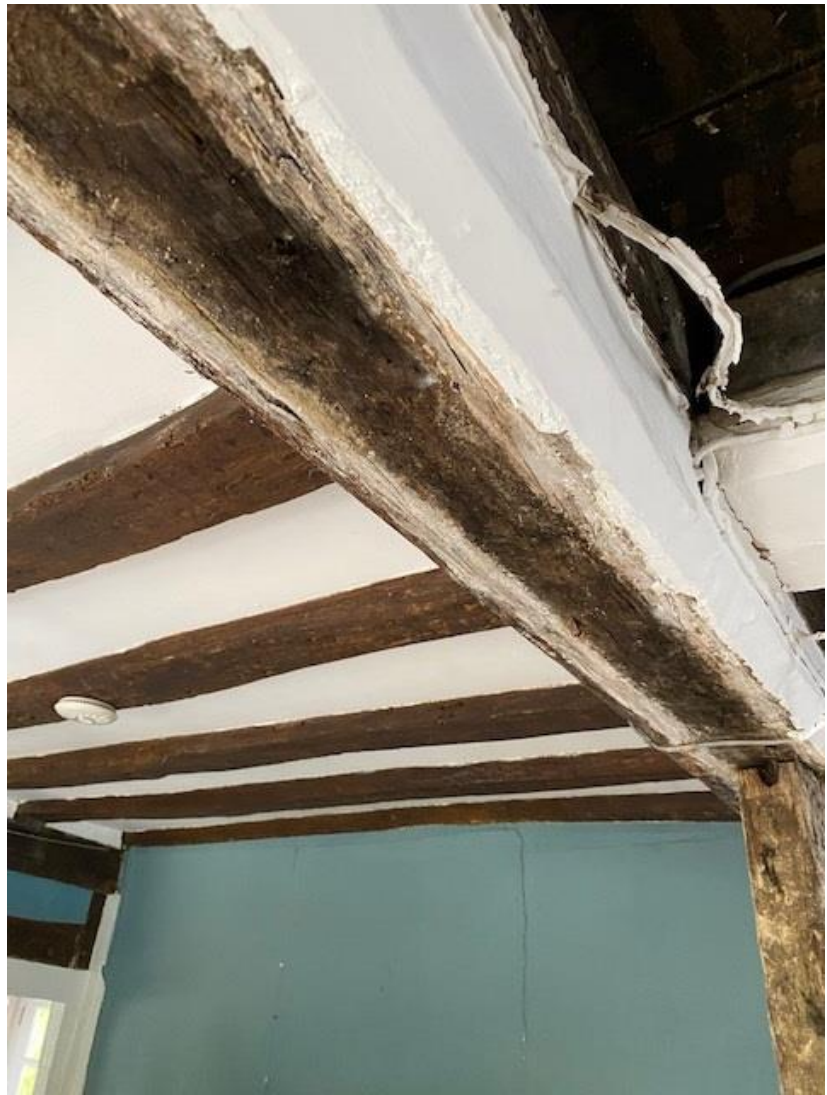
Picture 2. Beam above Wall A with no signs of mortice joints indicating that this wall was not original.

- 4.4 Wall A is a later addition to the property as it does not have any form of sole plate, brick plinth and the above beam does not have any mortice holes to locate the studwork (as shown in picture 2), indicating that it was not part of the property's original construction.

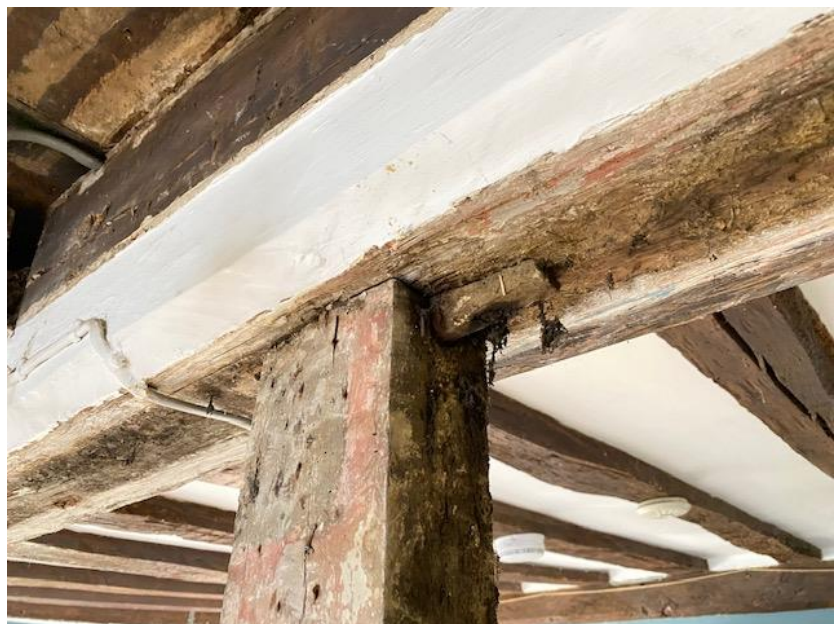
Picture 3. Studwork on Wall A is located and secured with nailed pegs onto the beam also indicating that this wall was not original.

- 5.3 The existing pegs used to secure the studwork of Wall A on the beam as shown in picture 3. will be retained as a reminder that there used to be a dividing wall in this location.

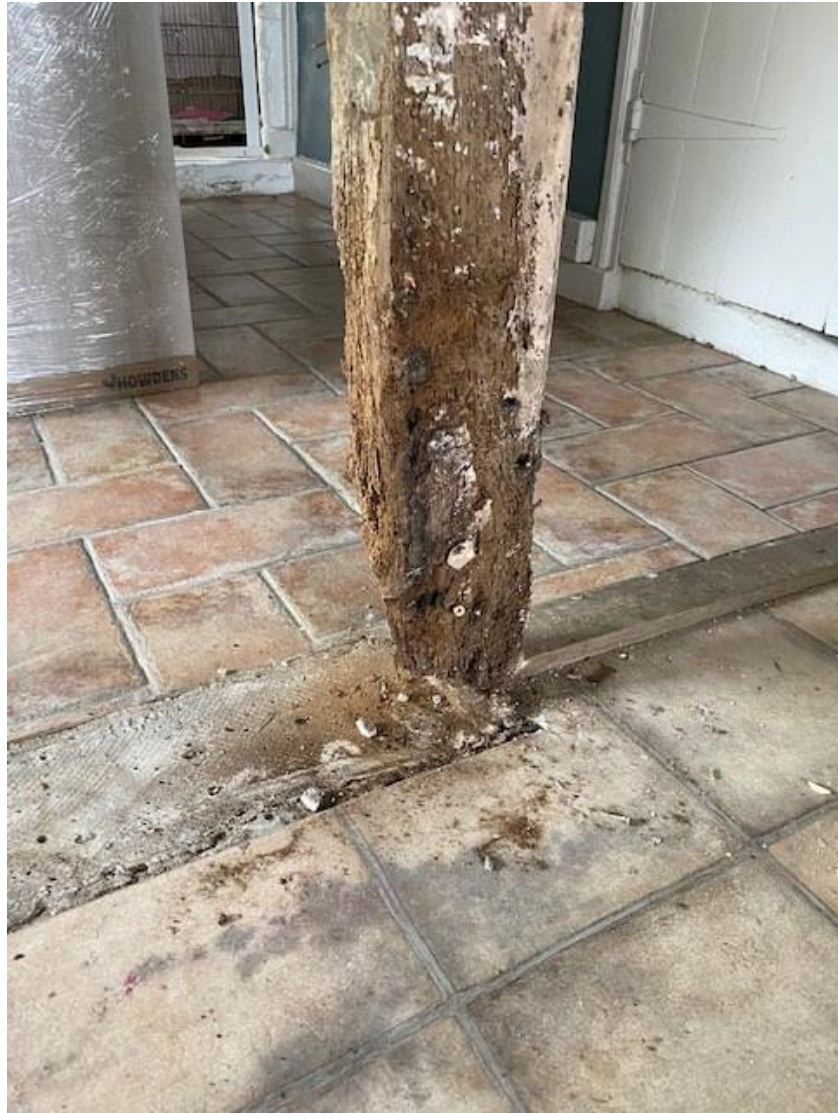
Picture 4. Timbers of Wall A showing significant deterioration.

- 4.5 Wall A also has some significant deterioration at ground level and is non supporting to the floor above.

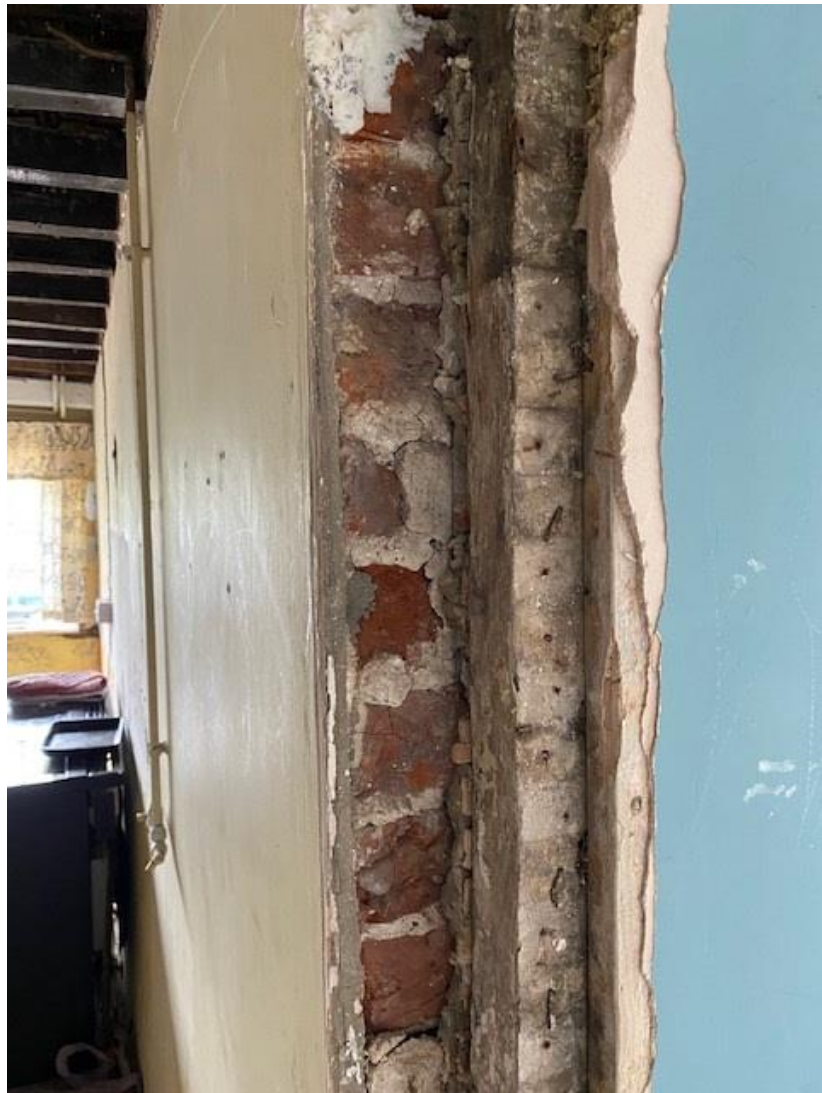
Picture 6. Cross section of Wall B where it meets Wall A.

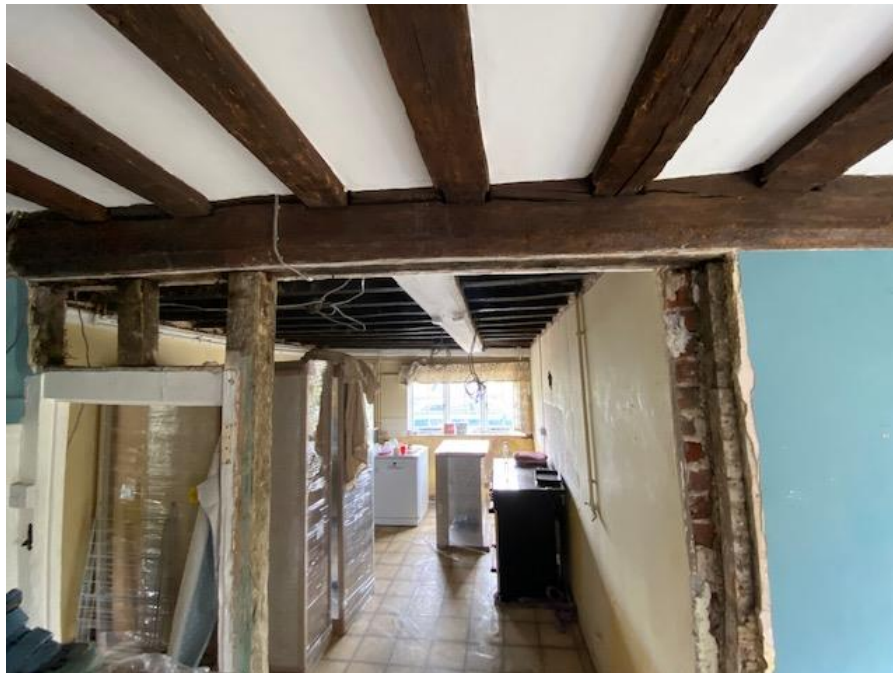
Picture 7. Location of Wall B in relation to the adjoining parallel running beam.

- 4.7 Wall B was never part of the original building layout due to its construction, materials and its proximity to the ceiling beam, which runs parallel approximately 1.2 meters to the left of it as shown in the photo below. Wall B also does not correspond to any other structural layout in the property and the above first floor ceiling joists run straight through the top of this wall further, confirming that it is not part of the property's original layout.

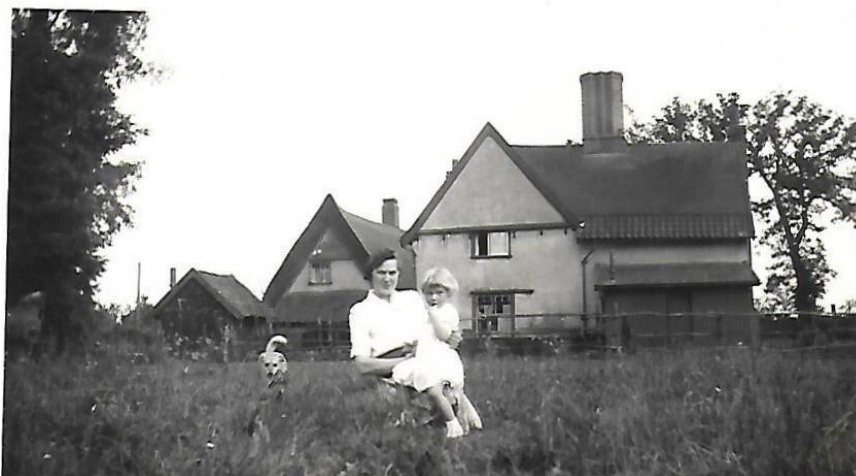
Picture 8. Historic Photo of Oak Farm from approx. 1940 showing the north facing gable end window on the ground floor in the middle of the room.

- 4.8 The location of the north facing gable end window is also telling that Wall B was a later addition as the window is located in the corner of the room. The photo below is from approximately 1940 and shows that the current location for the North gable end window, that has always been located in the middle of the gable consistent with its current position.
