**Glaven Ecology**

## Protected Species Survey

Linda,  
Aylmerton

Reference: 2040-MB

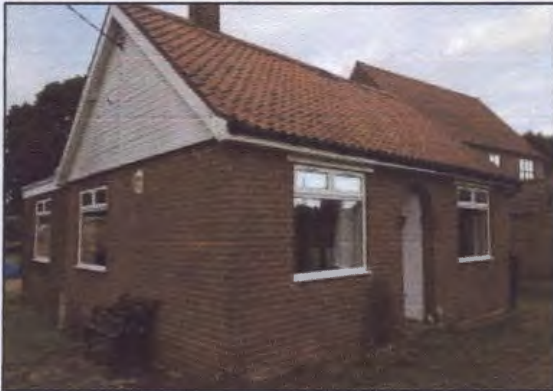
Figure 1: Linda - southern and western aspect

4.3.4 The bungalow was a detached 1970s brick structure with a pantile roof with a flat roof extension to the rear (Figure 1).

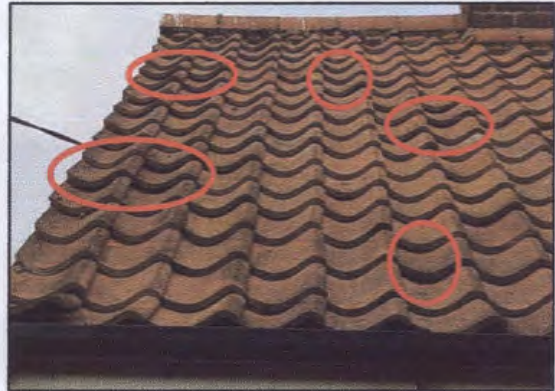
Figure 2: Close up of southern aspect roof at western corner, lifted tiles circled.

4.3.5 The ridge tiles were all well sealed, but there were raised pantiles on both aspects of the roof.

4.3.6 The main area of raised tiles was on the southern aspect in the west corner. There were also raised tiles around the base of the chimney on the southern aspect (Figures 2 and 3). There was no flashing at the base of the chimney.

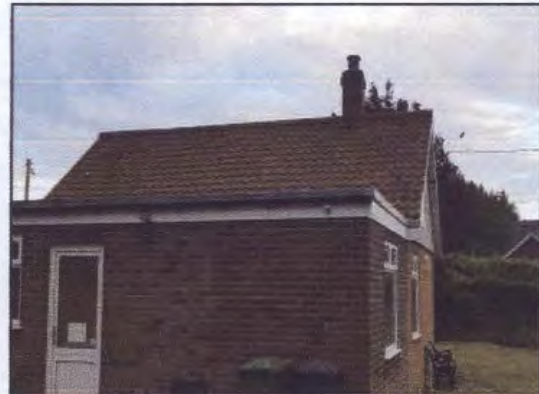
Figure 4: Northern aspect with flat roof extension.

4.3.9 The flat roof extension was well sealed with what looked like a fibre glass covering (Figure 4). There were cobwebs around the fascia where it met the wall, no gaps were present.

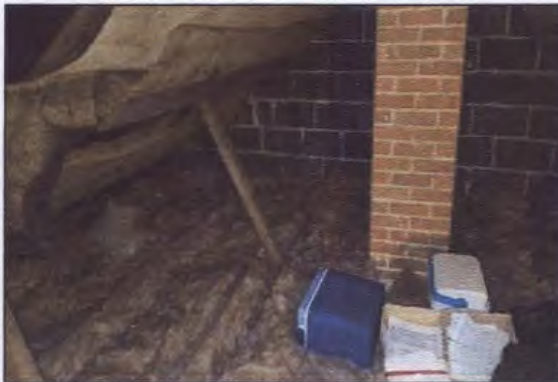
Figure 5: Loft space.

4.3.12 The loft was one space spanning the whole bungalow (Figure 5). It was very warm at the time of the survey.

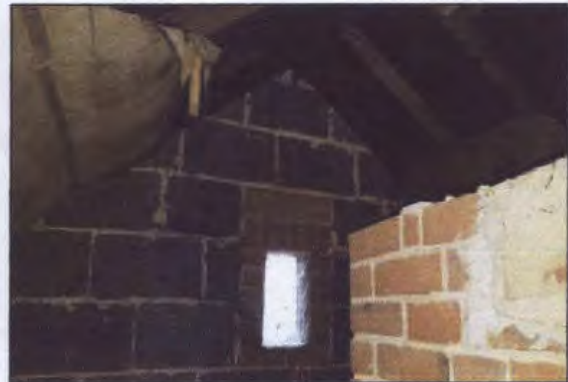
Figure 6: Eastern gable end window.

4.3.13 There was a small window in the western gable (Figure 6) end letting in some light with another small point of light ingress through the lining in the south westernmost corner.

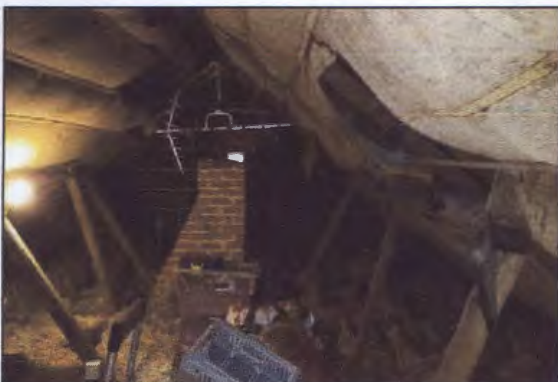
Figure 7: Loft space with tom felt to right of picture and cut of chimney in centre.

4.3.14 There was one layer of loose lining with tears and gaps in (Figure 7) with a second layer of lining underneath which appeared to be in a relatively good state of repair, where visible.

4.3.16 The breezeblock at each gable end was in good condition. The chimney breast brickwork was in sound condition. There was also a cut off chimney breast finishing in the loft space (see Figure 7). The cut off chimney inside was intact, dusty and no visible roosting opportunities were noted.

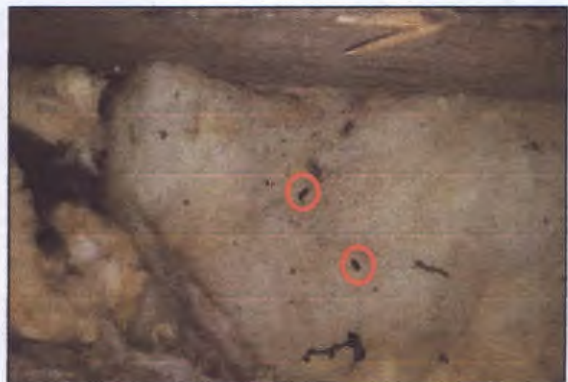
Figure 8: Old pipistrelle droppings

4.3.17 There were two old pipistrelle droppings on the insulation in the western corner of the loft (Figure 8). There were also a number of mice droppings in the loft, but again, these were not fresh.

There were two old pipistrelle droppings at the western end of the loft space, but no other signs were found. There was one possible access point through the felt lining, but this appeared cobwebbed. There were no obvious roosting opportunities within the loft space itself.

4.3.20 The bungalow was assessed as having **moderate potential** to support roosting bats.

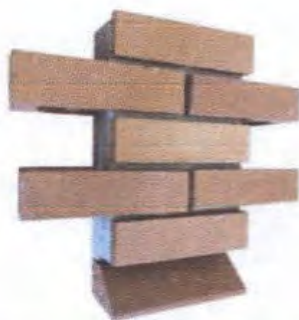
Figure 9: Habitat integrated bat box with brick finish.

- *Integrated bat box.* These are built into the fabric of the property and come in a variety of designs depending on the materials being used. For example, the Habibat bat box comes in a selection of designs to suit brick built buildings (Figure 9), whilst the Schwegler bat tube (Figure 10) is designed to be installed beneath a rendered surface. This makes it ideal for situations where you wish the box to be discrete as only the entrance hole will be visible. It can also be painted to match your building with an air permeable paint if desired.

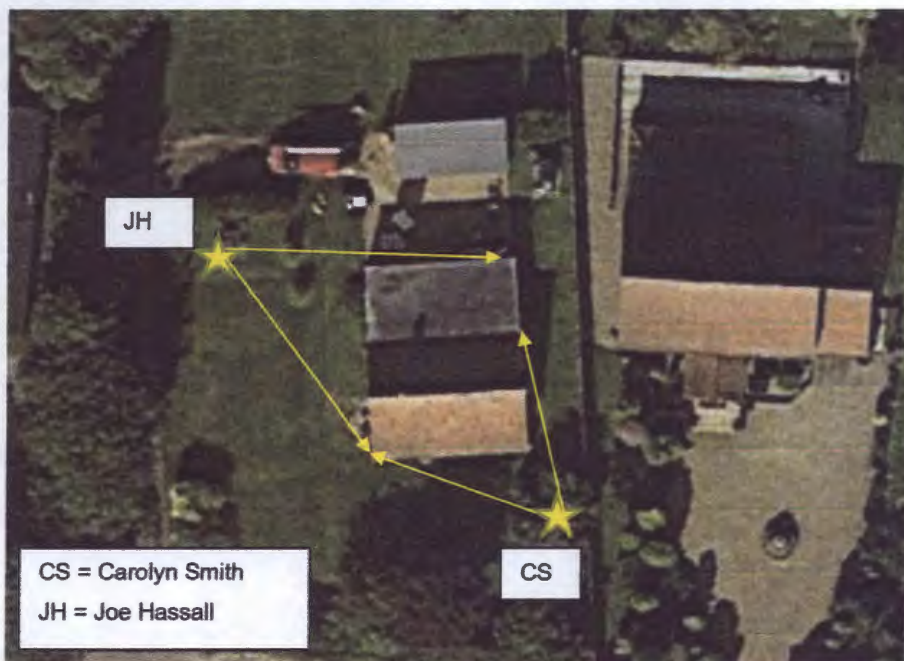
### Surveyor Locations:

3.2.8 Bat species were detected and analysed using Echo Meter Touch2 detectors with automatic recording facilities. Surveyor locations are indicated in Appendix 3. Bat calls were analysed using AnalookW and Kaleidoscope software.
