Our Ref: BEK-20750-2-211202-WCL

Victoria Street, Cloughfield, Rawtenstall– Site Investigation

BEK Enviro (BEK) have been commissioned by Wellbuilt Construction Limited to undertake an intrusive site investigation at the above site to determine depth to bedrock at selected locations and to recover samples of made ground/superficial strata to inform waste classification.

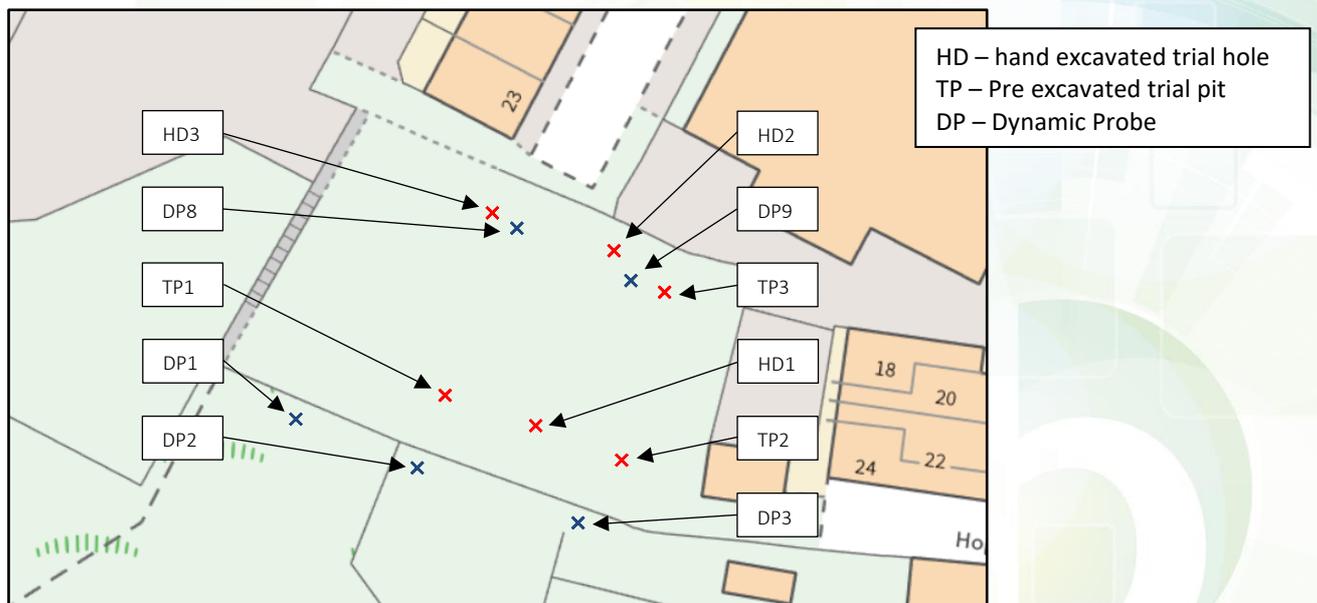
Figure 1: Approximate Exploratory Locations

The approximate Trial Pit and Borehole locations are illustrated in Figure 1 below:

Five dynamic probing boreholes were drilled at locations shown in Figure 1 to a maximum depth of 13.3 m. Drilling could not be carried out in the centre of the site due to the soft and steep ground conditions preventing access for the drilling rig. The SPT results of the dynamic probing boreholes are shown in Annex C.

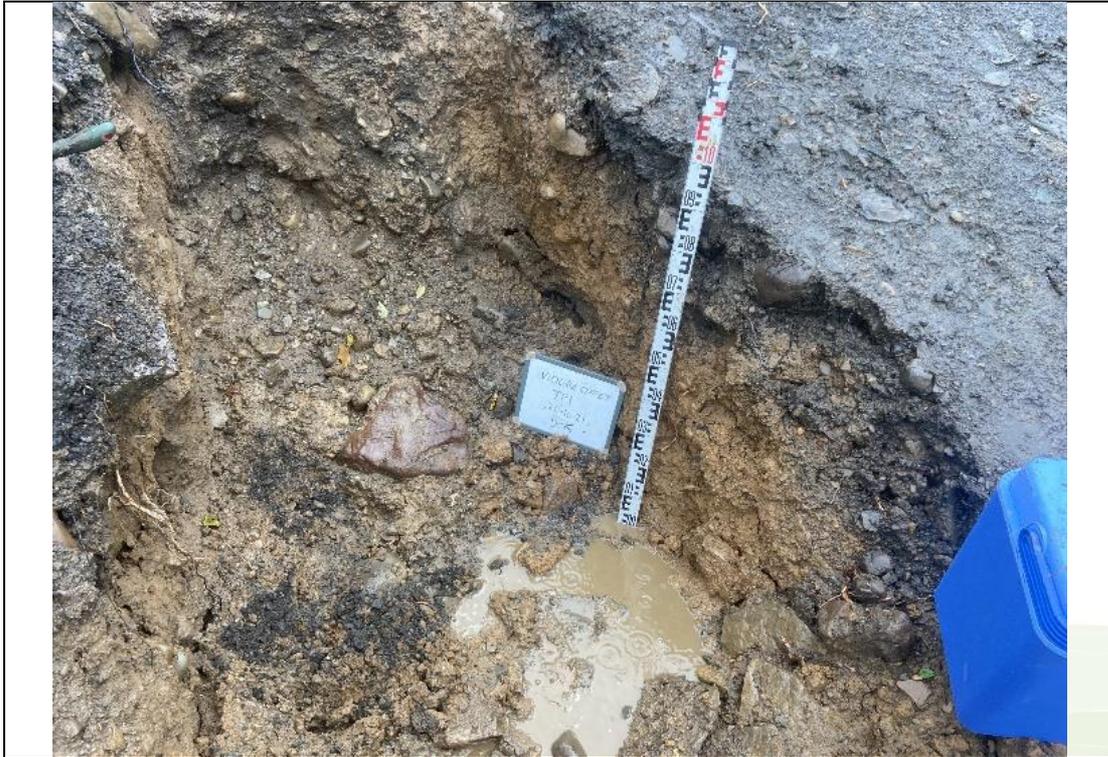
Photograph 1: Trial Pit TP1

- “Dark brown sandy silty gravelly CLAY with occasional cobbles and roots” – This strata was encountered from the ground surface in Trial Pits TP1, TP2, TP3, HD1 and HD2 down to depths ranging from 0.02 to 0.6 m. Varied content of deleterious material was encountered in this strata including slate, brick fragments, clay pottery, ceramics, stone flags and tiles.
- “Dark brown clayey silty SAND with frequent fine to coarse gravel and cobbles and roots and occasional boulders and rare brick, metal, plastic, rope and glass” was encountered from the surface to 0.4 m bgl in Trial Pit HD1 .
- “Light brown very clayey and gravelly SAND with frequent cobble and occasional boulders and roots” was encountered underlying the topsoil/madeground in Trial Pits TP1, TP2, and HD1 down to the base of the pits (0.4 m for HD1 and 1.0 m for TP1 and TP2).
