# Heritage Impact Assessment

## Cobble Cottage, Lerryn

23<sup>rd</sup> May 2022

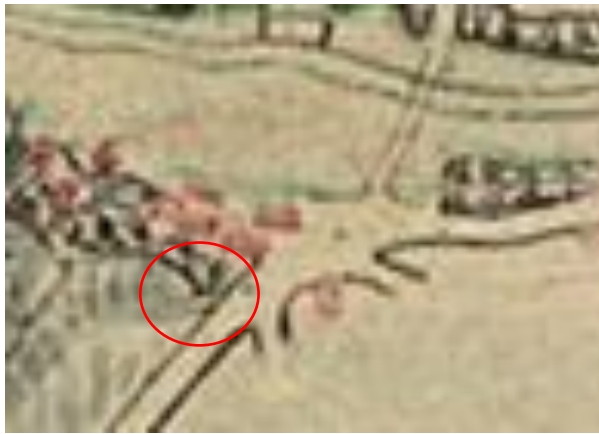
Fig 1: 1805 OS Drawing

The 1803 OS drawing (figure 1) shows the street plan around Lerryn in a similar configuration as found today. However a bridge runs across the creek in a more westerly location at this time. There is evidence of development along the lane where Cobble Cottage is located and it is possible that Cobble Cottage would have been built by this time.

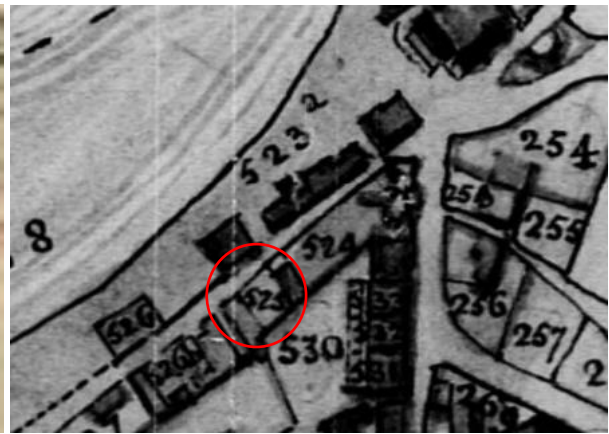
Fig 2: 1839 Tithe Map

The 1839 tide map (figure 2) shows a similar developmental status with the spelling *Lerren*. Plot 525 referred to as a cottage, owned by William Rashleigh and occupied by Henry Rowe. This is presumed to relate to Cobble Cottage and the remaining terrace giving way to the lime kiln to the east is in place.

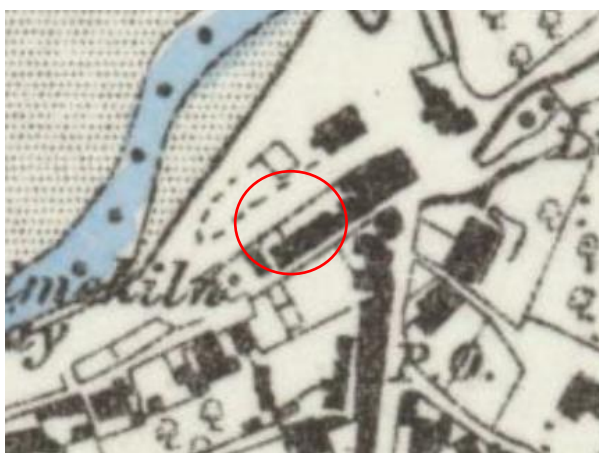
Fig 3: 1881 OS Map

The 1881 OS map (figure 3) shows the terrace and its footprint in a more complete form and the lime kiln to the east is clearly labelled. The footprint of Cobble Cottage is evident without the front extension found today.

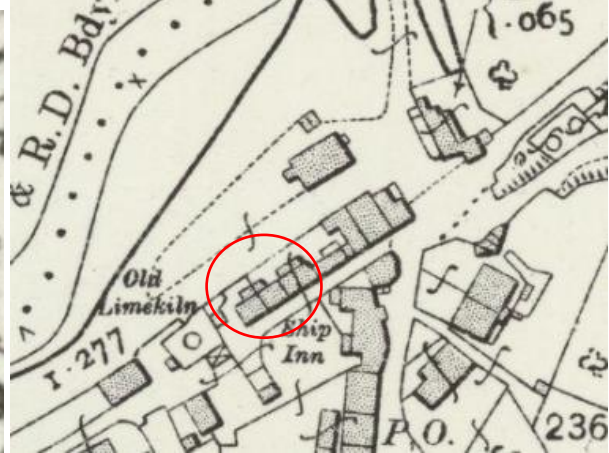
Fig 4: 1905 OS Map

The 1905 OS map (figure 4) again shows Cobble Cottage with a small front projection which has presumably since been replaced. The Ship Inn is also identified to the south within this map.

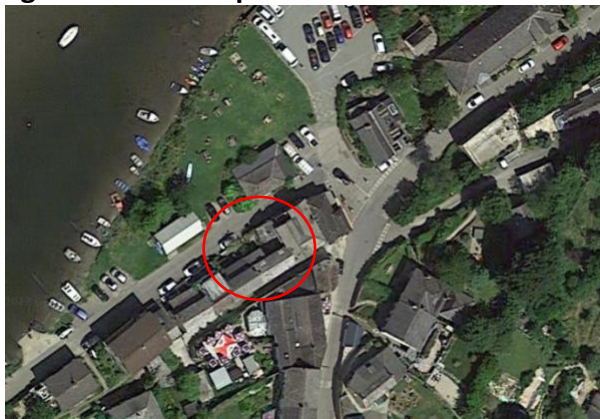
Fig 5: Modern Satellite image

The satellite image (figure 5) shows the situation as found today with the large dormer to the north side of Cobble Cottage evident with its imposing flat roof design. It is assumed that the front projection was added at some point in the mid C20.
