Phase 2: Site Investigation

Farmer Ward Road, Kenilworth

PHASE 2 SITE INVESTIGATION REPORT

FARMER WARD ROAD, KENILWORTH

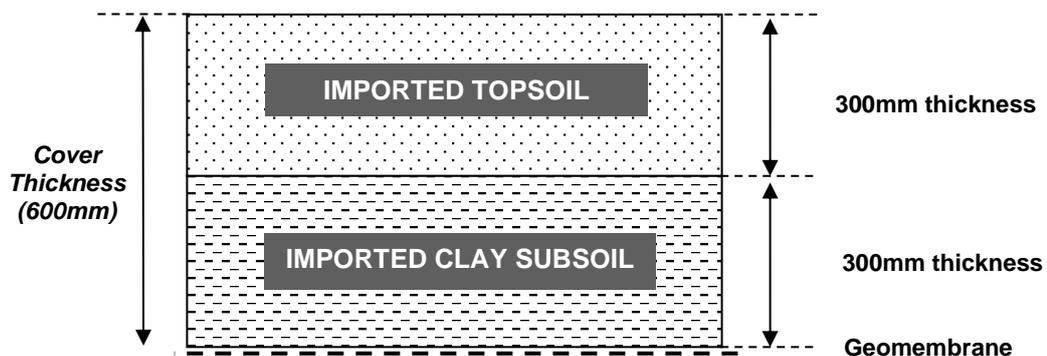
The diagram below gives an overview of the minimum thicknesses of clean cover that should be placed by the site operatives in soft landscaped or garden areas. The thickness of capping was selected due to the proposed end use as gardens with shallow rooted shrubs.

The cover system should include imported clean topsoil to a depth of 300mm over imported clean subsoil to 300mm. Appropriate certification would be required to ensure that the onsite or imported materials are clean and free from deleterious materials in accordance with the Local Authority Guidelines ‘*Verification Requirements for Cover Systems, Technical Guidance for developers, Landowners and Consultants*’ (Yorkshire and Lincolnshire Pollution Advisory Group Version 3.4 – November 2017).

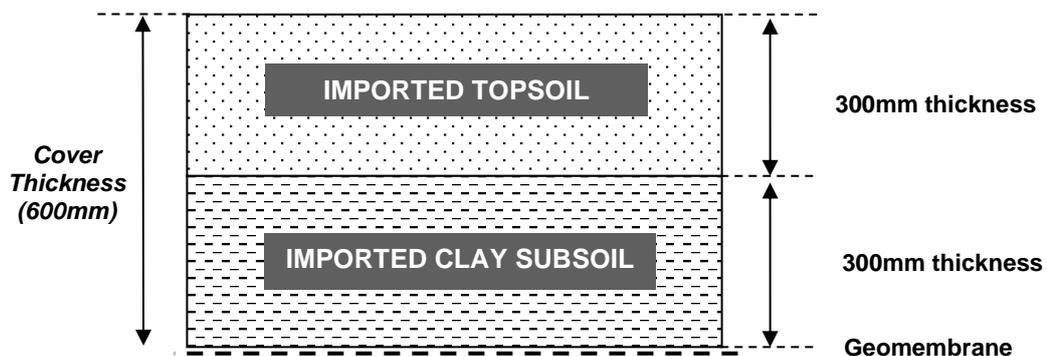
The diagram below gives an overview of the minimum thicknesses of clean cover that should be placed by the site operatives in soft landscaped or garden areas. The thickness of capping was selected due to the proposed end use as gardens with shallow rooted shrubs.

The cover system should include imported clean topsoil to a depth of 300mm over imported clean subsoil to 300mm. Appropriate certification would be required to ensure that the onsite or imported materials are clean and free from deleterious materials in accordance with the Local Authority Guidelines ‘*Verification Requirements for Cover Systems, Technical Guidance for developers, Landowners and Consultants*’ (Yorkshire and Lincolnshire Pollution Advisory Group Version 3.4 – November 2017).

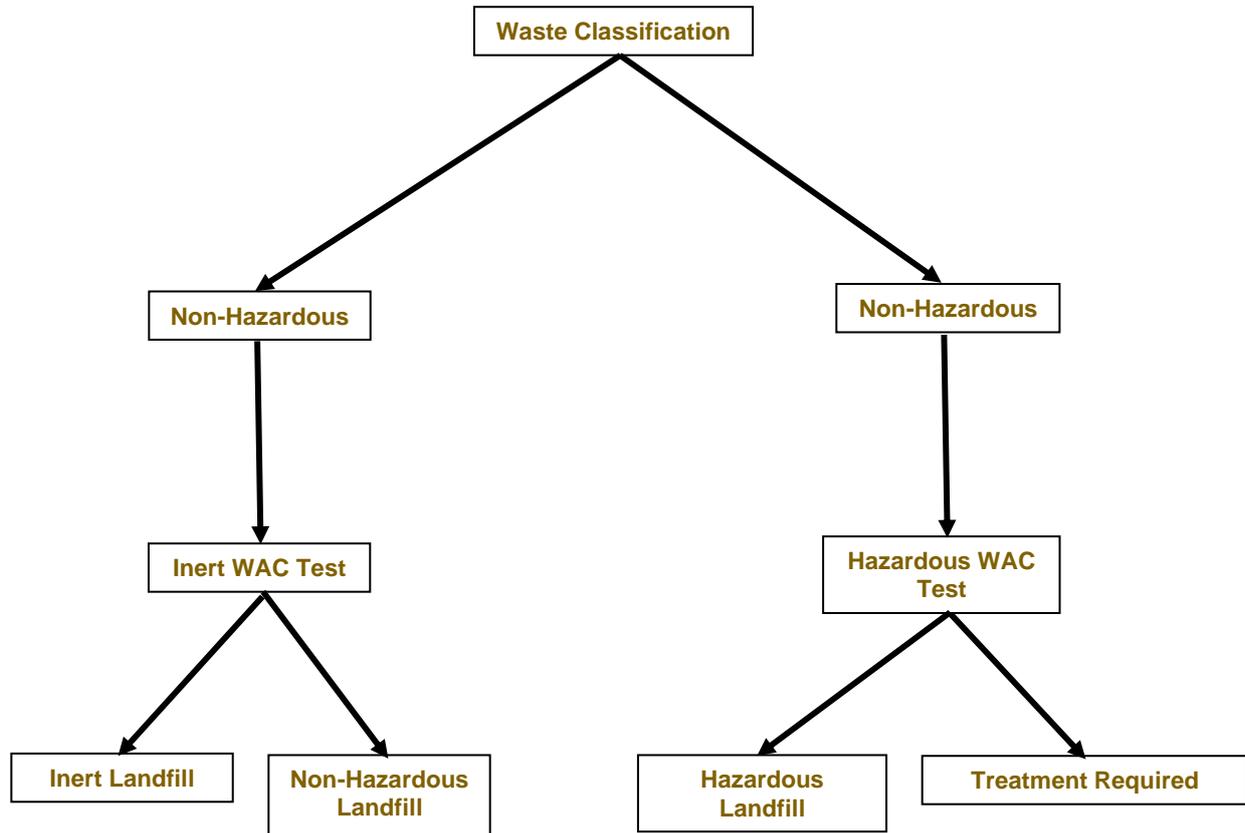
The below flow chart provides further information on the waste classification process.
